RE: Dominion Energy CVOW Pilot Project – Revised Protected Species Observer (PSO) Monitoring Report and Pile Driving Noise Monitoring Report for WTG Construction and Observations

FINAL NOISE AND PSO MONITORING REPORT

CVOW - COASTAL VIRGINIA OFFSHORE WIND

COMBINED TRANSPORT AND INSTALLATION OF FOUNDATIONS AND WTG

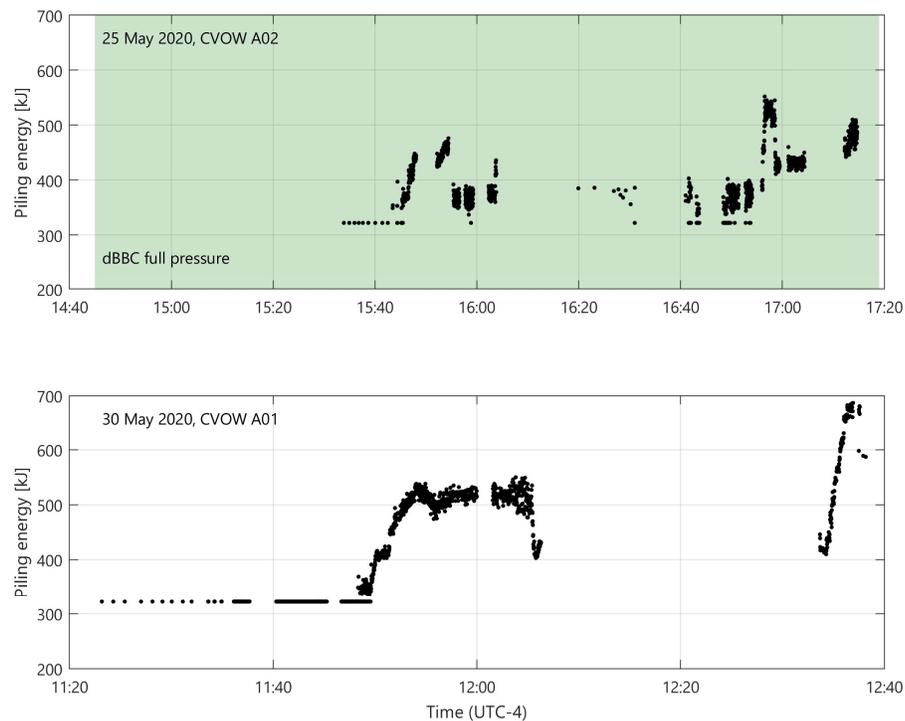
Figure 2.1 Piling energy per blow during installation of A02 and A01. The time period for which the double Big Bubble Curtain (dBBC) was on full pressure during installation of A02 is indicated in green.

The two monopile foundations (A02 and A01) for the wind turbines were installed by means of impulse pile driving, on (A02) 25 May 2020 from 15:33 to 17:14 and on (A01) 30 May 2020 from 11:23 to 12:38 (UTC-4). The IHC S-3000 hydrohammer was used to drive the monopile foundations, with a bottom diameter of 7.8 m and wall thickness of 86 mm, to a penetration depth of 37.51 m and 37.01 m for A02 and A01, respectively. The used piling energy was between 320 and 552 kJ for A02 and between 320 and 687 kJ for A01 (Figure 2.1), the total amount of blows was 1373 and 1558, respectively. Both a soft (low piling energy) start and a slow (large time period between strikes) start were used to reduce the noise impact by giving time to marine life to increase their distance to the piling location. Pile driving of foundation A01 was paused from 12:05 to 12:31 (Figure 2.1) for a survey check calibration to verify the pile height, the duration of this pause (26 min.) was shorter than 30 minutes and a soft start after the pause was thus not necessary.

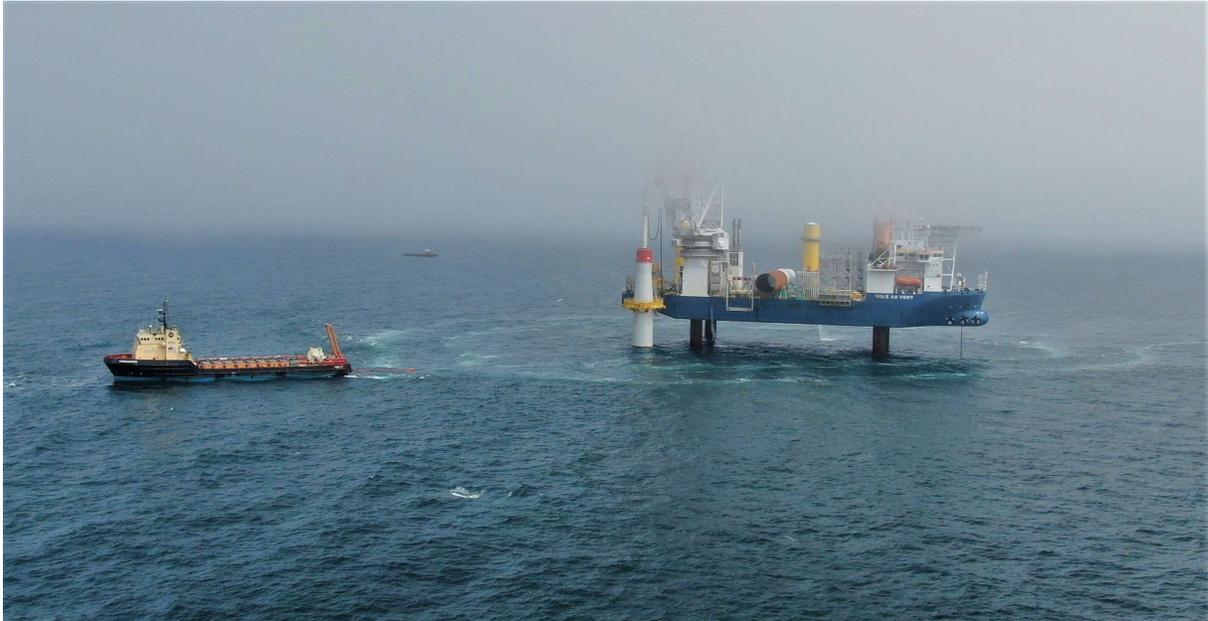
Figure 2.2 The double Big Bubble Curtain (dBBC), deployed and operated from the M/V Commander, during the installation of monopile A02.

During the installation of A02, a double Big Bubble Curtain (dBBC) was deployed to reduce underwater noise levels during the piling procedure. The dBBC consists of two hoses (an inner and an outer hose) with nozzles (diameter of 1.5 mm and distance of 250 mm) that are laid on the seabed and both fully encompass the monopile foundation (Figure 2.2). During the piling procedure, these hoses are connected to air compressors that are located on the Noise Mitigation Vessel (NMV). Air bubbles leave

the hose nozzles and rises as air bubbles to the water surface, thus forming a bubble curtain. The minimum distance between the monopile foundation A02 and the location of the hoses was 84 and 124 m for the inner and outer hose. The 16 compressors that fed both the inner and outer hose were on full pressure between 14:45 and 17:19 (UTC-4), see Figure 2.1, and inserted $0.35 (\pm 0.03) \text{ m}^3/(\text{min}\cdot\text{m})$ into the hoses. Monopile foundation A01 was installed without a bubble curtain.

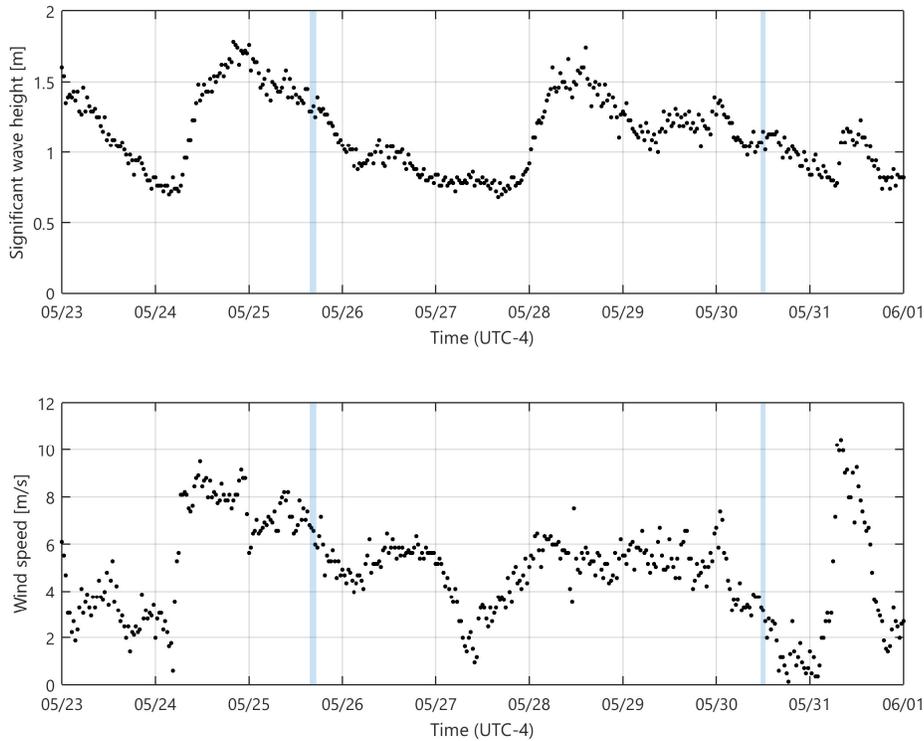
Figure 2.3 The (top) significant wave height and (bottom) wind speed during the week in which the monopiles were installed. The shaded intervals in blue indicate the time periods in which pile driving took place.

The weather and hydrodynamic conditions during the installation period were measured using a directional waverider buoy. The average wind speed was between 6 and 8 m/s during the installation of A02, and between 2 and 4 m/s during the installation of A01 (Figure 2.3). Corresponding significant wave heights were around 1.3 and 1.2 m, respectively. Tidal flow velocities in the area are relatively low, up to 0.10 to 0.25 m/s, but wind-induced flow velocities exceeded 0.5 m/s during the week in which installation took place (25 May – 01 June, Figure 2.4). Flow velocities during pile driving were between 0.15 near the bed and 0.32 m/s near the water surface during the installation of A02, and below 0.1 m/s throughout the water column during the installation of A01.

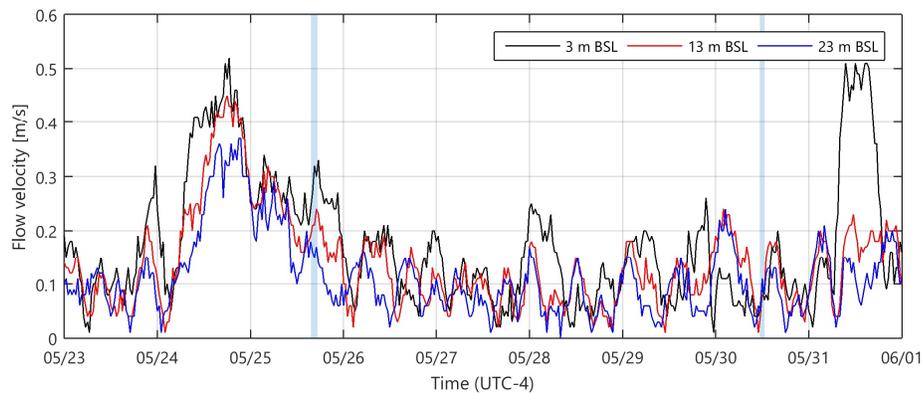
Figure 2.4 The flow velocity at (black) 3 m, (red) 13 m and (blue) 23 m below the instantaneous sea level (BSL). The lowest heights correspond roughly with the elevation of the two hydrophones. The shaded intervals indicate the time periods in which pile driving took place.

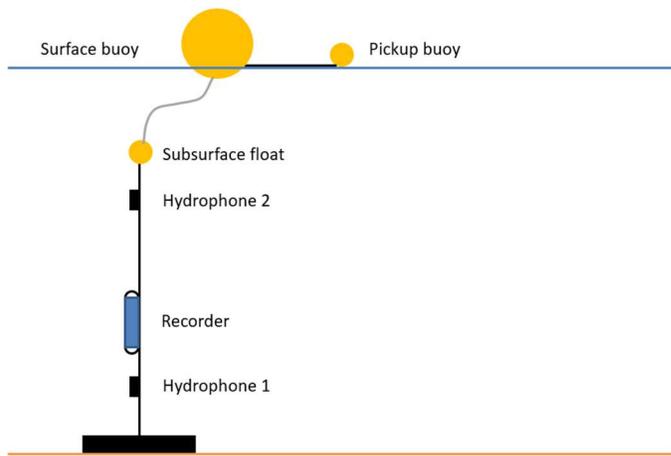
Figure 3.1 Setup of the measurement stations with a hydrophone at 12 and 1 m above the bed (not to scale).

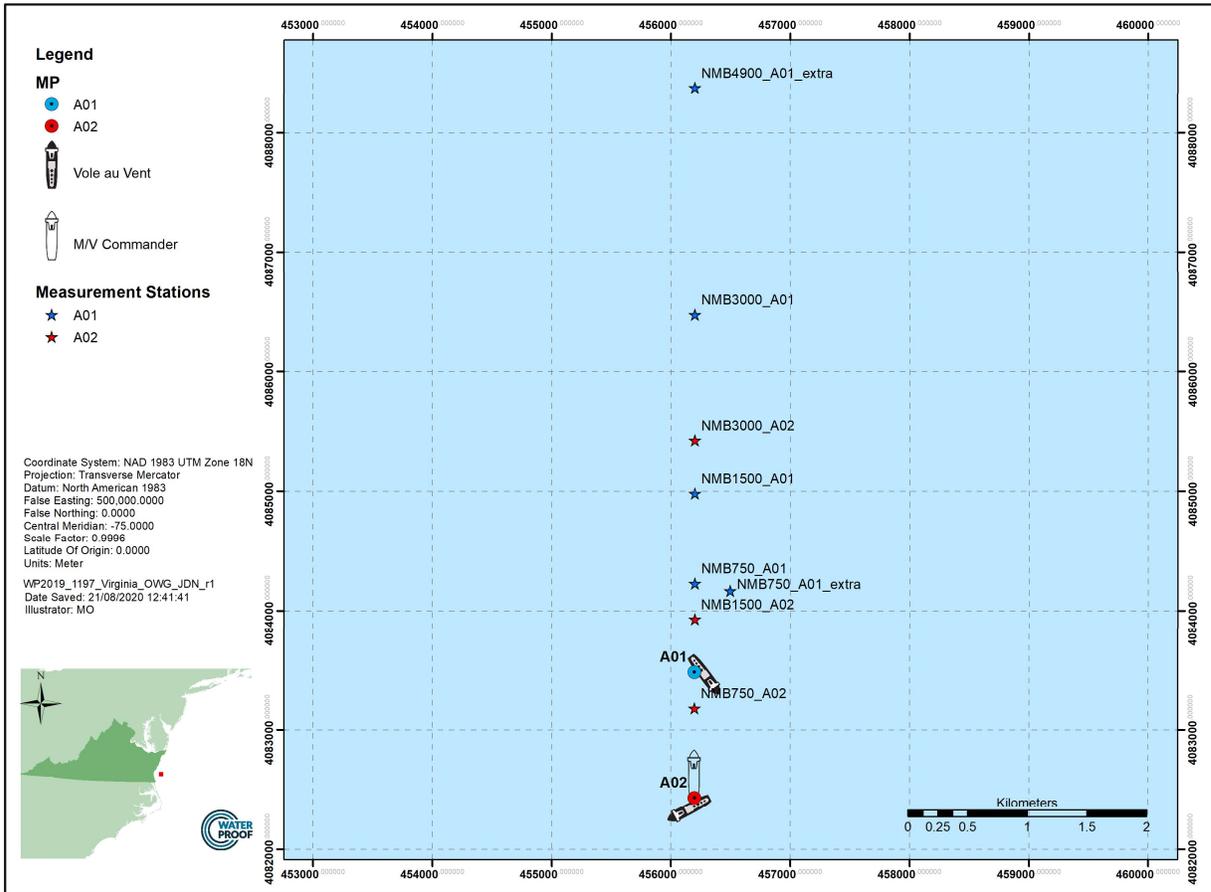
Figure 3.2 Location of the noise monitoring buoys during the installation of monopiles (red) A02 and (blue) A01. The location and heading of the installation vessel Vole au Vent (A02 and A01) and noise mitigation vessel M/V Commander (A02) during pile driving are also indicated.

While instruments were deployed at three distances (750, 1500 and 3000 m) during the installation of monopile foundation A02, measurements were not collected at 1500 m due to a technical malfunction of the underwater sound recorder. Due to this malfunction, only measurements at two locations are available for A02, limiting the calibration of the transmission loss model. To attain more input for the calibration of this model, it was decided to deploy the instrument at 4900 m for A01 as an extra location, instead of enlarging the distance of the 3000 m location. Moreover, it was decided to deploy an extra recorder at 750 m distance for redundancy. The deployment of recorders at these two additional measurement locations was only feasible as the noise mitigation vessel had ample time for the preparation and deployment of the systems prior to the piling activities, due to a weather delay and the decision to install the second pile without a bubble curtain.

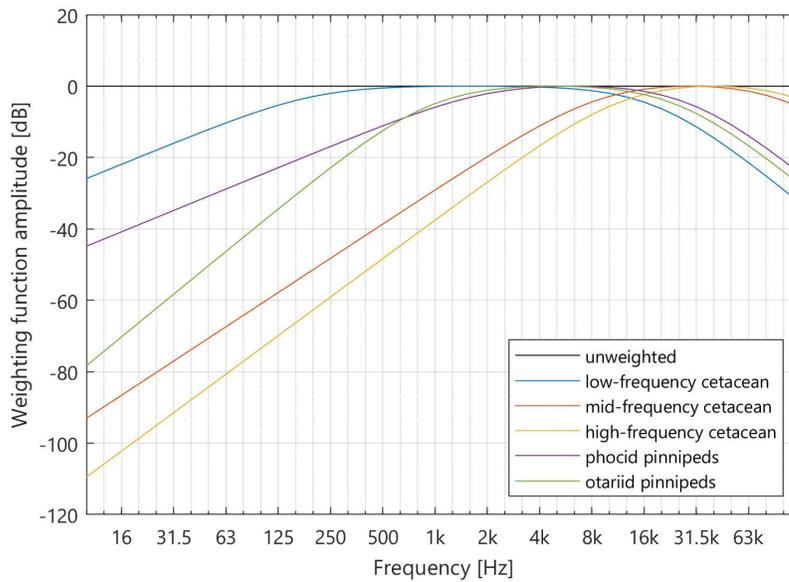
Figure 3.3 The NOAA (NOAA, 2018) frequency weighting functions for low-frequency, mid-frequency and high-frequency cetaceans, and phocid and otariid pinnipeds.

The frequency weighted cumulative sound exposure levels were estimated by first calculating the unweighted sound exposure levels over the decidecade bands between 20 Hz and 20 kHz for each piling blow. Background noise levels were calculated for the 5-minute period before the first piling blow, with an integration time equal to the average duration of a piling peak for that location. To avoid the inclusion of background noise in the frequency weighted cSEL values, individual SEL values that did not exceed the background levels in the same decidecade frequency band were not included (following Tougaard and Dähne, 2017). The values that did exceed the background level were weighted using the different auditory weighting functions in Figure 3.3 and summed over the duration of the installation of one foundation to attain the $cSEL_{fw}$ for each measurement location.

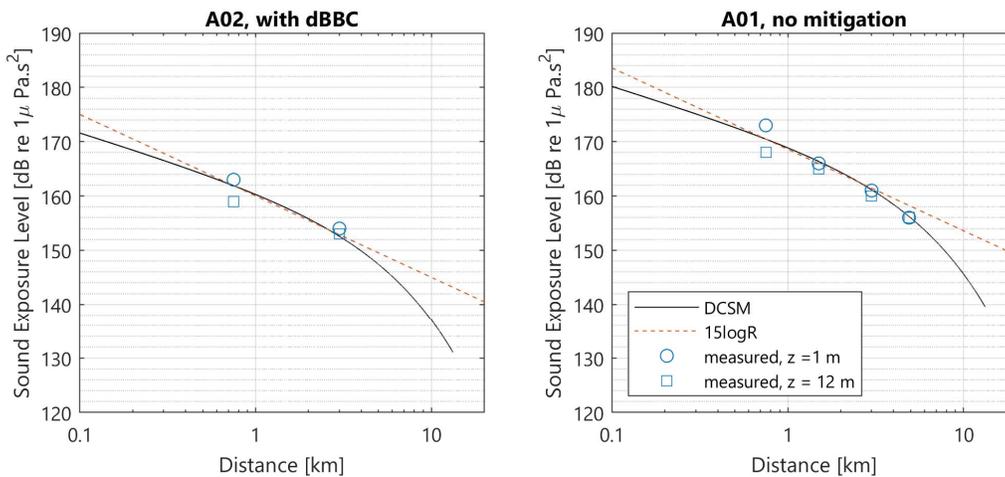
Figure 3.4 Modeled versus measured unweighted 5% exceedance single-strike sound exposure levels (SELs) for the installation of foundations (left) A02 and (right) A01.

The bottom reflection coefficient is related to seabed sediment characteristics as the bulk density, the sound speed and damping coefficient. The DCS model is valid for a range up to $\alpha r < 20$ dB (Haeney et al., 2020), as near-horizontal propagating sound is more important than the Mach cone at larger distances. The decay factor here is $\alpha = 1.47$ dB/km and the DCS model can thus be applied up to 13.6 km distance from the sound source (Figure 3.4).

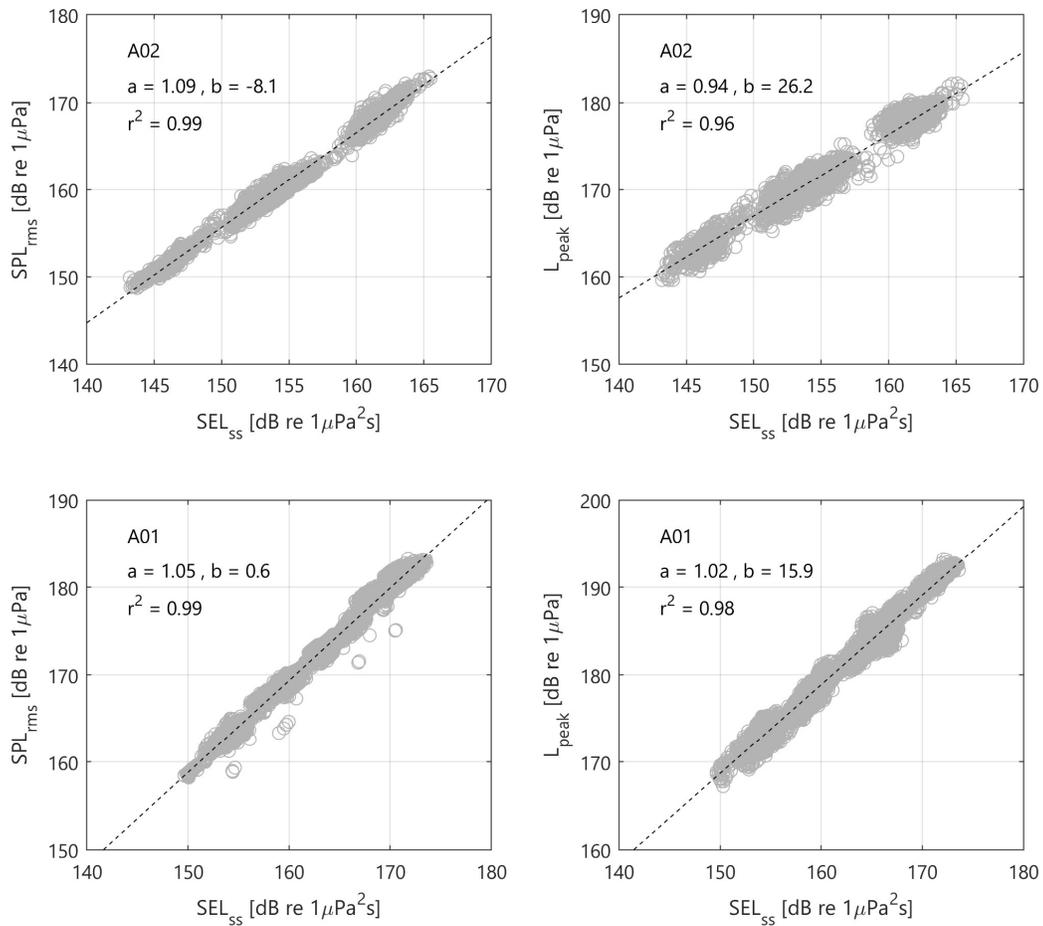
Figure 3.5 Regression analyses for the (left) SPL_{rms} and (right) L_{peak} versus SEL_{ss} for (top) A02 and (bottom) A01.

The estimated transmission losses are not directly applicable to SPL_{rms} and L_{peak} values, as the model only determines the transmission loss for L_E . There is, however, a site-specific linear relation between L_E and these parameters (Martin and Barclay, 2019; Ainslie et al. 2020). Linear regression was carried out for both monopiles using the measured SEL_{ss} , SPL_{rms} and L_{peak} for all individual blows. Correlation coefficients were $> r^2 > 0.96$ for all regression analyses (Figure 3.5). Similar linear regression analyses was conducted to determine the decay of the frequency weighted SEL values, following Martin and Barclay (2019). Source levels for all acoustic metrics that are calculated with the DCS model are given in Table 3.3.

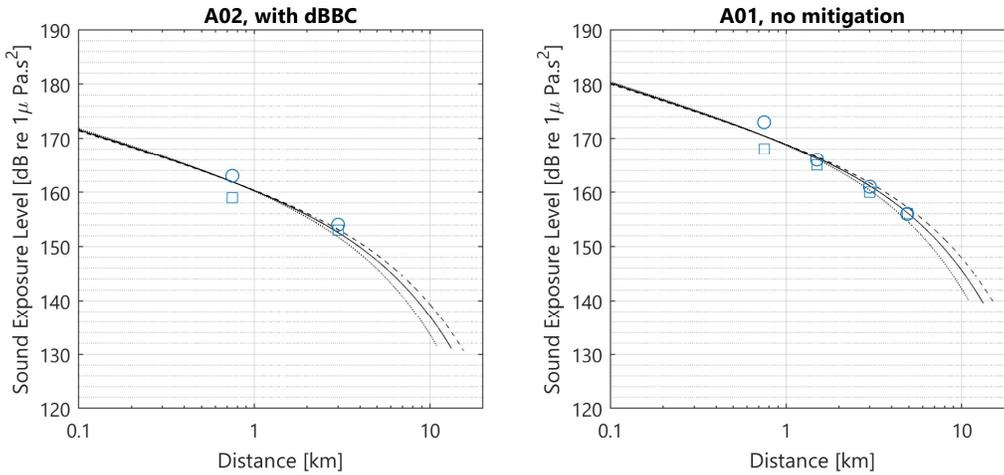
Figure 3.6 Sound exposure levels (SELs) modeled for the water depth of (dotted line) 20, (solid line) 25 and (dashed line) 30 m versus measurements.

The DCS model does not include effects of variable bathymetry over range, but the seabed around the monopiles is relatively flat. From the location of the monopiles to a distance of 10 km, the water depth increases/decreases with maximum 5 m. This gives minimal differences in modelled sound exposure levels (Figure 3.6). Earlier studies for this area showed that due to this minimal variation in water depth surrounding the monopiles, main uncertainties in the spatial spreading of sound at larger distances are related to unknown heterogeneity in the seabed sediments (e.g., Haeney, 2020). Uncertainty in the directional variability in SEL levels is further increased with the application of a dBBC, which typically introduces up to 2-3 dB directional variability in the SEL levels.

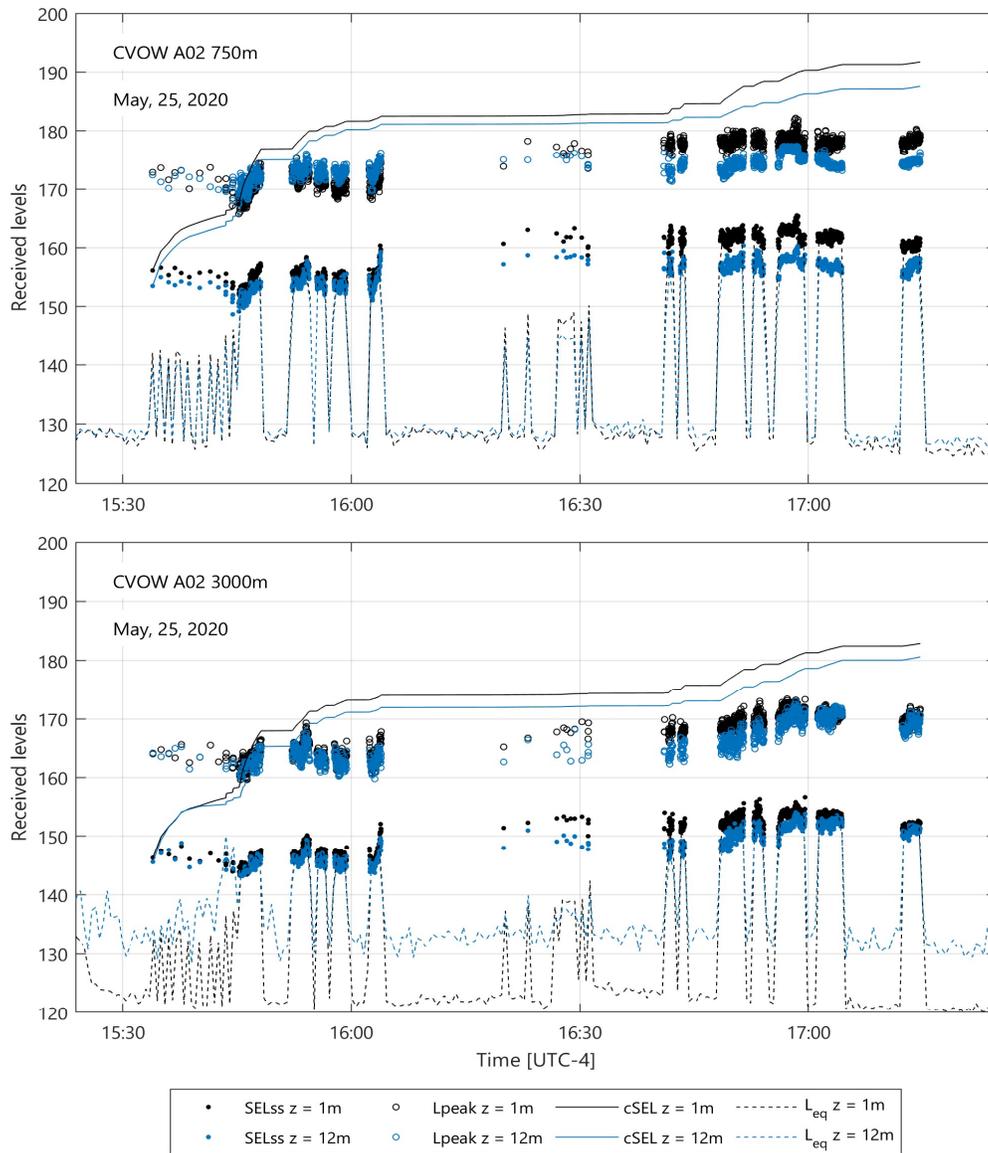
Figure 4.1 Sound levels measured at a distance of 750 and 3000 m, during pile driving monopile foundation A02. Units for SEL_{ss} and $cSEL$ are in dB re $1 \mu Pa^2s$, for L_{peak} and L_{eq} in dB re $1 \mu Pa$.

During the piling procedure to install monopile foundation A02, measurements at two distances, i.e. 750 and 3000 m, were collected (equipment was also installed at 1500 m distance, but no measurements were collected due to a malfunction, see Section 3.1.2.). At both locations, two hydrophones were spaced vertically, with one hydrophone at 1 m above the bed and one hydrophone in mid water depth, i.e. 12 m above the bed. During the installation of this foundation, noise levels were reduced using a dBBC.

During the second half of the piling procedure (from 16:40), sound levels at the lower and higher hydrophone start to deviate at 750 m distance. The difference in SEL_{ss} is up to 6 dB re $1\mu Pa^2s$, which is higher than differences that were typically observed in earlier studies. This is also reflected in the statistics in Table 4.1. It is unclear what caused the sound levels to deviate in the second half of the piling sequence, a smaller deviation was also observed at 750 m during the installation of the second foundation A01.

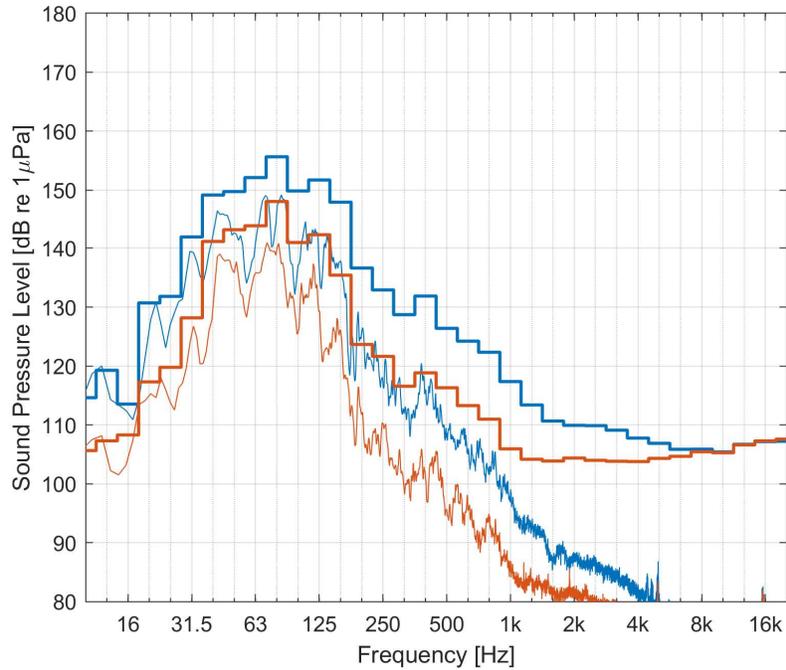
Figure 4.2 Sound pressure level in decade and narrow frequency bands averaged over 30 seconds at (blue) 750 m and (red) 3000 m distance from piling location A02. The averaging block was taken around 17:13 (UTC-4) and contained 27 detected piling blows (blowrate=54 blows/min).

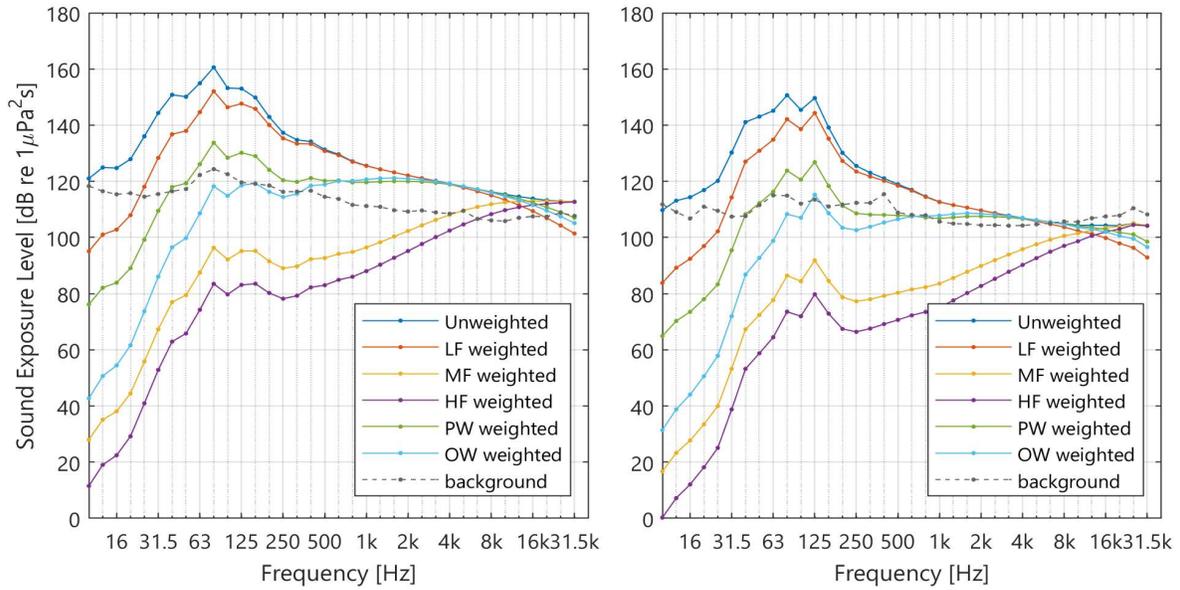
Figure 4.3 The 5% exceedance values of the sound exposure level for the decade frequency bands for the individual piling blows at (left) 750 m and (right) 3000 m distance from piling location A02. In grey the background noise level.

To calculate frequency weighted sound exposure levels, only the levels of the individual piling blows were included when these exceeded the background level at the particular frequency. This is illustrated in Figure 4.3, which shows the 5% exceedance value of the unweighted SEL (blue line) for each decade frequency band. At 750 m distance, the 5% exceedance value exceeds the background level for all frequencies, while at 3000 m this is only true up to 4 kHz. The resulting frequency weighted cSEL values are included in Table 4.2.

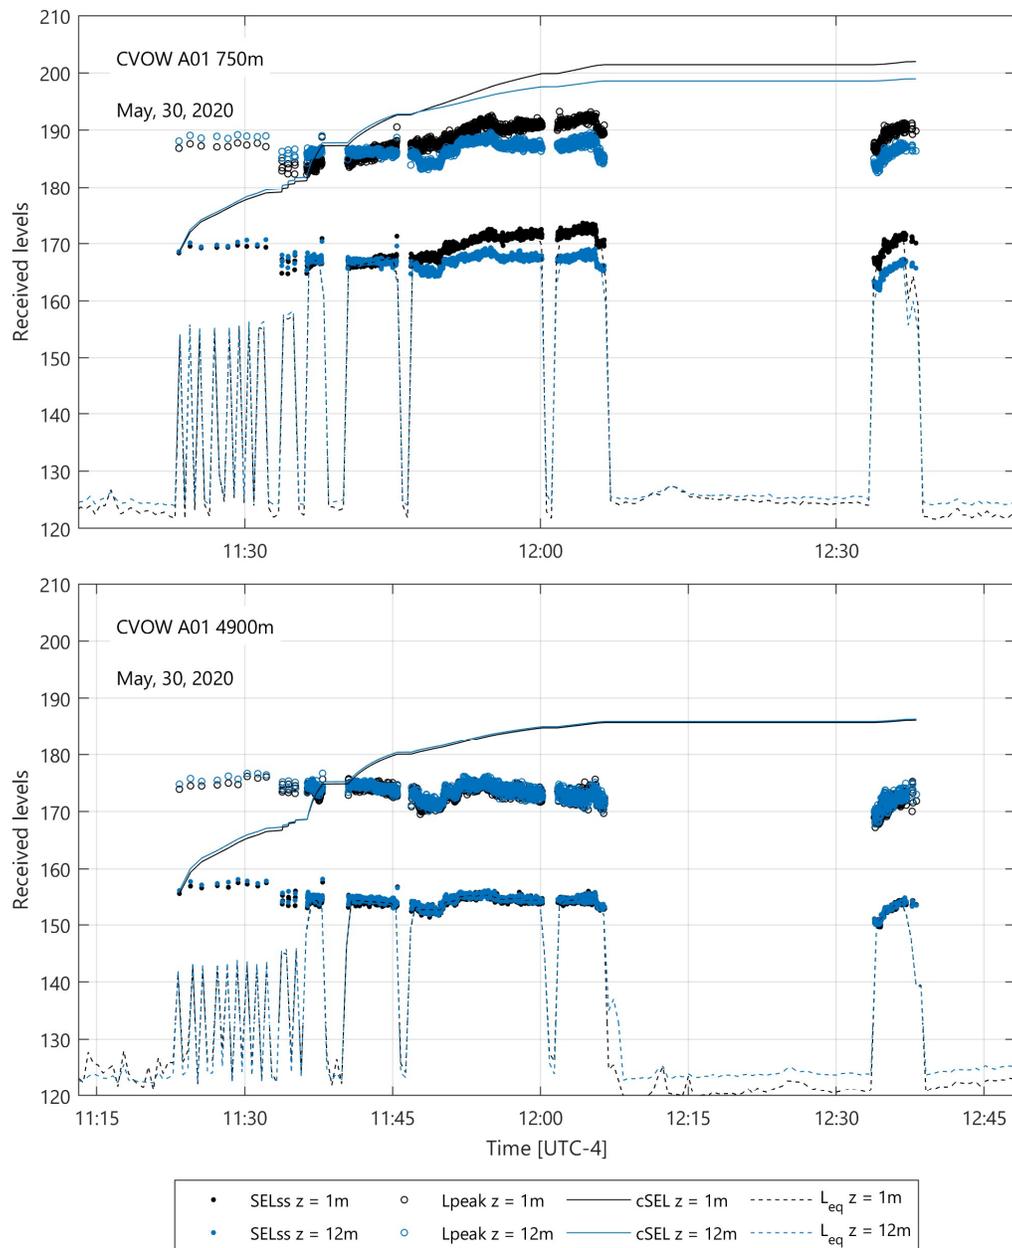
Figure 4.4 Sound levels measured at a distance of 750 and 4900 m, during pile driving monopile foundation A01. Units for SEL_{ss} and cSEL are in dB re 1 μPa^2s , for L_{peak} and L_{eq} in dB re 1 μPa .

Noise levels, SEL_{ss} and L_{peak}, for the individual piling blows are visualized in Figure 4.4 for both hydrophone depths in black (1 m above the seabed) and blue (12 m above the seabed). Continuous sound levels (L_{eq}) calculated over 30 seconds are shown over the full piling period as dashed lines and show the difference between periods that include and exclude piling noise. Solid lines represent the cumulative sound exposure levels (cSEL_{uw}) during the piling period. As observed during the installation of A02, a difference between the two vertically spaced hydrophones occurs in the last hour of pile driving. Noise levels are slightly larger close to the bed, the difference between the hydrophones reduces with distance from the piling location.

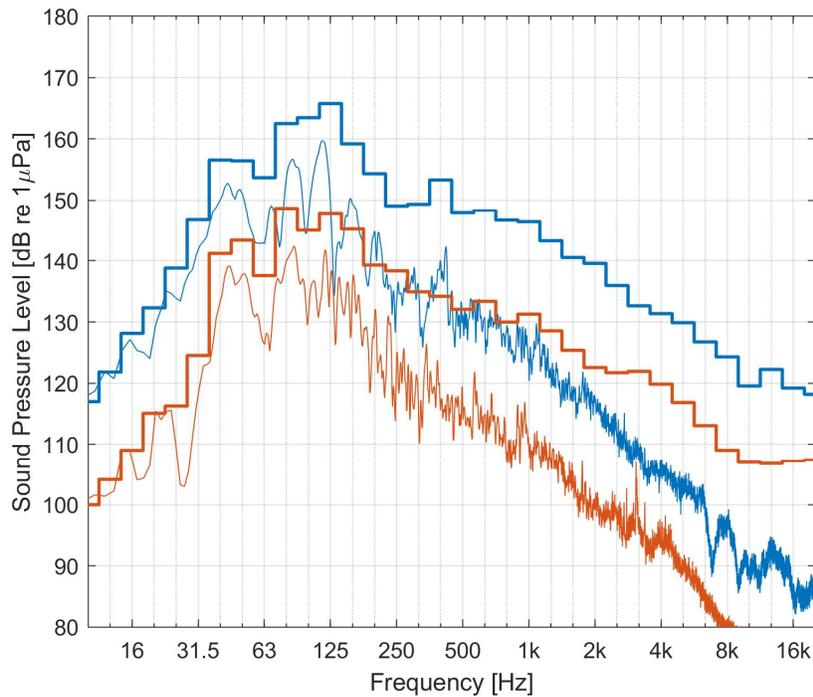
Figure 4.5 Sound pressure level in decidecade and narrow frequency bands averaged over 30 seconds at (blue) 750 m and (red) 4900 m distance from piling location A01. Averaging block was taken around 12:36 (UTC-4) and contained 28 detected piling blows (blowrate=56 blows/min).

frequencies higher than 16 kHz. The high levels in the higher frequencies directly relates with the absence of the bubble curtain during the installation of this foundation, as bubble curtains are most effective in reducing levels at higher frequencies (Bellmann, 2014). That these higher levels exceed the background level beyond the frequency range of the hydrophone setup only minimally affect calculated broadband and low-frequency weighted values, but cumulative values for the mid and high-frequency range ($cSEL_{mf}$ and $cSEL_{hf}$) are underestimated here (Table 4.4). At a distance of 4900 m, the piling noise levels are below the background level for frequencies above 16 kHz and here mid and high-frequency weighted values are thus accurate.

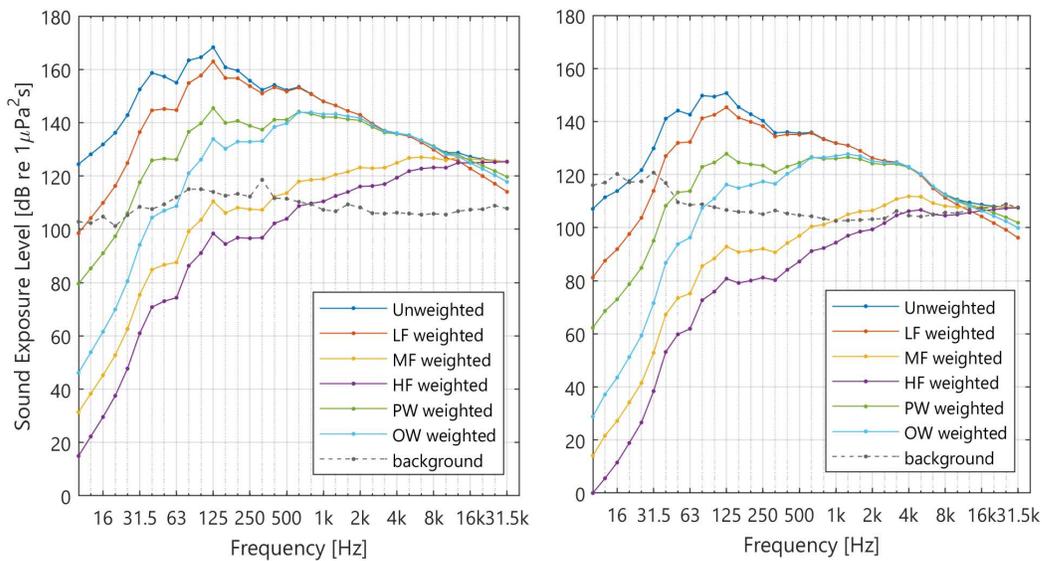
Figure 4.6 The 5% exceedance values of the sound exposure level for the decidecade frequency bands for the individual piling blows at (left) 750 m and (right) 4900 m distance from piling location A01. In grey the background noise level.

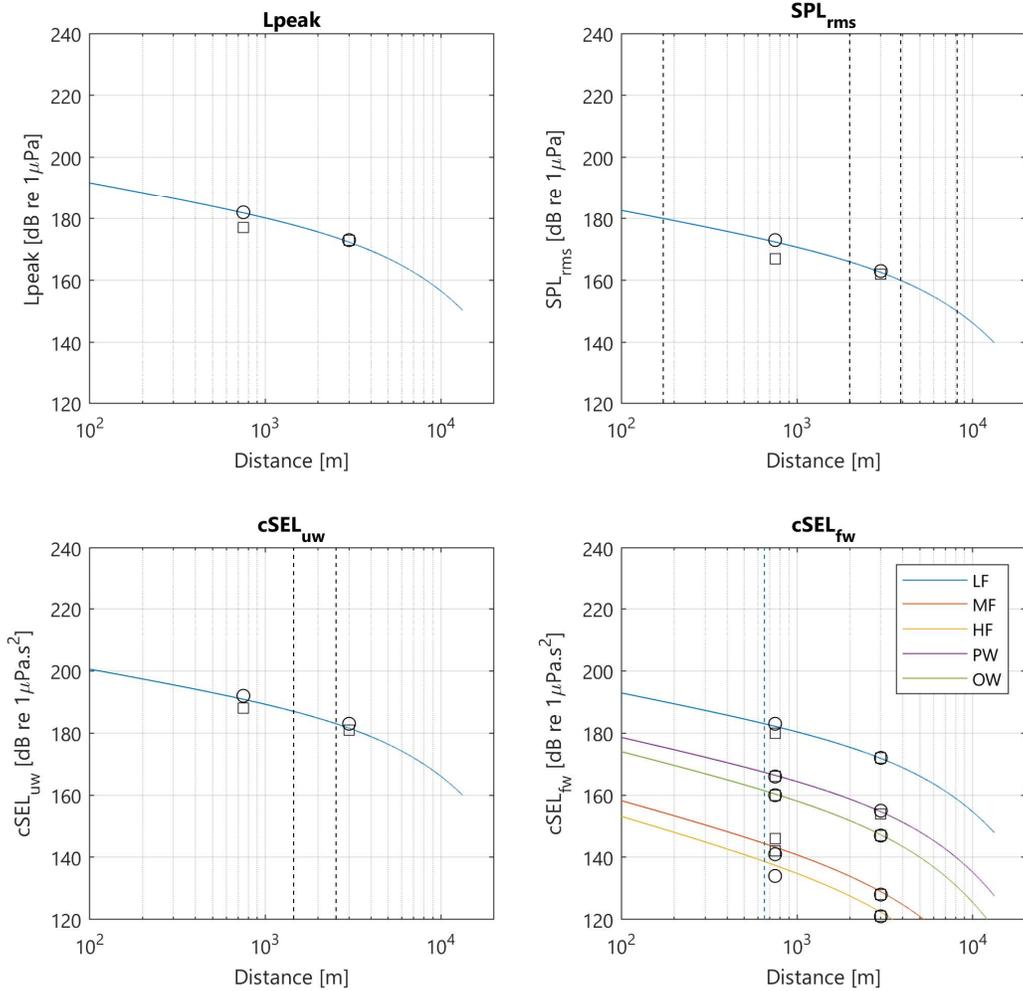
Figure 4.7 Estimation of distances to thresholds for L_{peak} , SPL_{rms} , $cSEL_{uw}$ and $cSEL_{fw}$ during the installation of A02. Vertical dashed lines represent calculated distances for Table 4.5 and Table 4.6.

Determined distances for disturbance and injury of fish, turtles and marine mammals are summarized in Table 4.5 and Table 4.6. The distances that are smaller than 100 m are not further specified, as these are within the extent of the outer bubble curtain. Estimates for actual distances within the extent of the bubble curtain can be attained from the results for monopile A01, which was installed without noise mitigation measures. Distances to sound levels that can cause injury are max. 2.5 km for fish, 0.2 km for turtles and max. 0.7 km for marine mammals. Except for the low-frequency cetaceans, the zone where the sound levels are exceeding the PTS threshold are contained within the outer bubble curtain.

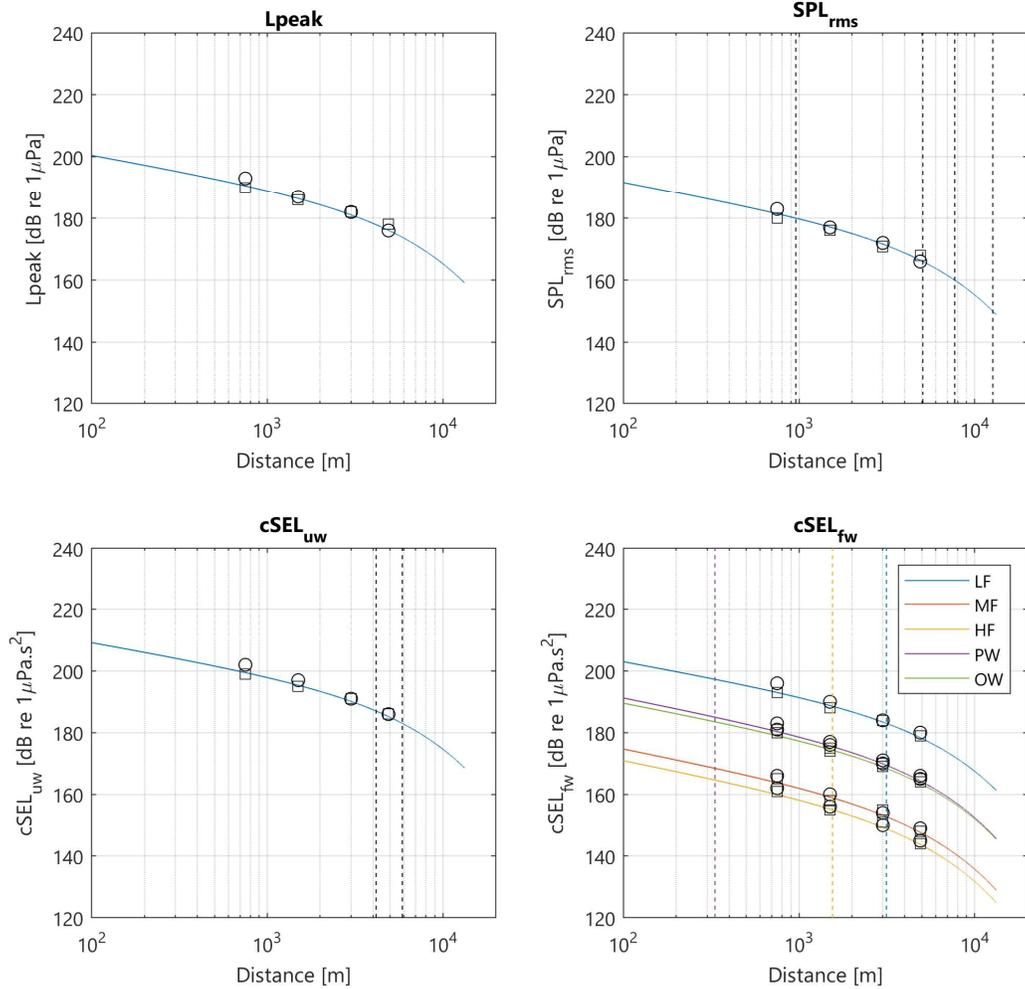
Figure 4.8 Estimation of distances to thresholds for L_{peak} , SPL_{rms} , $cSEL_{uw}$ and $cSEL_{fw}$ during the installation of A01. Vertical dashed lines represent calculated distances for Table 4.7 and Table 4.8.

Without the use of a bubble curtain, distances to disturbance and injury threshold are increased significantly (Table 4.7 and Table 4.8). Distances to sound levels that can cause injury are max. 5.9 km for fish, 1.2 km for turtles and max. 3.1 km for marine mammals. The distances to a threshold defined as a cumulative sound exposure level are based on a level that would accumulate if fish, turtles or marine mammals would remain in the same position throughout the piling procedure. This is a conservative estimate, as in reality fish, turtles and marine mammals will increase their distance to loud sound sources over time, if necessary.

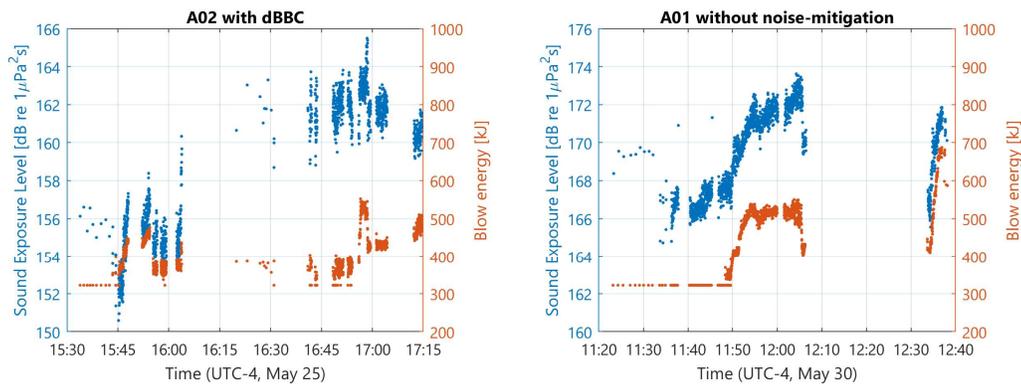
Figure 4.9 The single-strike sound exposure levels and blow energy for A02, with dBBC, and A01, without noise mitigation. The shown sound exposure levels are depth-averaged.

Underwater noise levels during the installation of a monopile foundation are related strongest to the size of the monopile, the piling energy, soil resistance and the piling procedure. The piling energy versus depth-averaged measured SEL for both monopiles is visualized in Figure 4.9. The piling procedures that were used to install both monopiles differ considerably. While monopile A01 was installed with a gradual

Values during the soft start (the first approx. 10 blows) show higher noise values than would be expected based on the blow energy, especially for A01. This is measured more often and can sometimes be ascribed to a high resistive upper soil layer, here it is unclear what causes these higher levels. In a recent extensive study (Bellmann et al., 2020) that used a large dataset of measurements collected during impulse pile driving events, a consistent explanation for the occasional higher levels during the soft start could also not be found.

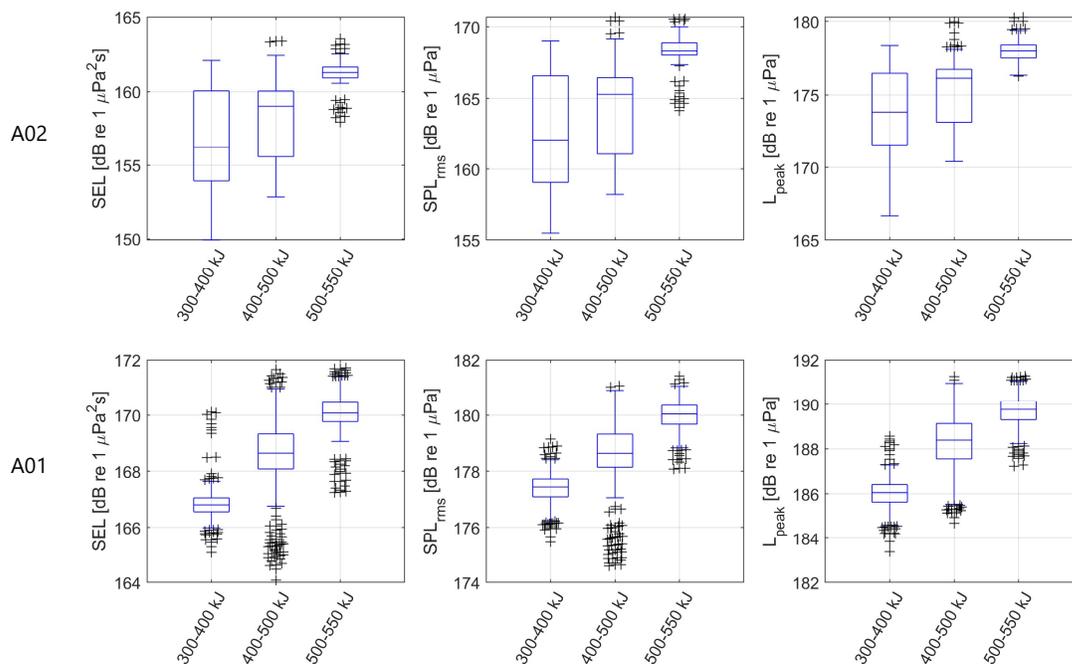
Figure 4.10 Variability of noise metrics in three classes based on the blow energy. The lines in the boxplots show the 1st, 25th, 50th, 75th and 99th percentile, outliers are shown separately as black crosses.

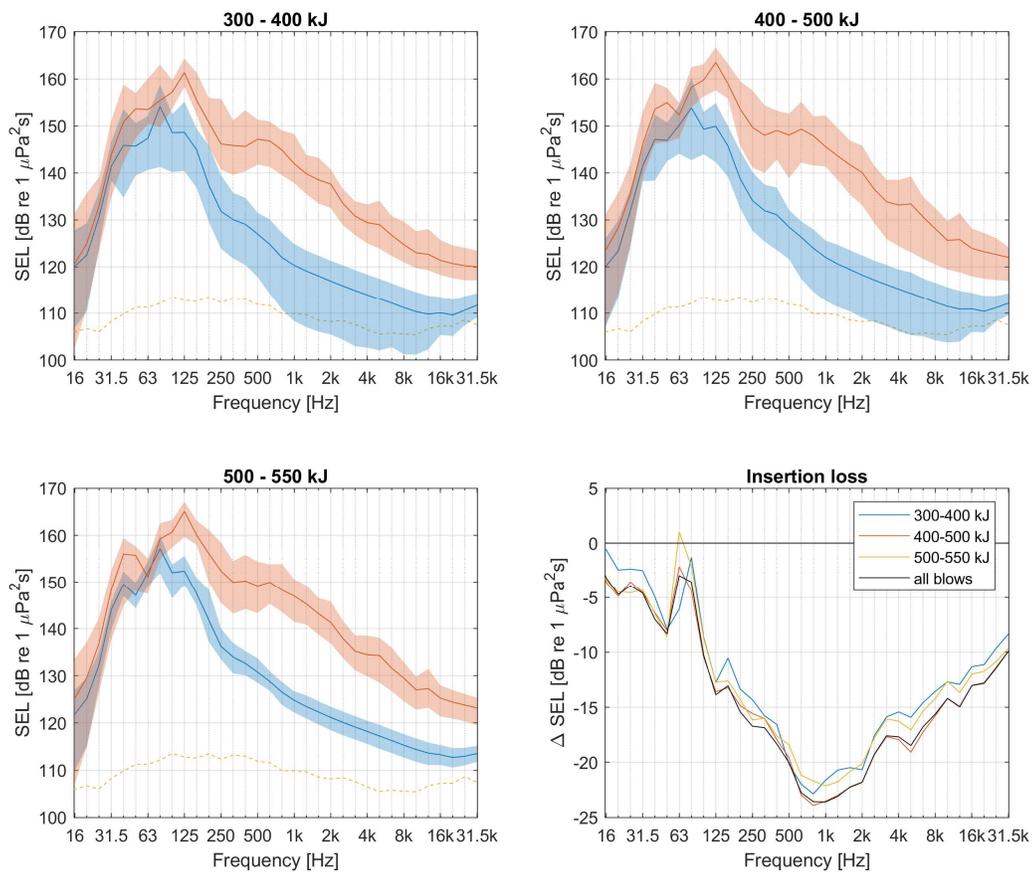
Figure 4.11 The mean and range in depth-averaged sound exposure level in decidecade frequency bands for (blue) A02 and (red) A01 for blows divided in three classes. The yellow dashed line represents the background (noise floor) level during A02. And (right-bottom) the difference between mean values for A02 and A01.

The decrease in insertion loss around 80 Hz is caused by a difference in the peak frequency between piling noise measured at A02 and A01 and is not related to dBBC effectiveness.

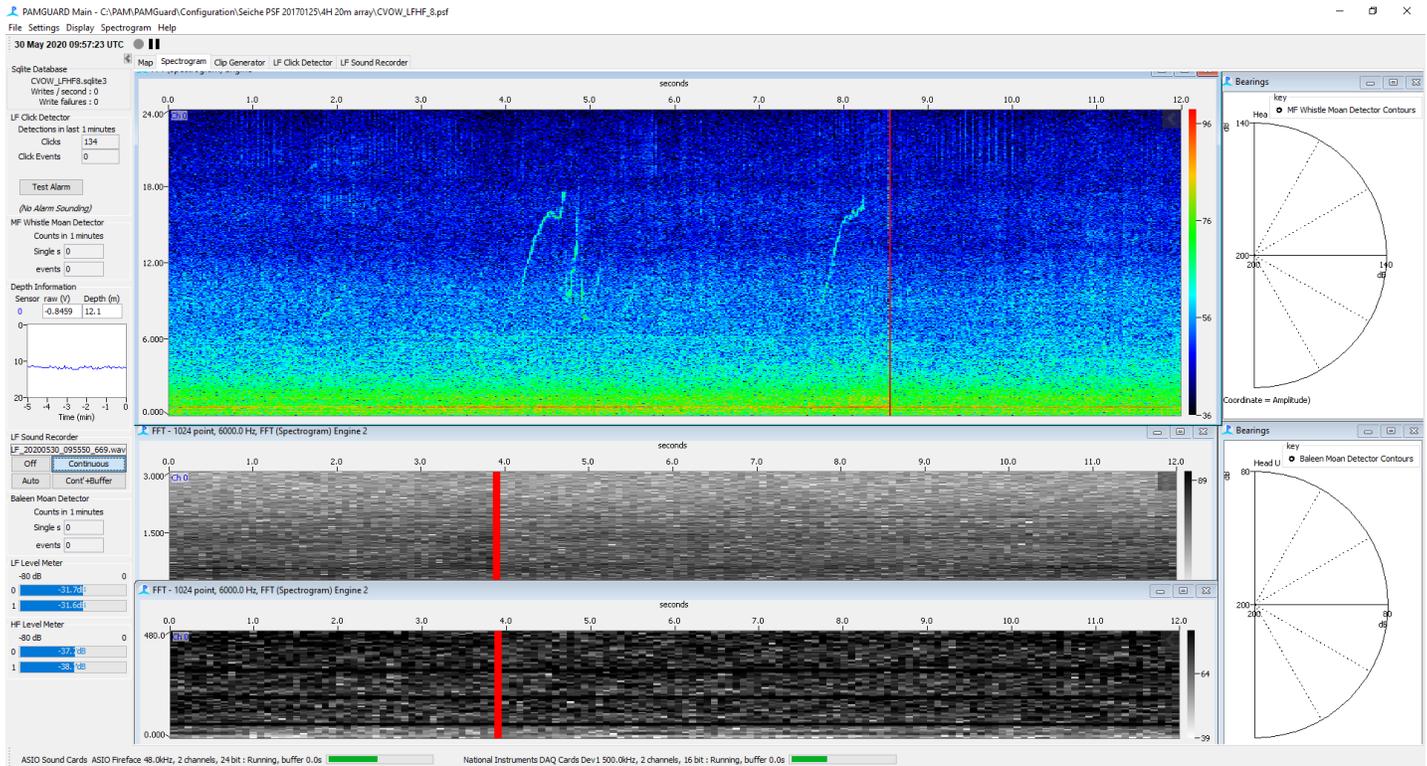
Figure 9 Passive Acoustic Monitoring Detection of Bottlenose Dolphin aboard the M/V Berto Miller

These high frequency clicks could be heard aurally, as well as seen on the spectrogram display. Clicks were fairly loud, producing a strong signal strength and an upper range of up to 250kHz, but with most below 218kHz. The low-mid frequency spectrogram displayed stacked whistles, indicating at least 5 individuals (PSO observed an estimated 10 individuals). Buzzes and burst pulses could also be heard aurally as well as seen on the spectrogram display. Buzzes had a high range of up to 125.6kHz. Burst pulses varied in sound, with some sounding like squeaks, and lasted less than half a second. While the M/V Berto Miller observer had lost sight of the pod, due to the movement of the pod in the opposite direction of the vessel's travel, the PAM operator could hear the dolphins until 06:30, and had been communicating with the Vole au Vent PSOs, which sighted a similarly sized group of dolphins at 06:06. Due to the continued nature of the PAM detection, it is suspected to be the same group of dolphins.

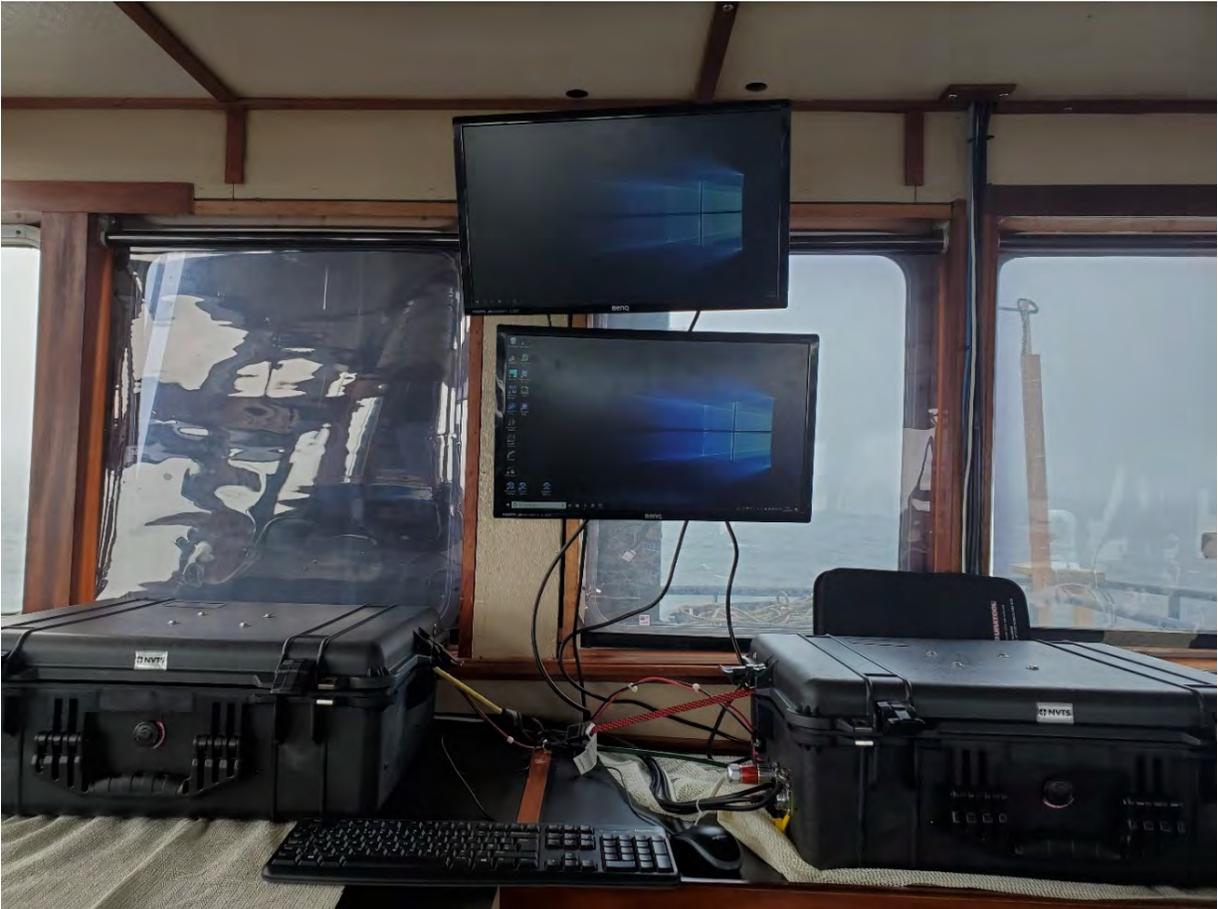
- 1) PAM monitors have to be stacked and wall mounted in order to also fit the HD/Thermal cameras on the two available desks.
