RE: Dominion Energy CVOW Pilot Project – Revised Protected Species Observer (PSO) Monitoring Report and Pile Driving Noise Monitoring Report for WTG Construction and Observations

FINAL NOISE AND PSO MONITORING REPORT

CVOW - COASTAL VIRGINIA OFFSHORE WIND

COMBINED TRANSPORT AND INSTALLATION OF FOUNDATIONS AND WTG

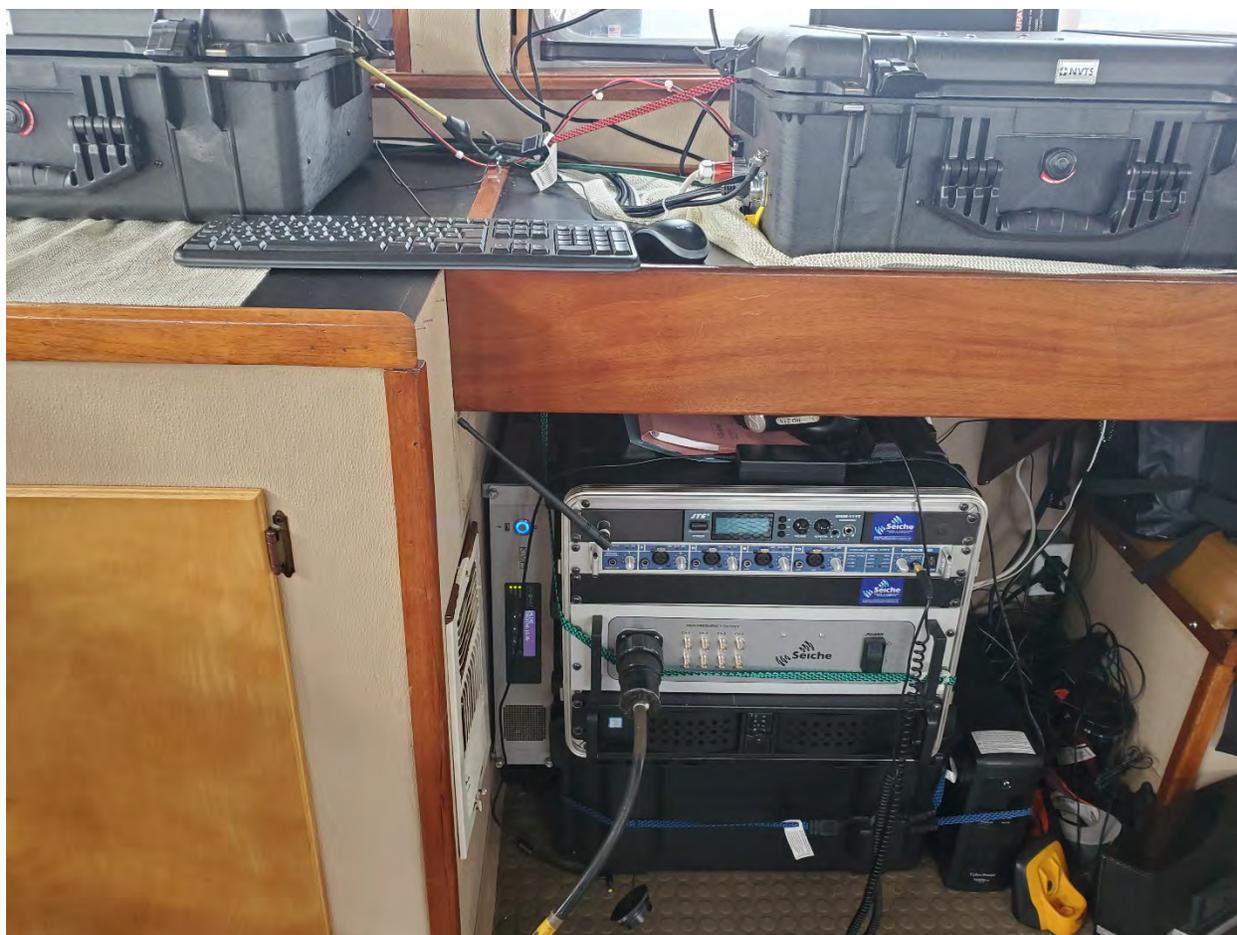
2) DPU goes under right desk. DPU sits atop case for camera gear because cords to monitors are not long enough to reach DPU without added height. Secure both DPU and platform (camera case) to vessel to prepare for weather. UPS battery backup secured next to DPU.

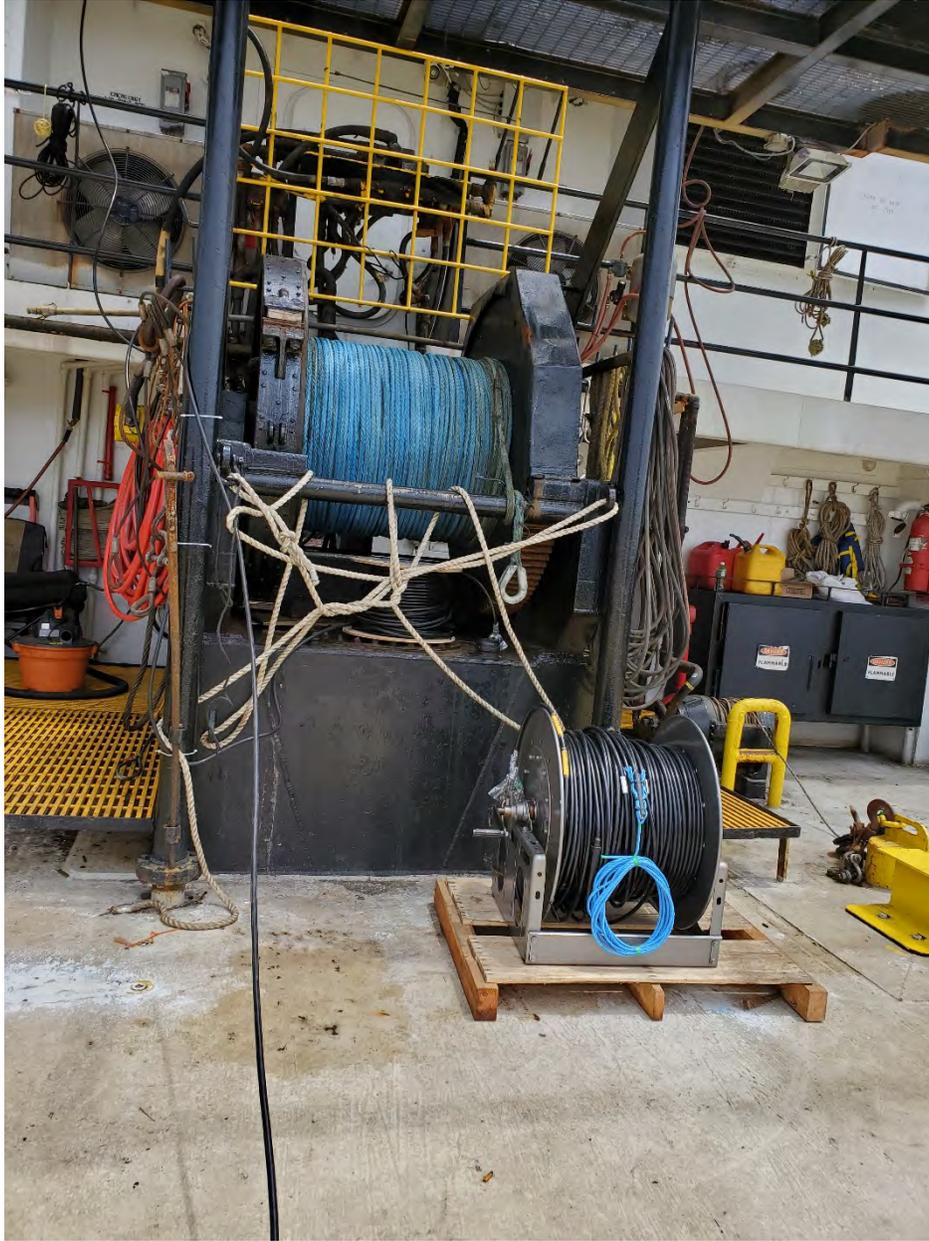
3) Spare deck and tow cables stored securely near forward back deck.

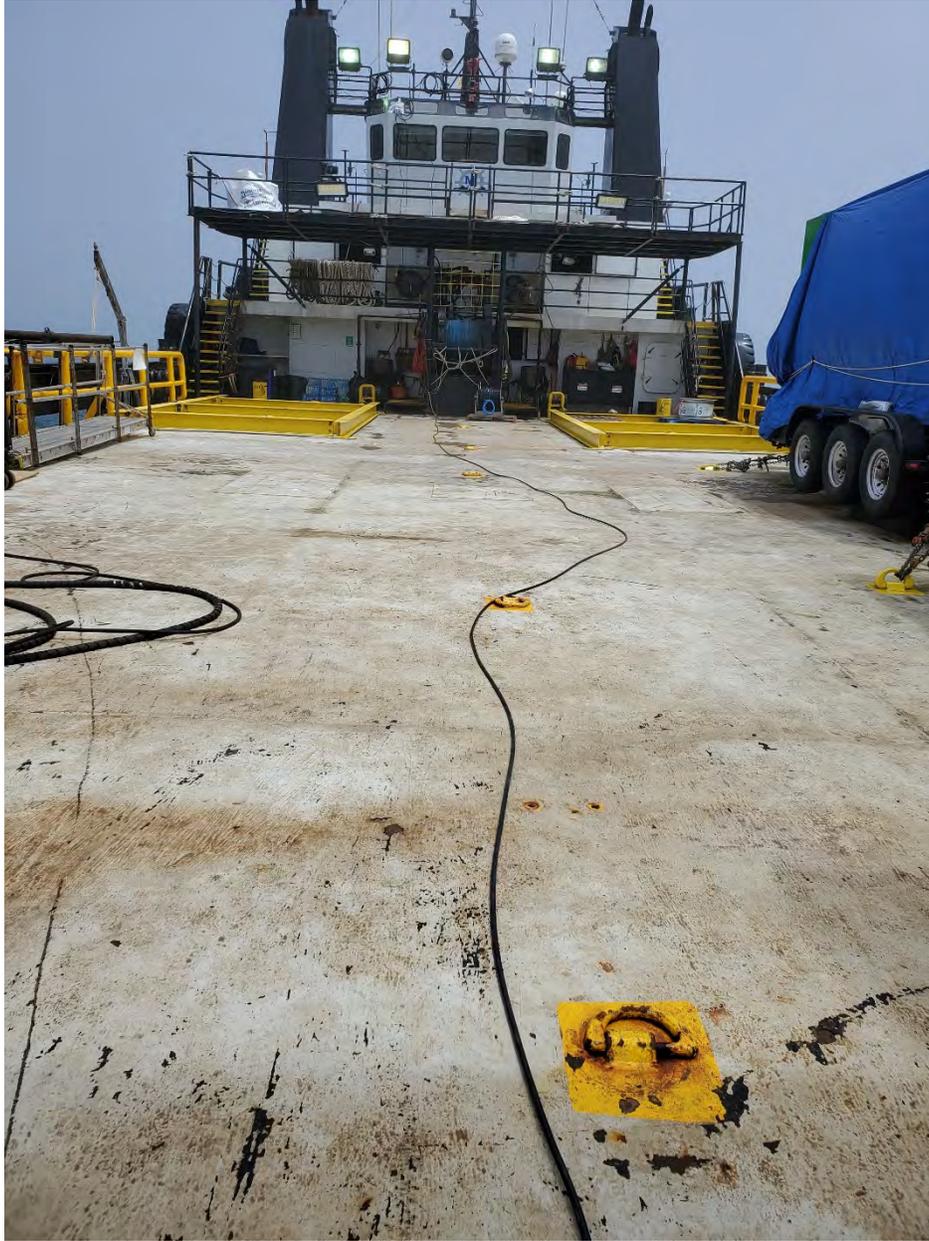
4) Deck cable runs from wheelhouse, across length of back deck, to tow cable.

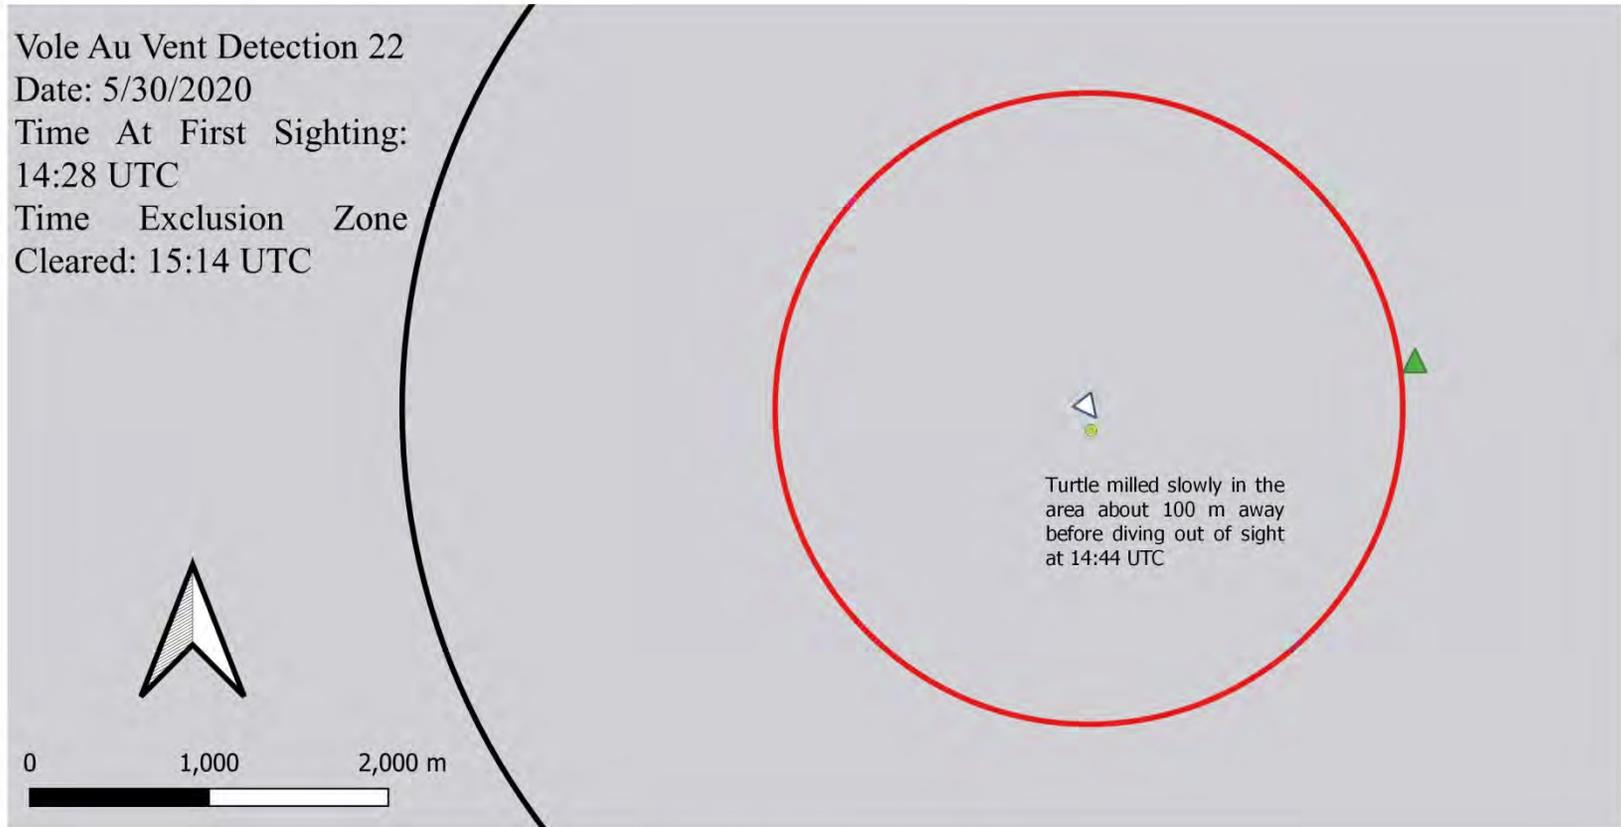
- First Sighting of Bottlenose Dolphins by VAV PSO's
- ↖ Location and Heading of the Vole Au Vent
- ▲ Location of Berto Miller at Initial Sighting
- 1750m Exclusion Zone
- 3830m Monitoring Zone

Vessel Activity at First Sighting:
 Ramp up/Soft Start

List all Sources Active:
 Pile Driving
