Subject: Monthly Field Report for July 2020, Petroleum and Cement Terminal Construction Project, Port of Alaska.

Port of Alaska Modernization Program Petroleum and Cement Terminal - 2020 Construction

Monthly Marine Mammal Monitoring Report

1 July to 31 July 2020

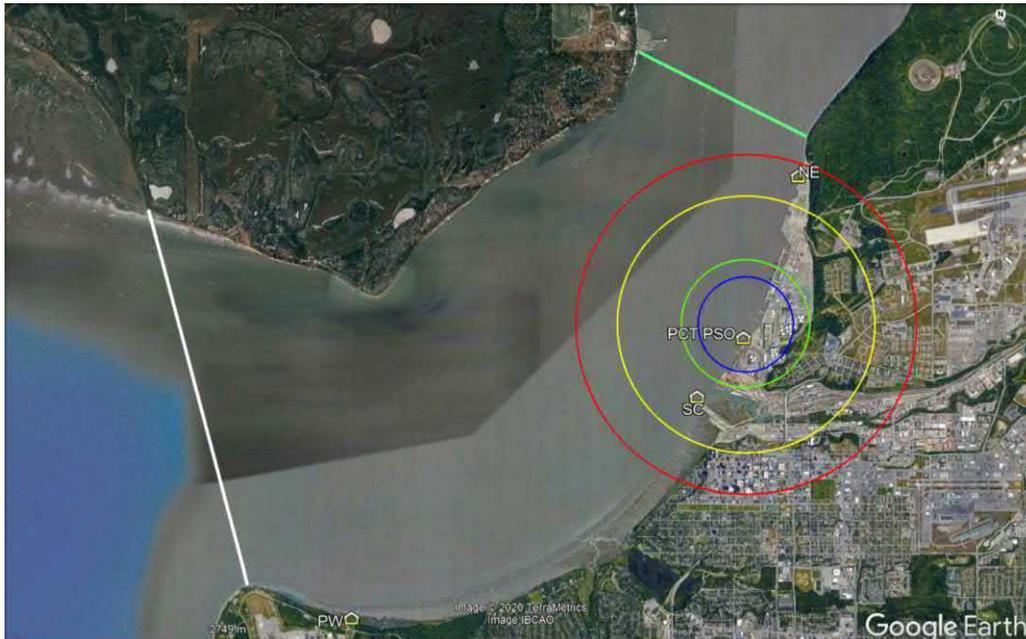
The waters of lower Knik Arm in upper Cook Inlet, Alaska near the PCT are monitored from four observation stations: near Point Woronzof (PW), at Ship Creek (SC), at the PCT, and at the North Expansion (NEX) of the POA (Figure 1).

Figure 1 - Observation Stations and the In-bound (white line) and Out-bound (green line) Pre-Pile Driving Clearance Demarcation Lines

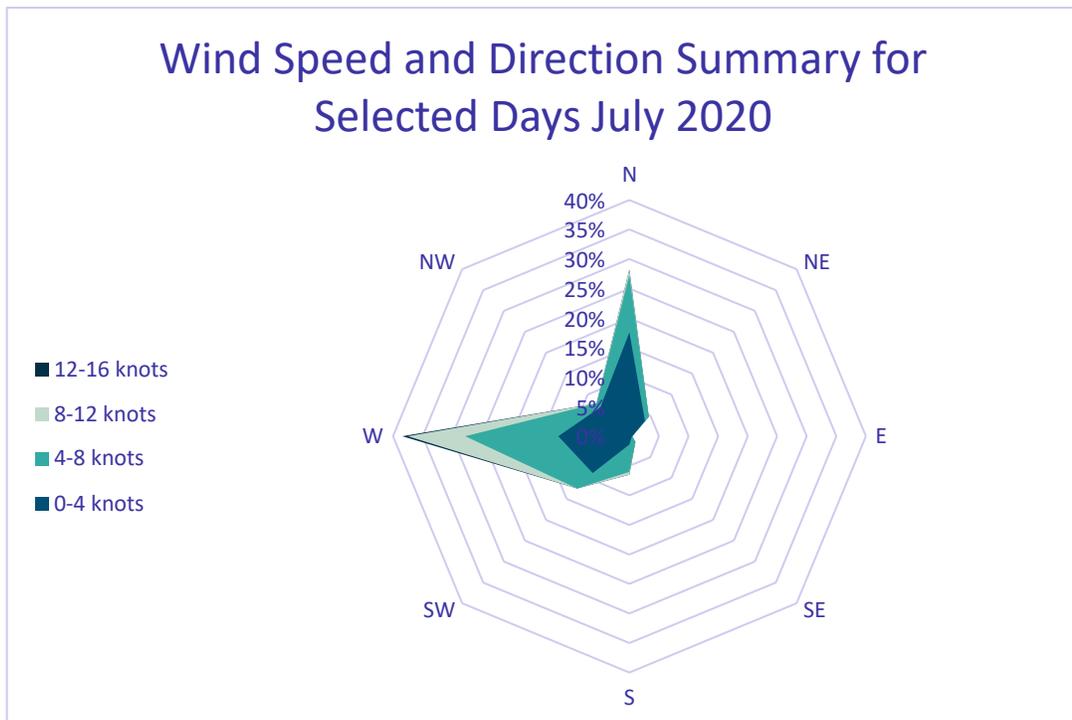
Figure 2. Wind Speed Rose, NOAA Tide Station 9455920, Anchorage Alaska, July 1, 2, 6-18, 19 – 22, and 31 (07:00 to 18:00 daily)

The wind rose presented in Figure 2 shows that wind was typically out of the west or north. It also shows that most (88 percent) of the wind speeds were at or below 8 knots, with only a small fraction between 8 and 16 knots.

The wind speed and direction for the 18 days worked in July were downloaded on an hourly basis from the NOAA meteorological observations page for the Anchorage, Alaska tide station 9455920 (2020b). The data for 07:00 through 18:00 were selected for each day. These data are summarized and presented in Figure 2.

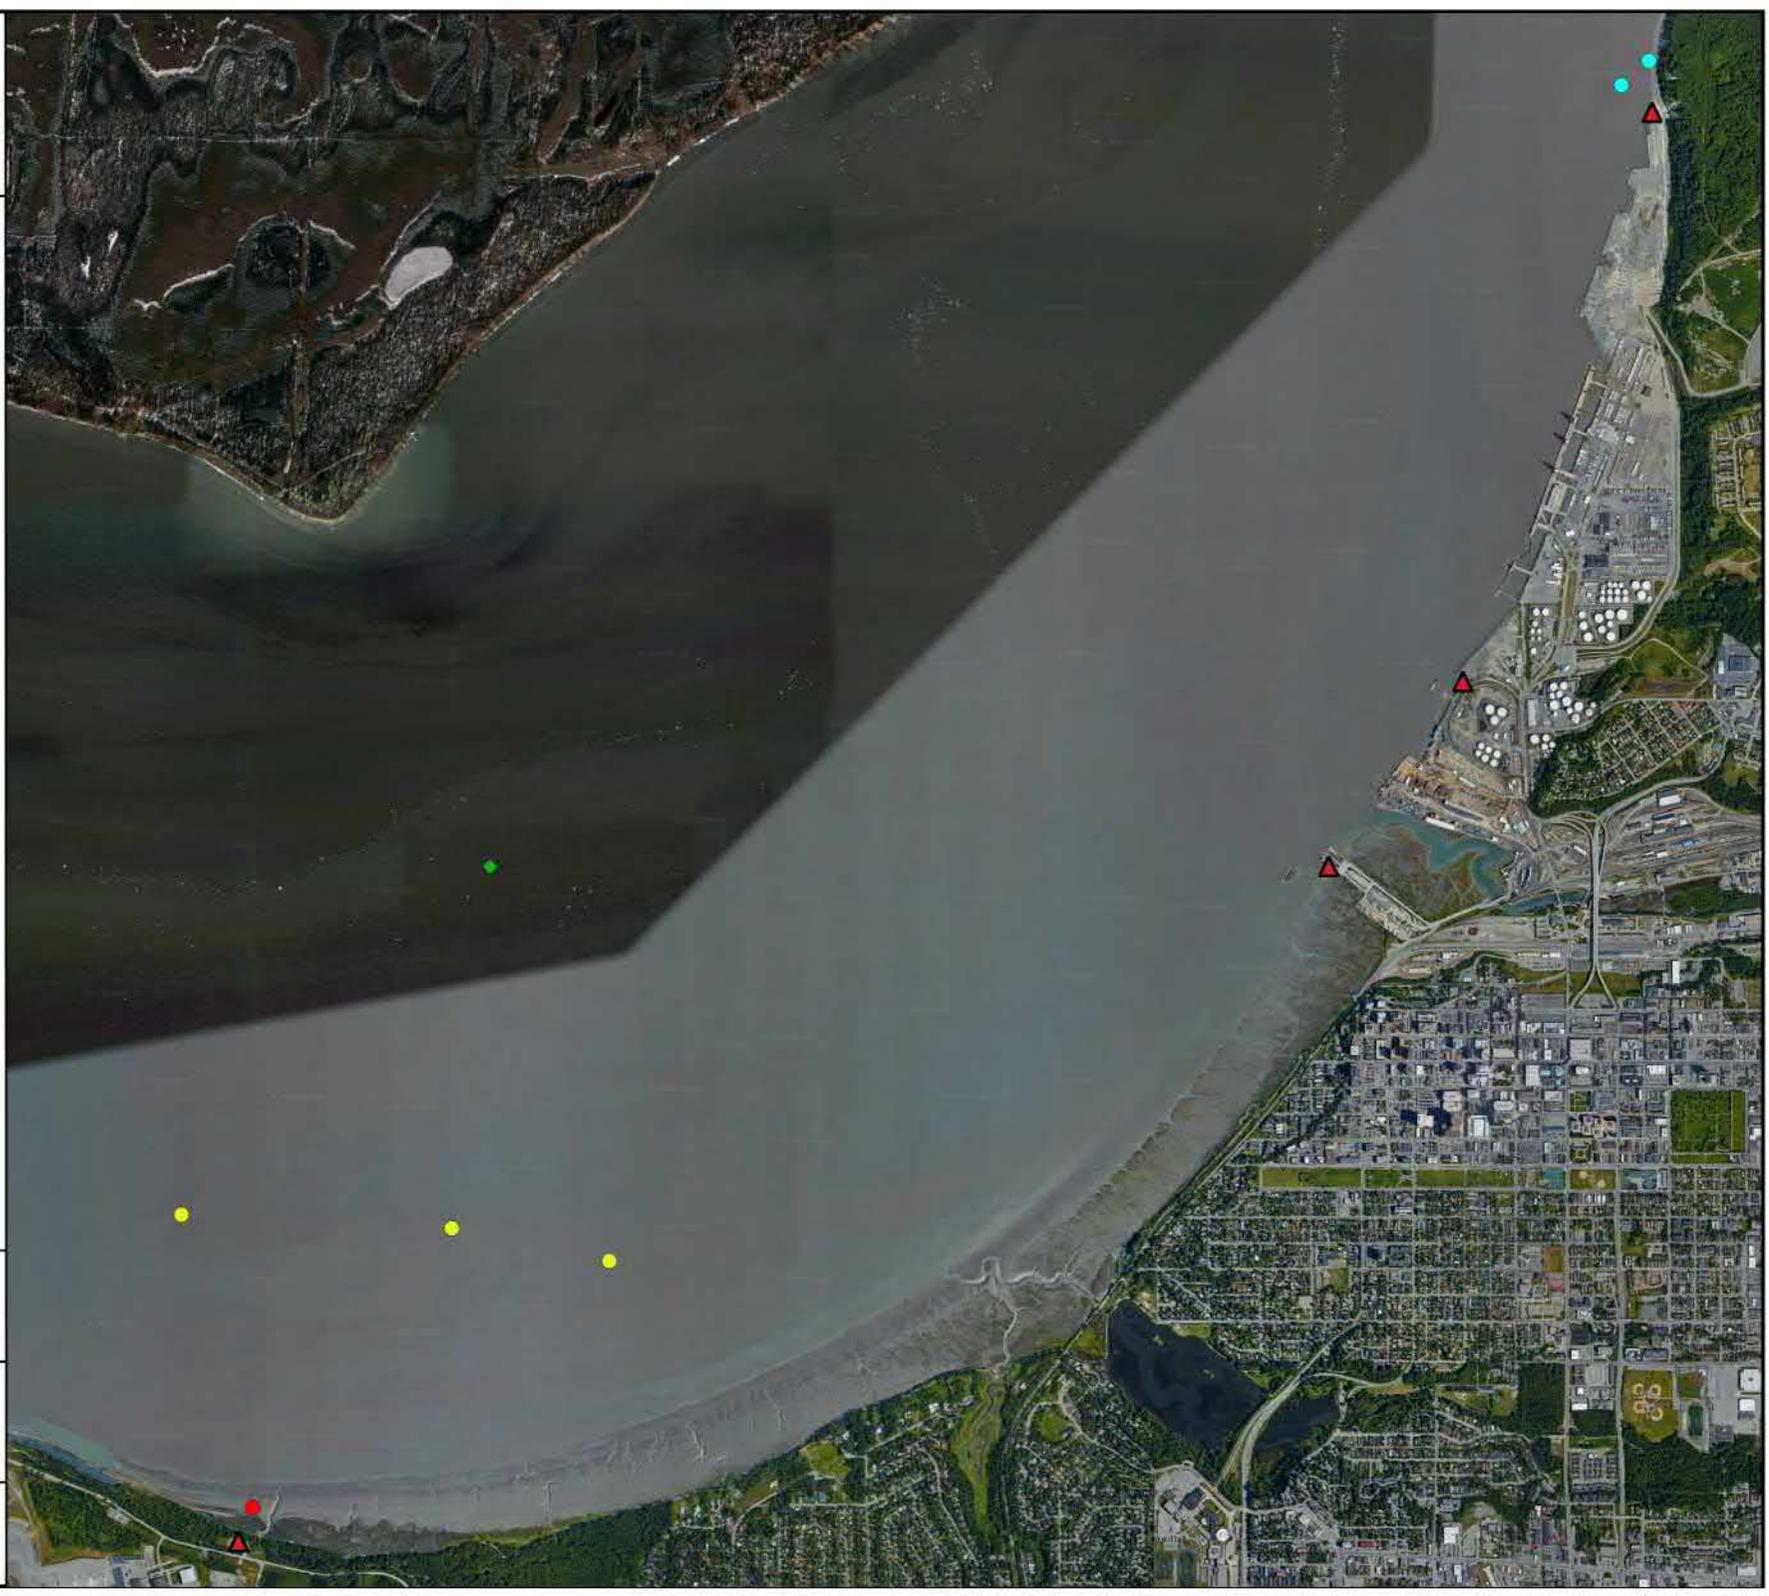
**2020 POA PCT
Beluga Sightings
07/20/20 - 07/26/20
Figure 1**

Beluga Track Lines

→ Group 436
