Subject: Monthly Field Report for June 2020, Petroleum and Cement Terminal Construction Project, Port of Alaska.

Port of Alaska Modernization Program Petroleum and Cement Terminal - 2020 Construction

Monthly Marine Mammal Monitoring Report

1 June to 30 June 2020

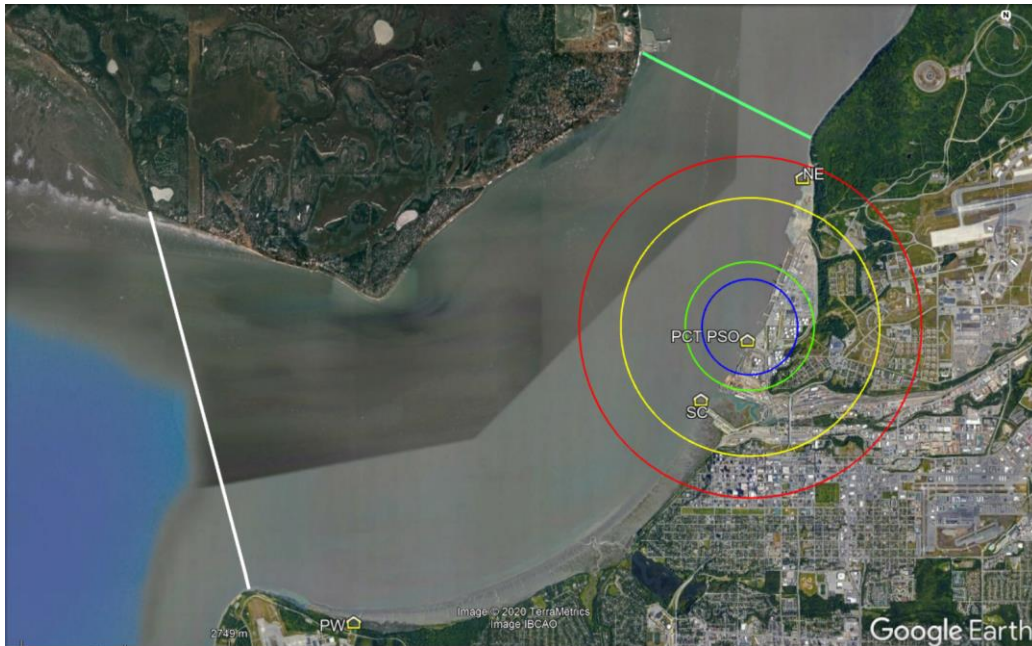
Figure 1 - Observation Stations and the In-bound (white line) and Out-bound (green line) Pre-Pile Driving Clearance Demarcation Lines

The waters of lower Knik Arm in upper Cook Inlet, Alaska near the PCT are monitored from four observation stations: near Point Woronzof (PW), at Ship Creek (SC), at the PCT, and at the North Expansion (NEX) of the POA (Figure 1).

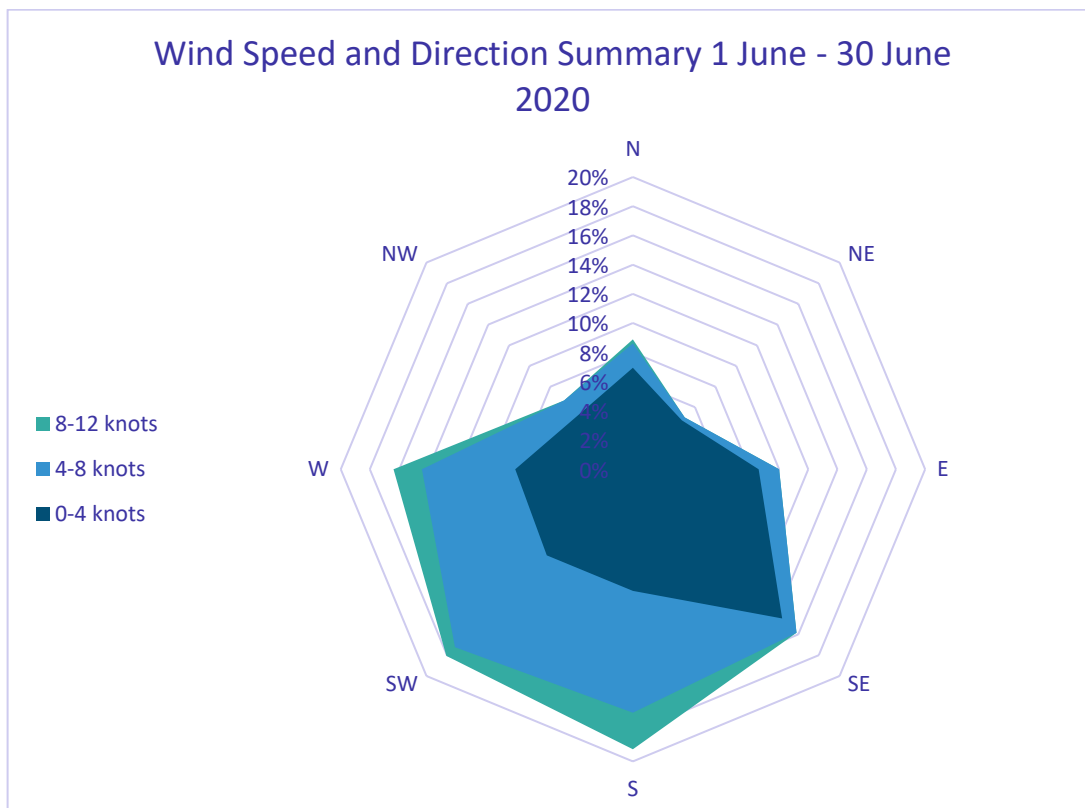
Figure 2. Wind Speed Rose, NOAA Tide Station 9455920, Anchorage Alaska, 1 June thru 30 June 2020 (7 am to 6 pm Daily)

The wind speed and direction for 1 June through 30 June were downloaded on an hourly basis from the NOAA meteorological observations page for the Anchorage, Alaska tide station 9455920 (2020b). The data for 7 am through 6 pm were selected for each day. These data are summarized and presented in Figure 2.

The wind rose presented in Figure 2 shows that wind was typically out of the southeast, south, southwest, and west. It also shows that most of the wind speeds were below 8 knots, with only a small fraction greater than between 8 and 12 knots (green sliver).
