Annual Marine Monitoring Report Parallel Thimble Shoal Tunnel Project Virginia Beach, Virginia

December 2020

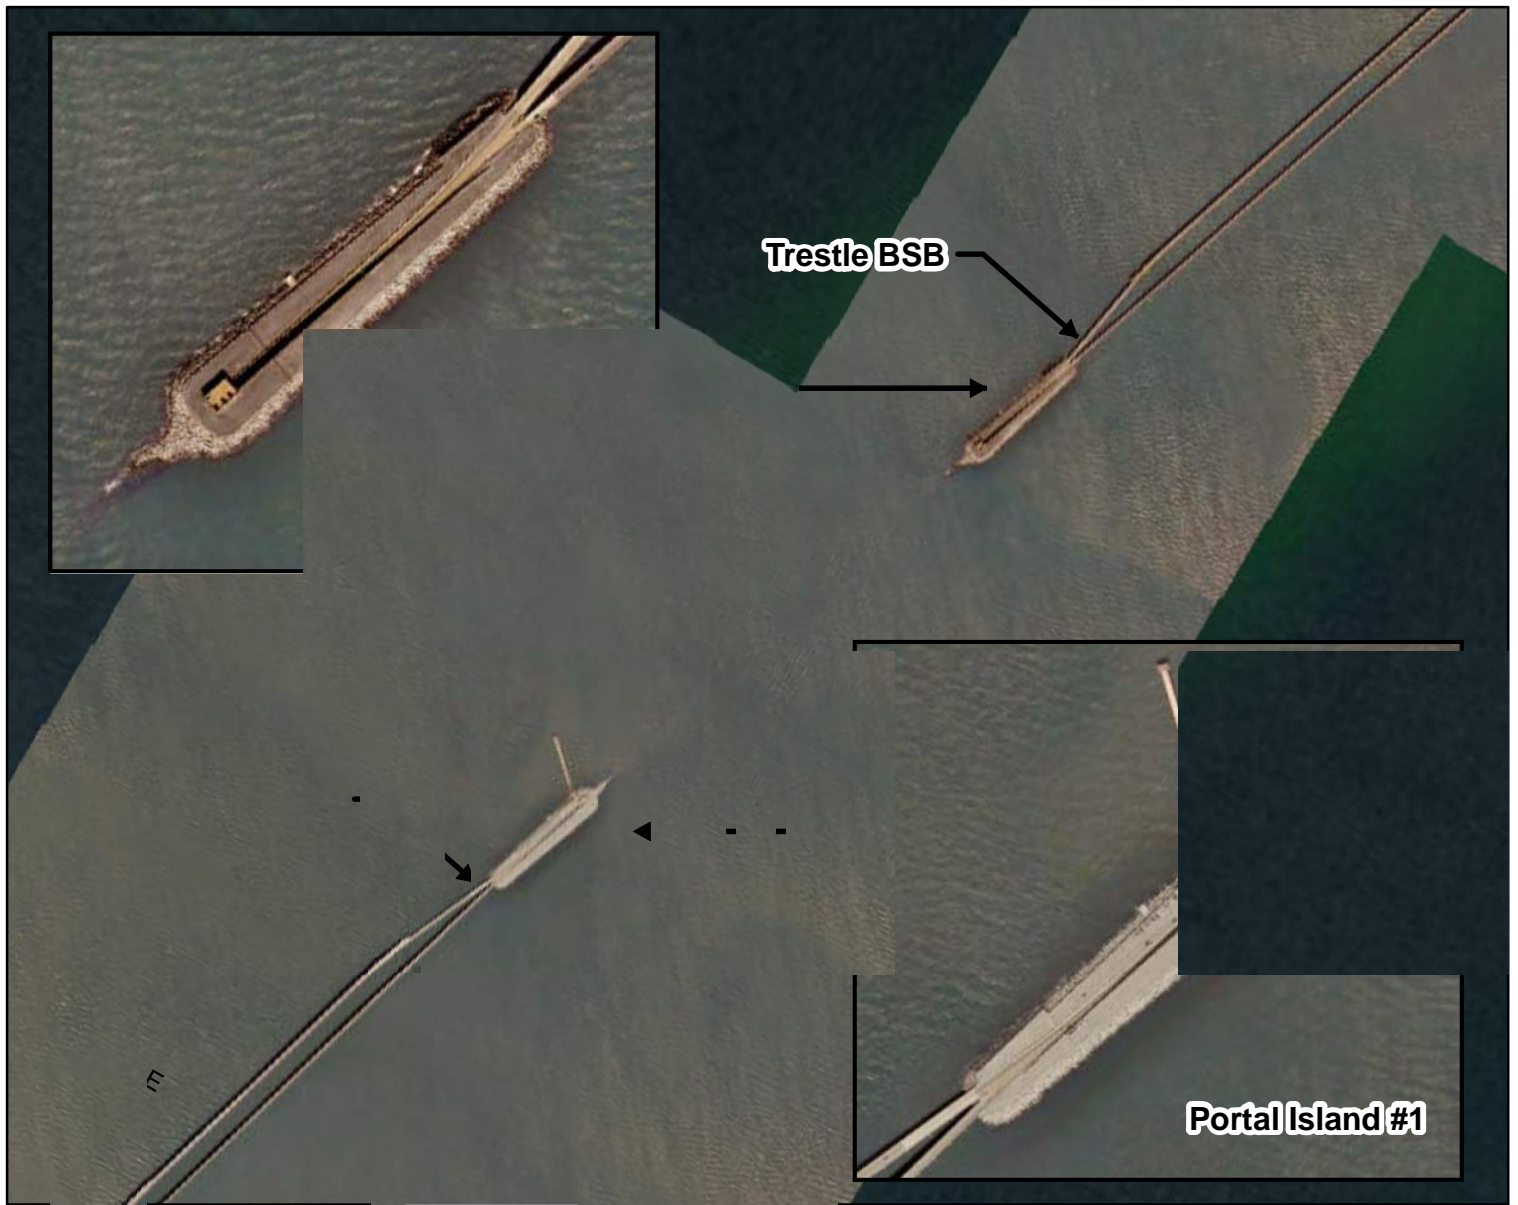
**Figure 1. Project Location Map
Chesapeake Bay Bridge and Tunnel District
Thimble Shoal Parallel Tunnel**

The Parallel Thimble Shoal Tunnel (PTST) Project consists of the construction of a two-lane parallel tunnel to the west of the existing Thimble Shoal Tunnel, connecting Portal Island Numbers (Nos.) 1 and 2 (Figure 1). Upon completion, the new tunnel will carry two lanes of southbound traffic and the existing tunnel will remain in operation and carry two lanes of northbound traffic. The 6,525 linear feet (ft) of new tunnel will be constructed using a tunnel boring machine (TBM), with 5,356 linear ft located below Mean High Water (MHW).

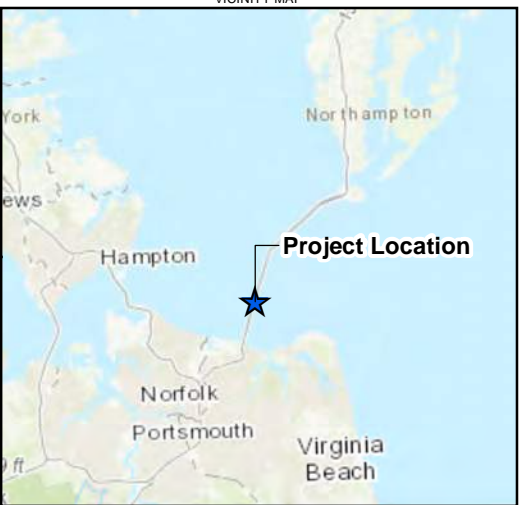
\\lovetongis\GIS\data\Commercial\Northeast\Virginia\Thimble Shoal\MXD\MMMP\IHA Figure 8 Shutdown Zone Impact Hammer w Bubble Curtain Non-Simult Dock 7 Piles Island 1.mxd

- Temporary Dock
- 7 Impact Piles per Day - Shutdown Zone**
 - 1,486.3 m - High-Frequency Cetaceans
 - 1,247.8 m - Low-Frequency Cetaceans
 - 667.8 m - Phocid Pinnipeds
 - 44.4 m - Mid-Frequency Cetaceans

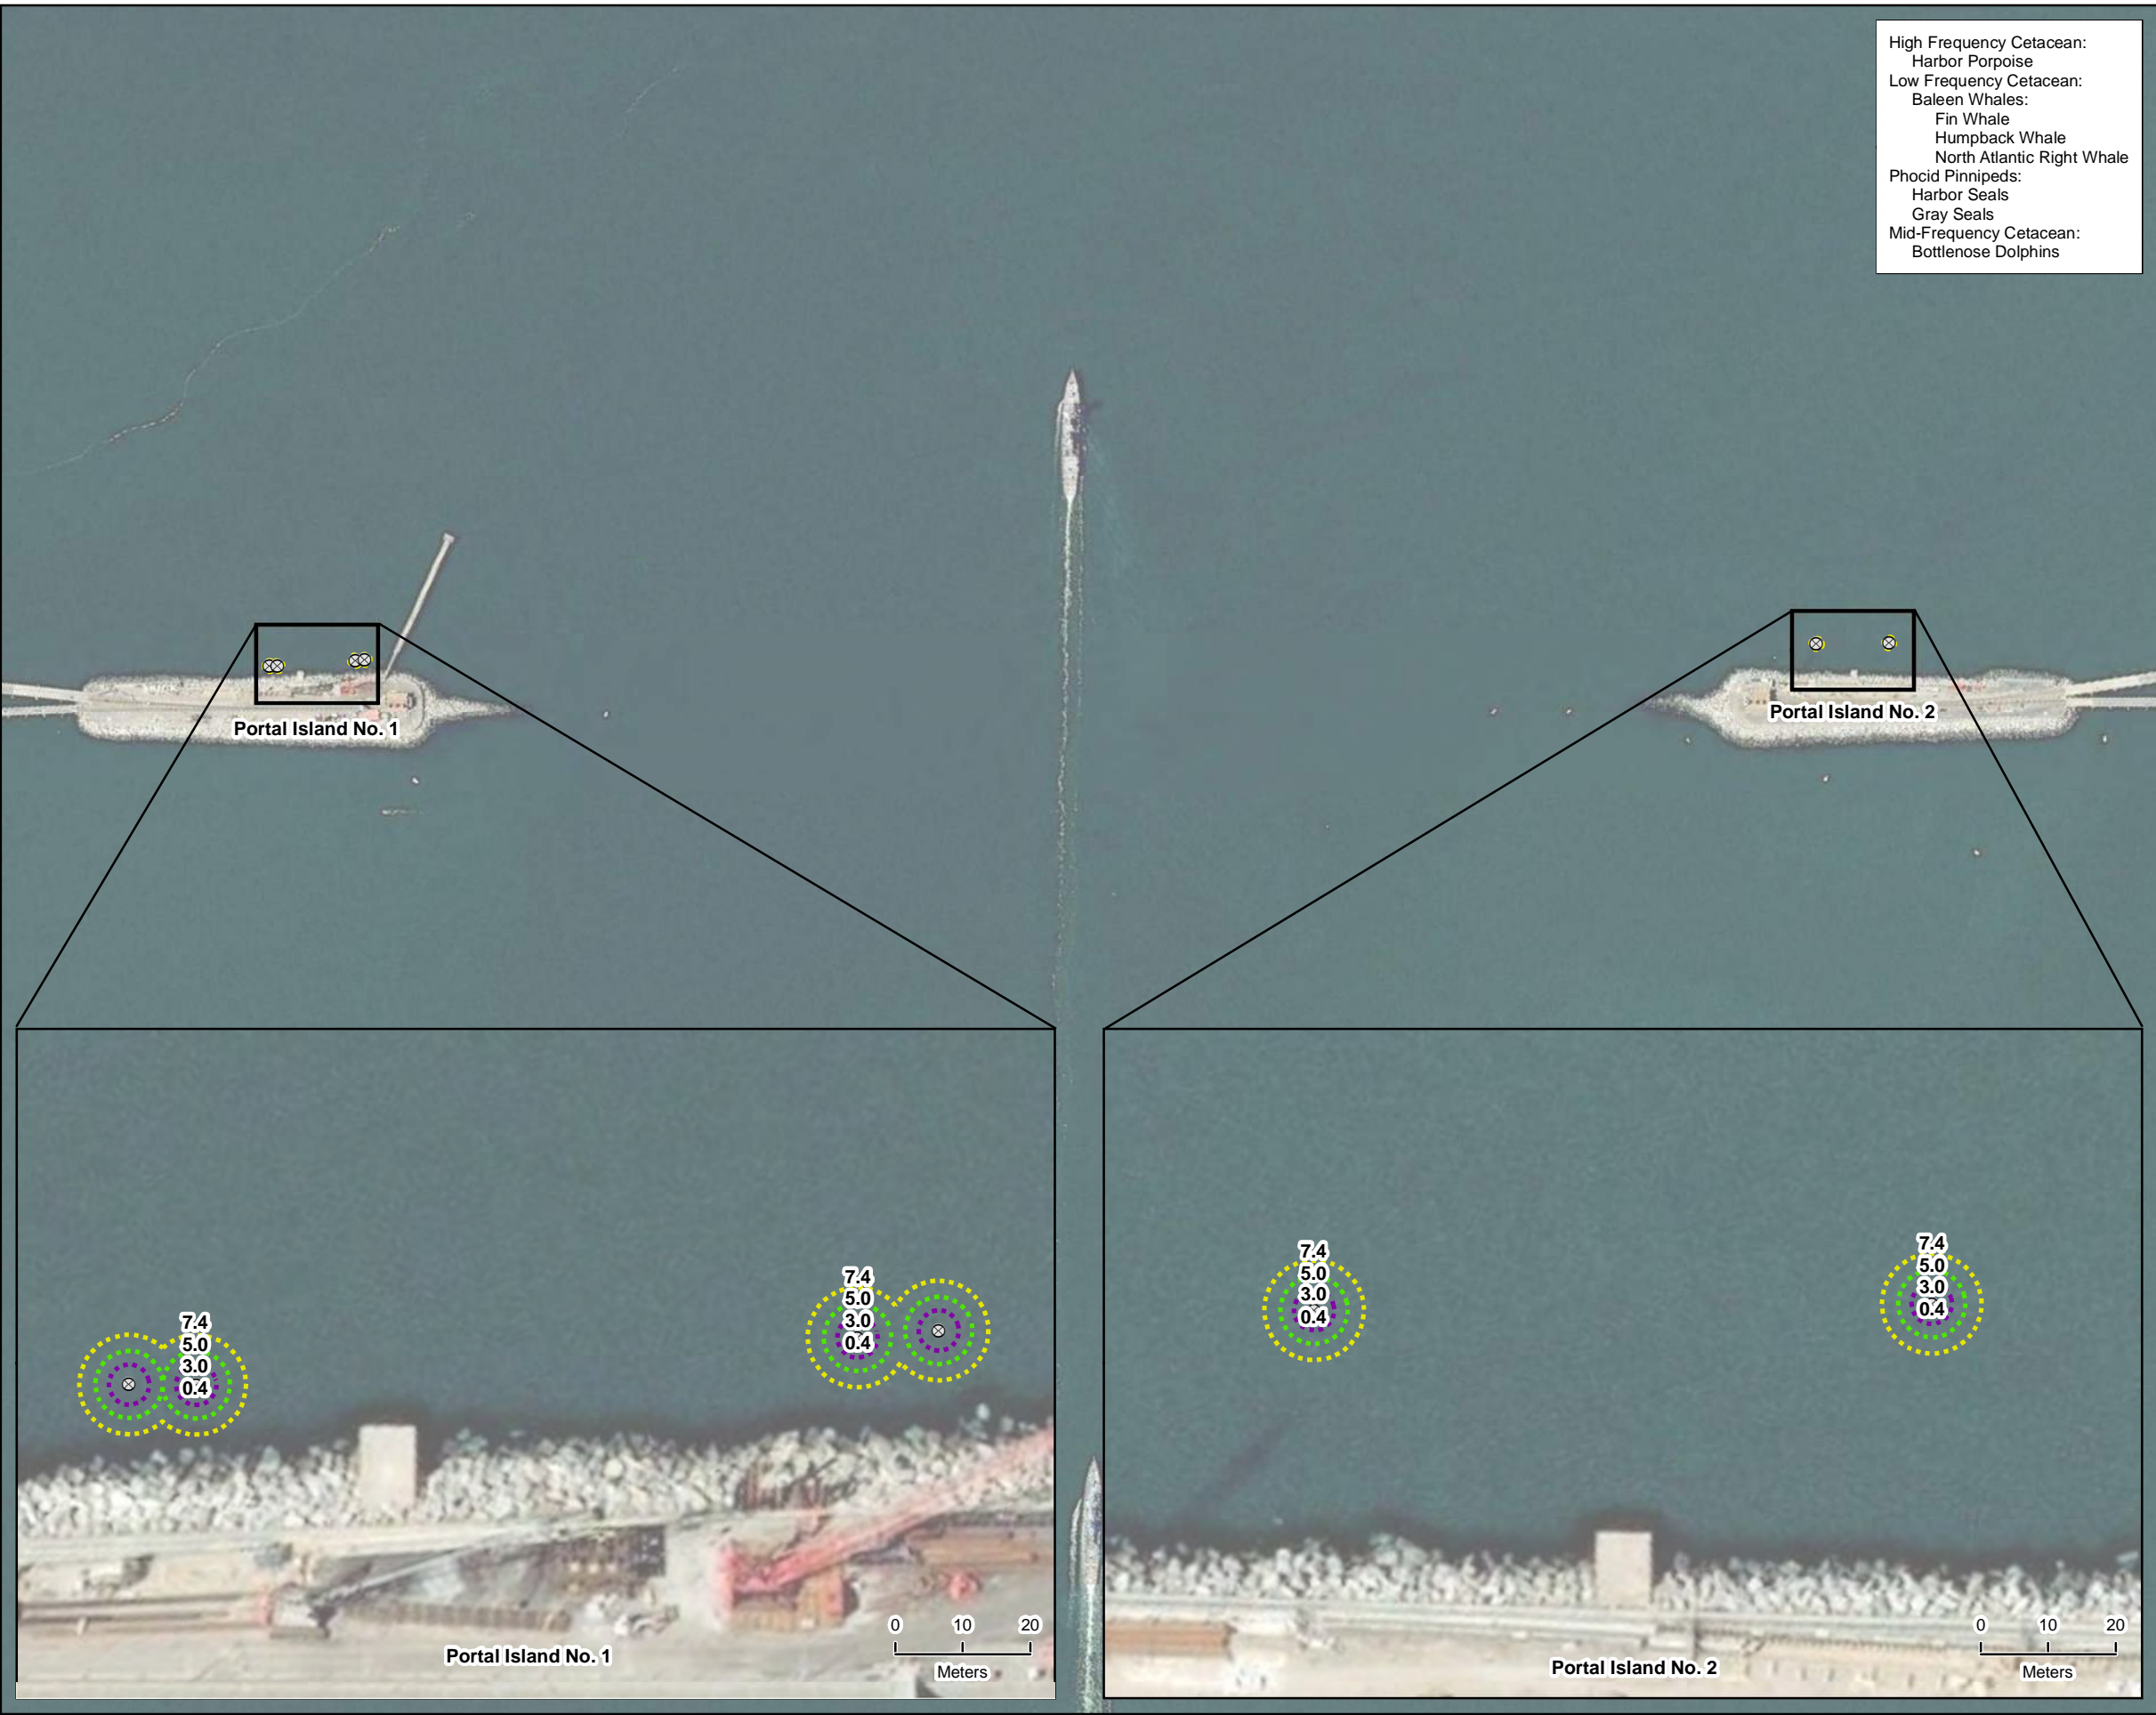
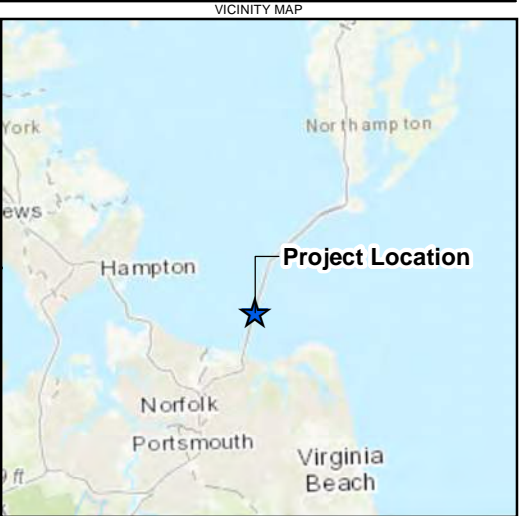
\\novetongis\GIS\data\Commercial\Northeast\Virginia\Thimble Shoal\MXD\MMMP\IHA Figure 9 Shutdown Zone Vibratory Hammer Timber Pile Non-Simult Mooring Dolphins 10 Piles Island 1 and 2.mxd

- ⊗ Mooring Dolphin
- 10 Vibratory Piles per Day - Shutdown Zone**
- 7.4 m - High-Frequency Cetaceans
- 5.0 m - Low-Frequency Cetaceans
- 3.0 m - Phocid Pinnipeds
- 0.4 m - Mid-Frequency Cetaceans

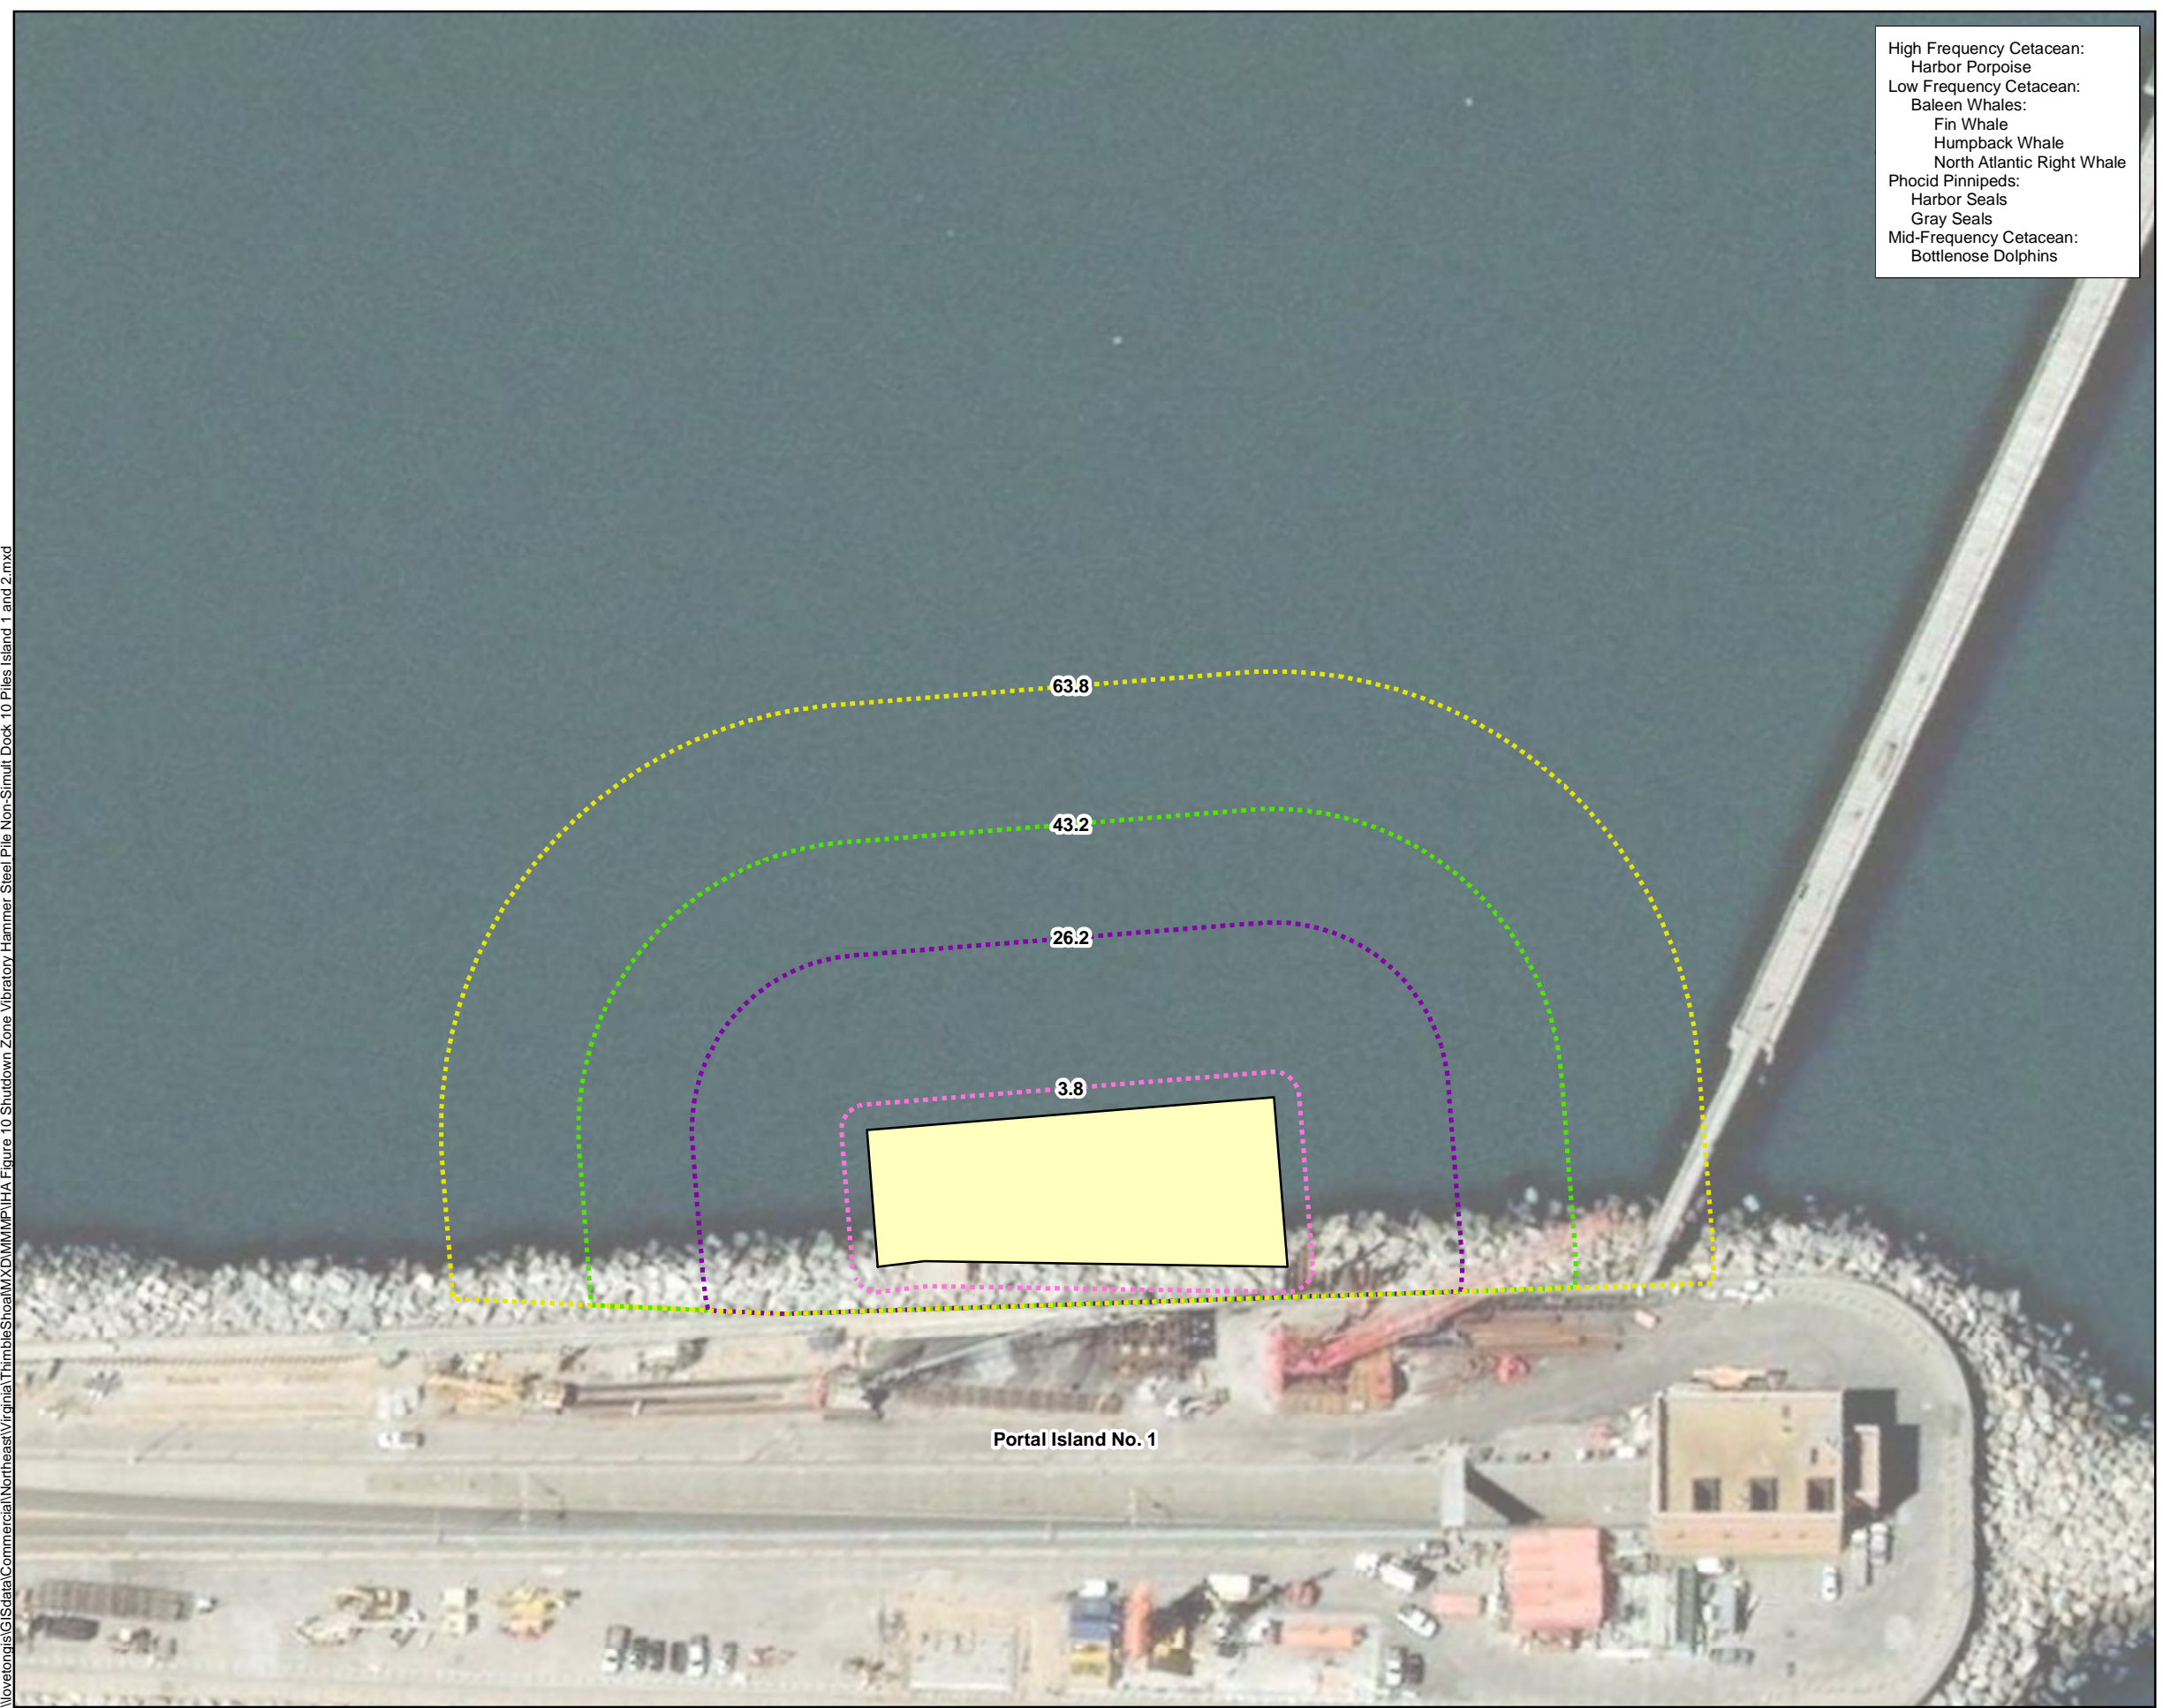
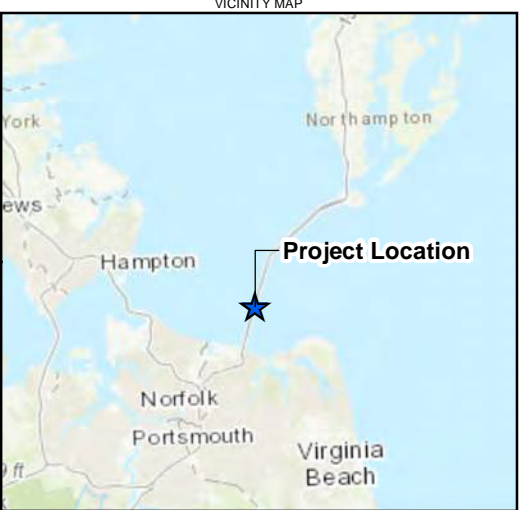
\\lovebond\GISData\Commercial\Northeast\Virginia\ThimbleShoal\MXD\MMMP\IHA Figure 10 Shutdown Zone Vibratory Hammer Steel Pile Non-Simult Dock 10 Piles Island 1 and 2.mxd

- Temporary Dock
- 10 Vibratory Piles per Day - Shutdown Zone**
- 63.8 m - High-Frequency Cetaceans
- 43.2 m - Low-Frequency Cetaceans
- 26.2 m - Phocid Pinnipeds
- 3.8 m - Mid-Frequency Cetaceans

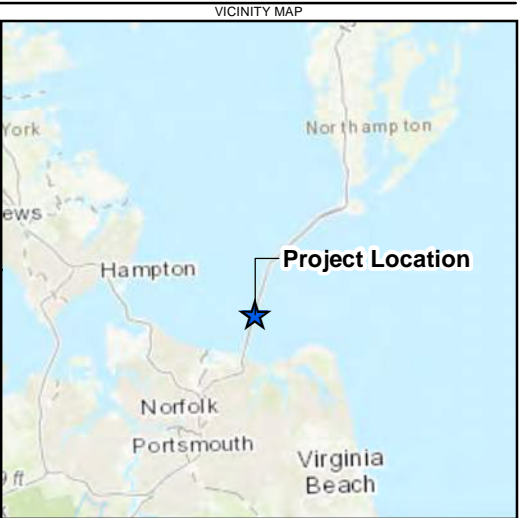
\\lovetongis\GISdata\Commercial\Northeast\Virginia\ThimbleShoal\MXD\MMMP\HA Figure 11 Shutdown Zone DTH + DTH Hammer Steel Pile Simult Omega O-Pile Wall West 6 Piles Island 1.mxd

- O-Pile Wall
■ Omega Trestle
6 Down-the-Hole Piles per Day - Shutdown Zone
--- 2,895.6 m - High-Frequency Cetaceans
--- 2,430.9 m - Low-Frequency Cetaceans
--- 1,300.9 m - Phocid Pinnipeds
--- 86.5 m - Mid-Frequency Cetaceans

Figure 4
Distance (meters) to Shutdown Zone
Using Two Down-the-Hole Hammers for
Simultaneous
36- and 42-in Steel Pile Driving for the
Omega Trestle/West O-Pile Wall/
Mooring Piles and Templates
– 6 Piles per Day
at Portal Island No. 1
Marine Mammal Protection Act
Parallel Thimble Shoal Tunnel

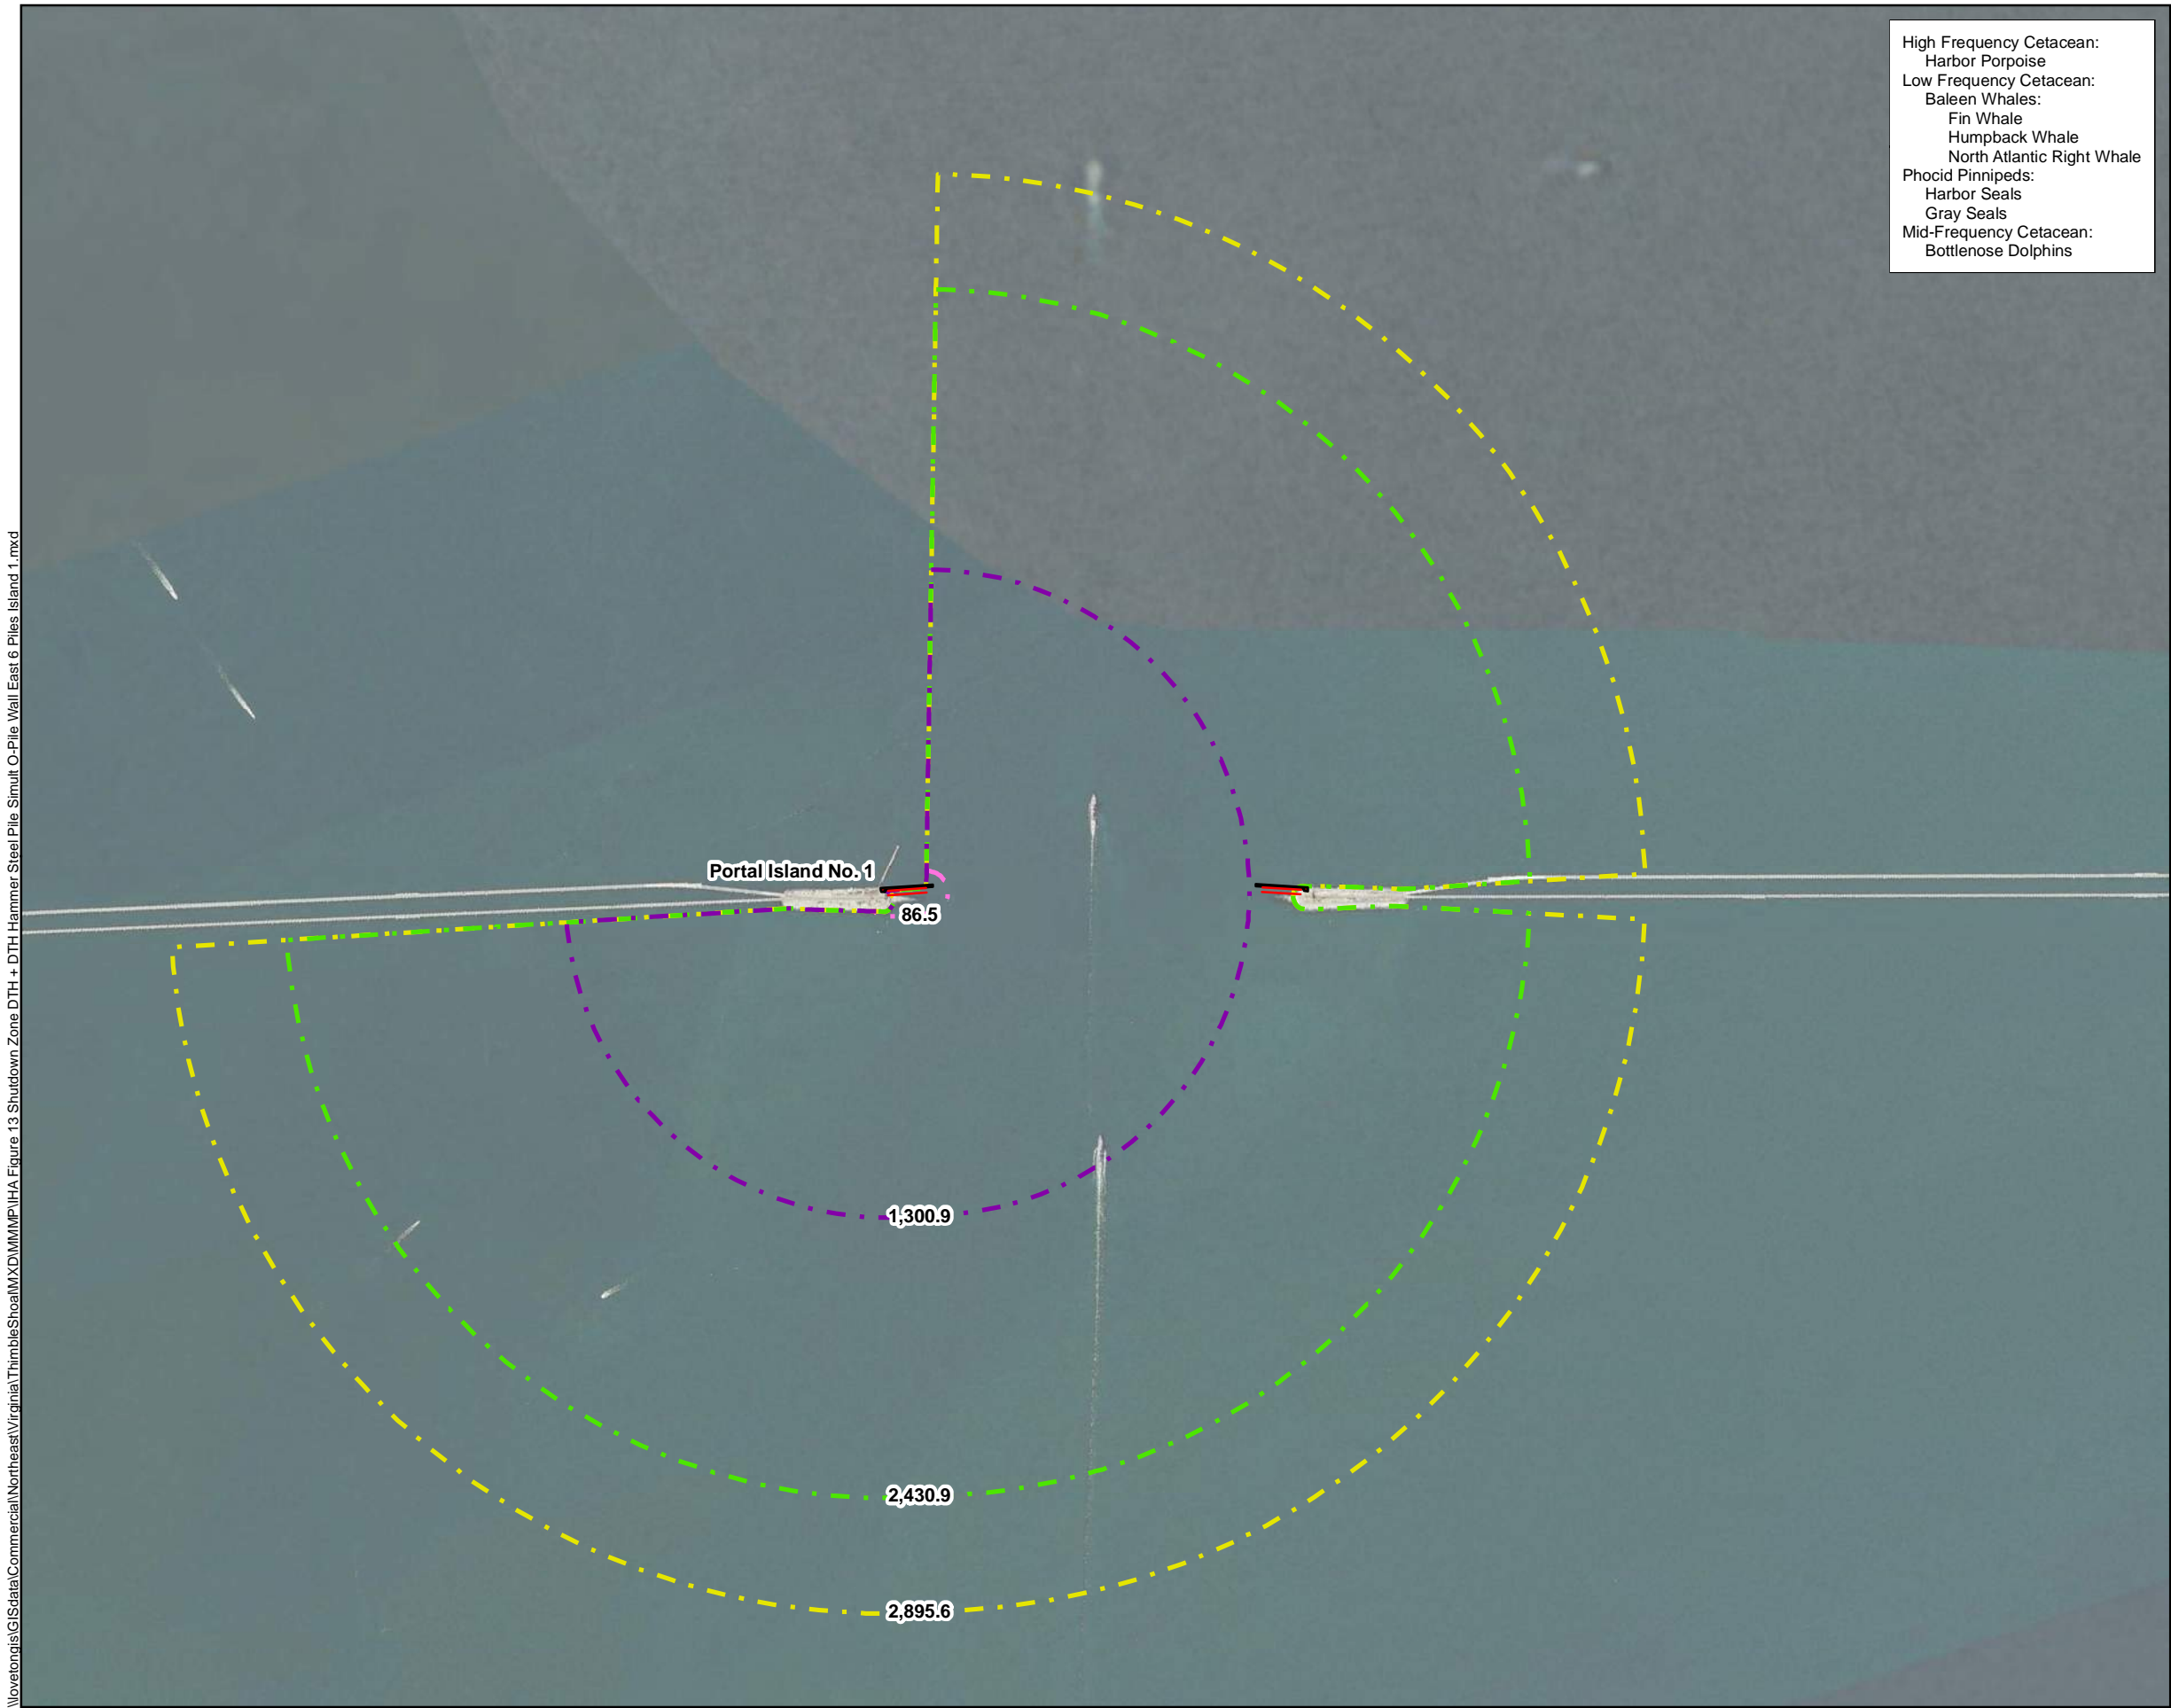
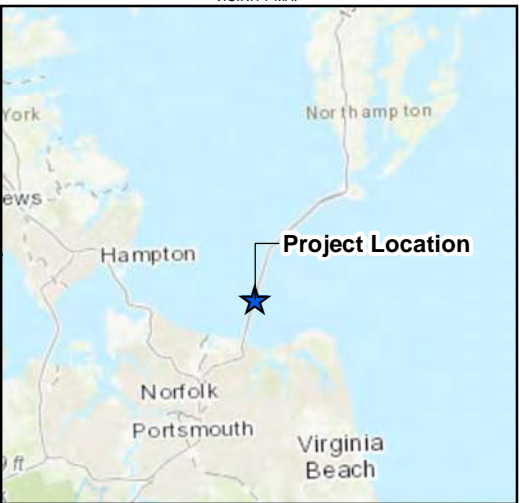
\\lovetongis\GISdata\Commercial\Northeast\Virginia\ThimbleShoal\MXD\MMMP\HA Figure 13 Shutdown Zone DTH + DTH Hammer Steel Pile Simult O-Pile Wall East 6 Piles Island 1.mxd

- O-Pile Wall
■ Omega Trestle
6 Down-the-Hole Piles per Day - Shutdown Zone
--- 2,895.6 m - High-Frequency Cetaceans
--- 2,430.9 m - Low-Frequency Cetaceans
--- 1,300.9 m - Phocid Pinnipeds
--- 86.5 m - Mid-Frequency Cetaceans

Figure 6
Distance (meters) to Shutdown Zone
Using Two Down-the-Hole Hammers for
Simultaneous
36- and 42-in Steel Pile Driving for the
East O-Pile Wall
– 6 Piles per Day
at Portal Island No. 1
Marine Mammal Protection Act
Parallel Thimble Shoal Tunnel

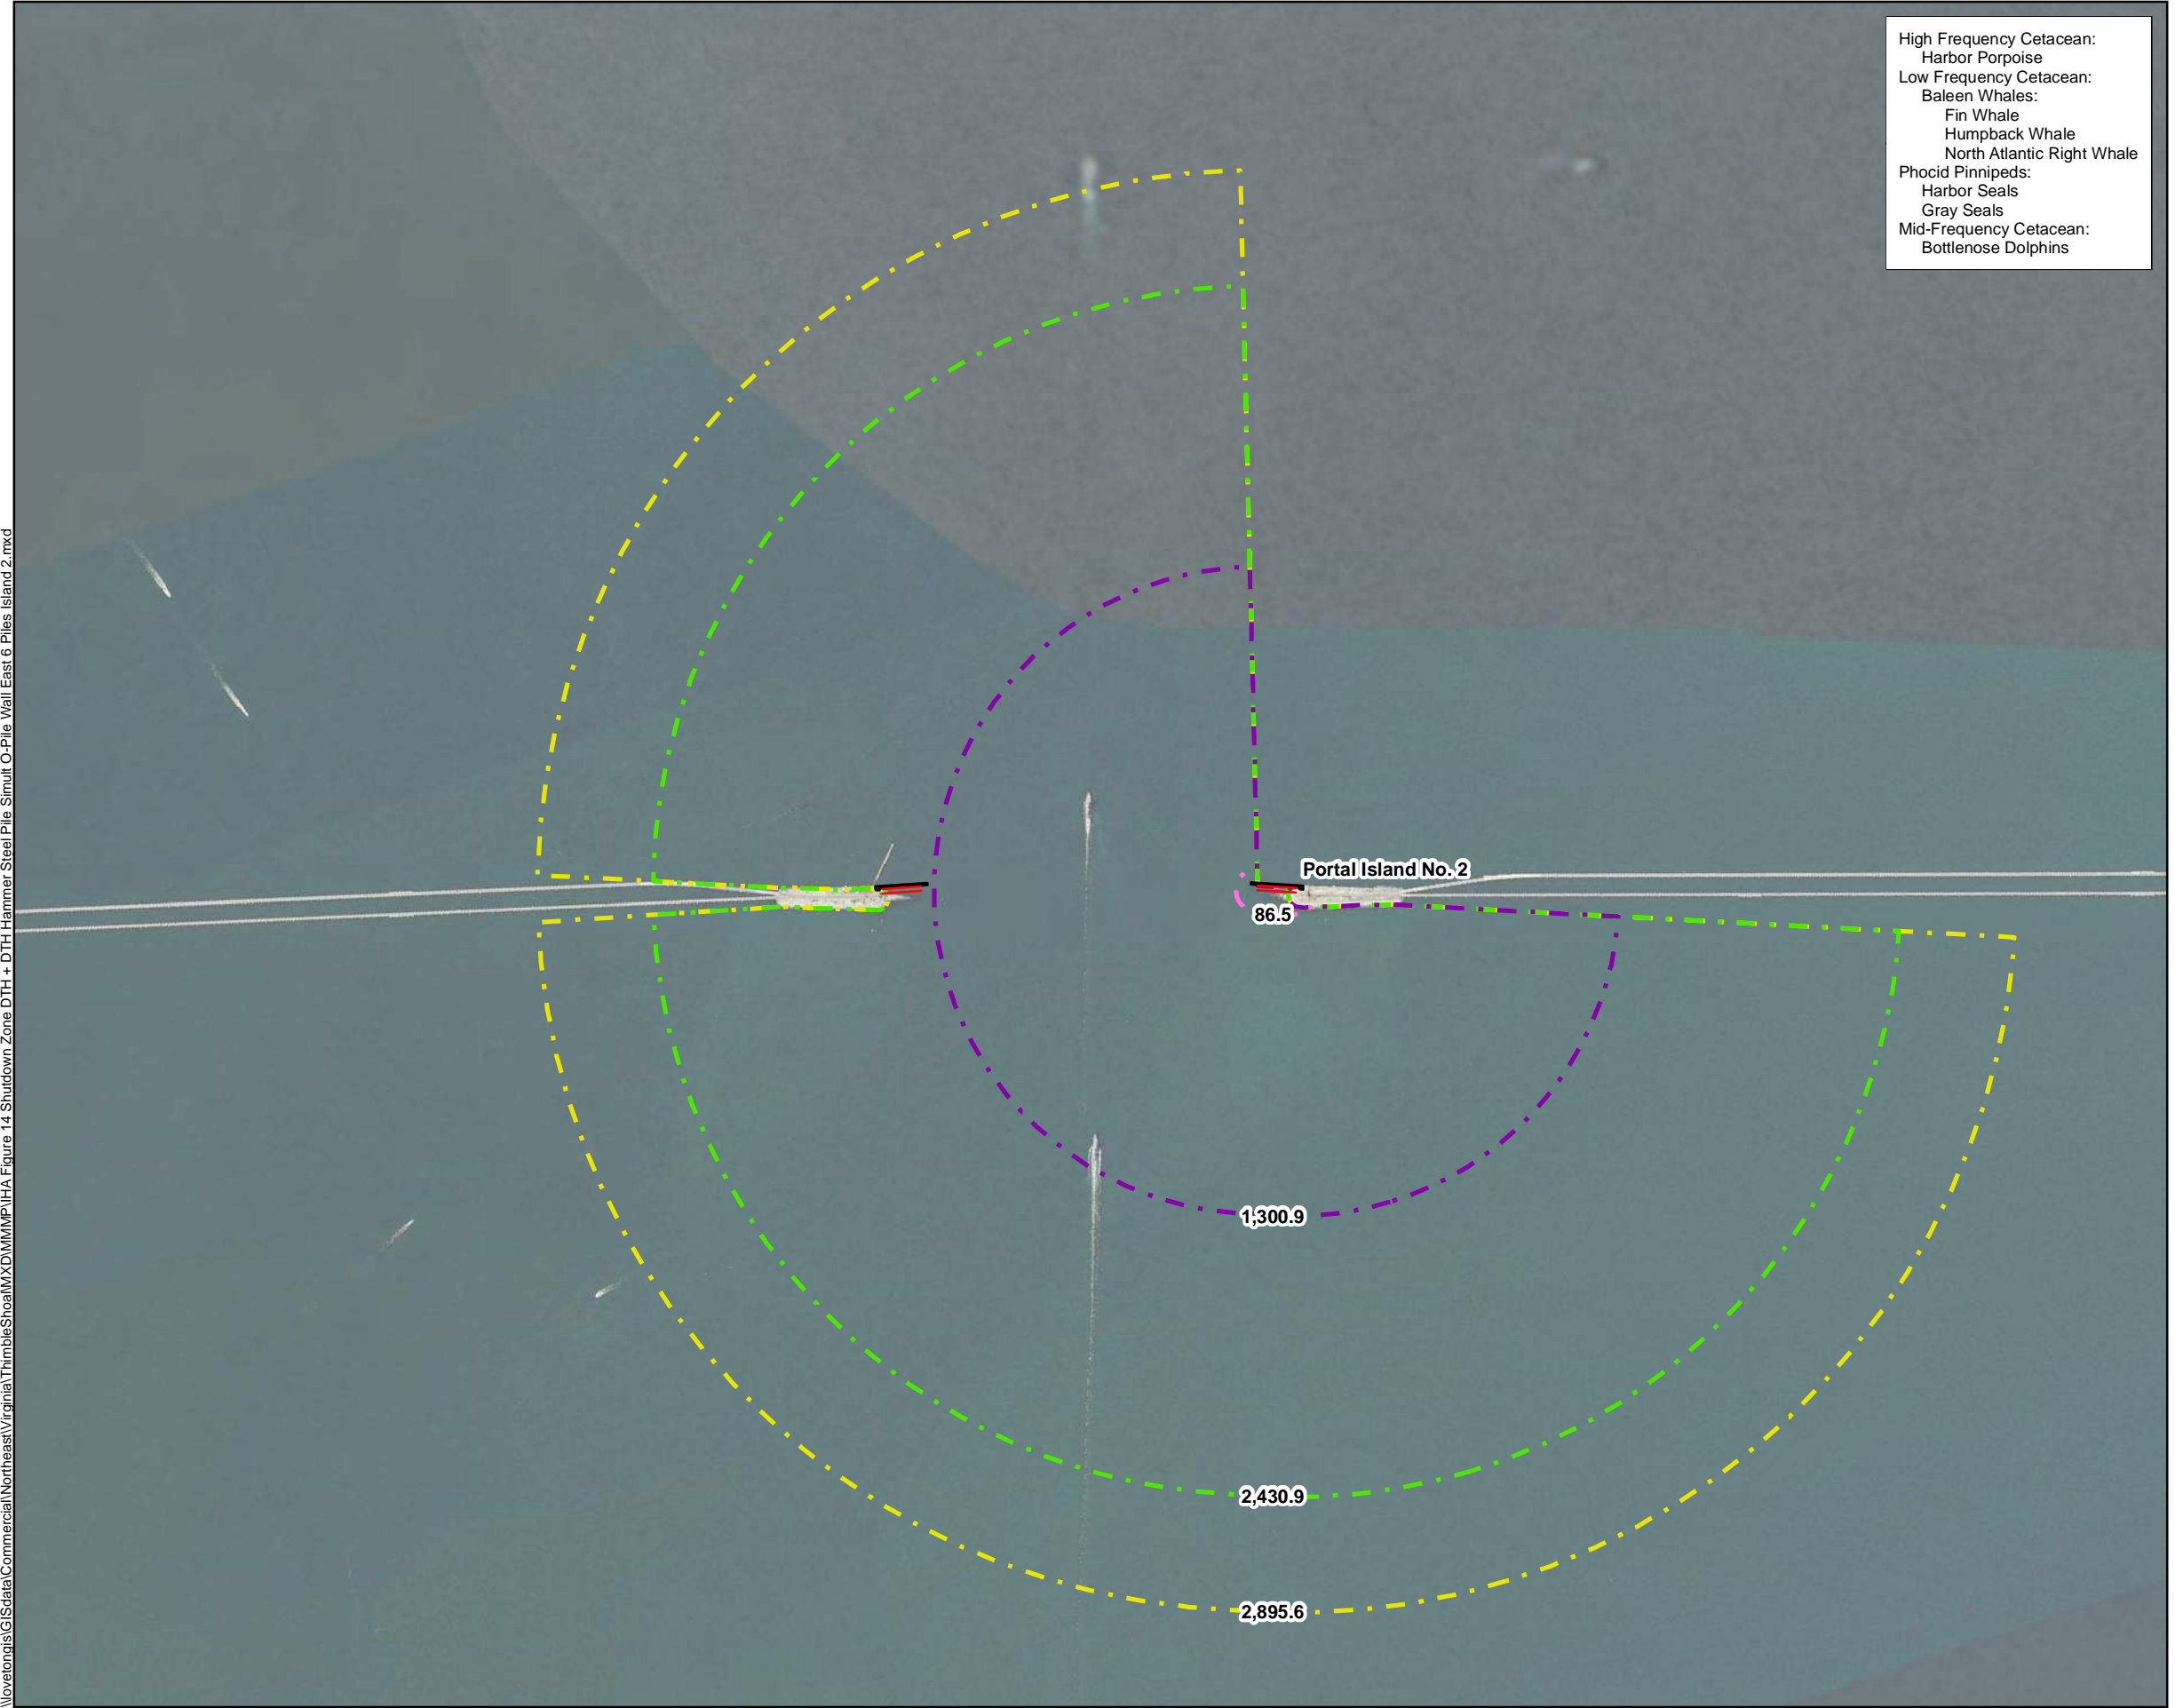
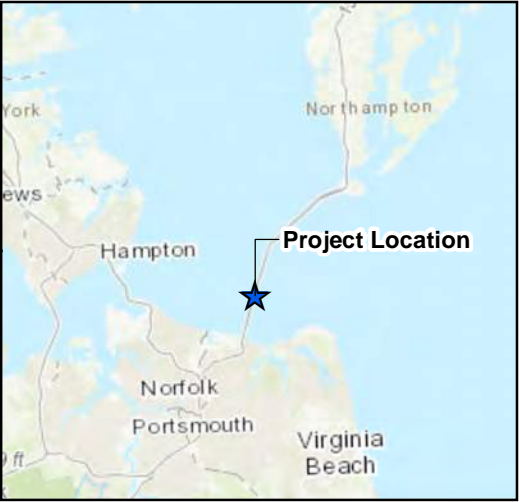
\\lovetongis\GISdata\Commercial\Northeast\Virginia\ThimbleShoal\MXD\MMMP\IHA Figure 14 Shutdown Zone DTH + DTH Hammer Steel Pile Simult O-Pile Wall East 6 Piles Island 2.mxd

- Legend**
- O-Pile Wall
 - Omega Trestle
 - 6 Down-the-Hole Piles per Day - Shutdown Zone**
 - 2,895.6 m - High-Frequency Cetaceans
 - 2,430.9 m - Low-Frequency Cetaceans
 - 1,300.9 m - Phocid Pinnipeds
 - 86.5 m - Mid-Frequency Cetaceans
