Annual Marine Monitoring Report Parallel Thimble Shoal Tunnel Project Virginia Beach, Virginia

December 2020

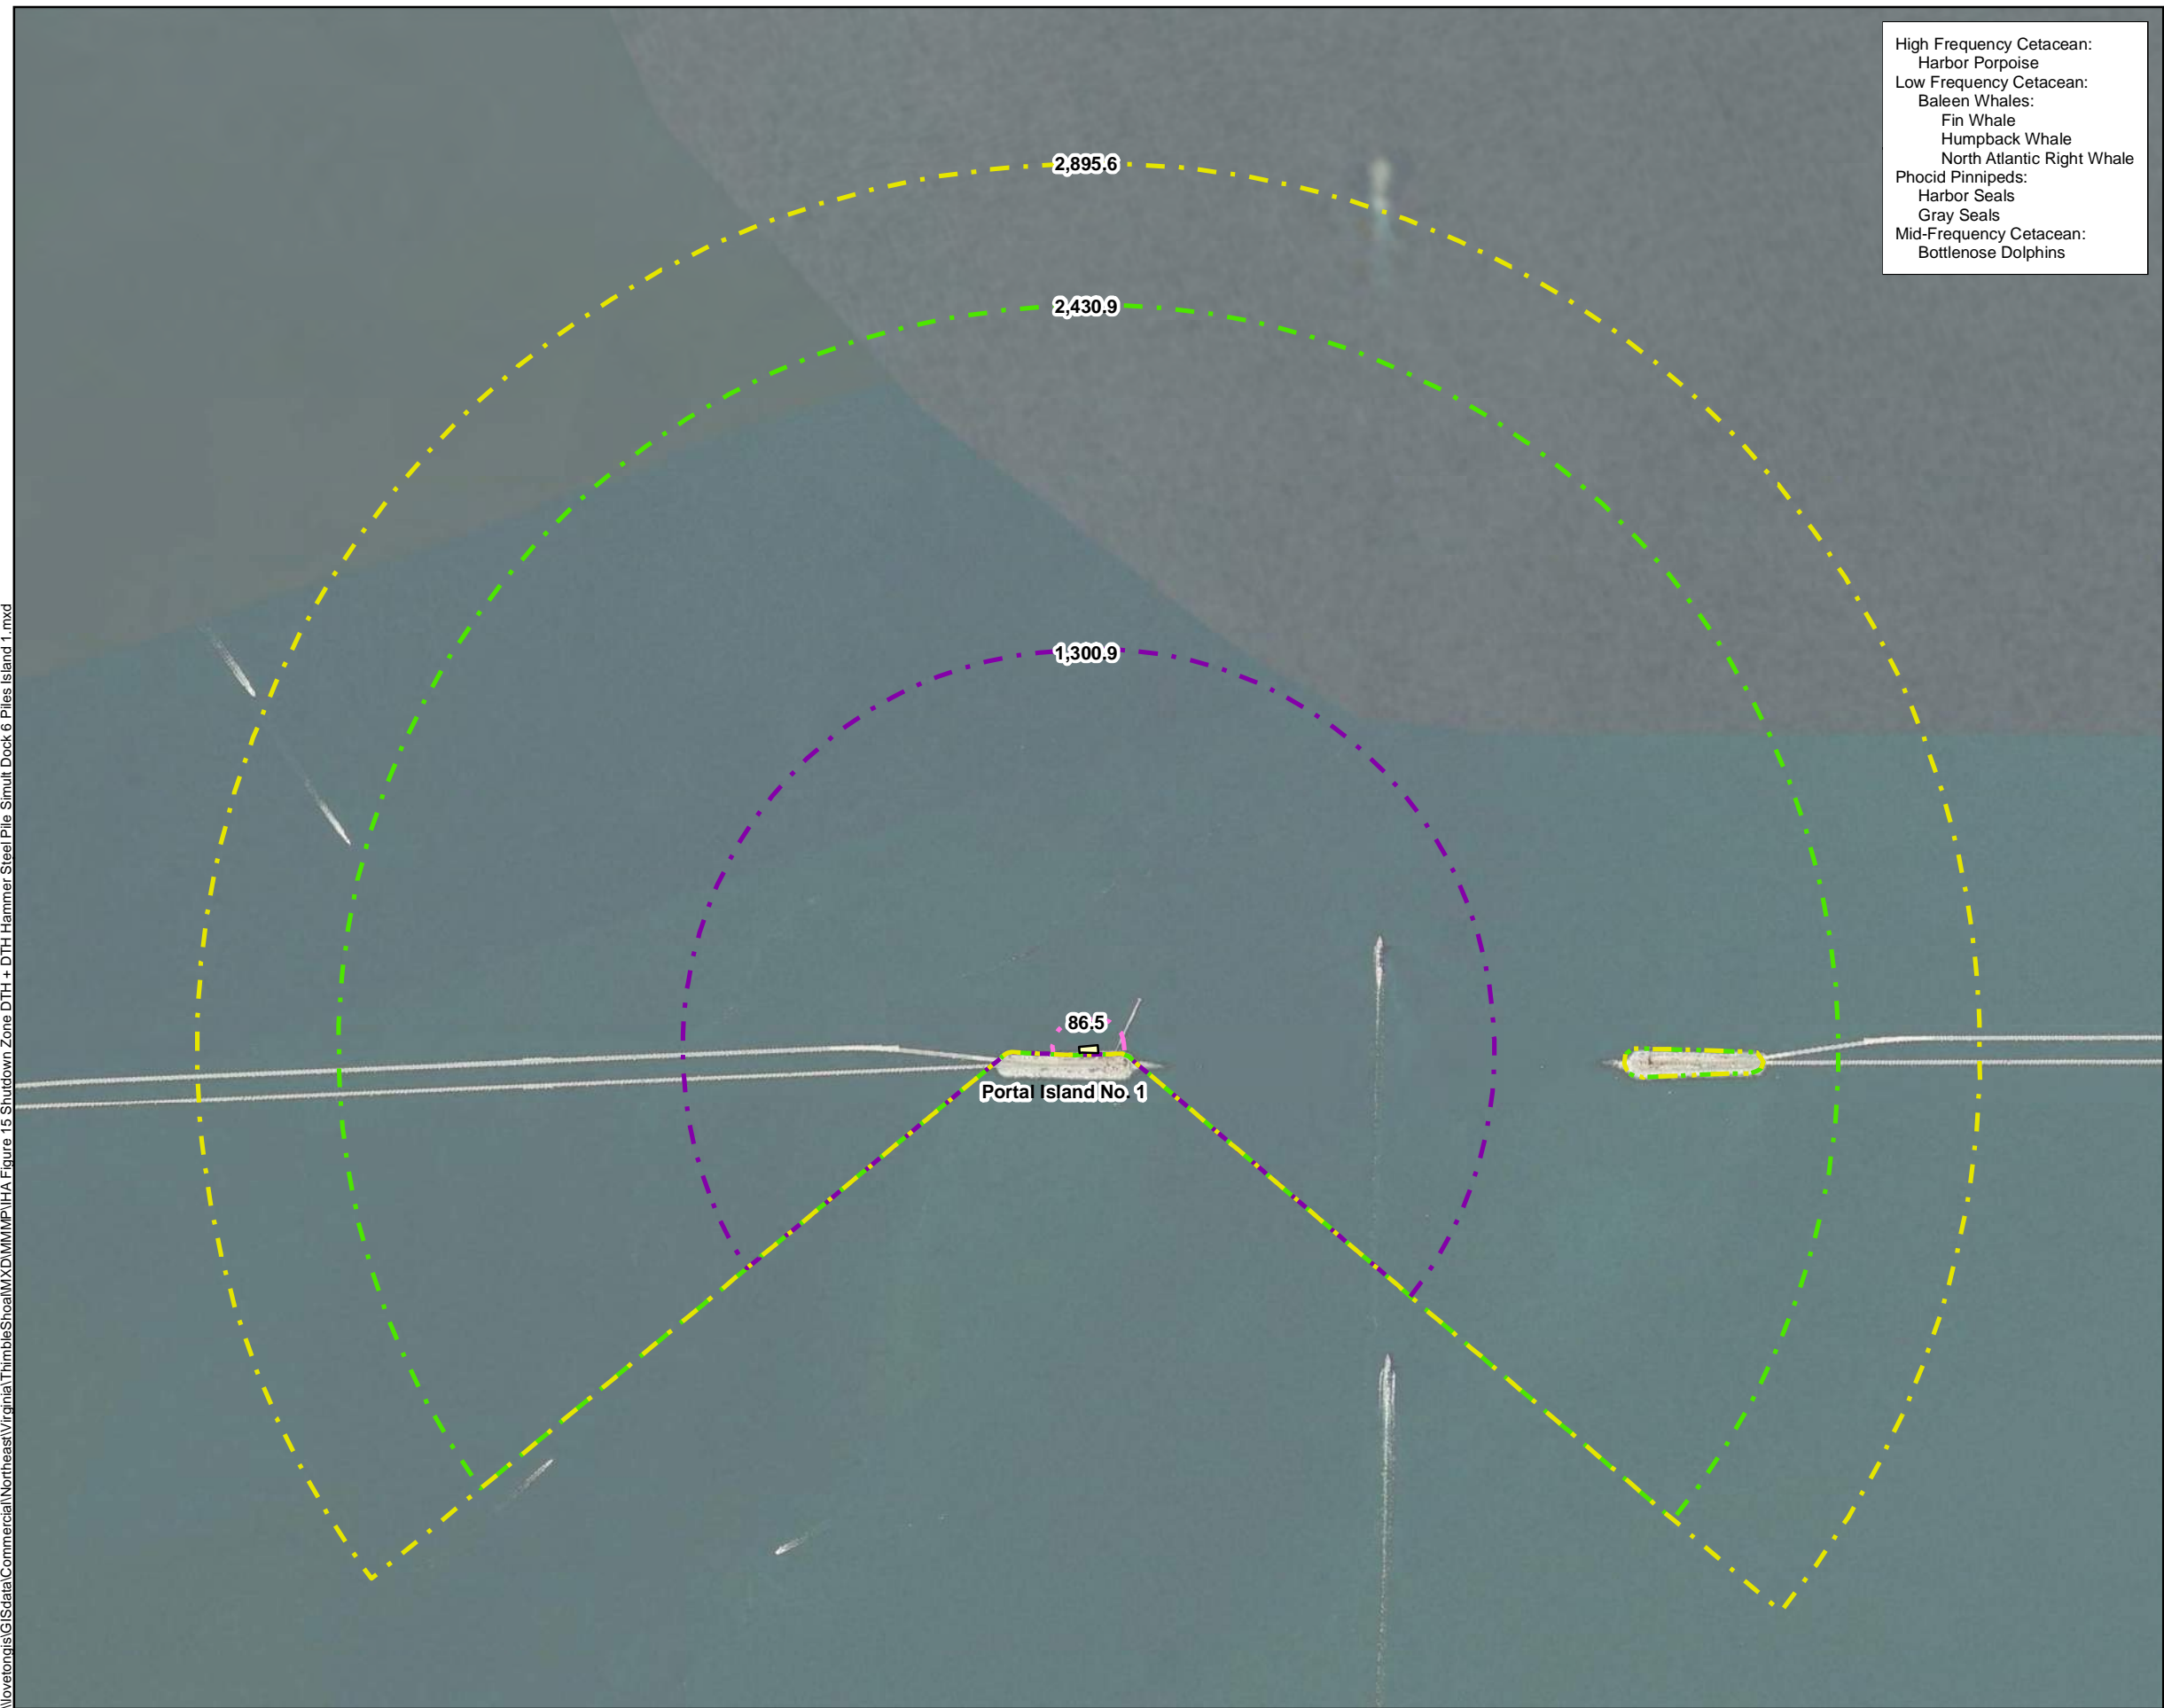
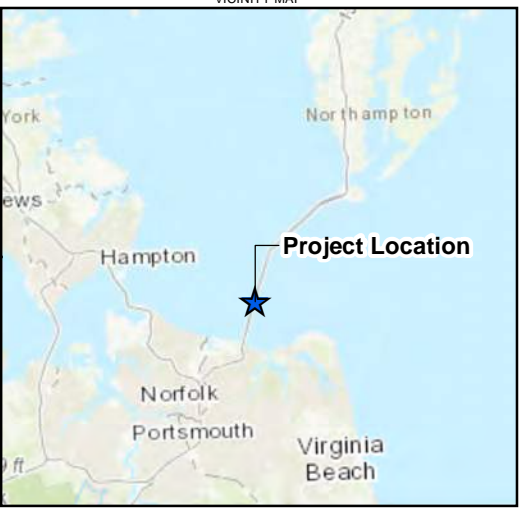
\\lovetongis\GIS\data\Commercial\Northeast\Virginia\Thimble Shoal\MXD\MMMP\IHA Figure 15 Shutdown Zone DTH + DTH Hammer Steel Pile Simult Dock 6 Piles Island 1.mxd

- Temporary Dock
- 6 Down-the-Hole Piles per Day - Shutdown Zone**
- 2,895.6 m - High-Frequency Cetaceans
 - 2,430.9 m - Low-Frequency Cetaceans
 - 1,300.9 m - Phocid Pinnipeds
 - 86.5 m - Mid-Frequency Cetaceans

Figure 8
Distance (meters) to Shutdown Zone
Using Two Down-the-Hole Hammers for
Simultaneous
36- and 42-in Steel Pile Driving for the
Temporary Dock
– 6 Piles per Day
at Portal Island No. 1
Marine Mammal Protection Act
Parallel Thimble Shoal Tunnel

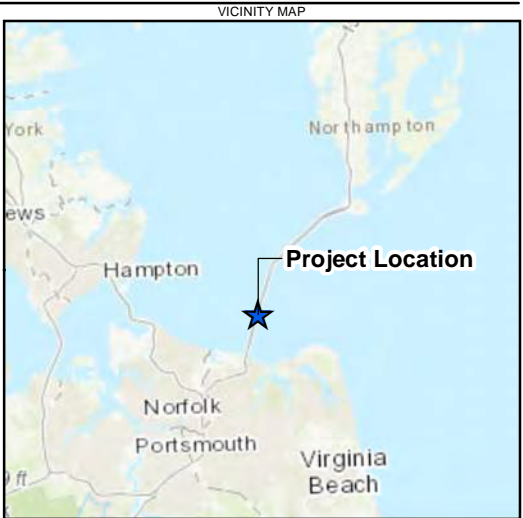
\\lovetongis\GISdata\Commercial\Northeast\Virginia\ThimbleShoal\MXD\MMMP\IHA Figure 16 Shutdown Zone DTH + Impact Hammer Steel Pile Simult Omega O-Pile Wall West10 Piles Island 1.mxd

- O-Pile Wall
■ Omega Trestle
3 Down-the-Hole and 10 Impact Piles per Day - Shutdown Zone
--- 3036.2 m - High-Frequency Cetaceans
--- 2548.9 m - Low-Frequency Cetaceans
--- 1364.1 m - Phocid Pinnipeds
--- 90.7 m - Mid-Frequency Cetaceans

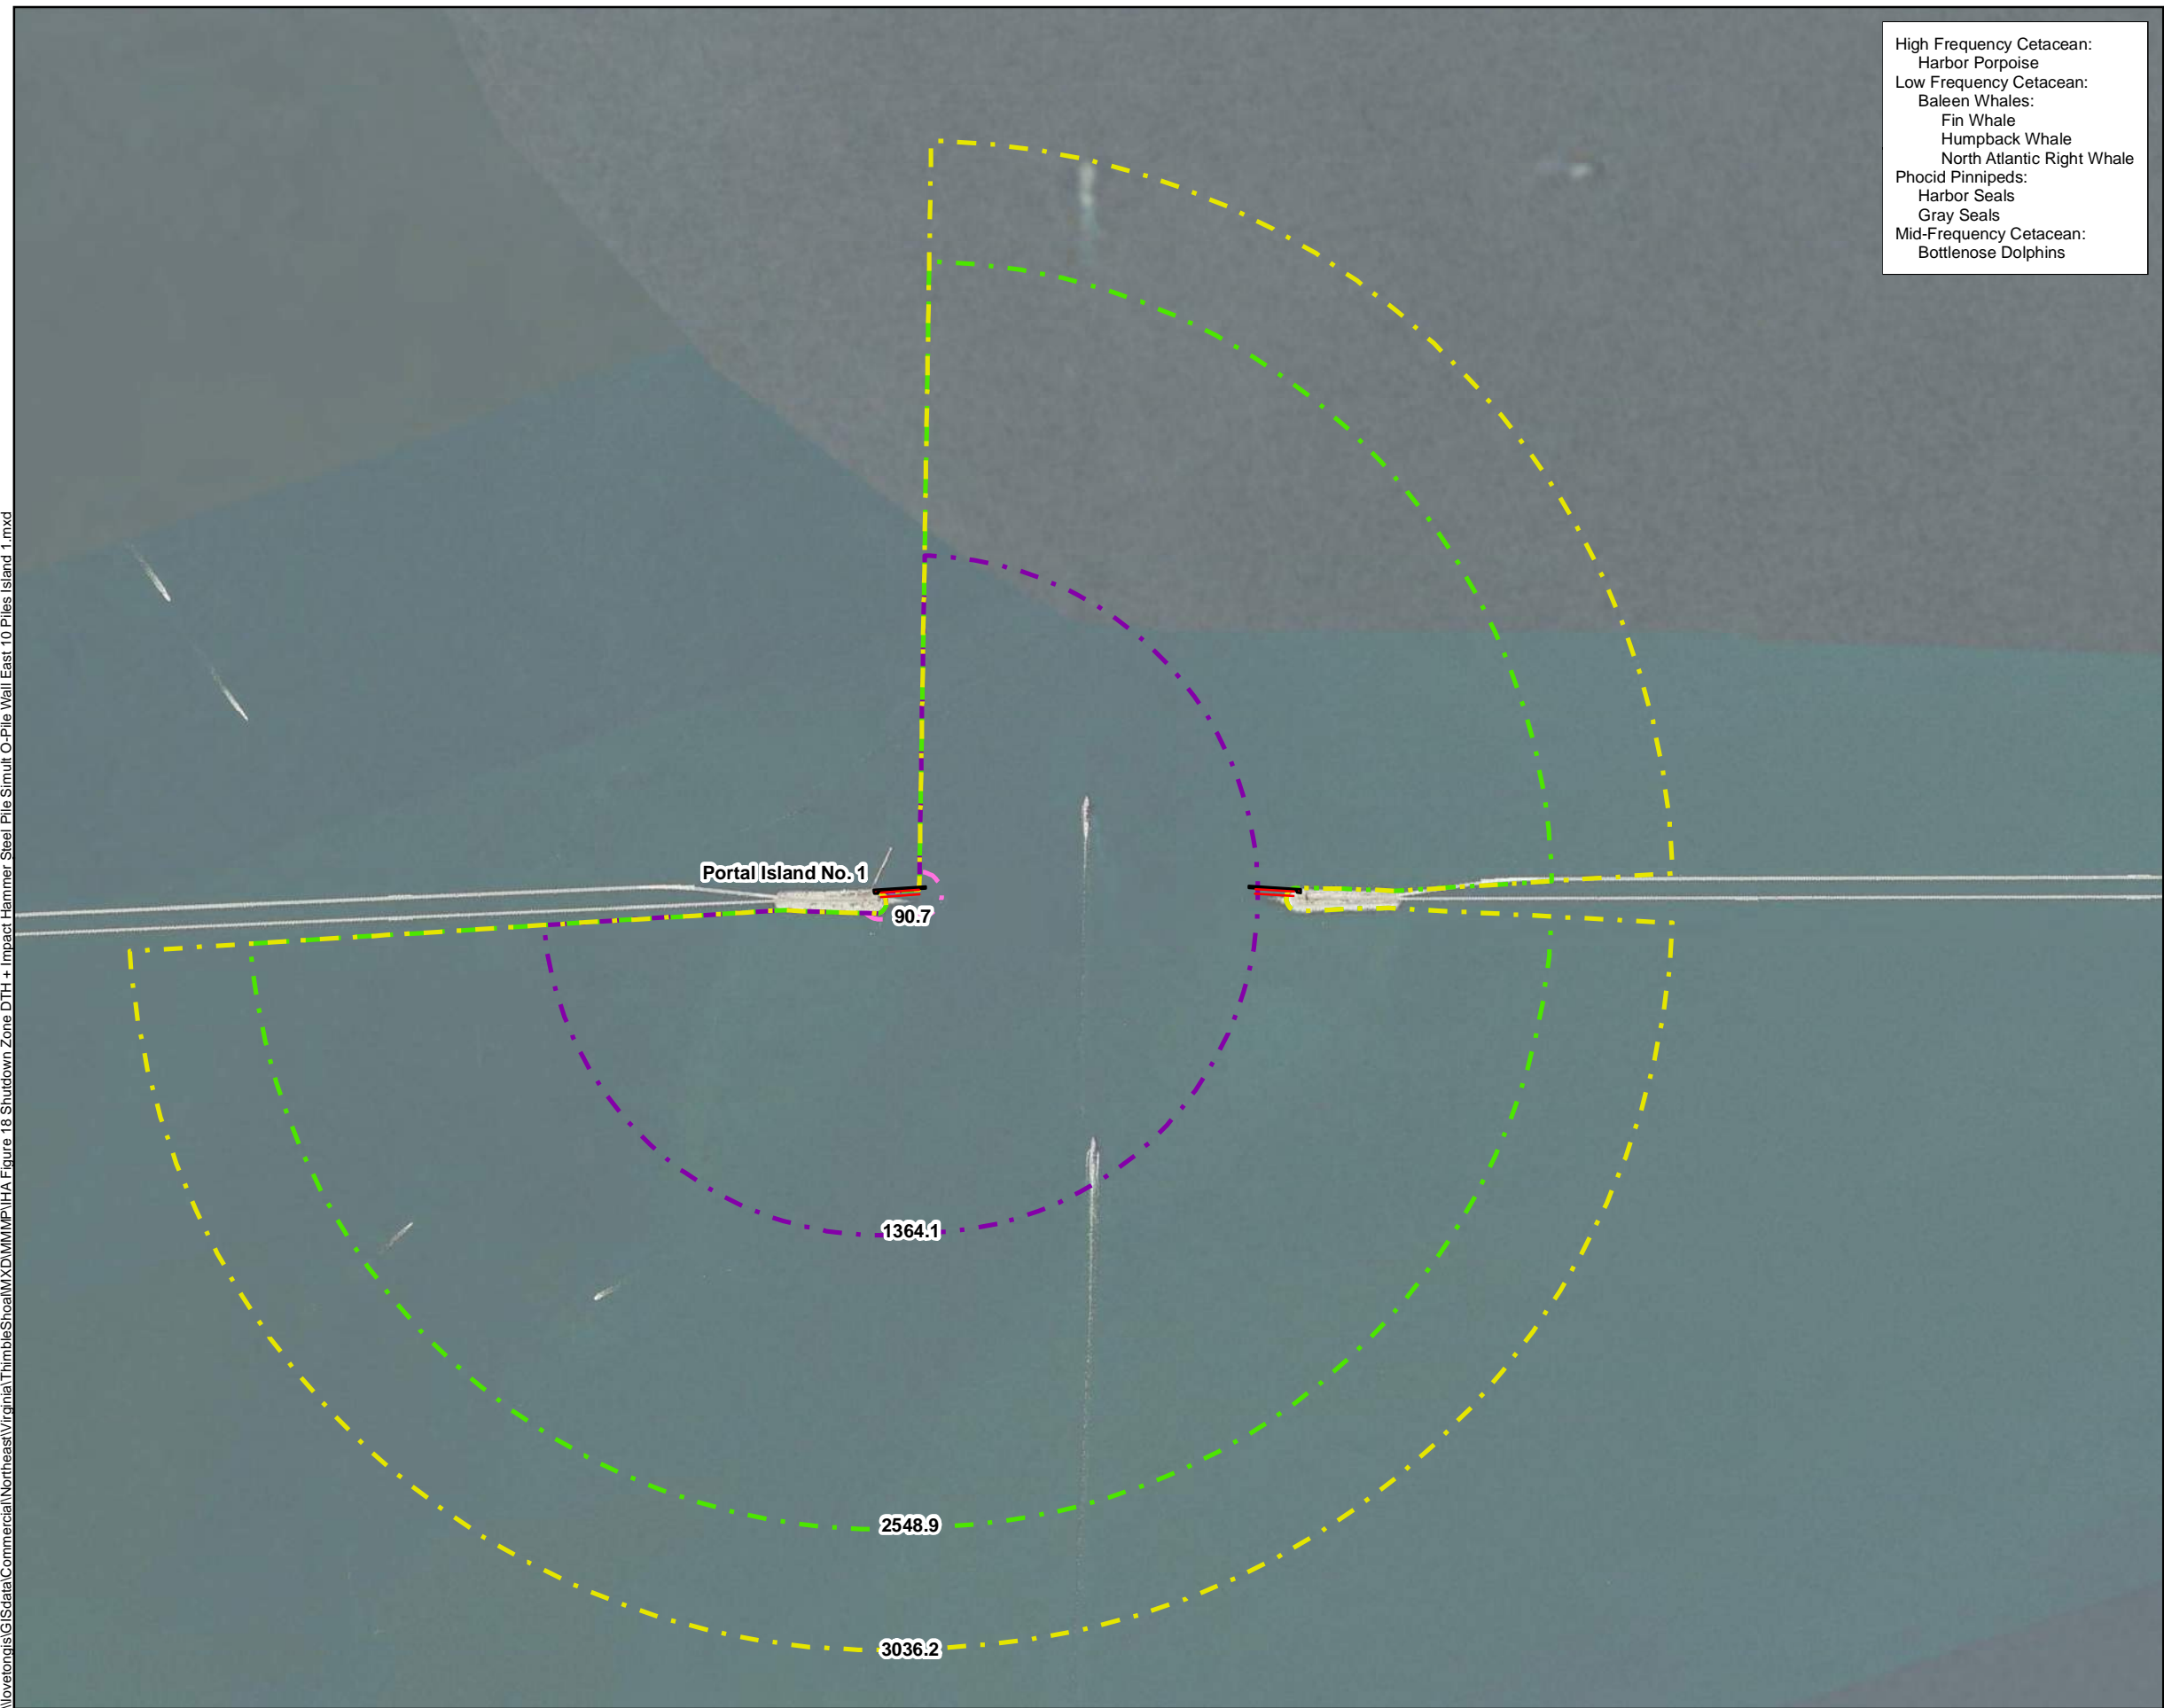
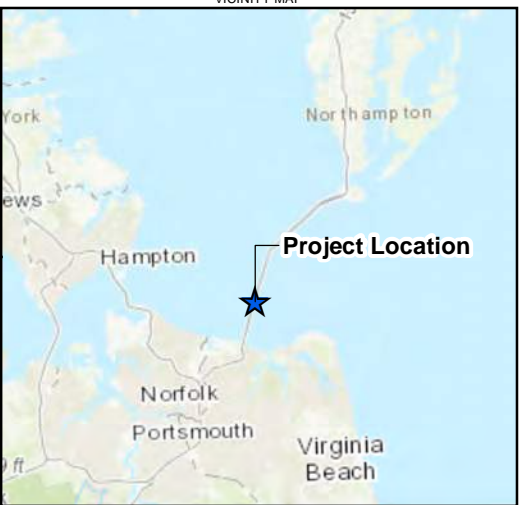
\\lovetongis\GISdata\Commercial\Northeast\Virginia\ThimbleShoal\MXD\MMMP\IHA Figure 18 Shutdown Zone DTH + Impact Hammer Steel Pile Simult O-Pile Wall East 10 Piles Island 1.mxd

- O-Pile Wall
■ Omega Trestle
3 Down-the-Hole and 10 Impact Piles per Day - Shutdown Zone
--- 3036.2 m - High-Frequency Cetaceans
--- 2548.9 m - Low-Frequency Cetaceans
--- 1,364.1 m - Phocid Pinnipeds
--- 90.7 m - Mid-Frequency Cetaceans

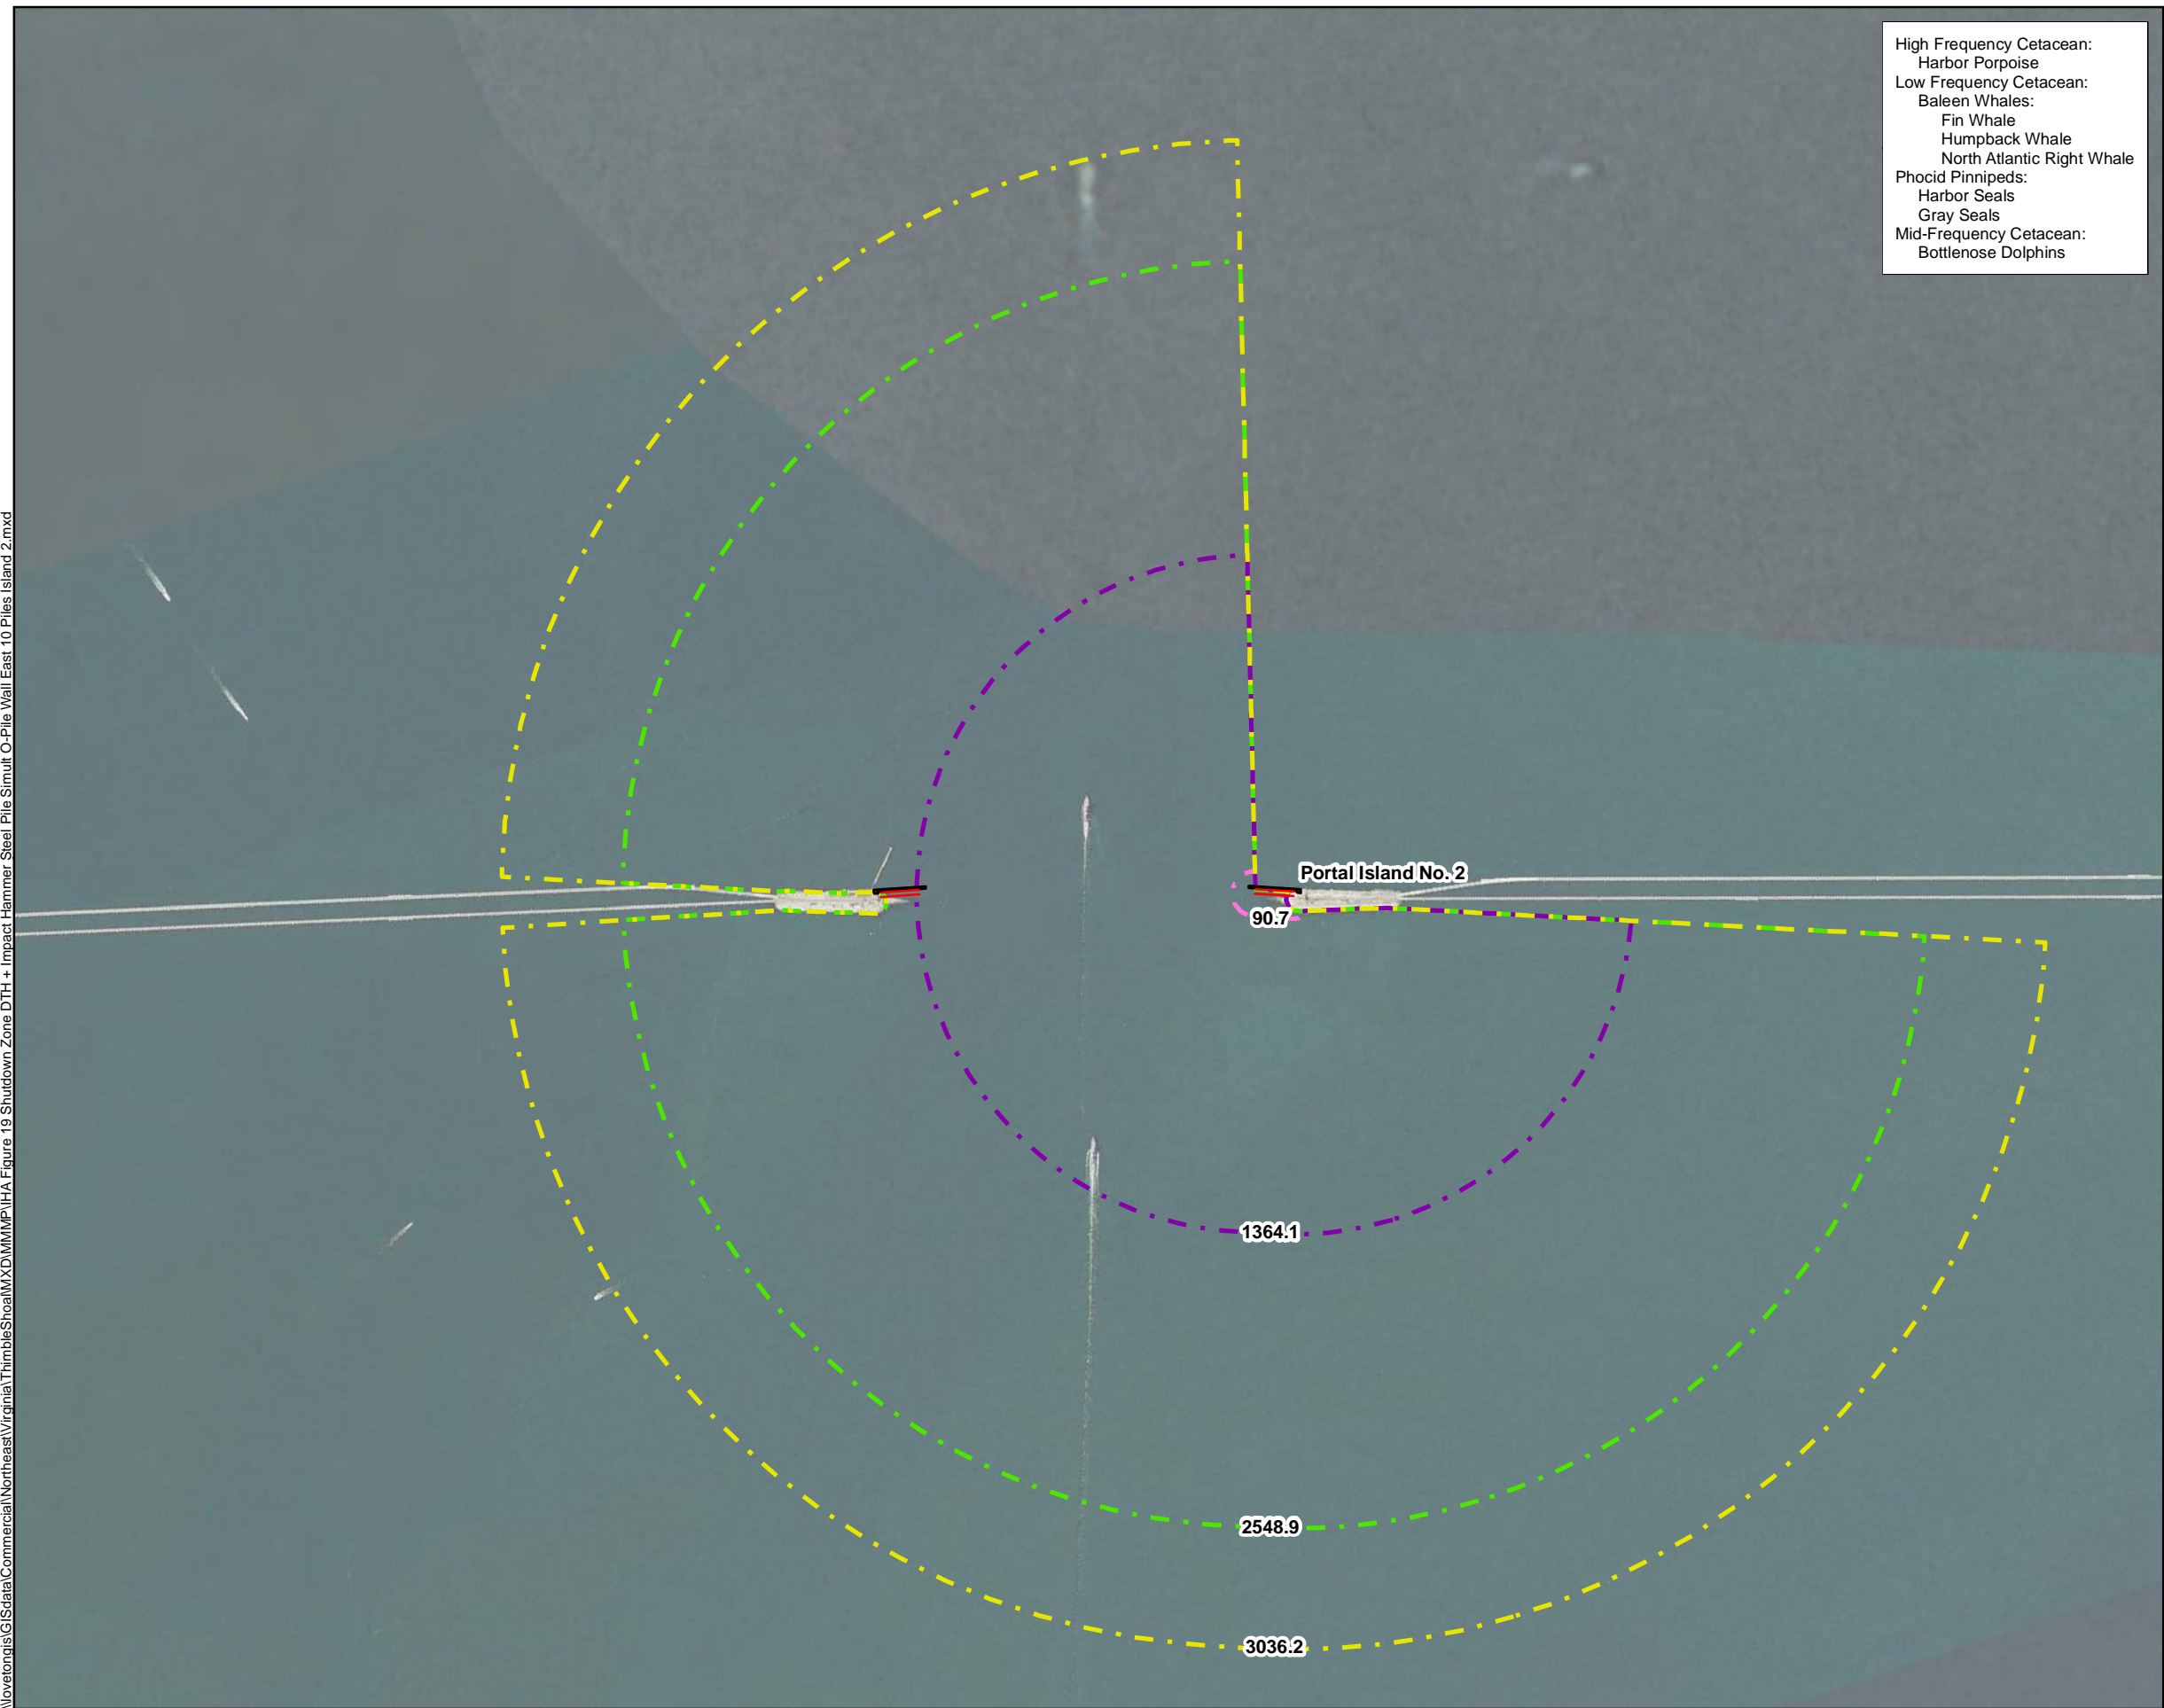
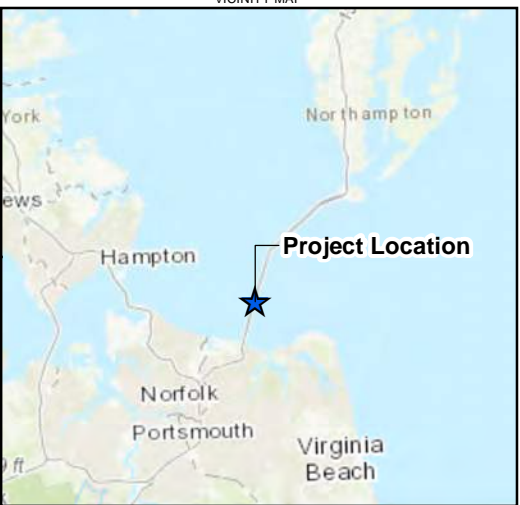
\\lovetongis\GISdata\Commercial\Northeast\Virginia\ThimbleShoal\MXD\MMMP\IHA Figure 19 Shutdown Zone DTH + Impact Hammer Steel Pile Simult O-Pile Wall East 10 Piles Island 2.mxd

- O-Pile Wall
■ Omega Trestle
3 Down-the-Hole and 10 Impact Piles per Day - Shutdown Zone
--- 3036.2 m - High-Frequency Cetaceans
--- 2548.9 m - Low-Frequency Cetaceans
--- 1364.1 m - Phocid Pinnipeds
--- 90.7 m - Mid-Frequency Cetaceans

Figure 12
Distance (meters) to Shutdown Zone
Using a Down-the-Hole and Impact
Hammers for Simultaneous
36- and 42-in Steel Pile Driving for the
East O-Pile Wall
– 3 DTH and 10 Impact Piles per Day
at Portal Island No. 2
Marine Mammal Protection Act
Parallel Thimble Shoal Tunnel

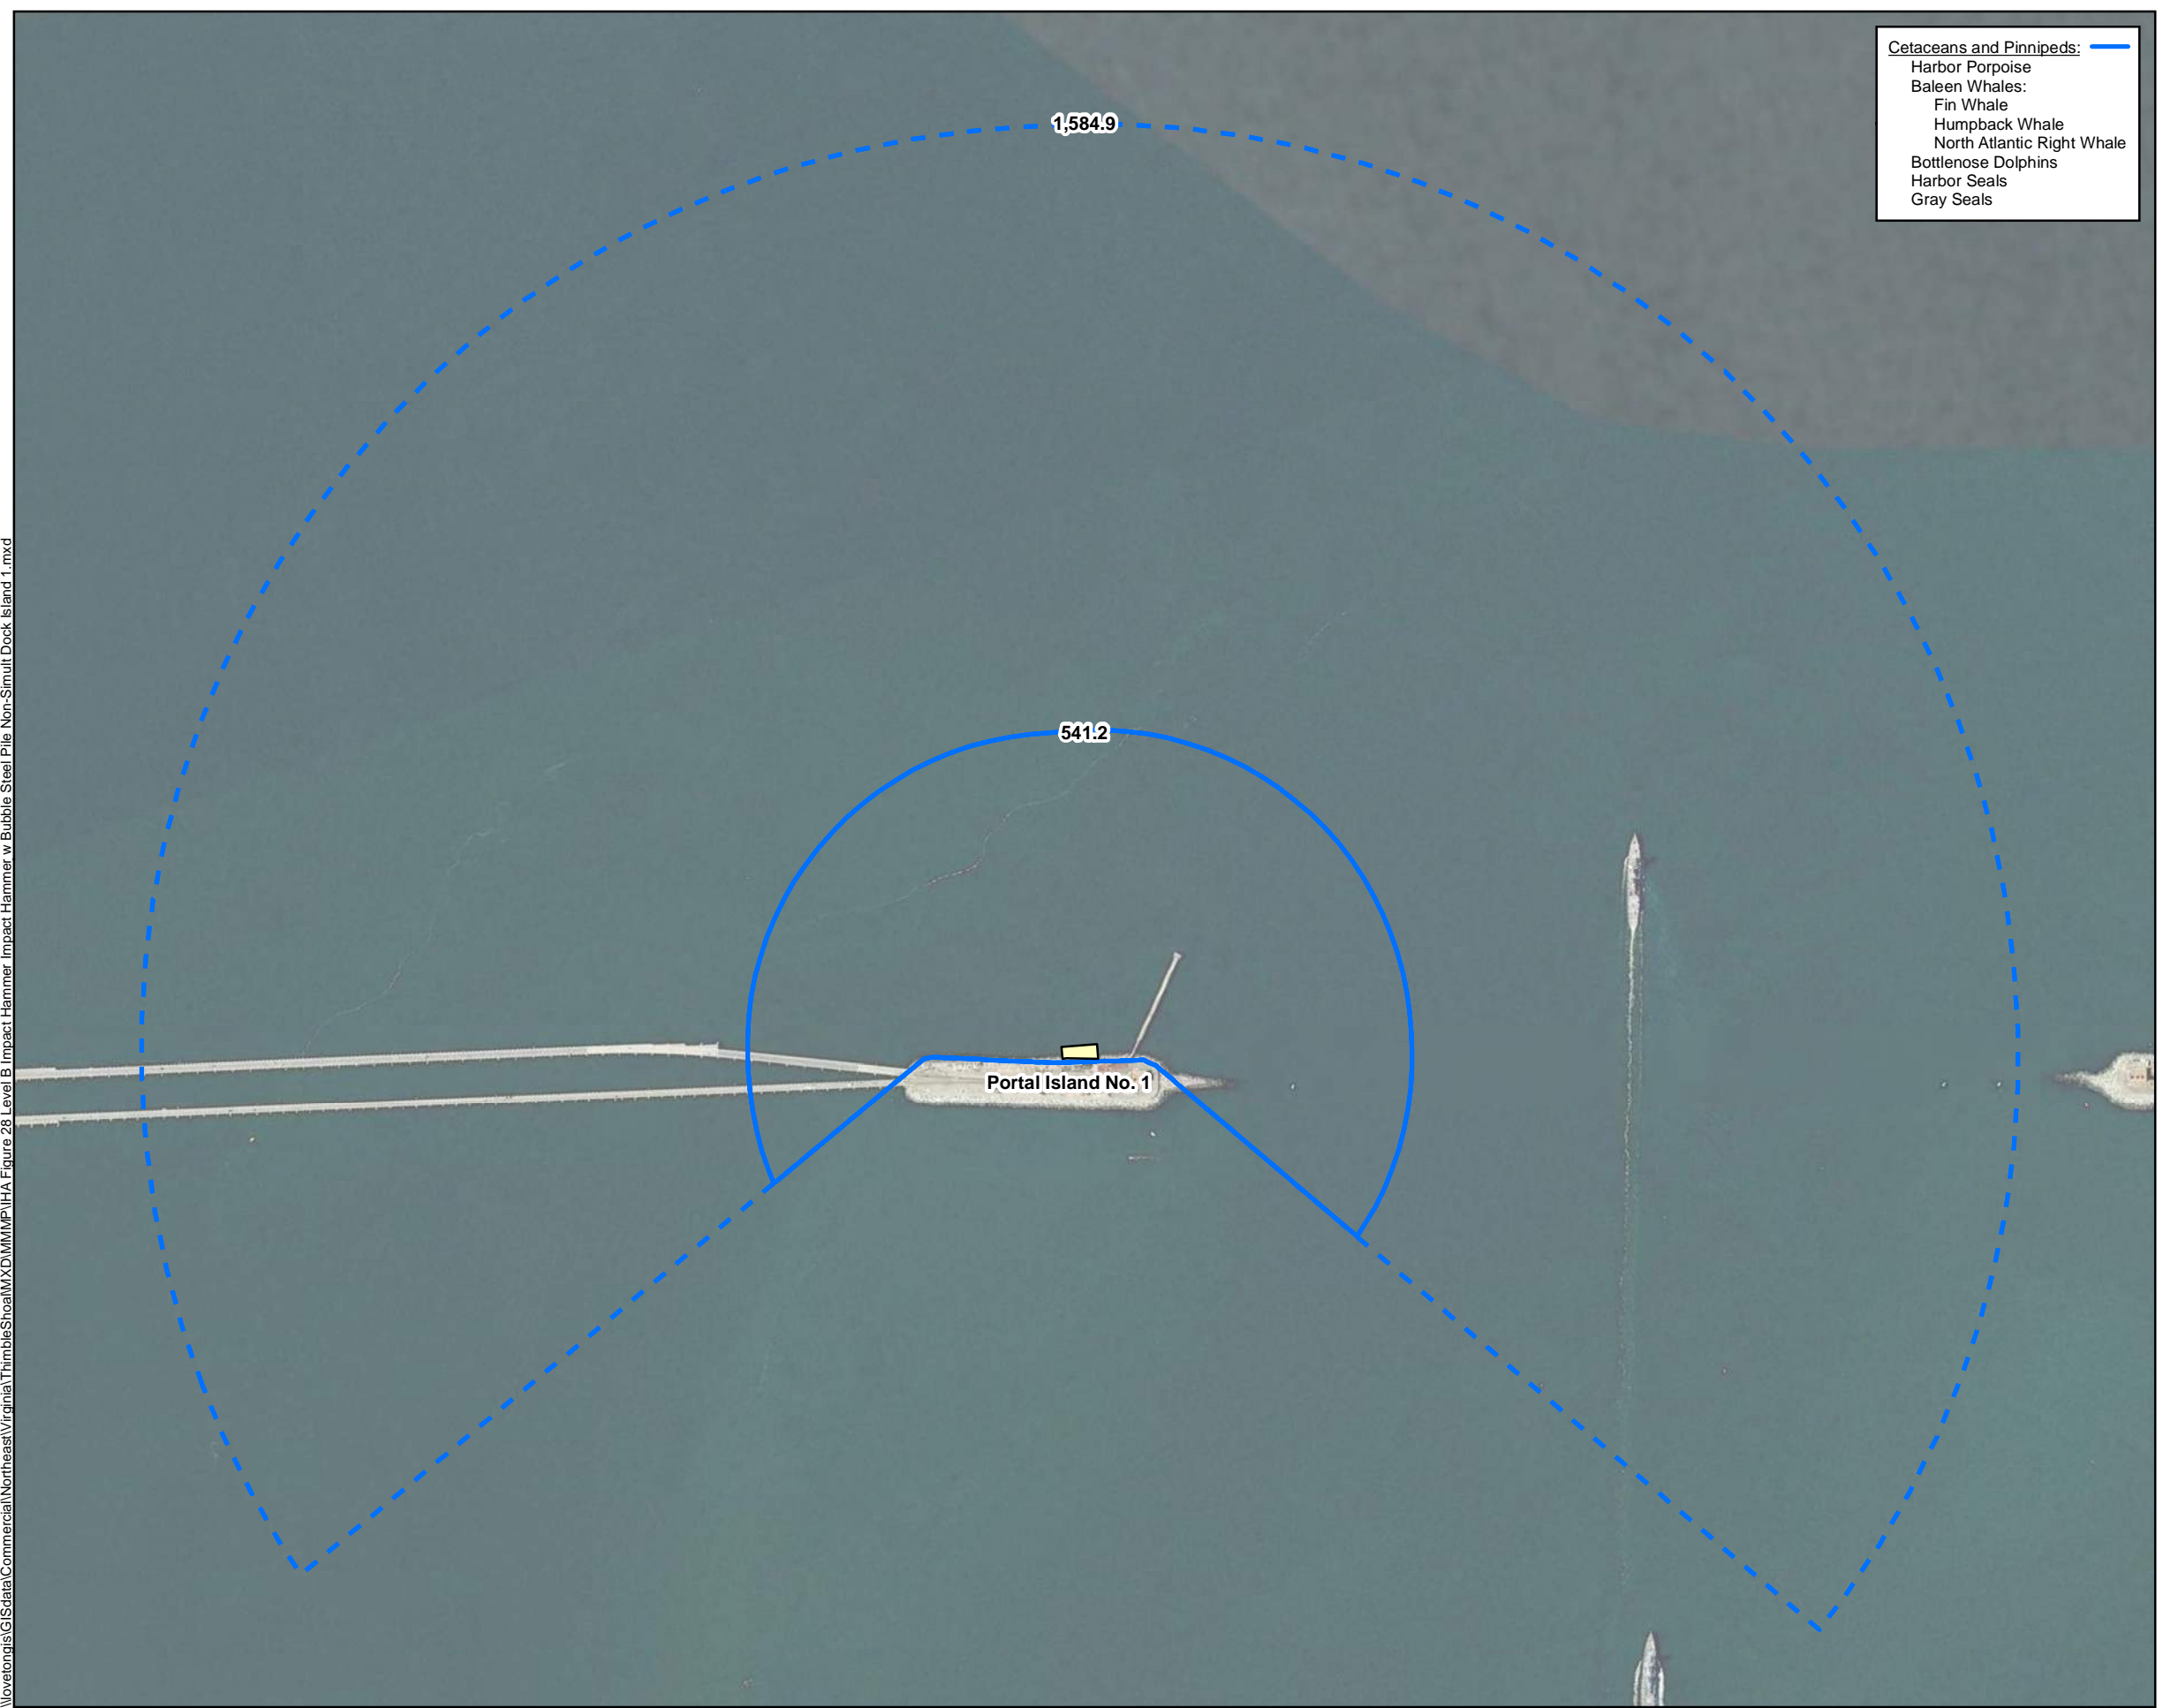
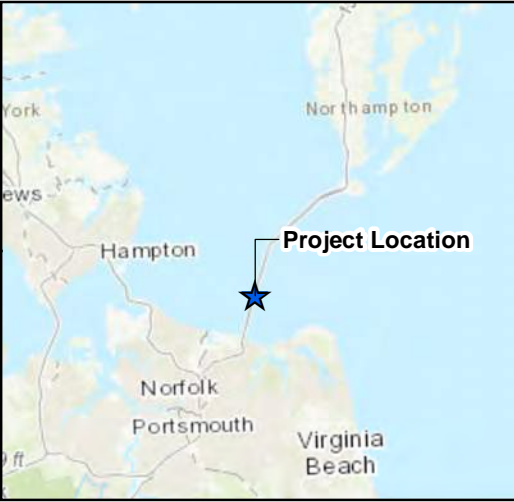
\\lovetongis\GISdata\Commercial\Northeast\Virginia\ThimbleShoal\MXD\MMMP\IHA Figure 28 Level B Impact Hammer w Bubble Steel Pile Non-Simult Dock Island 1.mxd

- Legend**
- Temporary Dock
 - Impact Pile - Level B**
 - 1,584.9 m - Cetaceans and Pinnipeds
 - Impact Pile with Bubble Curtain - Level B**
 - 541.2 m - Cetaceans and Pinnipeds

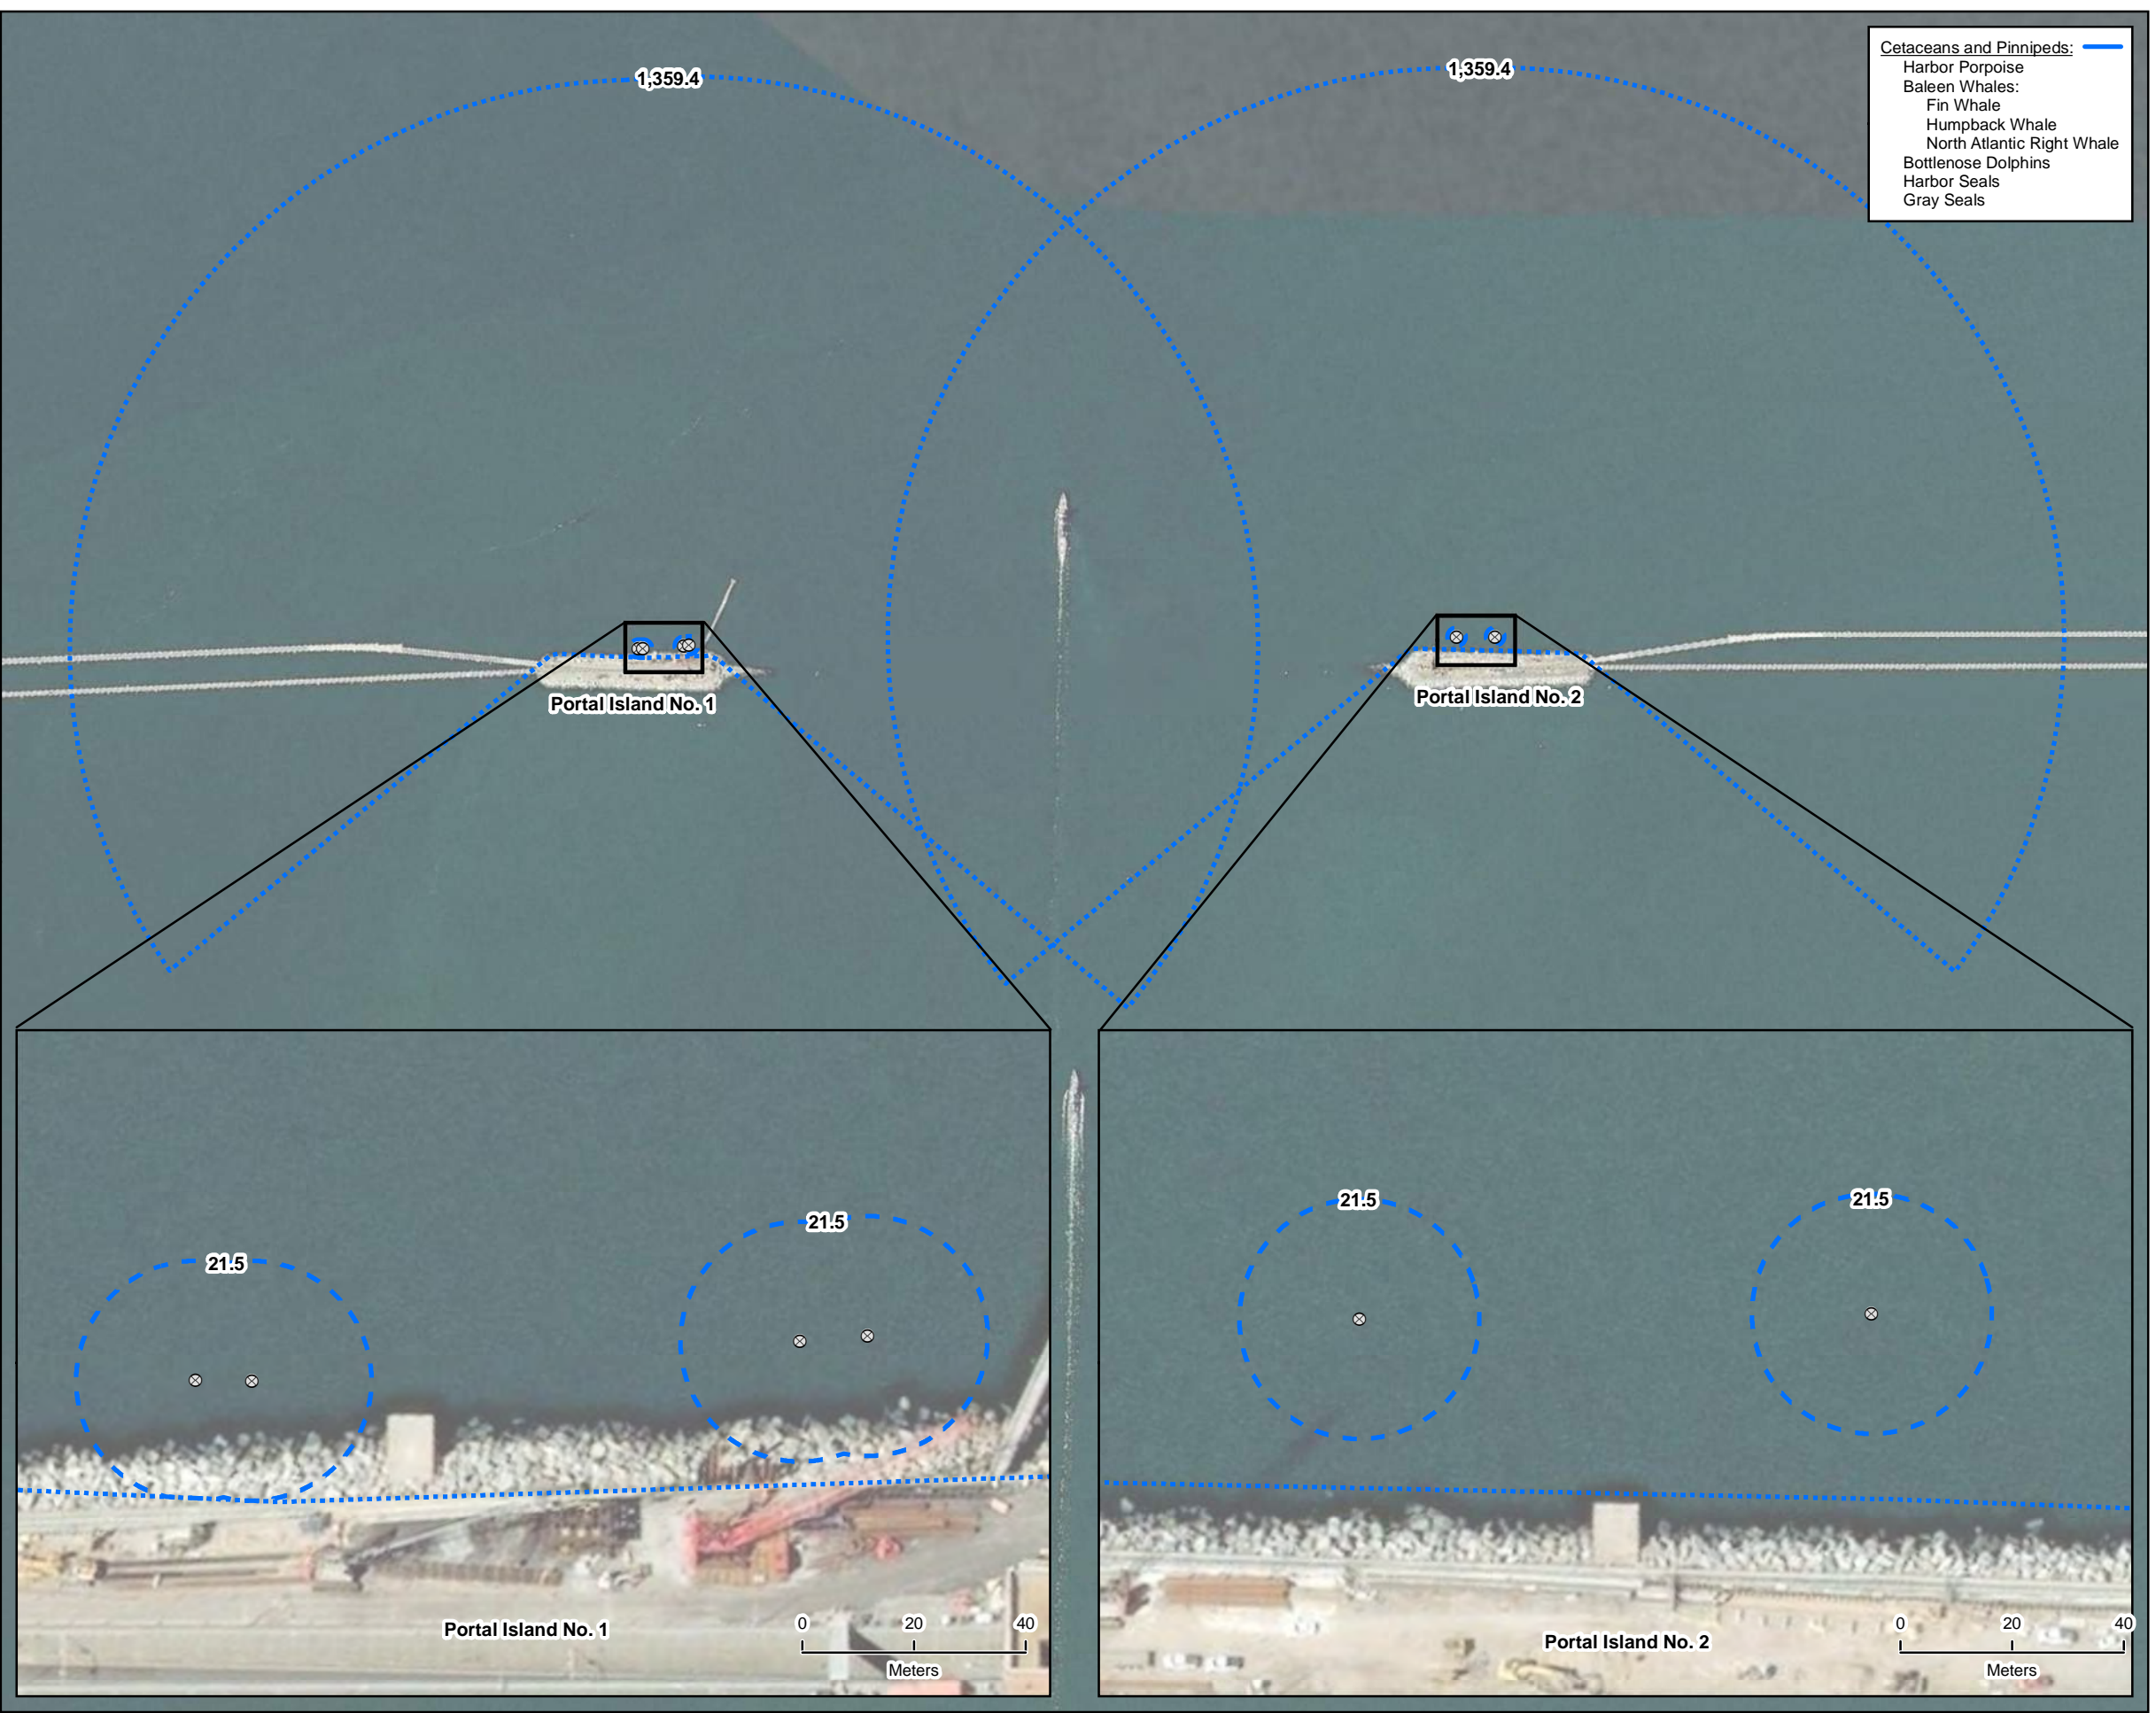
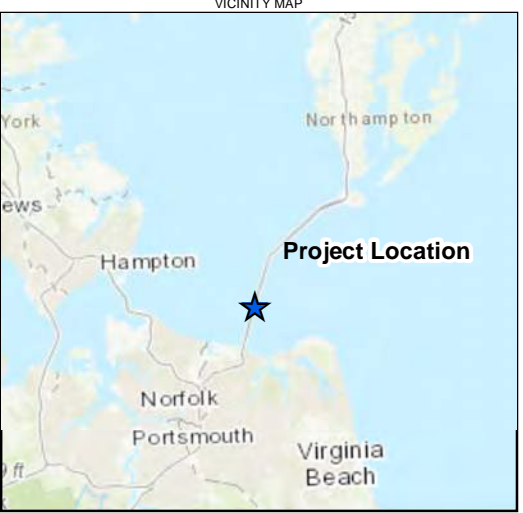
\\lovetongis\GIS\data\Commercial\Northeast\Virginia\Thimble Shoal\MXD\MMMP\IHA Figure 30 Level B Impact Hammer Vibratory Hammer Timber Pile Non-Simult Mooring Dolphins Island 1 and 2.mxd

- ⊗ Mooring Dolphin
- Impact Pile - Level B**
 - 21.5 m - Cetaceans and Pinnipeds
- Vibratory Pile - Level B**
 - 1,359.4 m - Cetaceans and Pinnipeds

Figure 14
Distance (meters) to Level B Threshold
Using an Impact Hammer or
Vibratory Hammer for
Non-Simultaneous
Timber Pile Driving for the
Mooring Dolphins
at Portal Island Nos. 1 and 2
Marine Mammal Protection Act
Parallel Thimble Shoal Tunnel
