Annual Marine Monitoring Report Parallel Thimble Shoal Tunnel Project Virginia Beach, Virginia

December 2020

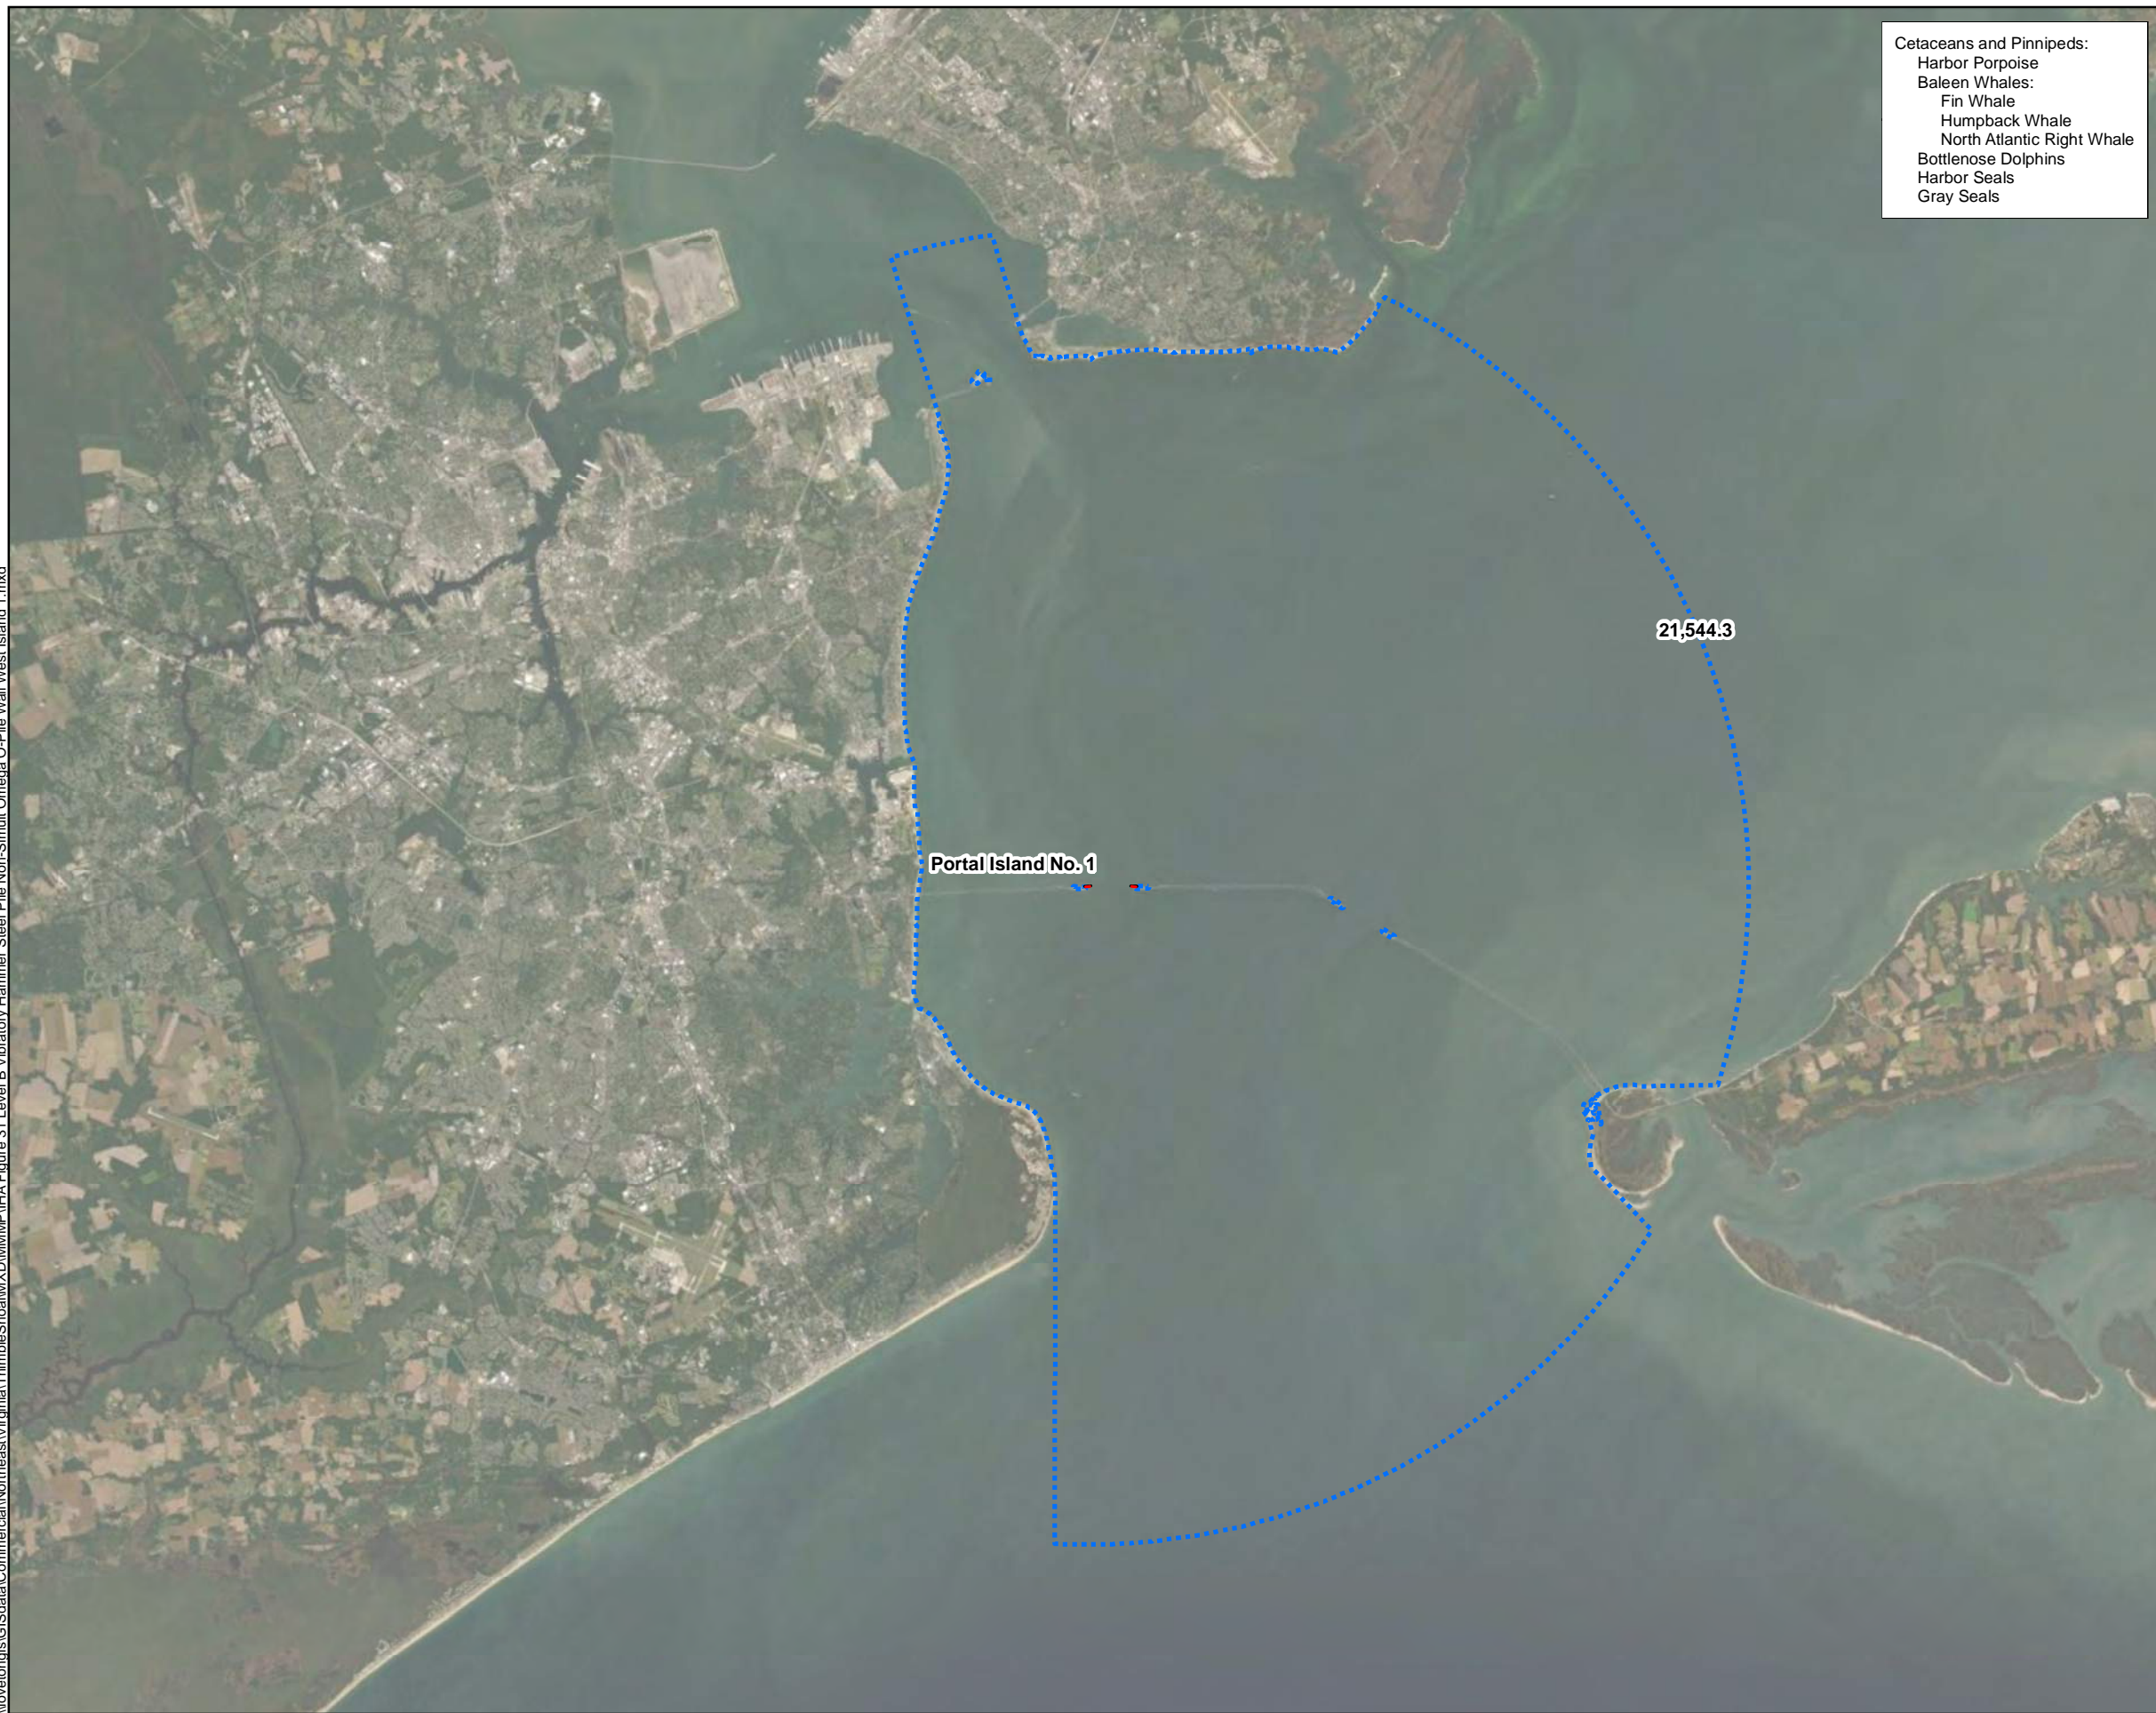
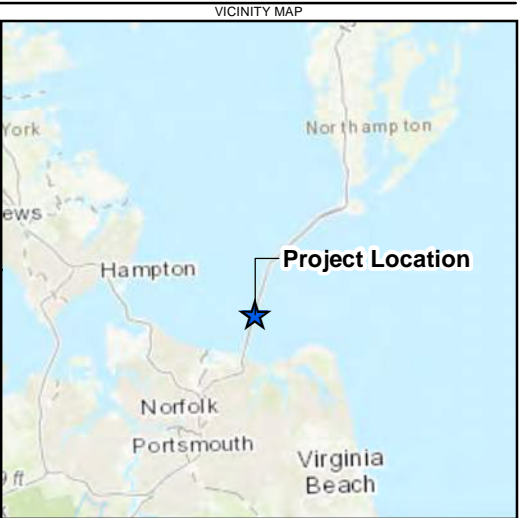
\\lovetongis\GIS\data\Commercial\Northeast\Virginia\ThimbleShoal\MXD\MMMP\IHA Figure 31 Level B Vibratory Hammer Steel Pile Non-Simult Omega O-Pile Wall West Island 1.mxd

- O-Pile Wall
- Omega Trestle
- Vibratory Steel Piles - Level B**
- 21,544.3 m - Cetaceans and Pinnipeds

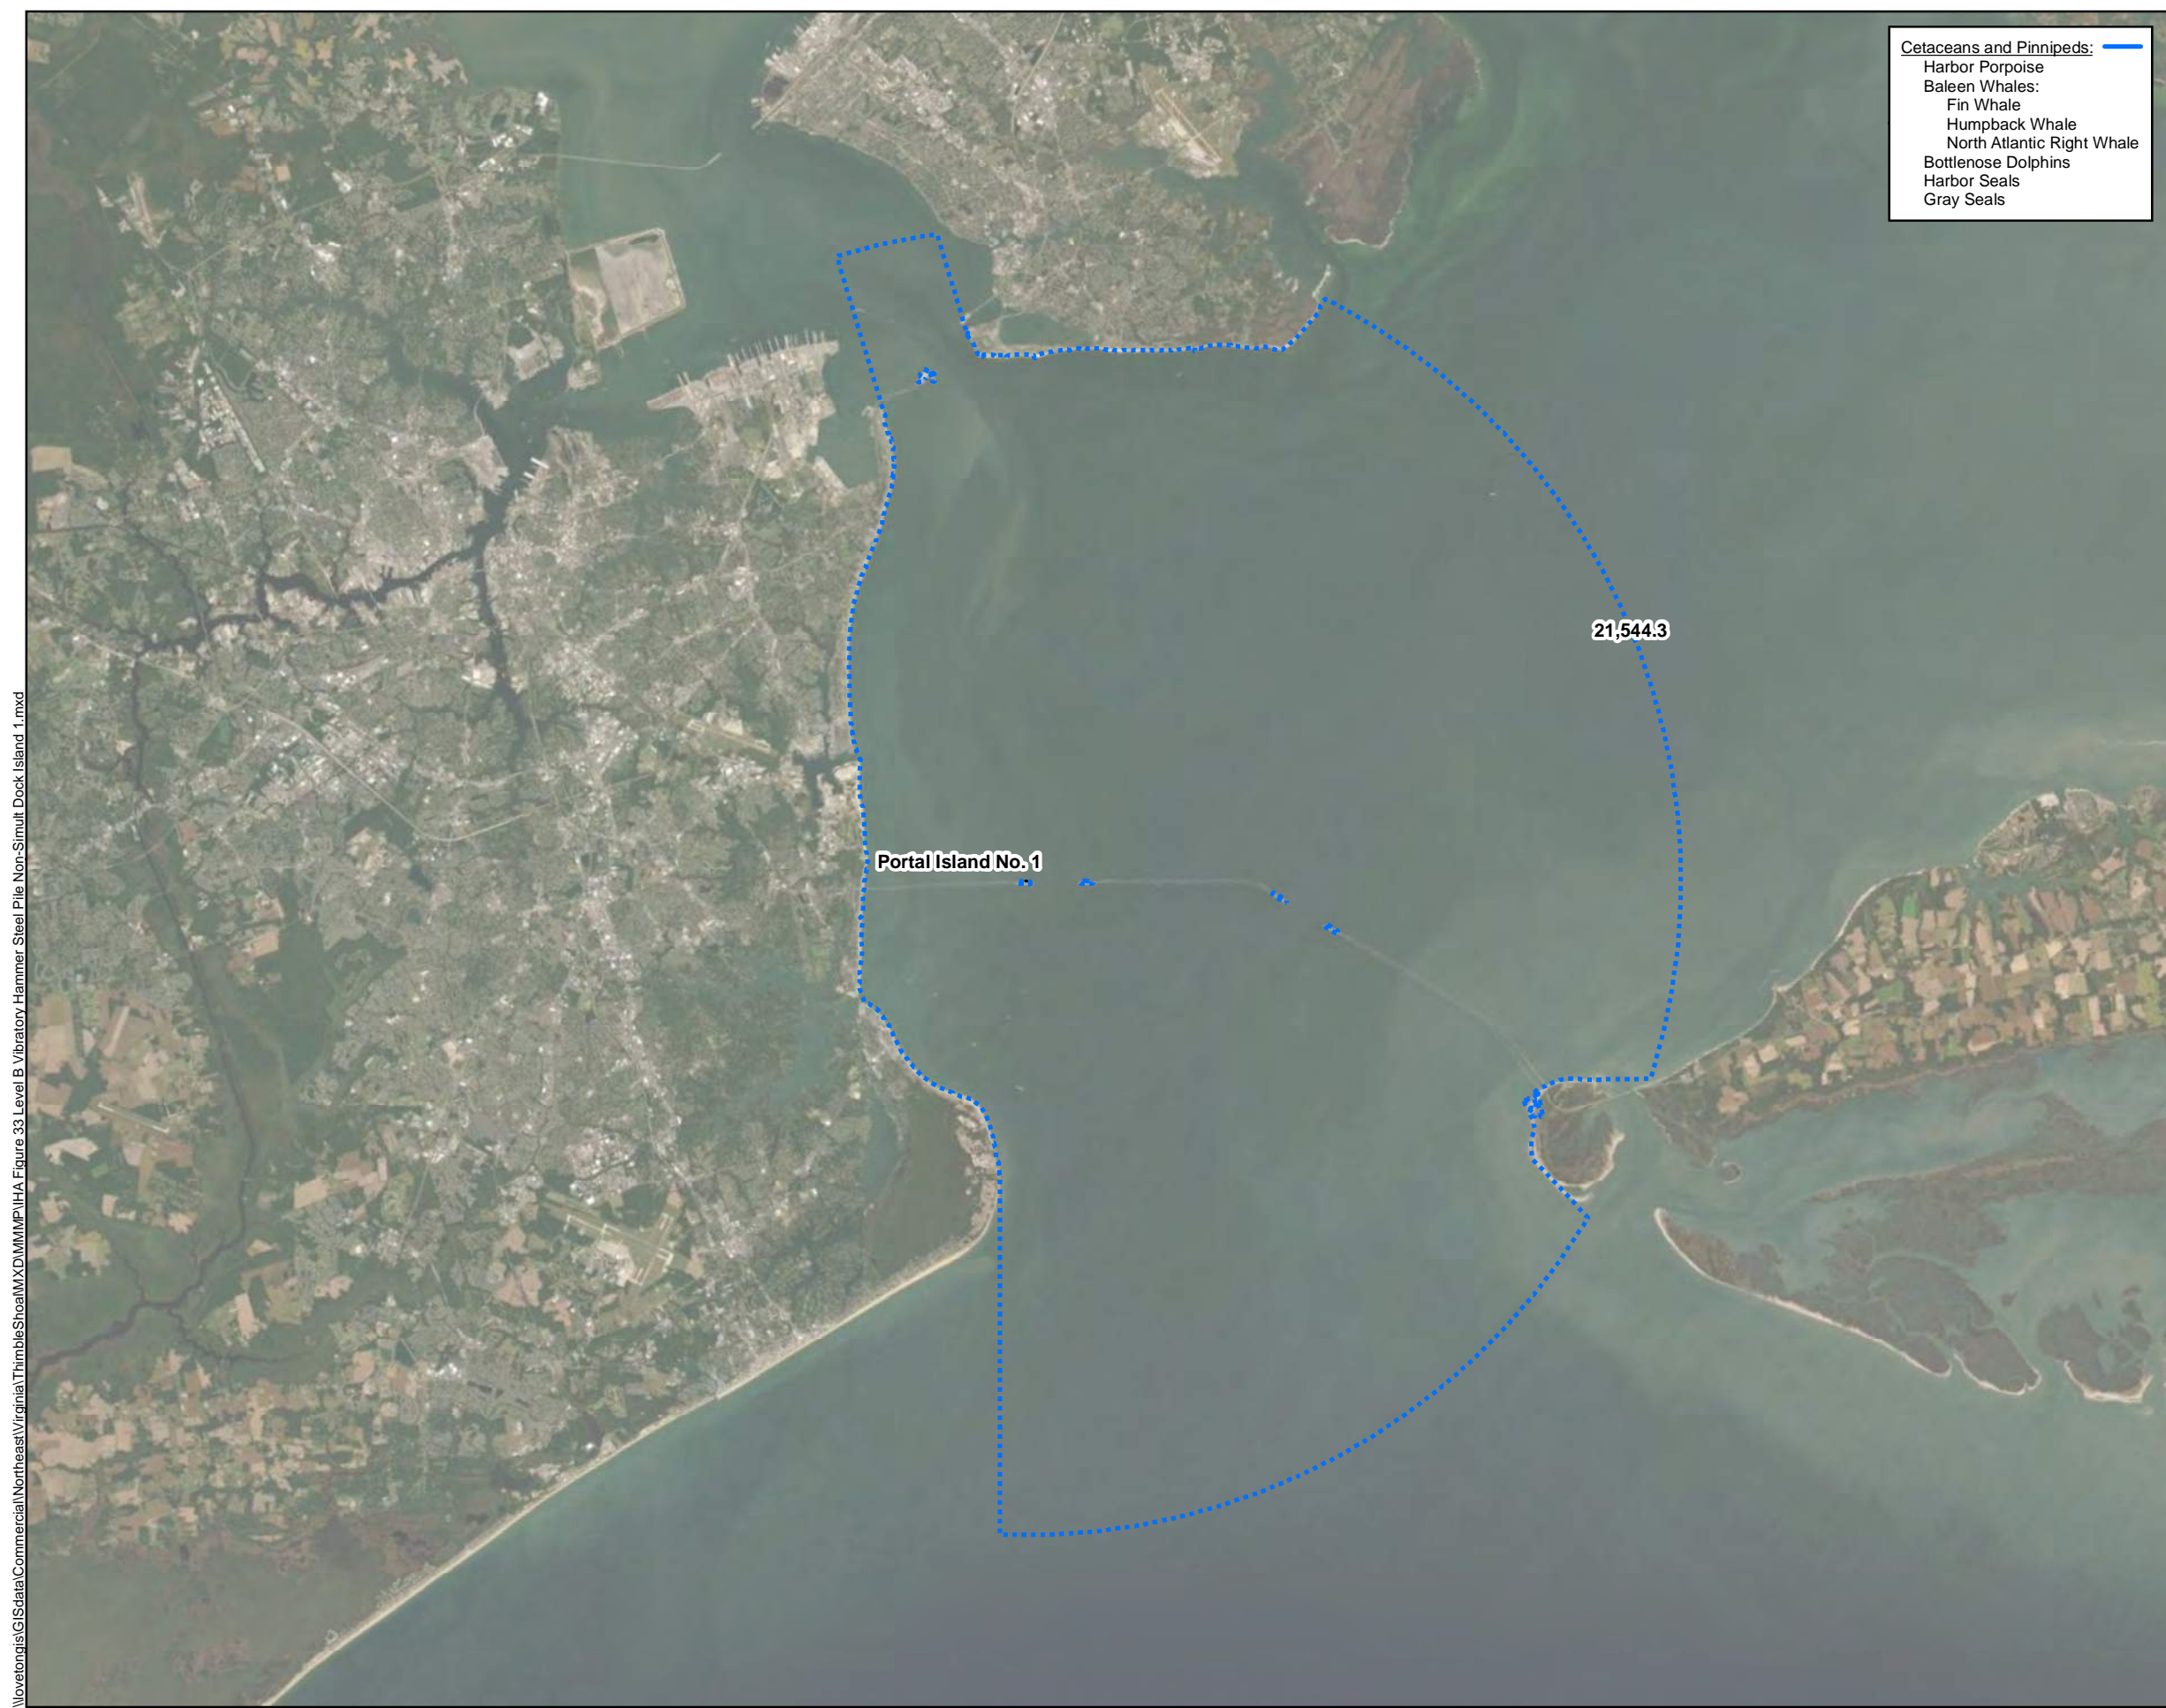
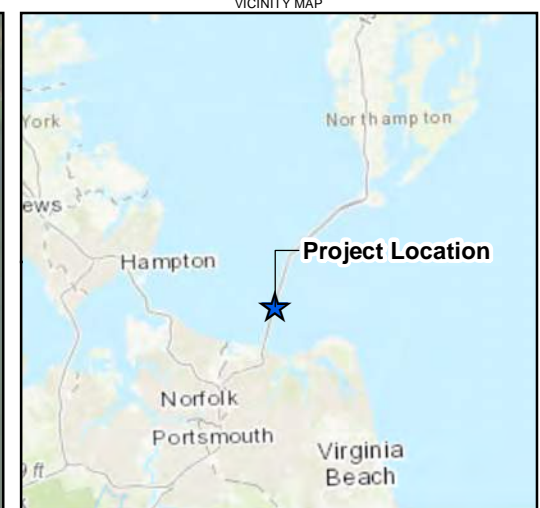
- Temporary Dock
- Vibratory Steel Piles - Level B**
 - 21,544.3 m - Cetaceans and Pinnipeds
