PORTSMOUTH NAVAL SHIPYARD  
KITTEERY, MAINE

**PRELIMINARY MONITORING REPORT FOR NOAA FISHERIES  
INCIDENTAL HARASSMENT AUTHORIZATION (IHA) FOR YEAR ONE  
ACTIVITIES**

**FROM MAY 12, 2020 TO DECEMBER 9, 2020**

**Super Flood Basin (P-310)**

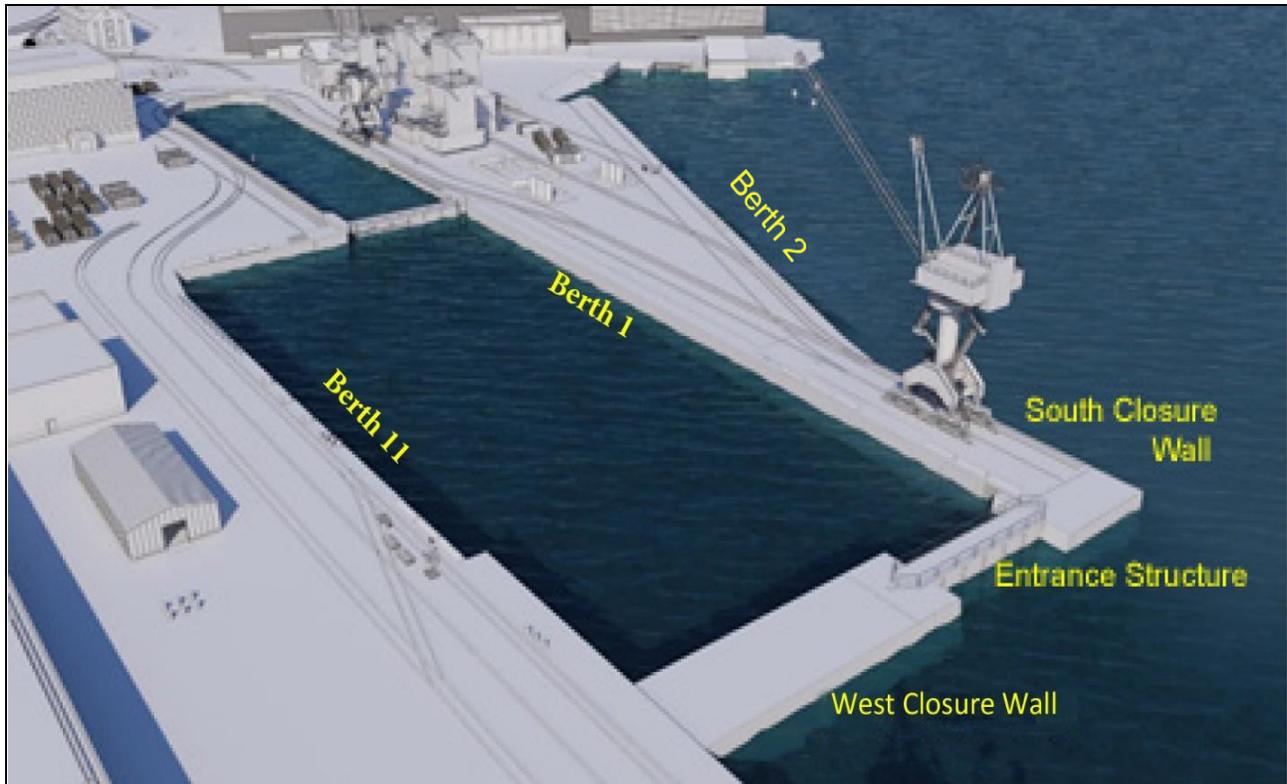
**Figure 1. Conceptual Drawing of Super-Flood Basin (P-310).**

During the initial phase of construction of the Super Flood Basin (P-310), closure walls are being constructed that extend from Berth 1 to Berth 11B (Figure 1). As described in the Navy's IHA application, the super flood basin consists of three primary components: a south closure wall, an entrance structure, and a west closure wall. Construction activities during this initial phase included: construction of the Berth 1 bulkhead, install of drilled shafts for the entrance structure, and the construction of the sheet pile cell and combi-wall for the south closure wall. More specifically the work included setting steel sheet piles to create a bulkhead outboard of the existing quay wall along Berth 1 and placing concrete within the void between the sheet piles and existing quay wall. The south closure wall work included driving of steel H-piles, Z-sheet piles and 30-inch (in) pipe piles. The entrance structure work involved the drilling of 84in steel casings needed to support the entrance structure.

During the reporting period, the Super-Flood Basin (P-310) combi-wall and cofferdam were installed as part of the south closure wall. The combi-wall extends from Berth 1 and 2 and ends at the cofferdam comprising the corner of the south closure wall. Installation of these structures included vibratory and impact driving techniques.

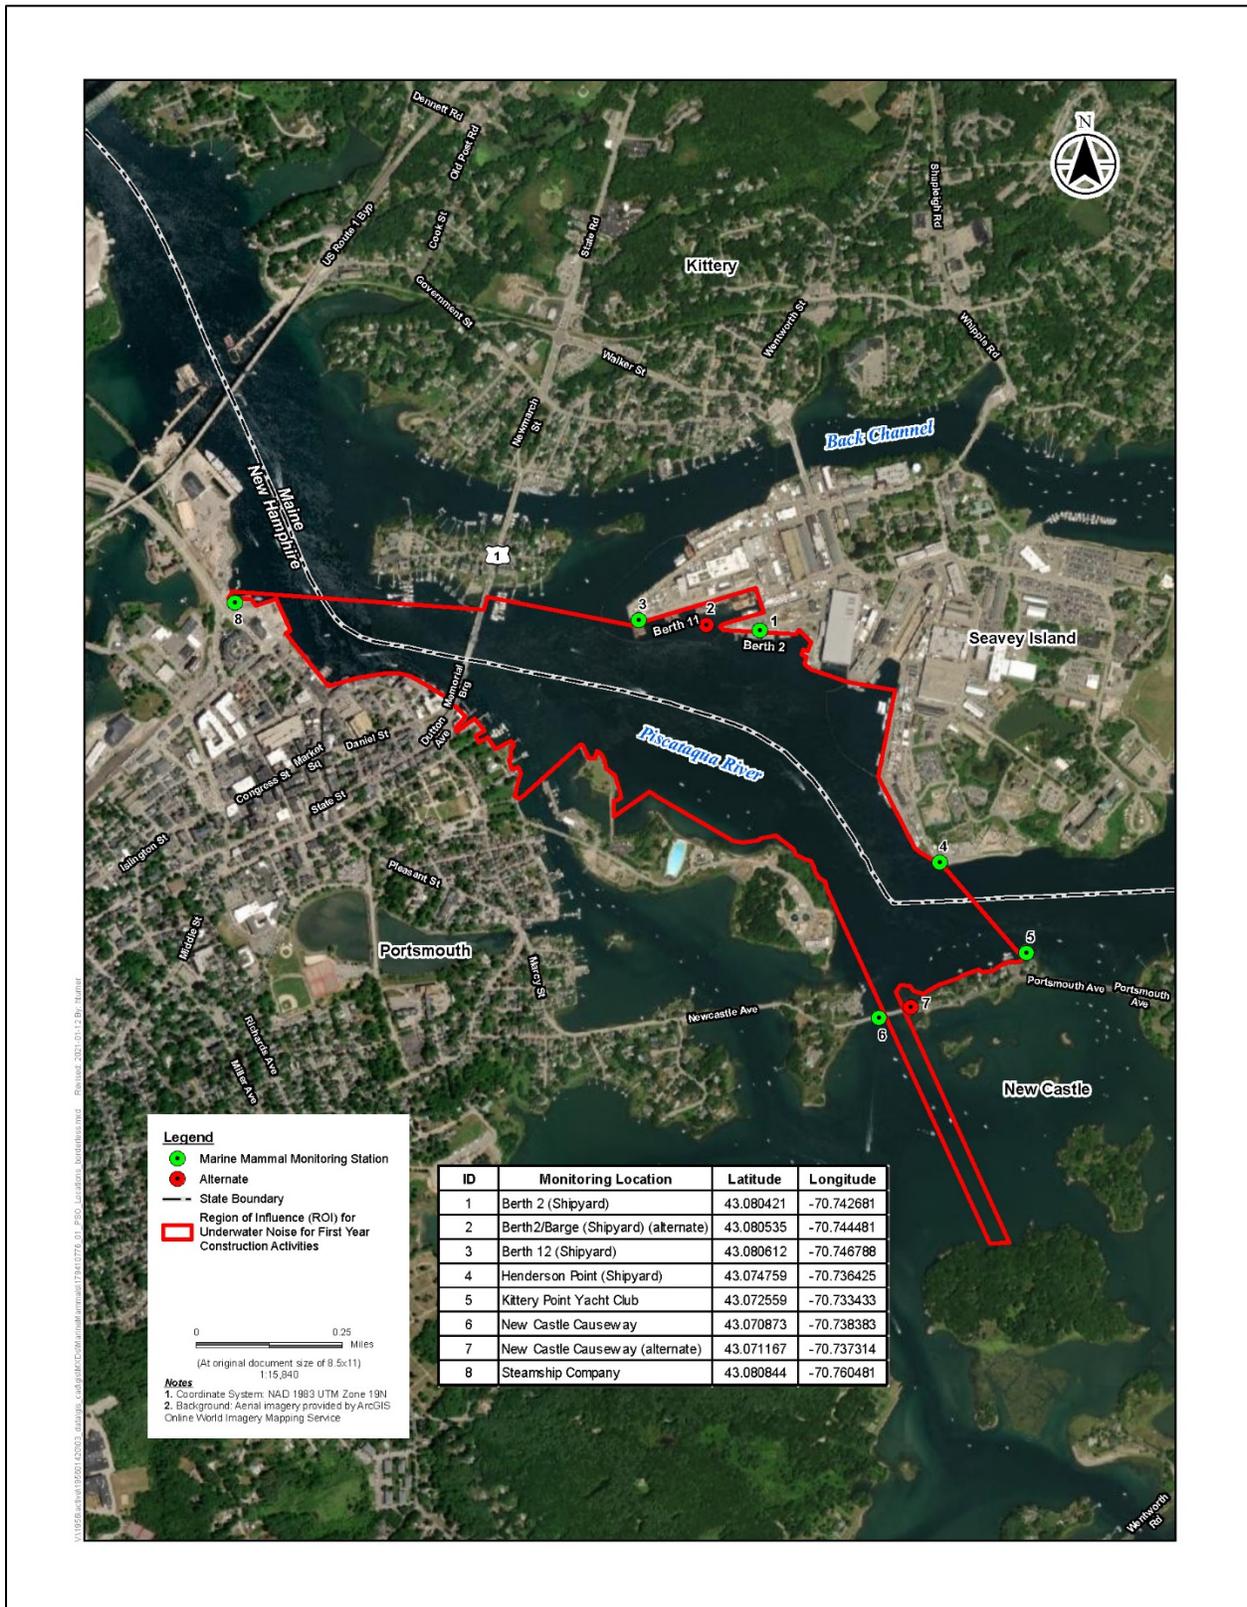
Figure 2. Locations of Marine Mammal Monitoring Stations

While monitoring, PSOs were located at positions approved by NOAA Fisheries (Figure 2). Monitoring of the ZOIs began 30 minutes prior to the anticipated start of in-water work, continued throughout the day, and concluded 30 minutes after notification that in-water work was complete for the day. Use of Kittery Point Yacht Club was rescinded by the property owner during Year One, causing PSOs to shift back to New Castle Causeway. An alternative location at New Castle Causeway was subsequently selected, which provided a complete view of the ZOI but provided better safety from traffic for the PSO. Additionally, during the course of Year One, the presence of active construction equipment reduced the PSO's ability to fully monitor the ZOIs from Berth 2. As a result, the Berth 2 location was shifted to a barge (Berth 2/Barge) location to allow for complete monitoring.

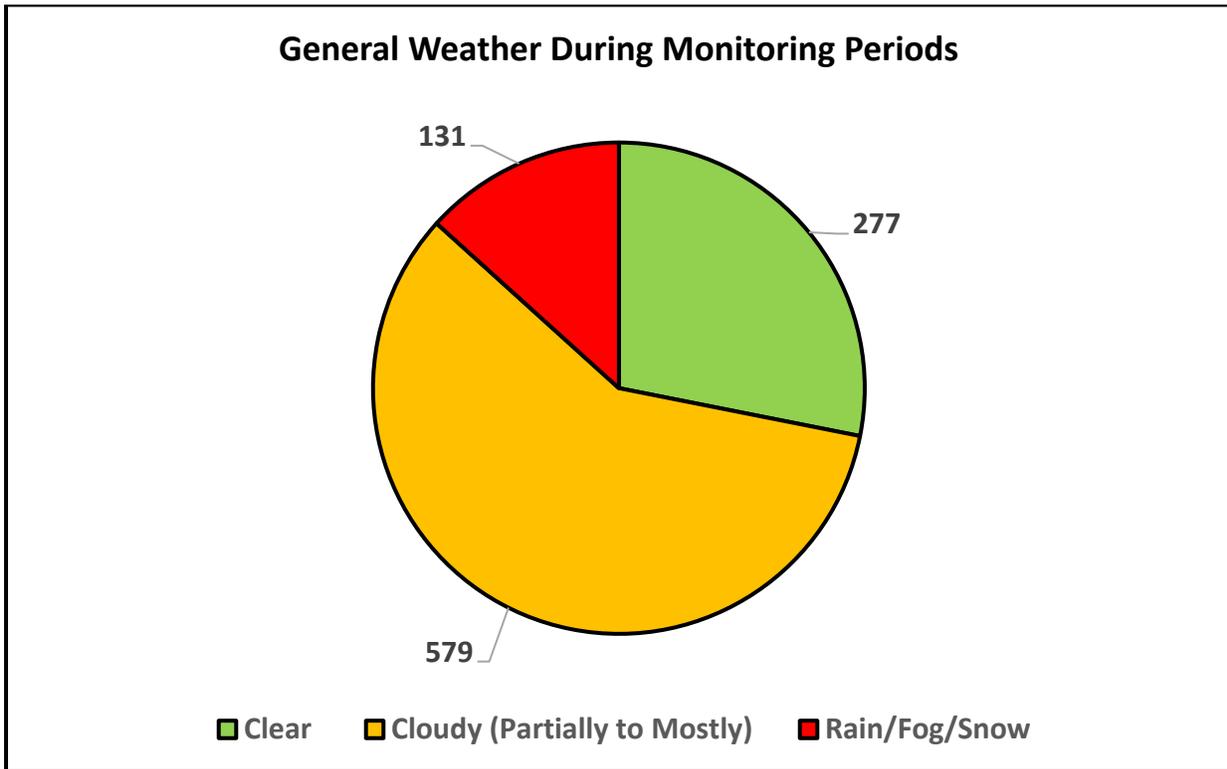
**Figure 3. Weather Conditions by Number of Monitoring Periods**

Overall weather conditions while monitoring were generally fair to partly cloudy with occasional occurrence of rain and/or fog. Visibility during monitoring periods was predominately fair to good with PSOs completing daily weather assessments twice a day (once in the morning and once in the afternoon). Out of a total of 987 monitoring periods, poor visibility conditions were reported during 32 periods (or roughly 3%). During poor conditions, PSOs still had a complete view of the Level A zones. Figures 2 and 3 provide a summary of visibility and weather conditions, respectively, by monitoring hour. Weather records are provided to NOAA Fisheries in an electronic format (i.e., Excel) with this report.

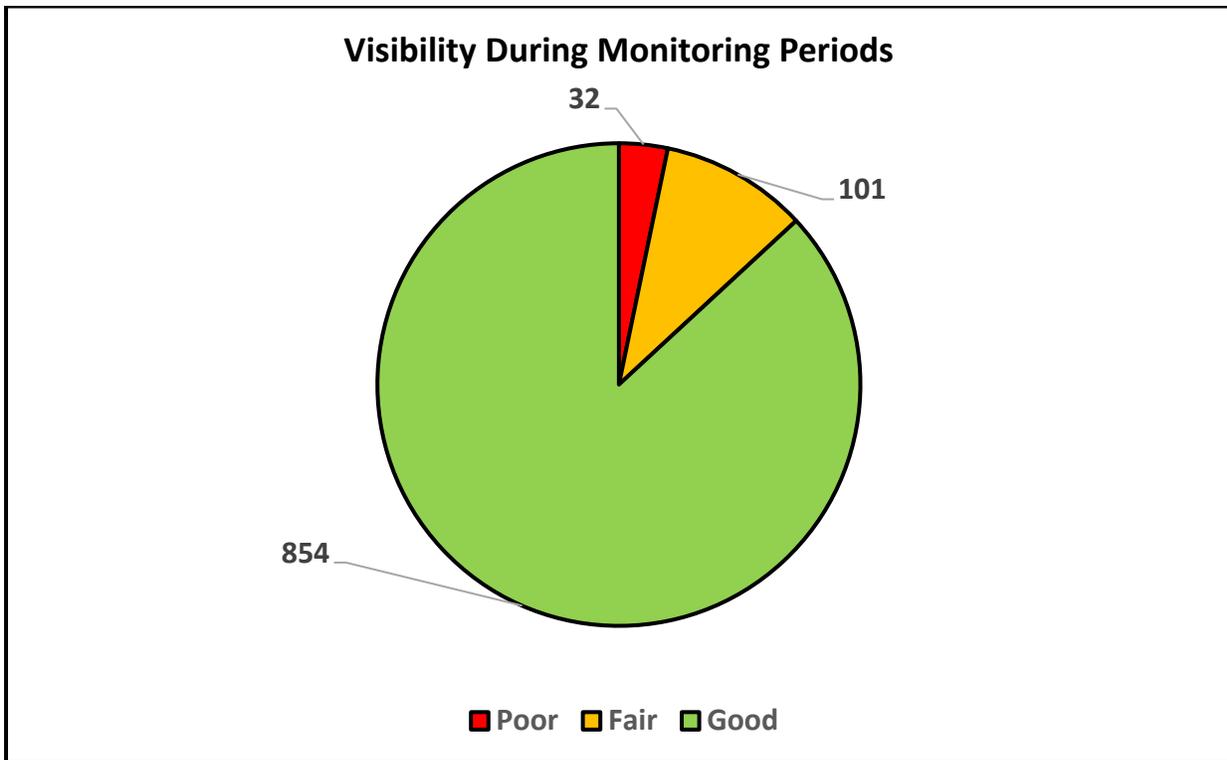
**Figure 4. Visibility Categories by Number of Monitoring Periods**

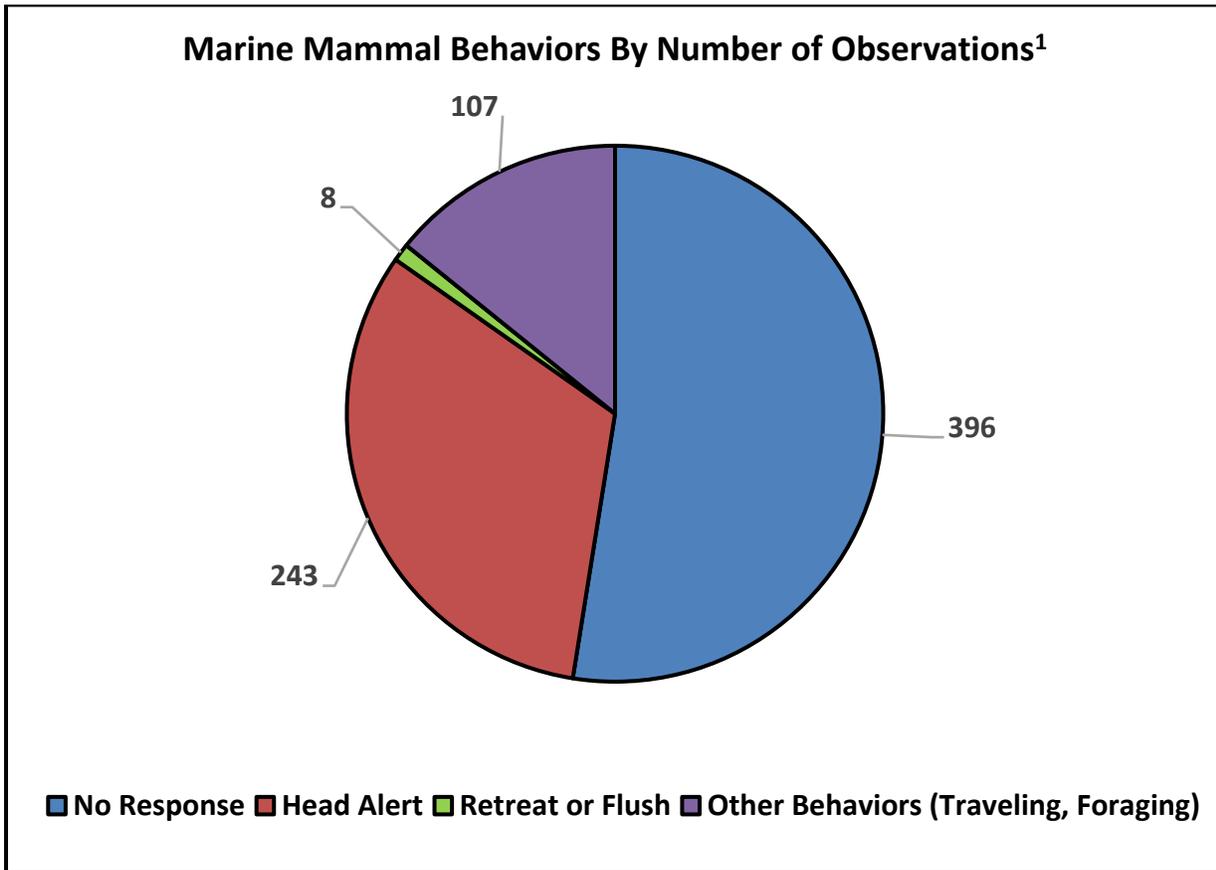
**Figure 5. Summary of Observed Behaviors**

<sup>1</sup> Number of behaviors add up to 754 versus 772 total observations because some observations were of multiple individuals and PSOs documented the same behaviors for all individuals observed.

During marine mammal observations, the most noted behavior was no response, followed by head alert. These behaviors were observed regardless of whether active construction was underway at the time. PSOs recorded eight instances where the marine mammal was observed retreating or flushing (presumably in response to some stimulus) and are described further in Table 5. Figure 4 provides a visual summary of the behaviors recorded during the reporting period.

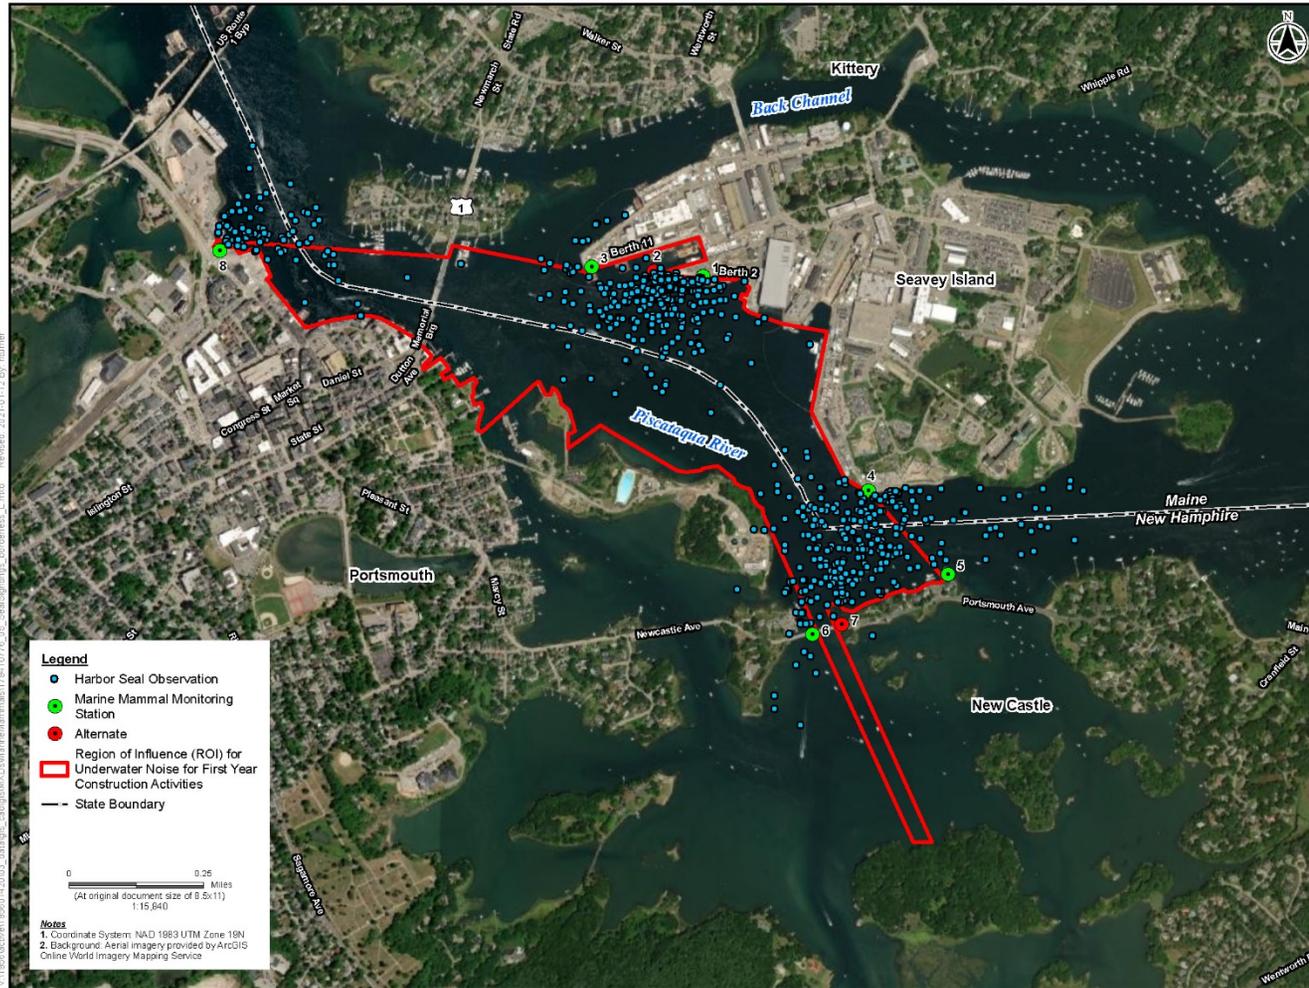
Figure 6. Locations of Harbor Seal Observations

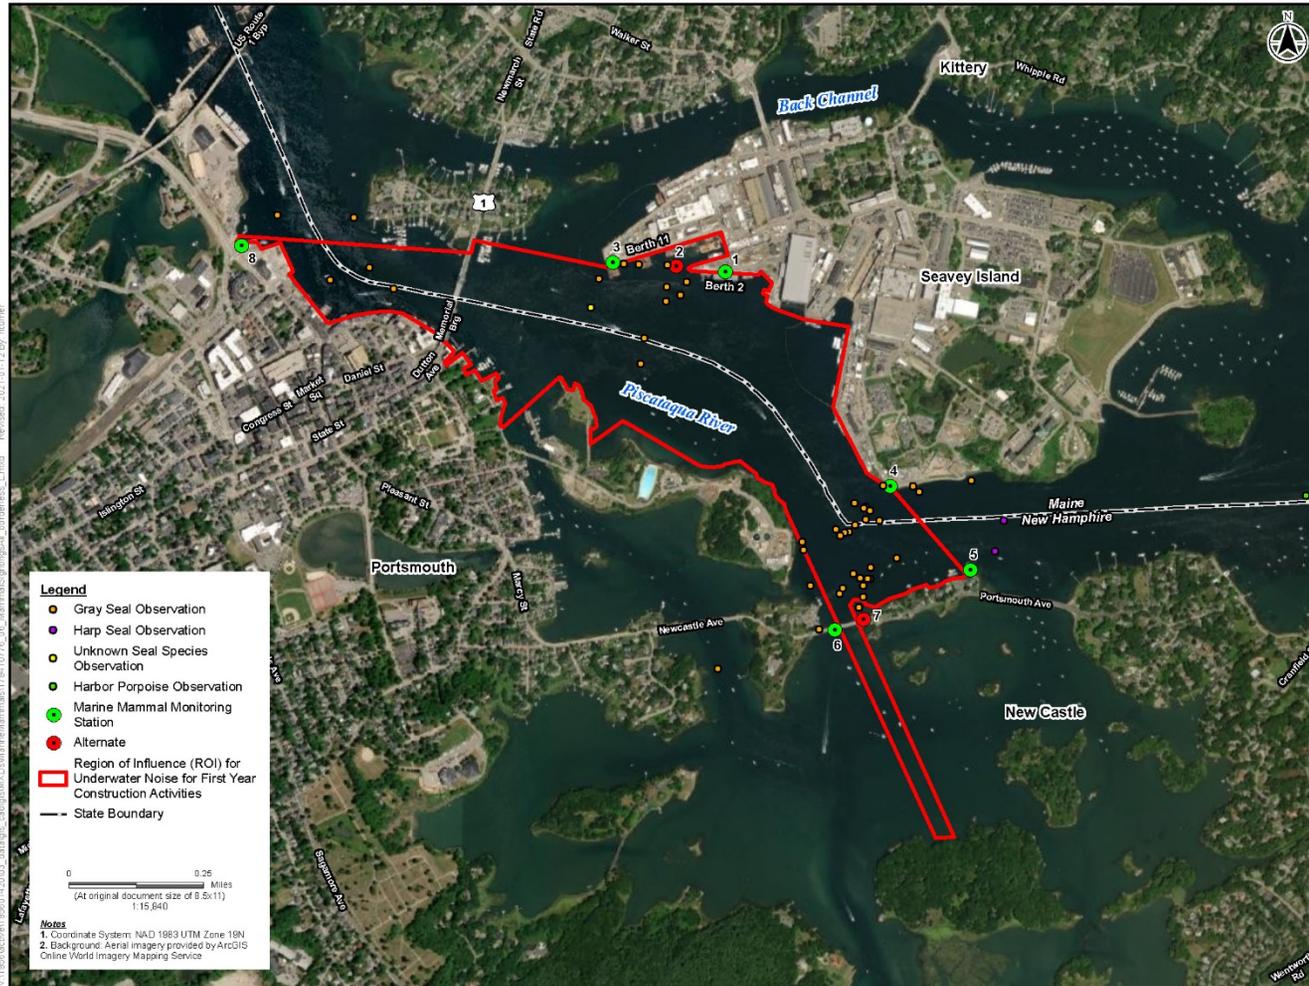
Figure 7. Locations of Other Marine Mammal Observations
