Submittal Title: PCT 2020 - Marine Mammal Monitoring Monthly Report – November 2020

Port of Alaska Modernization Program Petroleum and Cement Terminal - 2020 Construction

Monthly Marine Mammal Monitoring Report

1 November to 30 November 2020

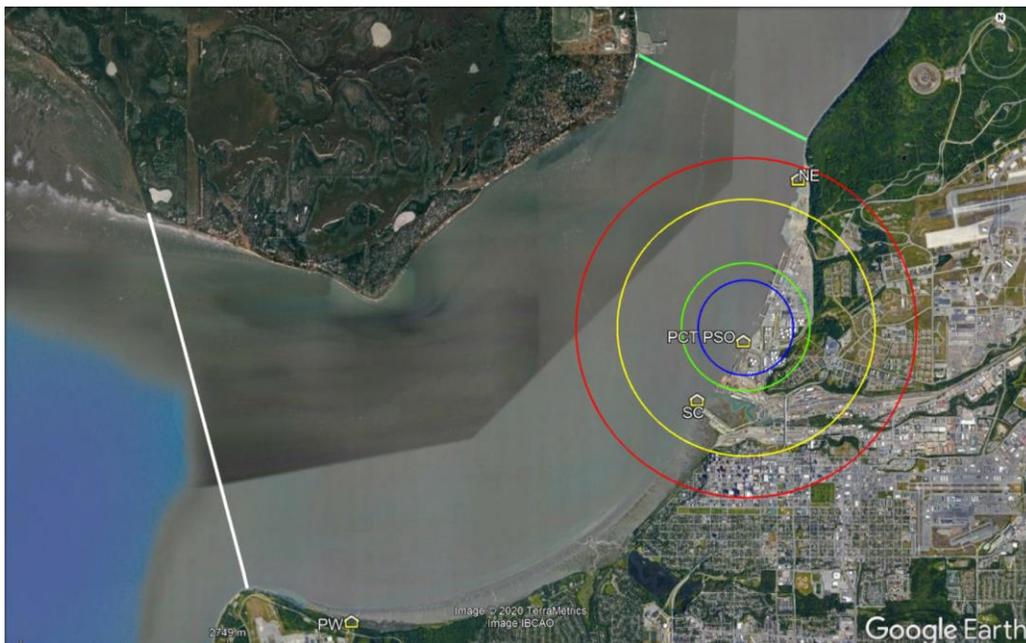
Figure 1 - Observation Stations and the In-bound (white line) and Out-bound (green line) Pre-Pile Driving Clearance Demarcation Lines

The waters of lower Knik Arm in upper Cook Inlet, Alaska near the PCT are monitored from four observation stations: near Point Woronzof (PW), at Ship Creek (SC), at the PCT, and at the North Expansion (NEX) of the POA (Figure 1).

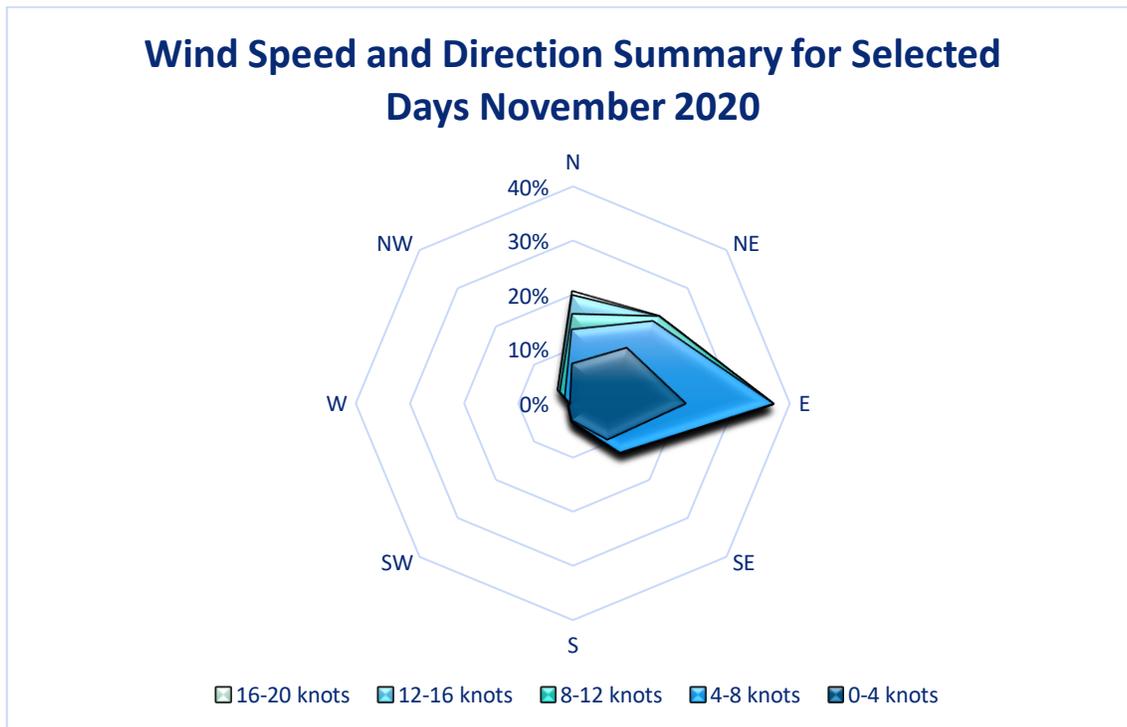
Figure 2. Wind Speed Rose, NOAA Tide Station 9455920, Anchorage Alaska, During Observation Times in November

The wind rose presented in Figure 2 shows that wind was typically out of the east, northeast, or north. Winds were generally low in November given that 90-percent of the wind speeds were at or below 8 knots, with only a small fraction between 8 and 20 knots.

Wind speed, direction, and air temperature are not recorded by the MMOs as these meteorological data are available from the National Oceanic and Atmospheric Administration (NOAA) tide station 9455920 located at the POA, a few hundred meters from the PCT (NOAA 2020b). The wind speed and direction for the 19 days worked in November were downloaded in six-minute intervals from the NOAA meteorological observations page for the Anchorage, Alaska tide station 9455920 (2020b) at the times observations were conducted. The meteorological station malfunctioned for a portion of 1 November and all of 13 – 15 November and did not record the wind speed. The air temperatures in November were significantly colder than in previous months with a minimum of 5.2°F, maximum of 36.1°F, and average of 20.8°F. The wind data are summarized and presented in Figure 2.
