*San Francisco–Oakland Bay Bridge
East Span Seismic Safety Project*

**Pier Retention Pile Driving and Pier Removal
Marine Mammal Monitoring Report**

January 2019

California Department of Transportation

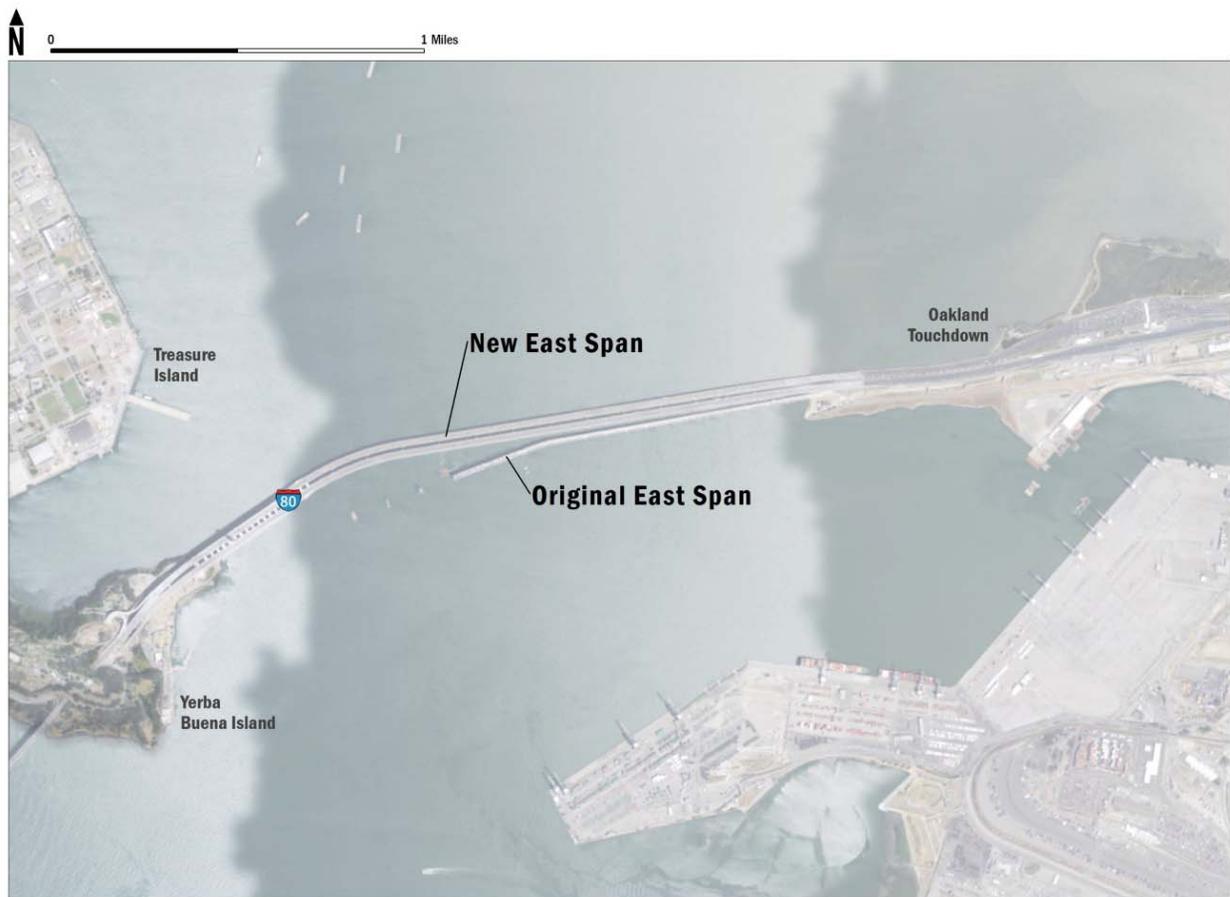
Figure 1-1. SFOBB New East Span and Original East Span

The California Department of Transportation (Department), as part of the San Francisco–Oakland Bay Bridge (SFOBB) East Span Seismic Safety Project (SFOBB Project), has replaced the original east span of the SFOBB with a new bridge north of the former bridge (Figure 1-1). The SFOBB Project included both constructing the new east span bridge and dismantling the original east span bridge. This report discusses the marine mammal monitoring associated with the removal or repurposing of marine foundations, Piers E19 to E23, completed in 2018.

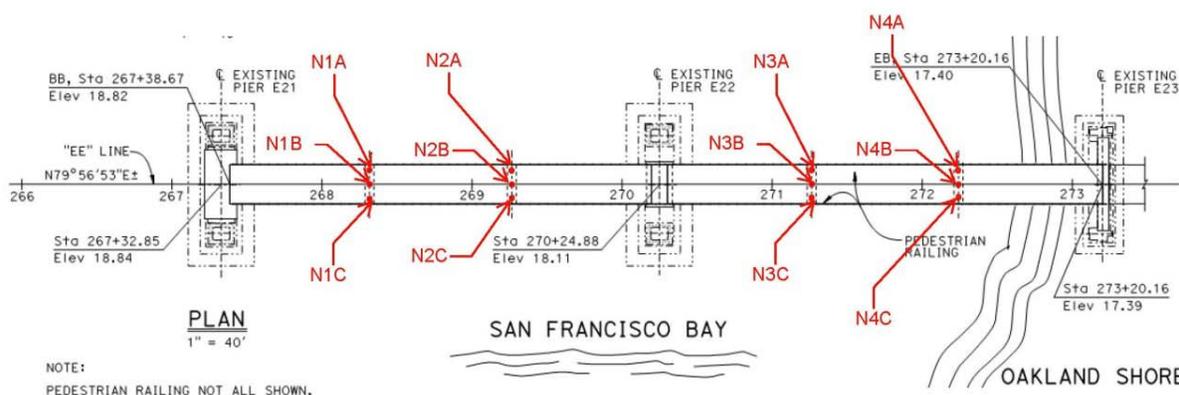
Figure 2-1. OTD Public Access Pier Pile Layout

Twelve 36-inch-diameter steel pipe piles with a 1-inch wall thickness were required for the Public Access Pier. Two sets of three piles were driven between existing Piers E22 and E23 using a crane positioned on the temporary access trestle, described below. Two additional sets of three piles were driven between existing Piers E21 and E22 using a crane positioned on a barge. Figure 2-1 shows the pile layout for the OTD Public Access Pier.

The six piles installed from the temporary trestle were driven to the greatest extent practicable with a vibratory hammer and then driven with a diesel impact hammer to seat. The six piles installed from the barge were driven with only a diesel impact hammer. A marine pile-driving attenuator (bubble curtain) was used to minimize sound pressures and impacts to fish and marine mammals during impact driving.

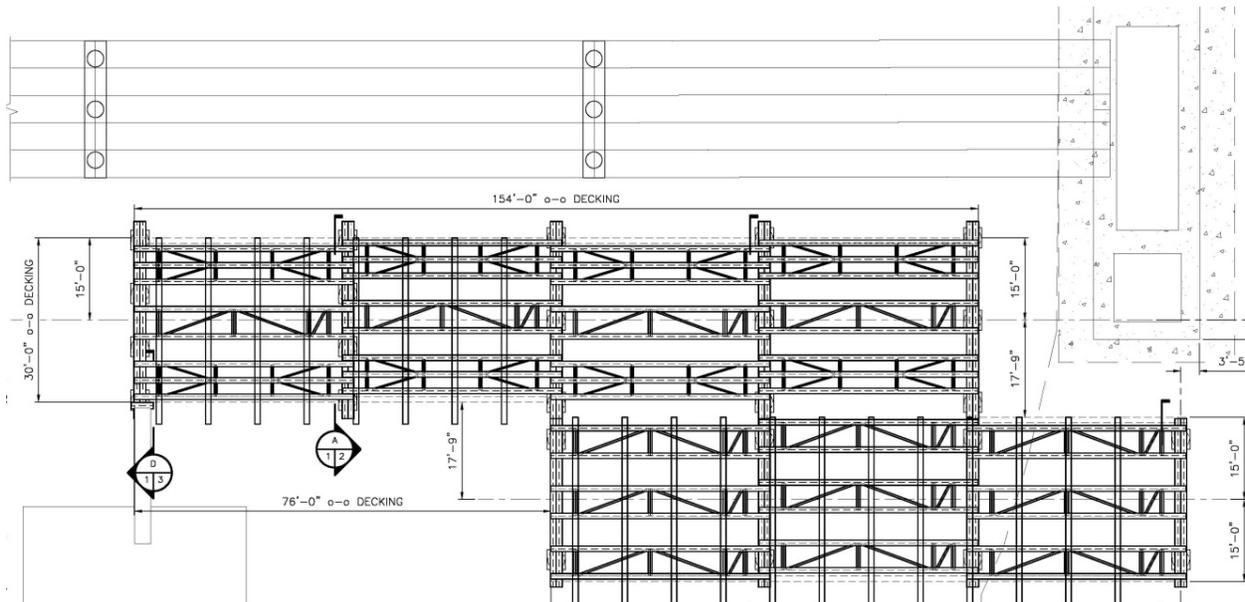
Figure 2-2. Temporary Access Trestle Pile Layout

As part of the temporary trestle construction, twenty-five 36-inch-diameter steel pipe piles were included in the original pile-driving plans (Figure 2-2). However, hard ground conditions were encountered making installation of one of the piles difficult. That pile was cut short, and two additional piles (one to the east and one to the west) were installed to support a beam that passed over the planned pile. Additionally, three 36-inch steel pipe piles were driven near the terminal end of the trestle and are not shown in the plans. These fender piles were installed to support landing of marine barges. The total number of piles, therefore, was thirty 36-inch-diameter steel pipe piles.

A temporary access trestle was needed to facilitate construction of the permanent OTD Public Access Pier (Figure 2-2). The trestle was required to support a crane that was used to drive six of the permanent piles that would support the OTD Public Access Pier, as stated above. The trestle itself was pile-supported; it was situated at the western end of the OTD, extending approximately 58.5 meters (192 feet) into the Bay from the shore south of Pier E23. Construction of the approximately 836-square-meter (9,000-square-foot) trestle started June 1, 2018, and was completed by July 20, 2018.

The piles were installed with a vibratory hammer to the greatest extent practicable and then driven with a diesel impact hammer to seat, if necessary. The piles were driven to depths of

approximately 25.9 to 32 meters (85 to 105 feet) below the mudline. A marine pile-driving attenuator (bubble curtain) was used to minimize sound pressures and impacts to fish and marine mammals during impact driving. The air bubble curtain was not used during installation of the piles at the shoreline, because they were out of water during low tide and use of a bubble curtain would be ineffective. Efforts were made to install other piles at low tides. In shallow water, less sound would be transmitted into the water column. The water depth ranged from exposed Bay floor (no water depth) to less than 0.6 meter (2 feet) during low tide.

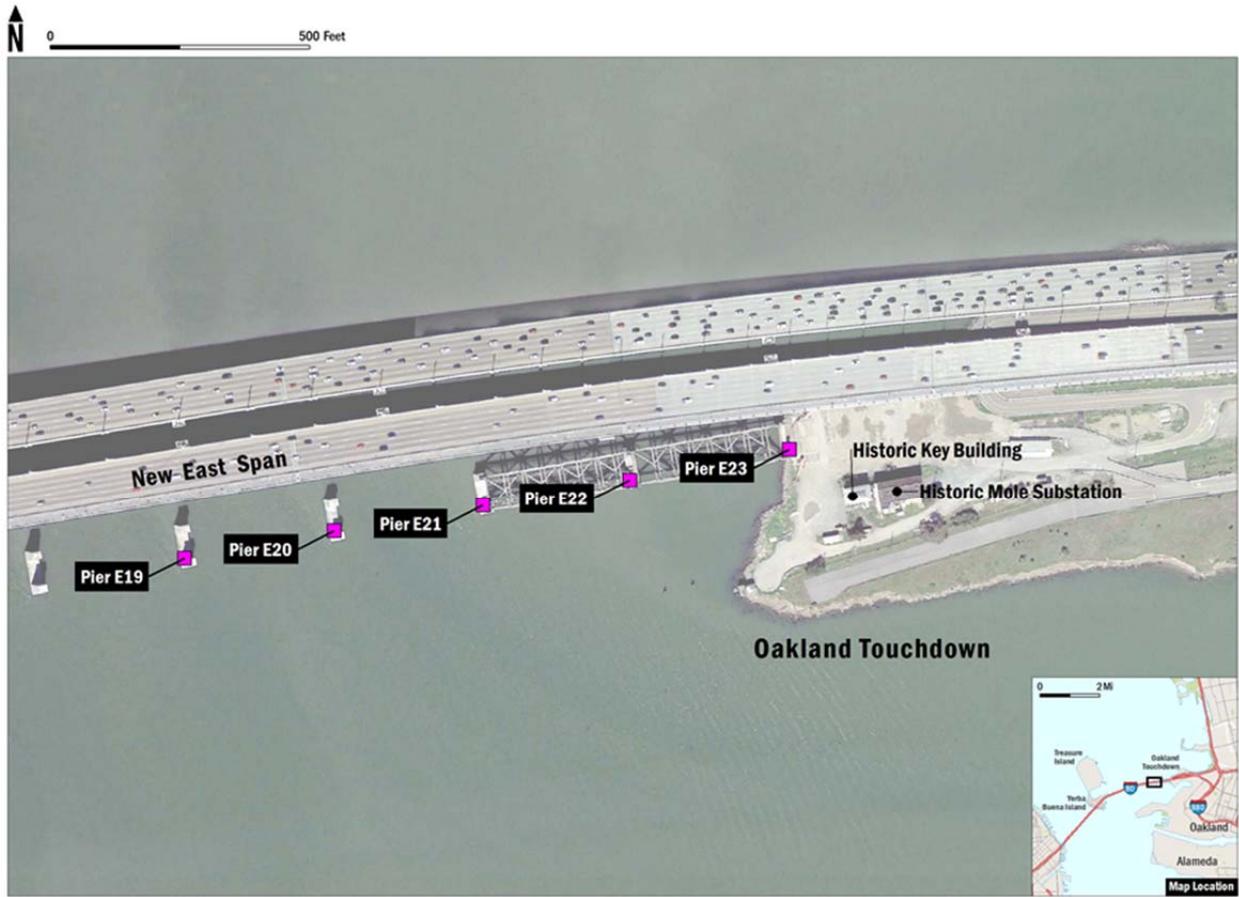
Figure 2-3. Location of Piers E19 to E23

The blast event lasted approximately 2.4 seconds. The timing between the last charge on Pier E19 and the first charge on Pier E20 was approximately one-half of a second, providing enough time between blasts to avoid accumulating peak sound pressure waves. The location of former Piers E19 and E20 is shown on Figure 2-3.

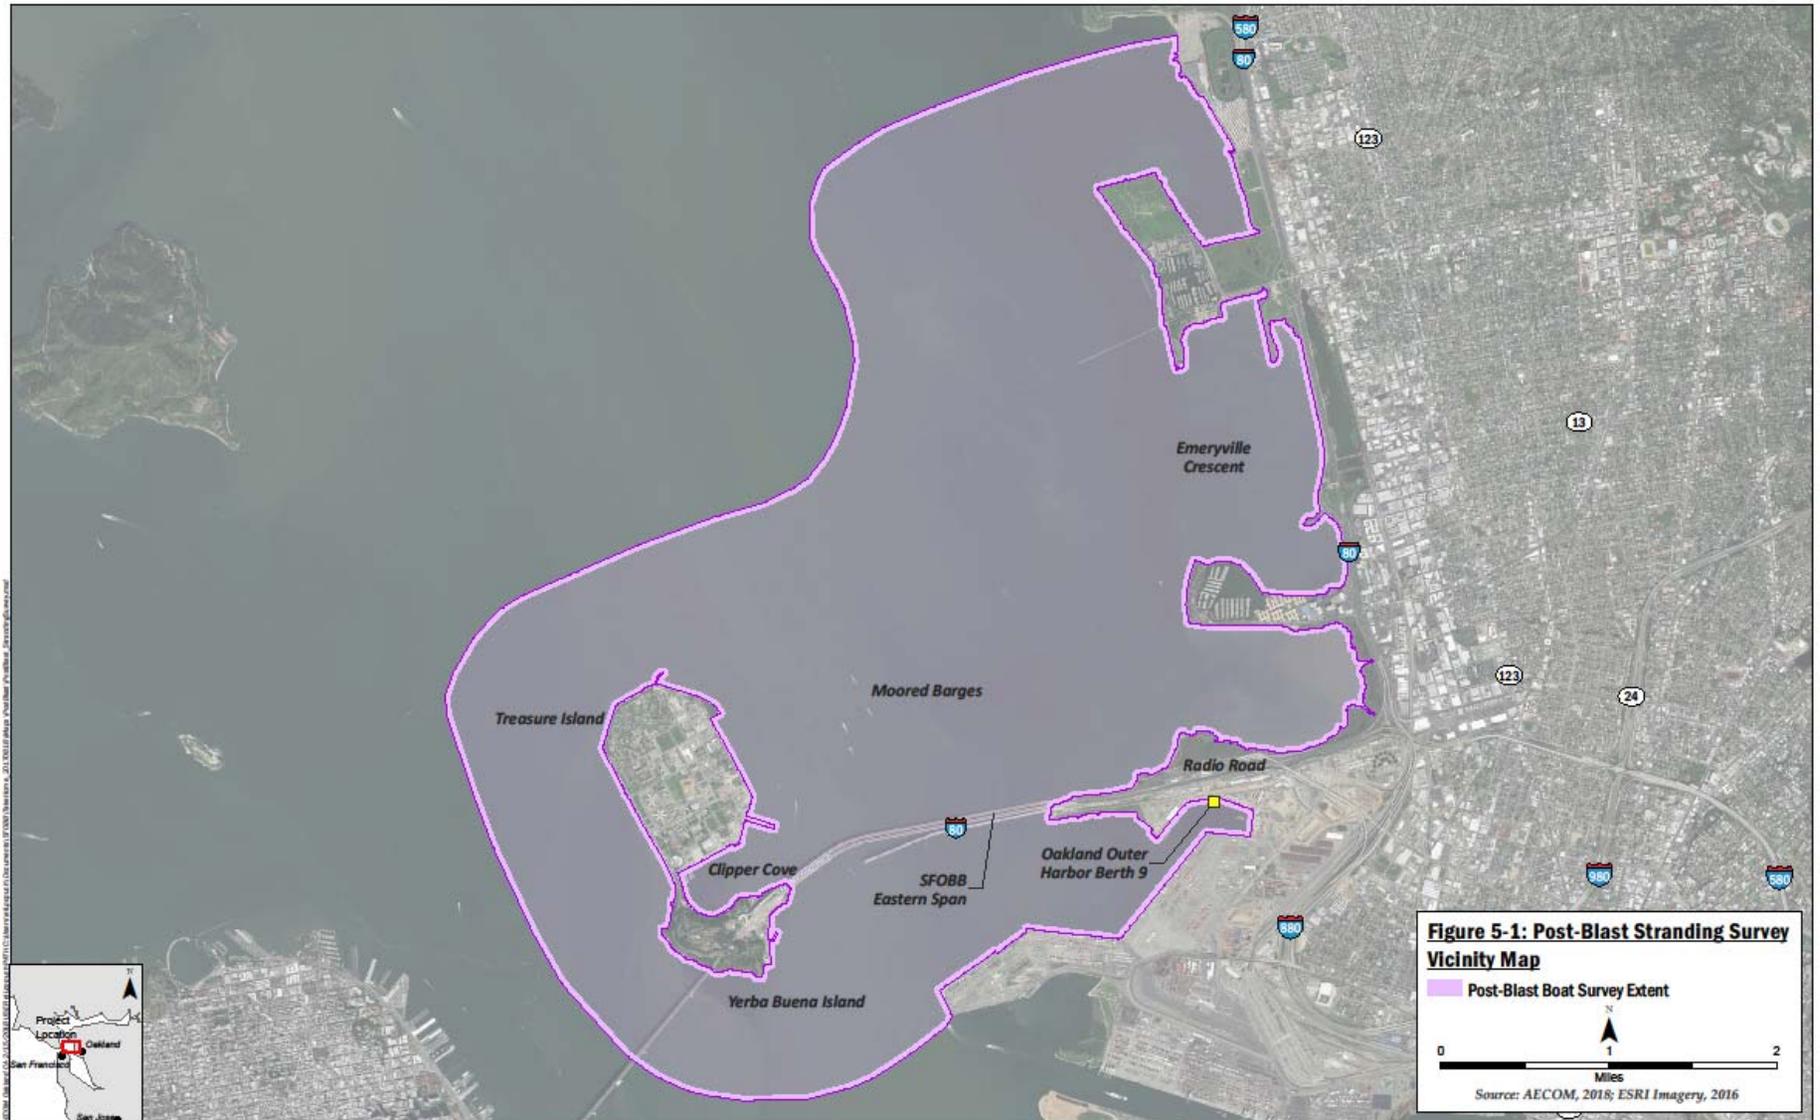
Figure 6-1. Stranding Survey Area

Stranding surveys were conducted by boat and by car along the shoreline in the vicinity of the SFOBB eastern span (Figure 6-1). Boat surveys were conducted from Oakland Outer Harbor Berth 9 to Clipper Cove on the southeastern side of Treasure Island, counter-clockwise around Treasure Island and Yerba Buena Island (YBI). From YBI, the boat surveys continued east through the moored barges on the northern side of the new span, along the Emeryville breakwater, into the Emeryville Crescent, and returned to Berth 9. Each survey path varied slightly depending on field and tide conditions. Land surveys were conducted along the shoreline at the OTD, at the Emeryville Crescent, and along the shoreline north of the Oakland toll plaza and SFOBB approaches. This shoreline includes two stretches of sandy beach, riprap, and portions of Radio Road, which runs parallel to the northern side of Highway 80 westbound.

A pre-blast land survey was conducted by the Lead MMO on September 7, 2018. The Emeryville Crescent west of Interstate 580, the shoreline at the end of Radio Road, the shoreline north of the SFOBB toll plaza, and the shoreline under the OTD were surveyed (Figure 6-1). No injured or dead animals were observed.
