**INCIDENTAL HARASSMENT AUTHORIZATION (IHA) APPLICATION
FOR
OPERATIONS AND MAINTENANCE (O&M)
PORT SAN LUIS HARBOR BREAKWATER REPAIRS
SAN LUIS OBISPO COUNTY, CALIFORNIA**

**U.S. Army Corps of Engineers
South Pacific Division
Los Angeles District
915 Wilshire Blvd.
Los Angeles, California 90017**

February 2021

**BIOLOGICAL INVESTIGATIONS OF THE
PORT SAN LUIS BREAKWATER
IN SUPPORT OF THE
PORT SAN LUIS BREAKWATER REPAIR SECTIONS
STATION B 6+00 to STATION B 13+00
SAN LUIS OBISPO COUNTY, CALIFORNIA**

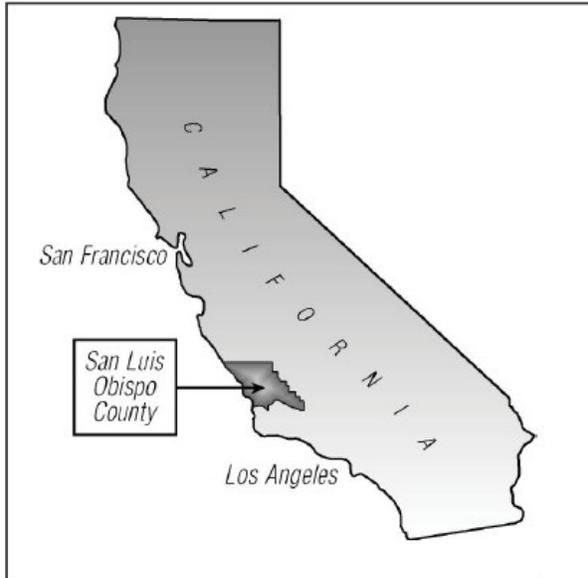
Figure 1. Regional Vicinity Map & Figure 2. Local Vicinity Map

Figure 1 Regional Vicinity Map

Figure 2 Local Vicinity Map

Port San Luis is located on the central California Coast, approximately midway between Los Angeles and San Francisco, in San Luis Obispo County (Figures 1 & 2). Breakwater repairs are tentatively scheduled to occur from April 2022 to October 2022, thus the Corps requests the IHA issuance by May 2021 in order to secure contracts and IHA effective dates to be April 1, 2022 to March 31, 2023. O&M PSL breakwater proposed repair schedule is time dependent on weather conditions, equipment availability, working performance of the equipment, contractual commitments, and availability of funds. Due to the location of the PSL breakwater, the contractor would be fully or partially exposed to open ocean wave conditions. Adverse wave and inclement winter weather conditions at PSL preclude safe working conditions during the months of November to March when PSL experiences consistently high and/or rough sea conditions. Therefore, the work season *generally* extends from April through October, with extensions, contractions, and additional work windows outside of the summer season varying by weather patterns.

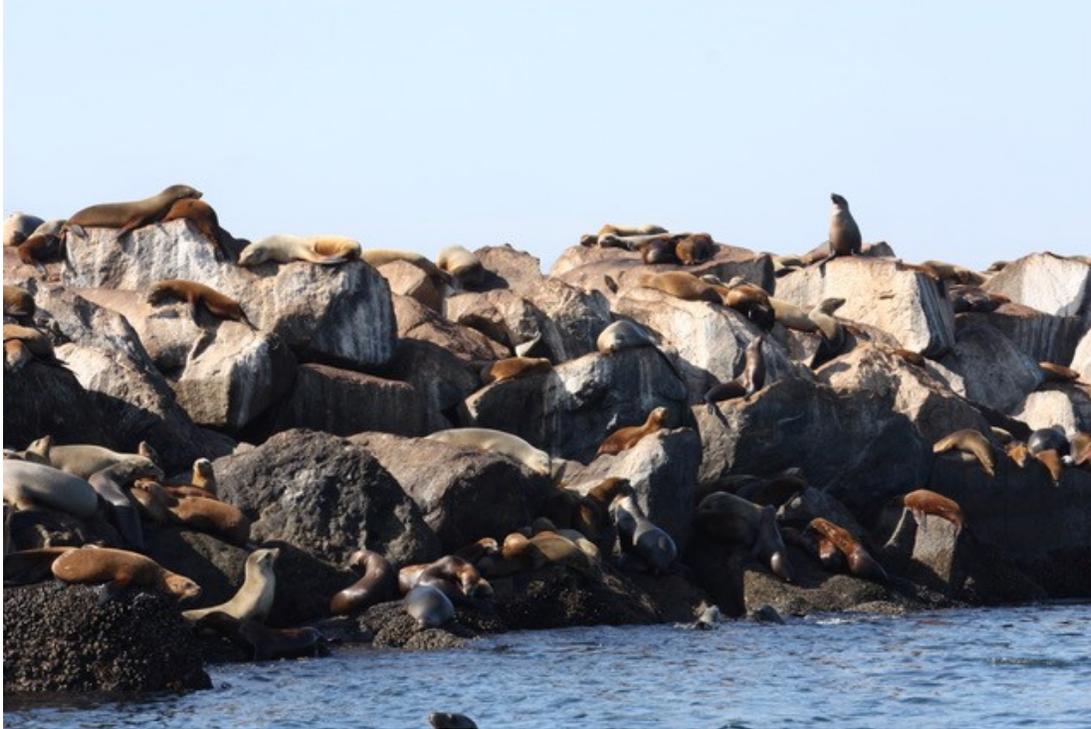
Figure 7. Pinniped Breakwater Images

PSL Breakwater: Head Section, Leeward. 6NOV2019

California sea lions are common in PSL year round where they are often hauled out on the PSL breakwater structure and within San Luis Obispo Bay on buoys and work docks (Figures 7 & 9). The general distribution of CSLs along the breakwater is influenced by direct wave energy against exposed breakwater segments. The distribution of CSLs on the breakwater is greatly influenced by the season and day to day sea state conditions. Four dead young pup carcasses were observed on the breakwater during the June 2018 survey conducted by M&A, no very young live pups were noted during either the on-water surveys or within the aerial survey photographs. During the contractor's marine mammal surveys (Table 9) and the Corps' monthly 2019 marine mammal surveys (Table 8) there was no observed nursing occurring by any of the CSLs in PSL and the majority of the animals in the pup-yearling size class (Table 9) were in the

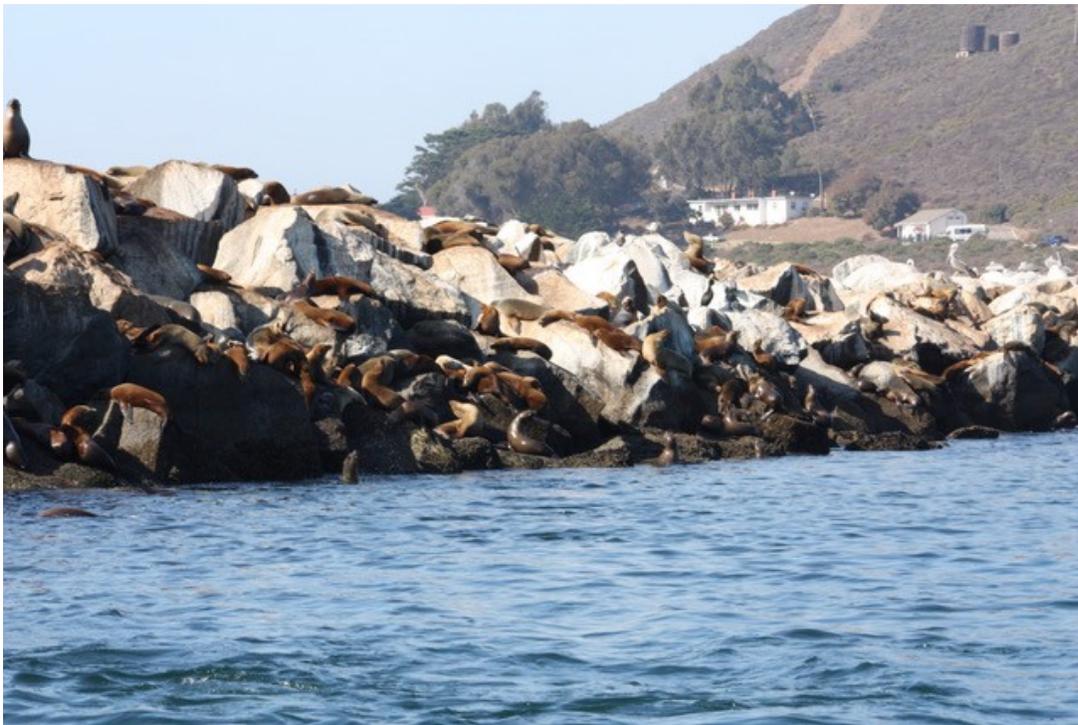
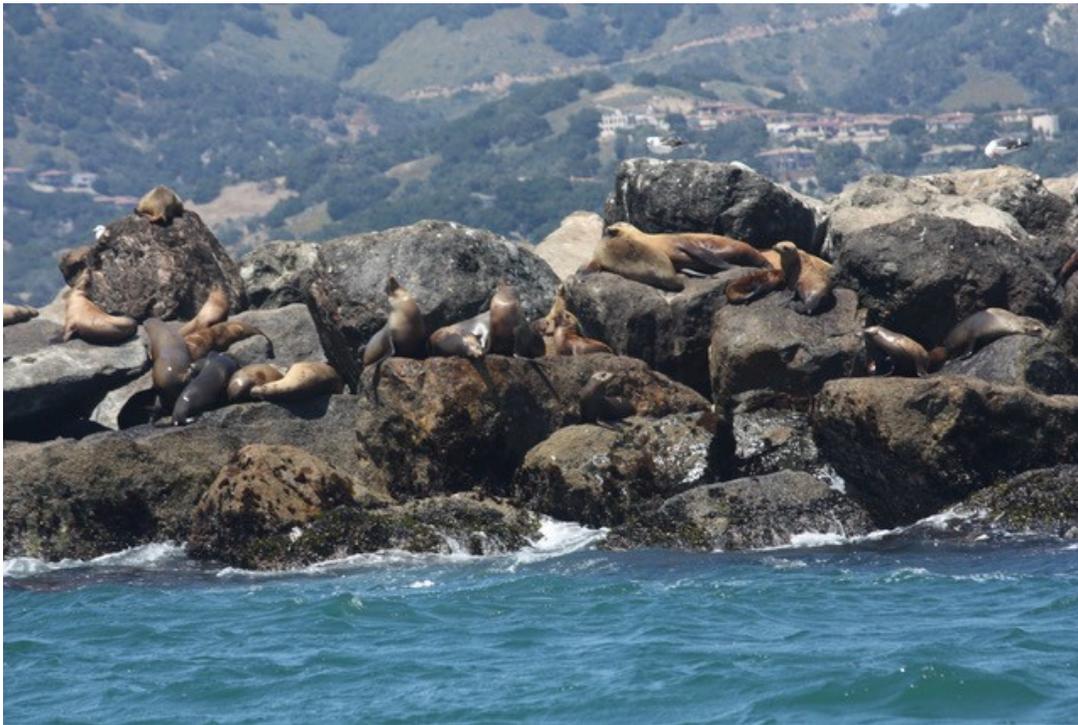
PSL Breakwater: South Eastern Section looking north towards Whaler's Rock, Leeward. 6NOV2019

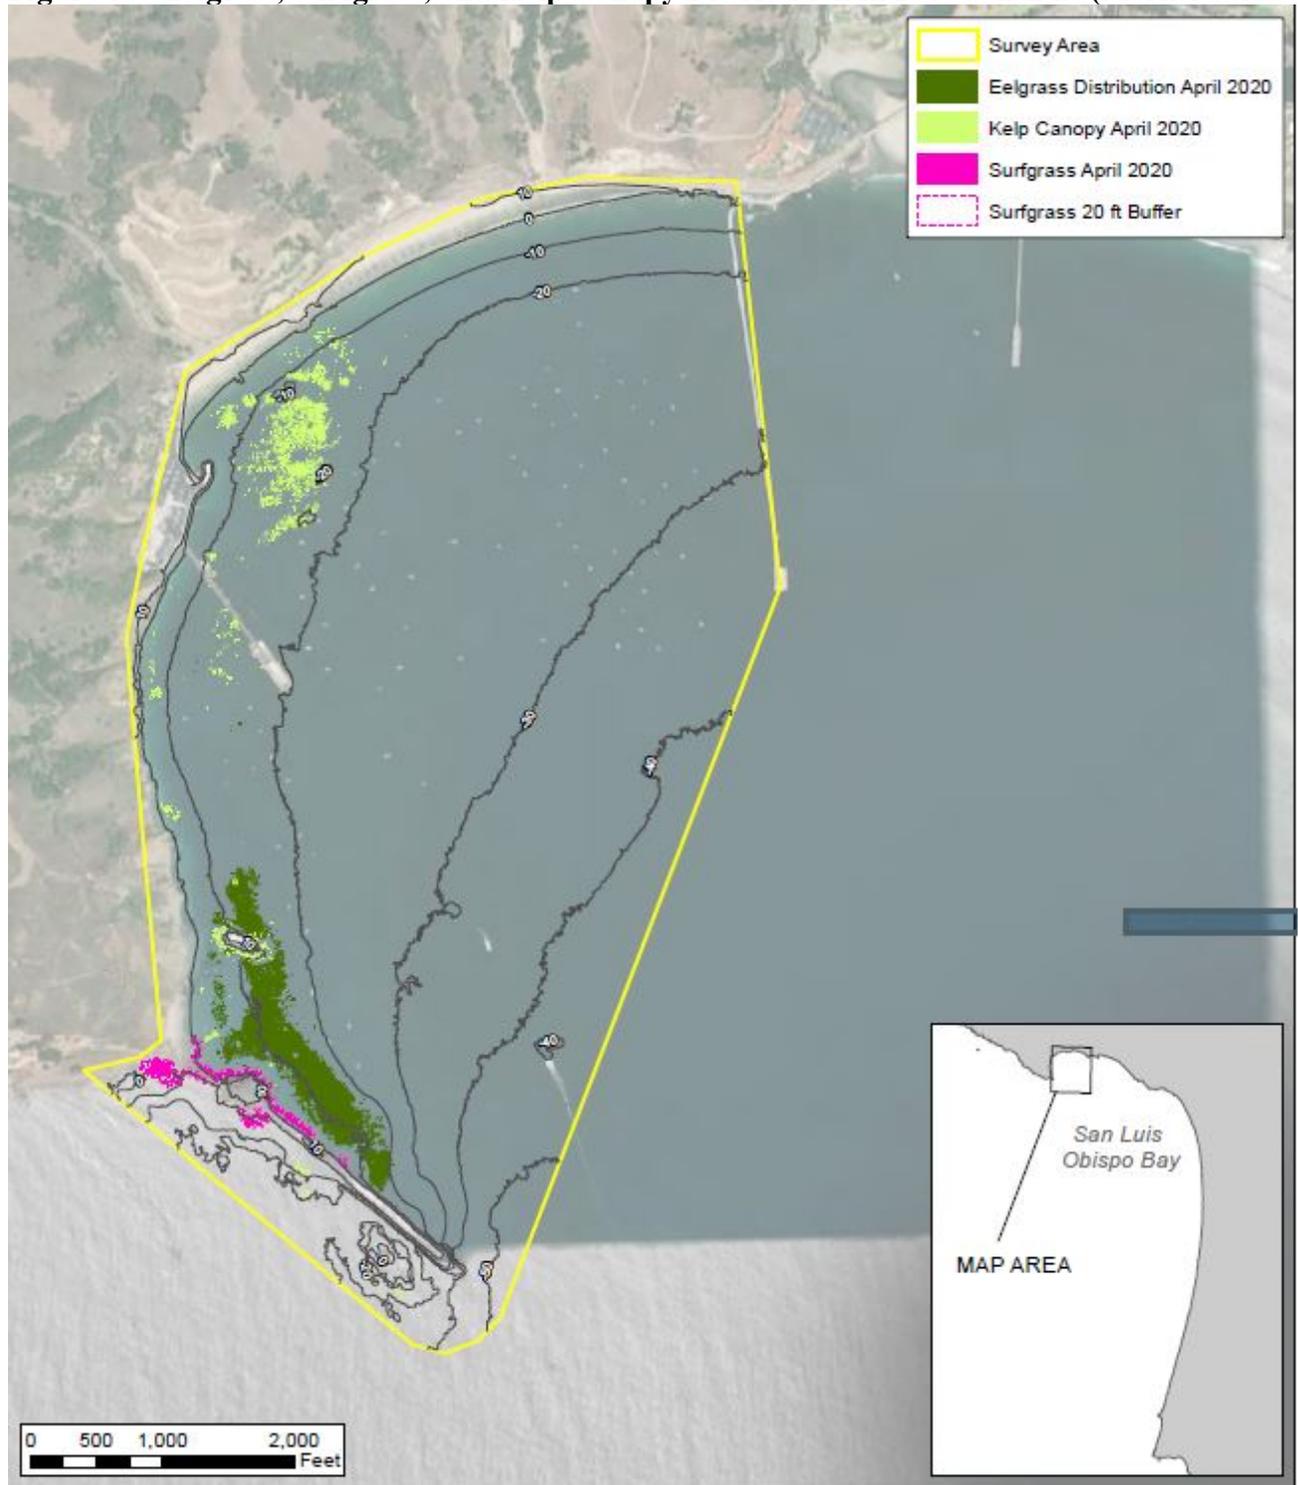
Figure 10. Eelgrass, Surfgrass, and Kelp Canopy Distribution in Port San Luis (Merkel & Associates)

Survey Area and Resource Overview Map
 Port San Luis Breakwater Repair Sections
 San Luis Obispo County, California

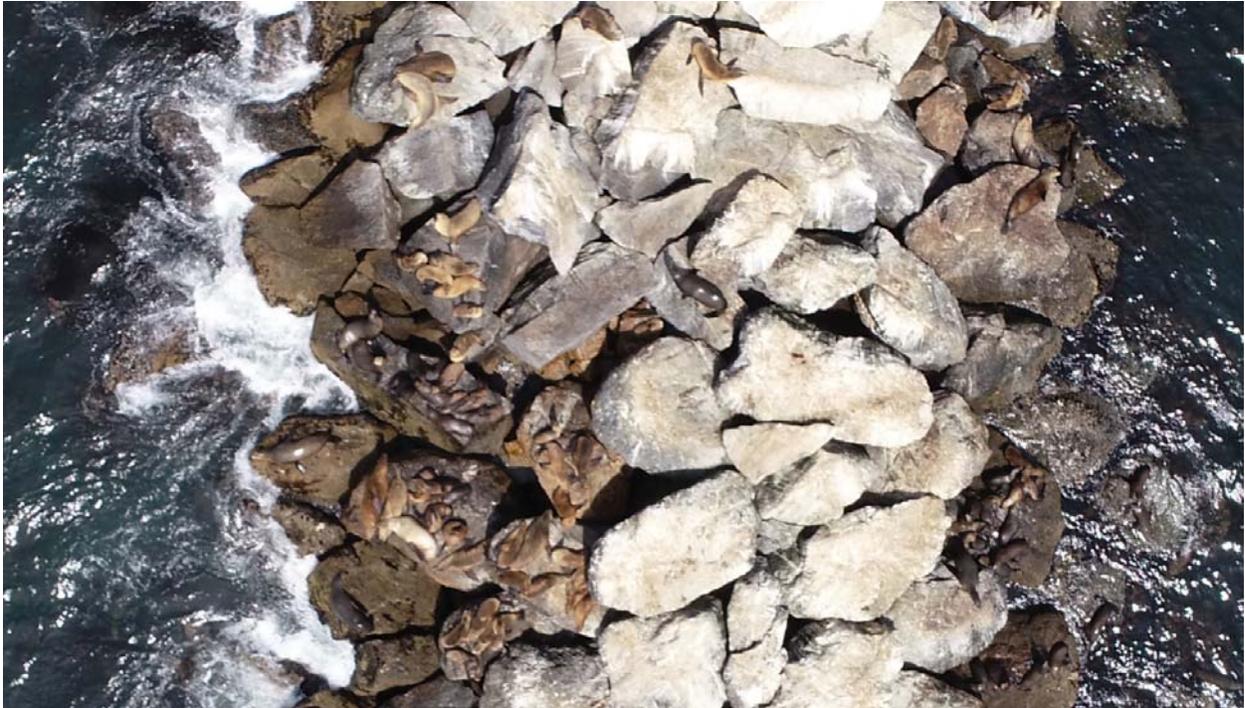
Sea lions photographed in June 2018 using high resolution low altitude UAV aerial photography. Overflights provided an opportunity to map individual animals hauled out by species, gender, and age class.

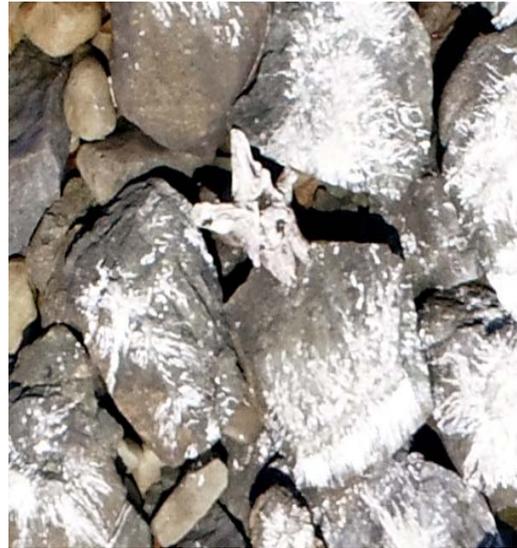
One of two whale vertebrae observed on breakwater June 30, 2018

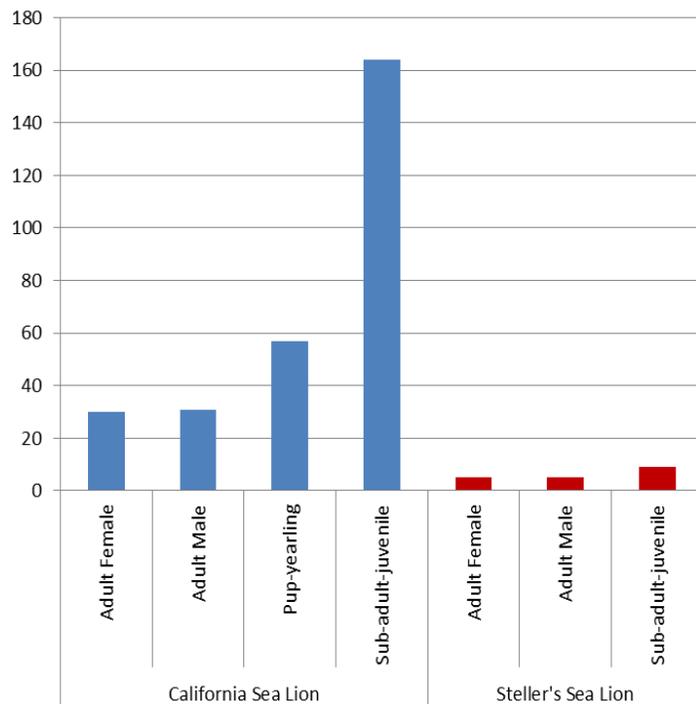
Total Pinnipeds on Breakwater - June 2018

Population demographics of sea lions hauled out on Port San Luis Breakwater June 30, 2018

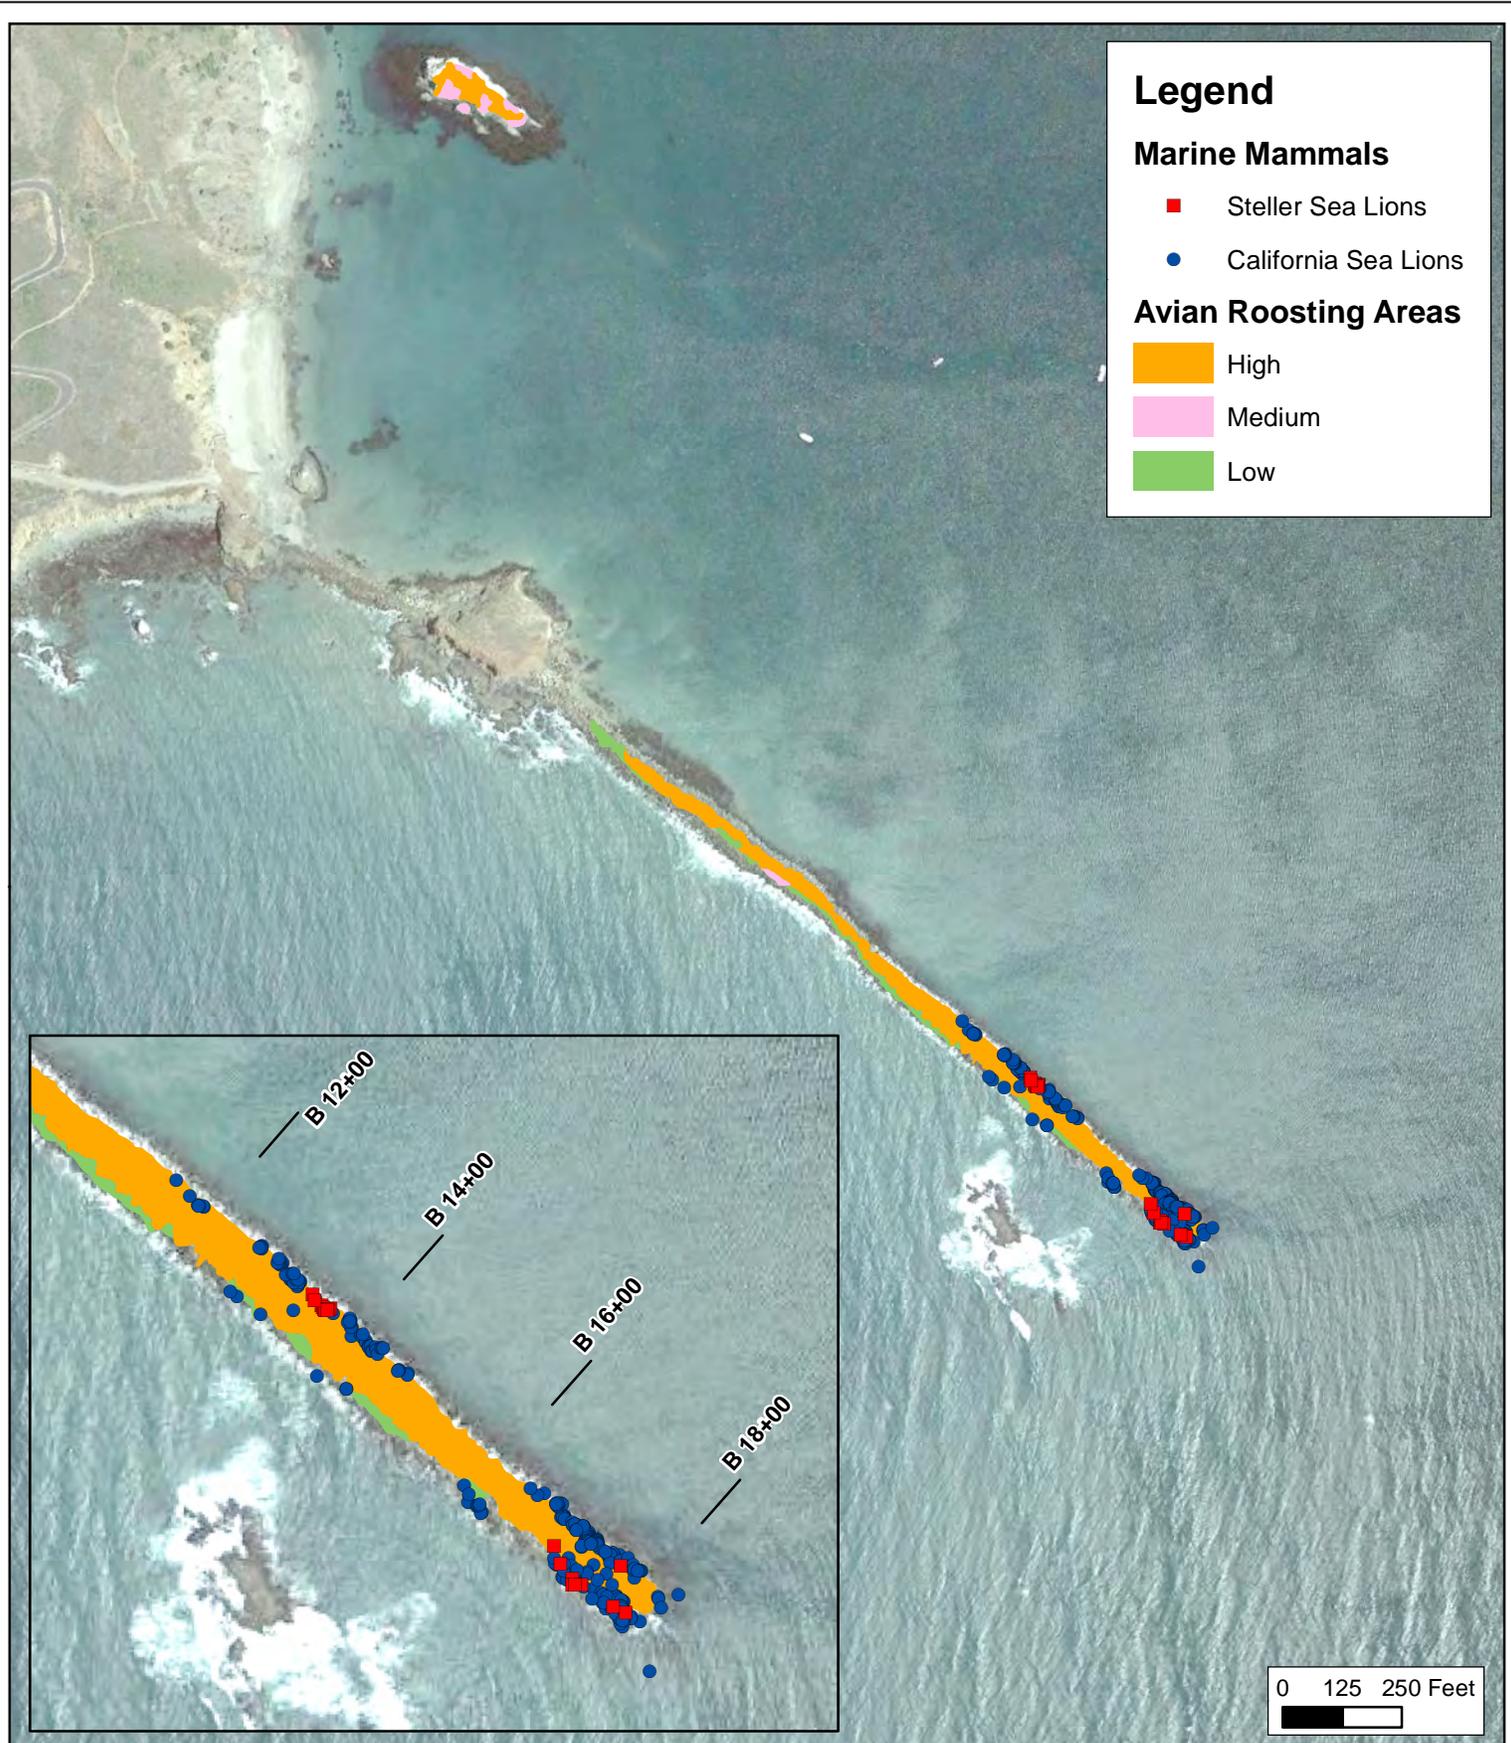
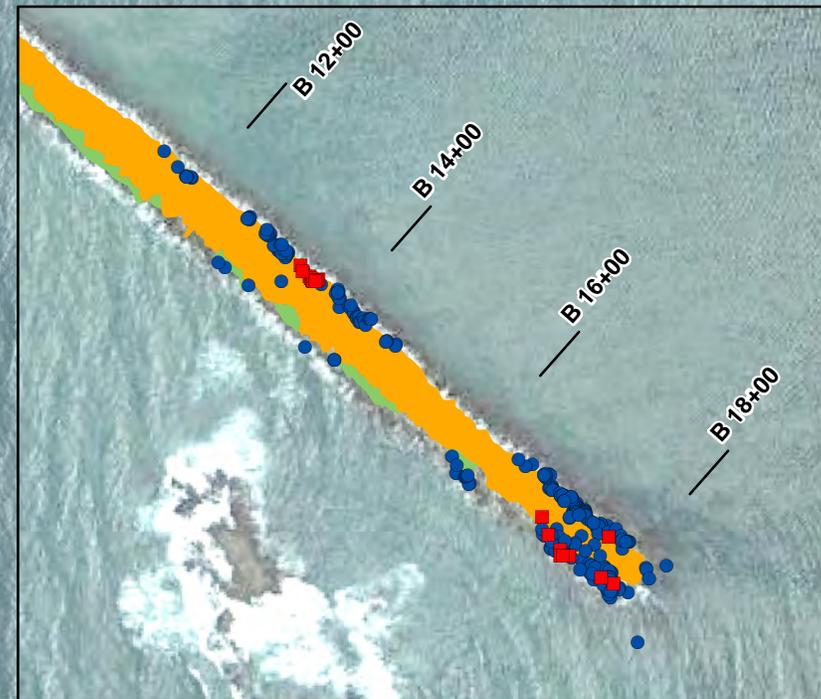
Figure 7

Marine Mammal Haul Out Use/Avian Roosting - June 2018
Port San Luis Breakwater Repair Sections
Stations B 6+00 to Station B 13+00
San Luis Obispo County, California

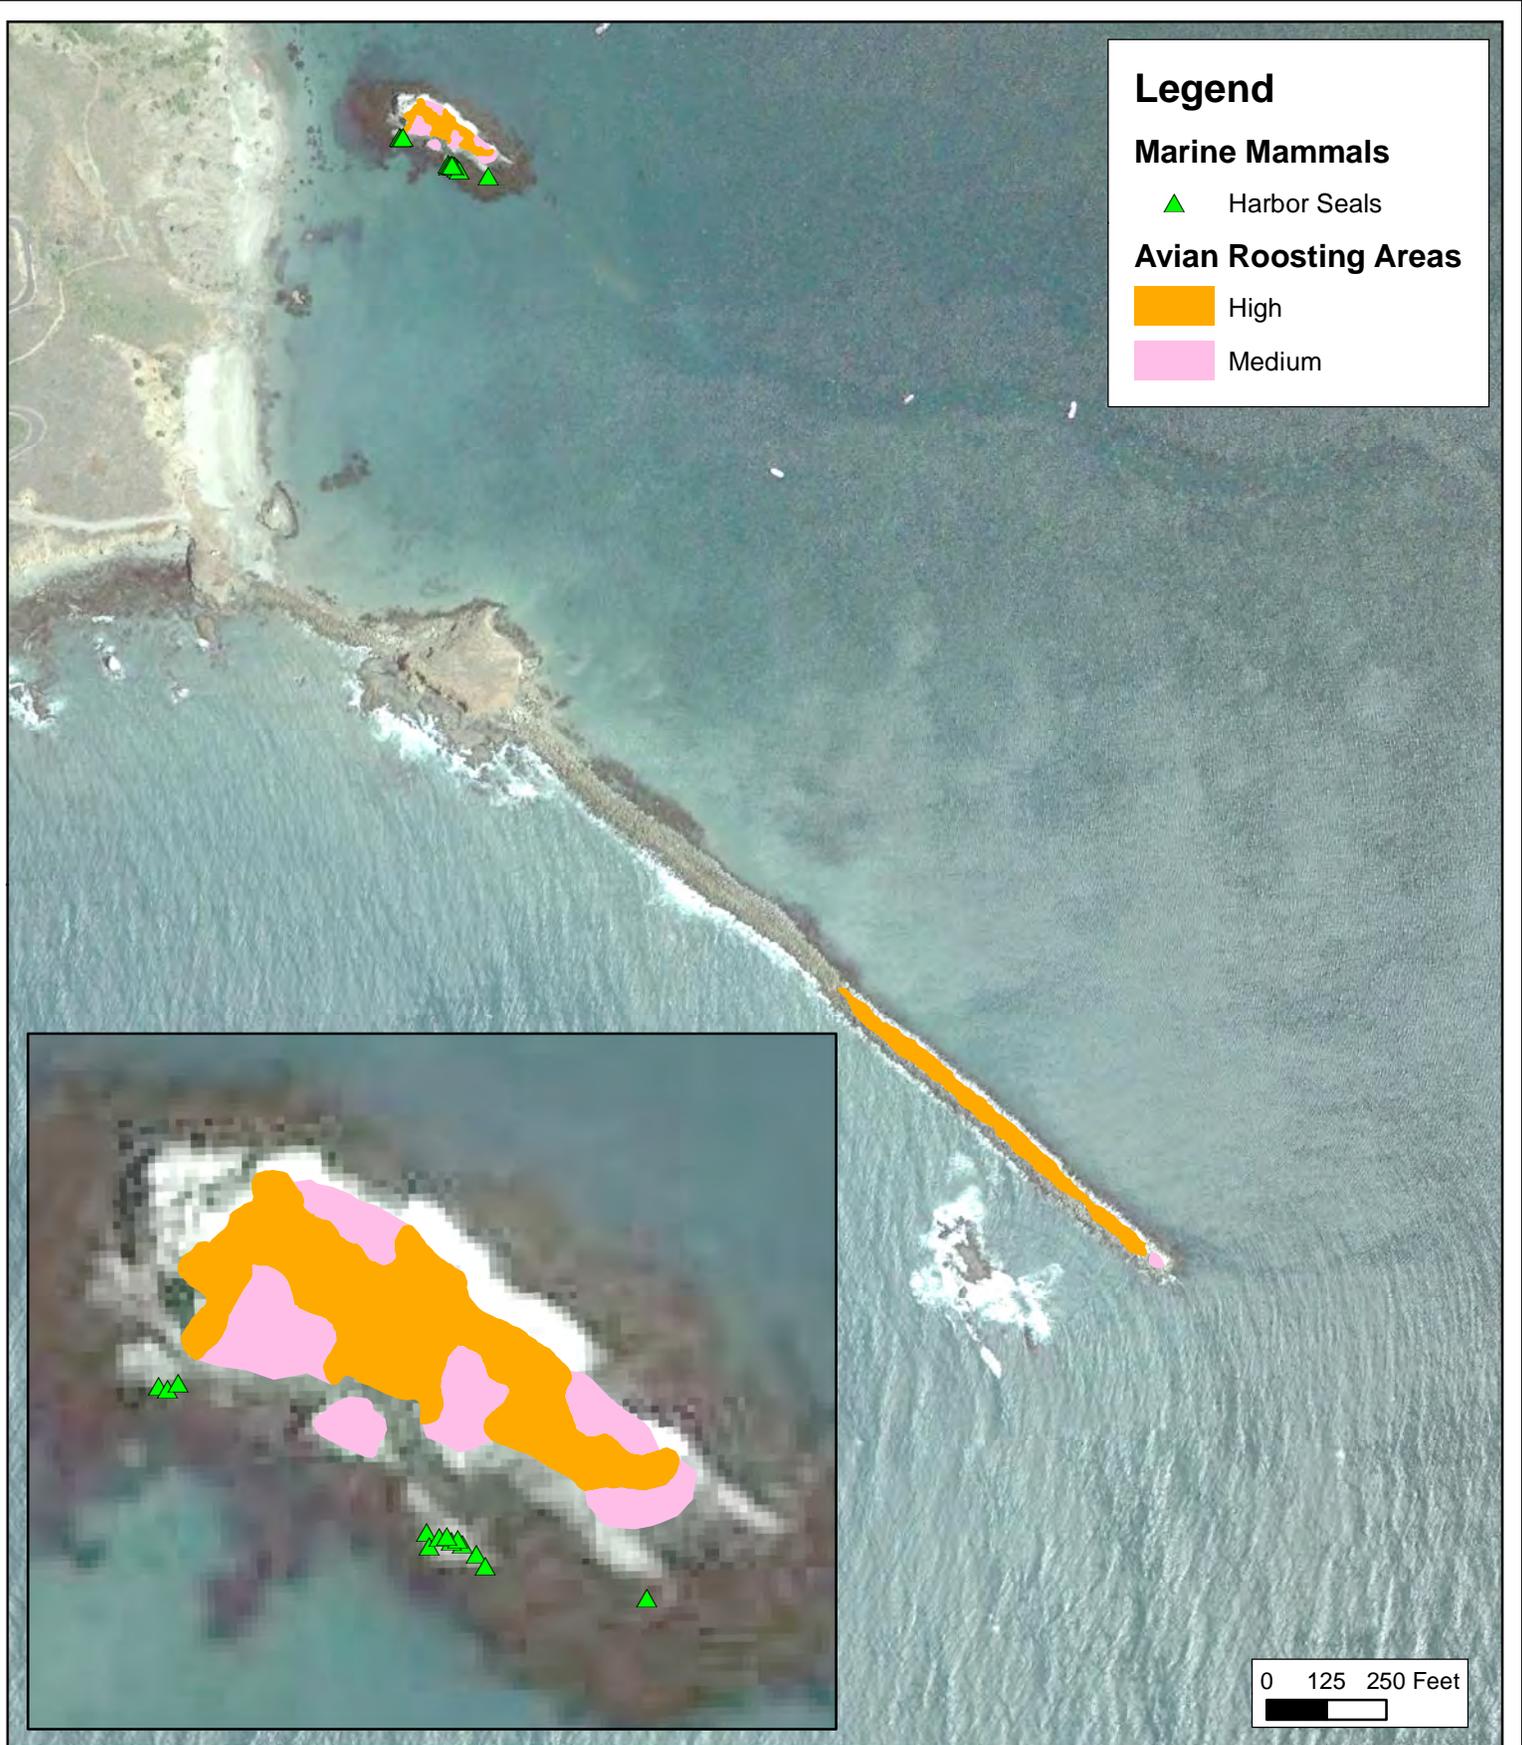
Figure 8

Marine Mammal Haul Out Use/Avian Roosting - February 2019
Port San Luis Breakwater Repair Sections
Stations B 6+00 to Station B 13+00
San Luis Obispo County, California
