Protected Species
Preliminary Monitoring Report
October – December 2020
DRAFT

Alaska Department of Transportation and Public Facilities
Ferry Berth Improvements: Phase 1
Tongass Narrows, Ketchikan, Alaska

December 28, 2020

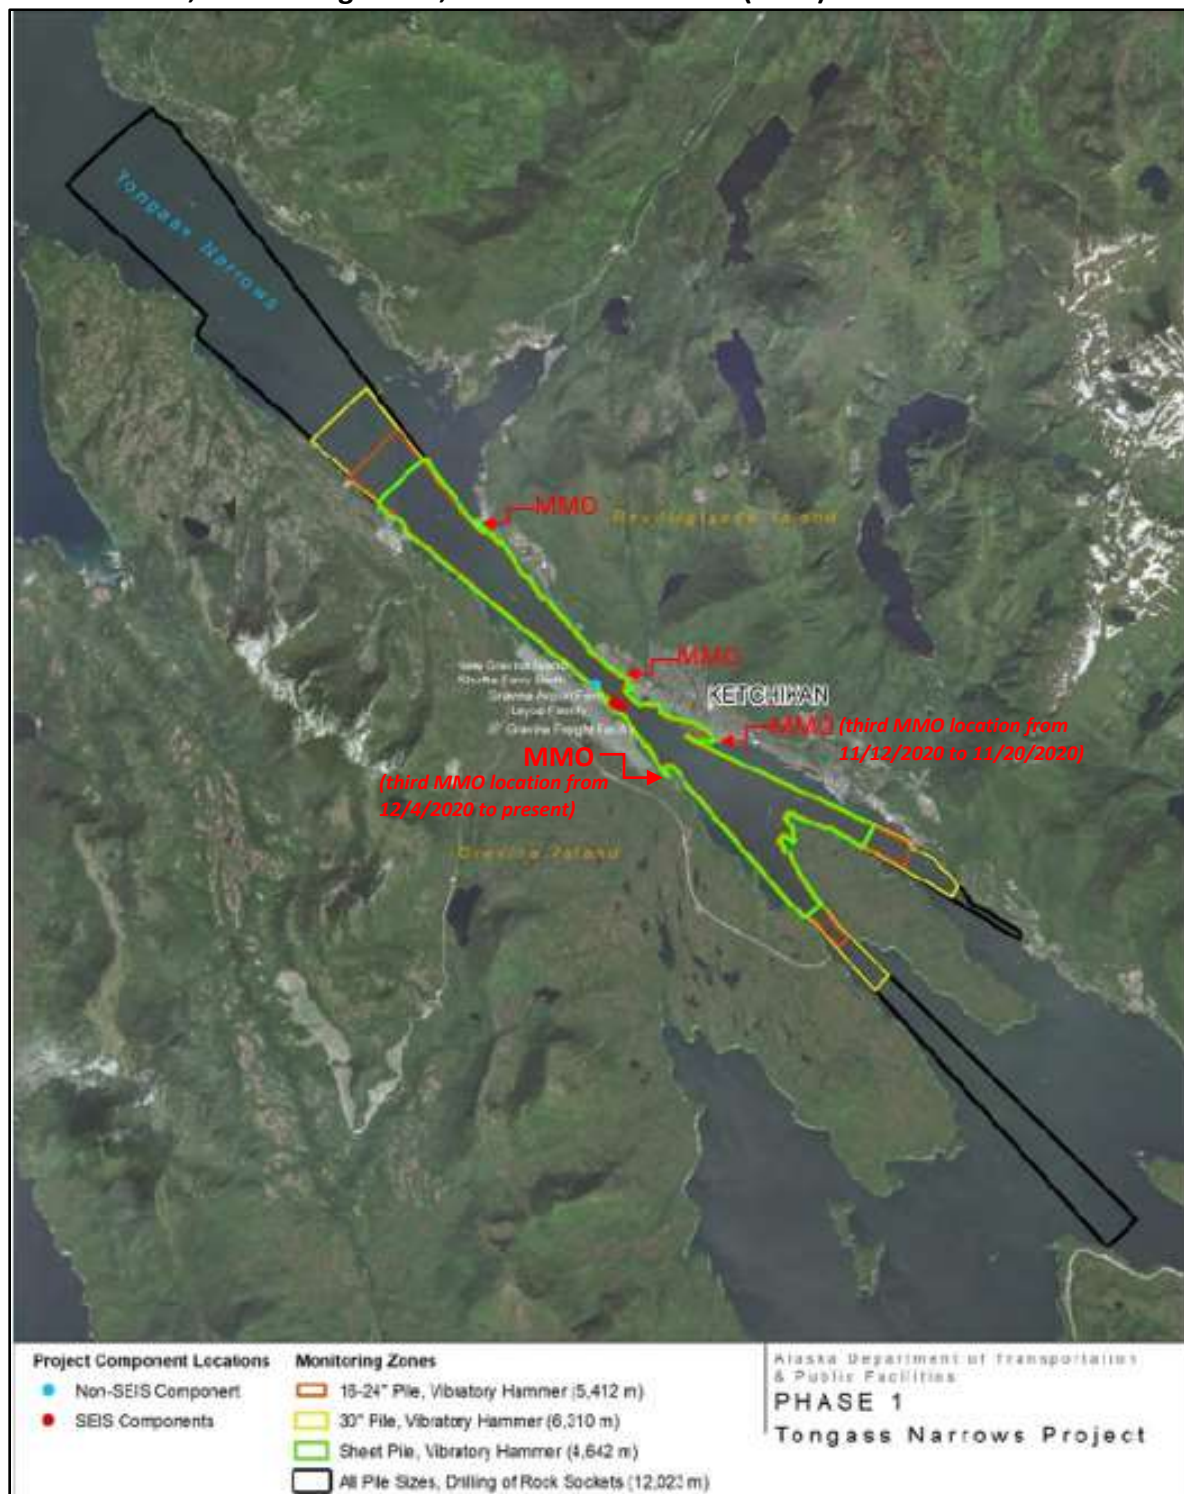
FIGURE 2. Tongass Narrows Ferry Berth Improvements: Phase 1 Construction NMFS-Approved PSO locations, Monitoring Zones, and Shutdown Zones (2020)

In 2020, construction occurred on the Revilla Ferry Berth in Tongass Narrows in Ketchikan, Alaska at approximately Latitude: 55° 21' 32.9"N, Longitude: 131° 42' 9.8"W (Figure 1). Between October and December, piles were installed using a vibratory hammer and impact hammer. Each of these methods and pile sizes required varying monitoring zones, Level A shutdown zones, and Level B shutdown zones (Table 2 and Figure 2).

When in-water work began on October 28, 2020, two qualified and NMFS-accepted PSOs scanned the area for marine mammals, recorded and reported sightings, and implemented mitigation actions (shut downs) in accordance with the IHA throughout the project. To mitigate for barge positions that prevented a full view of the action area, a third NMFS-approved observer was added on November 12, 2020. See Figure 2 for observer locations.

The PSOs also performed a 30-minute watch prior to the start of and at the conclusion of any in water work and consistently observed the areas while all in water work occurred. The three land-based PSOs had a clear view of the action areas and had a nearly full view of Tongass Narrows (Figure 2).

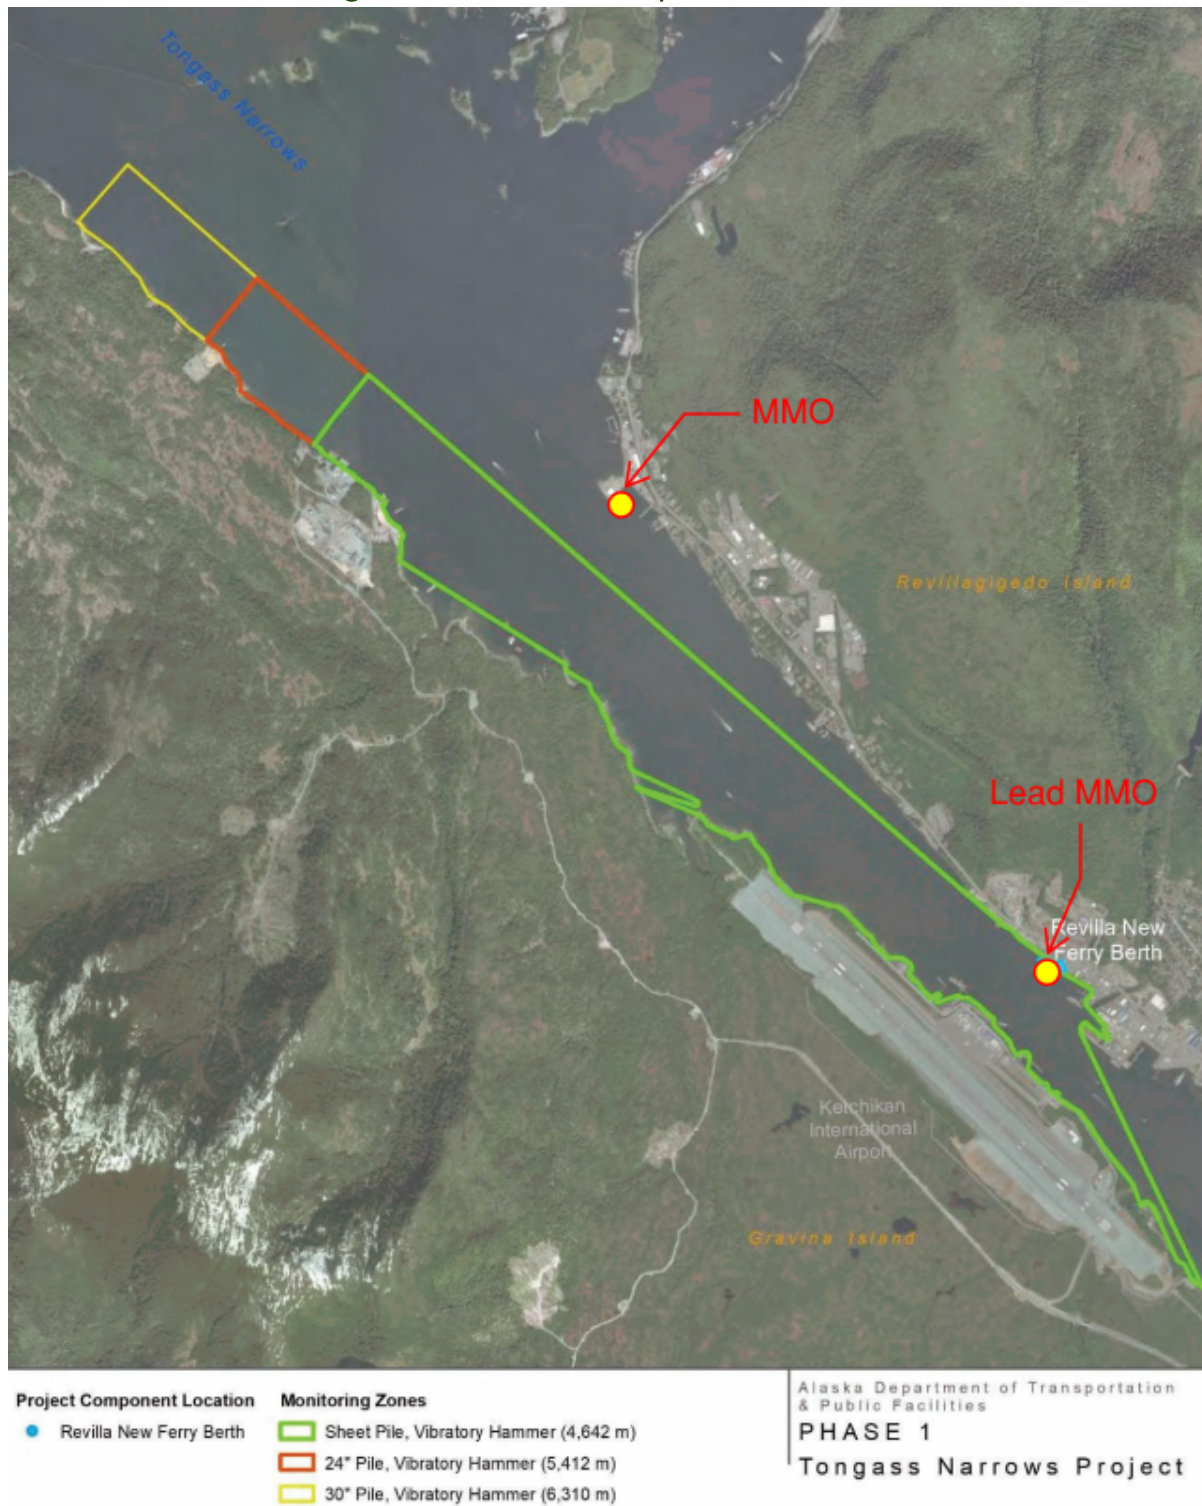
6.1 Phase 1 - Revilla: Single Hammer - Vibratory

Figure 5.1: Marine Mammal Monitor locations during Revilla vibratory hammer work. One MMO on the rig; one MMO at the Peninsula Point (eastern edge of the TEMSCO float plane hangar).

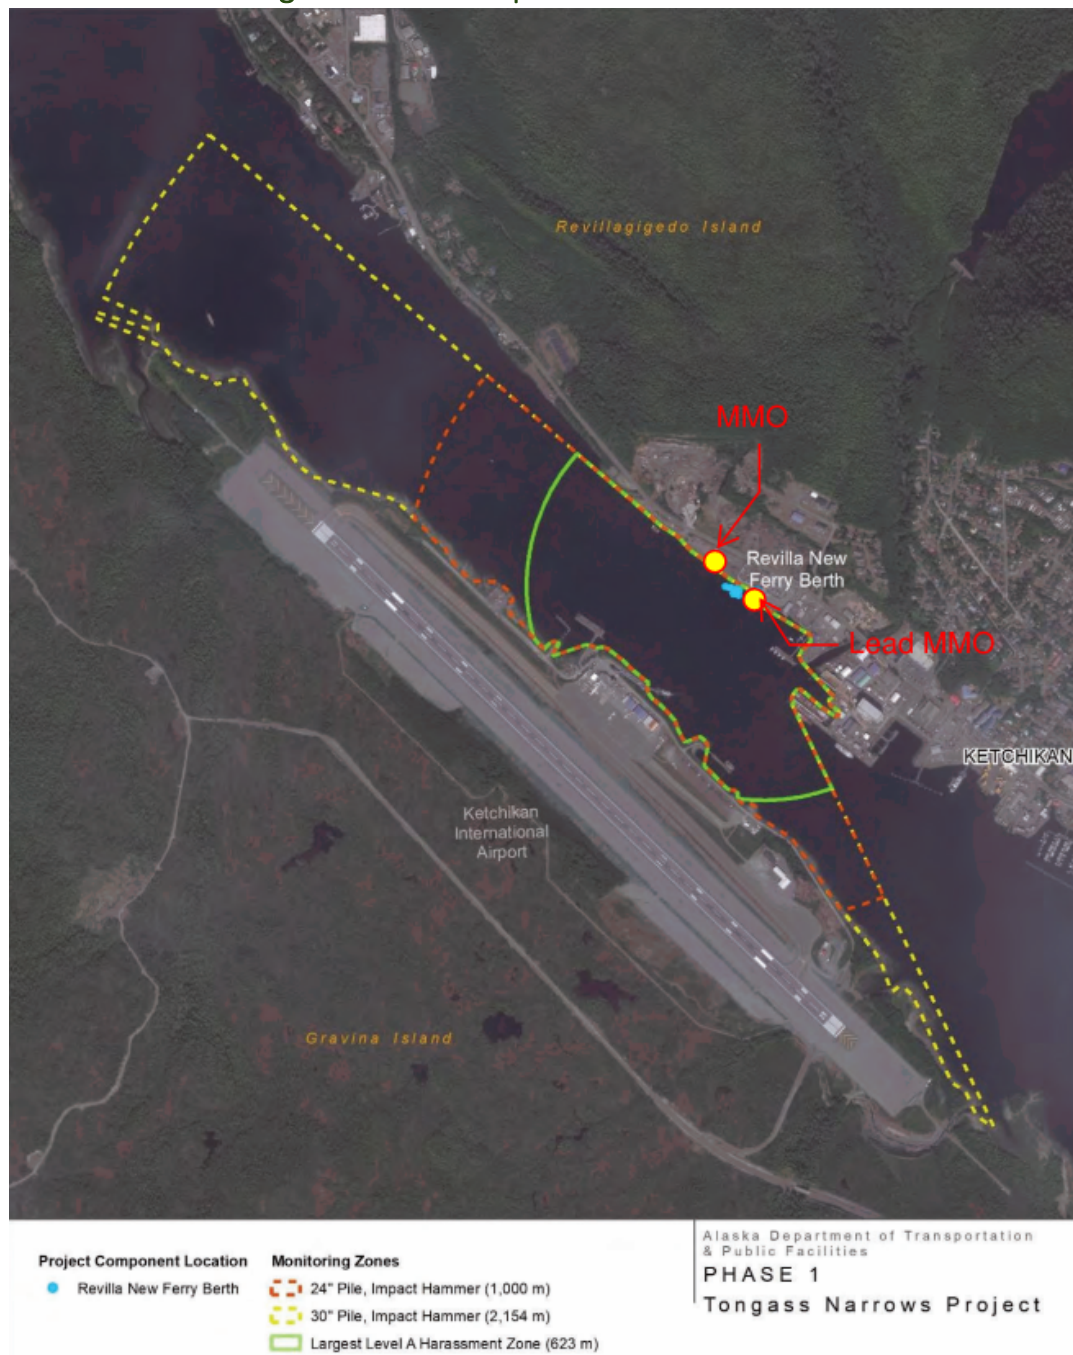
6.2 Phase 1 - Revilla: Single Hammer - Impact

Figure 5.2: Marine Mammal Monitor locations during Revilla impact hammer work. One MMO on the rig; one MMO on the north end of the jobsite.

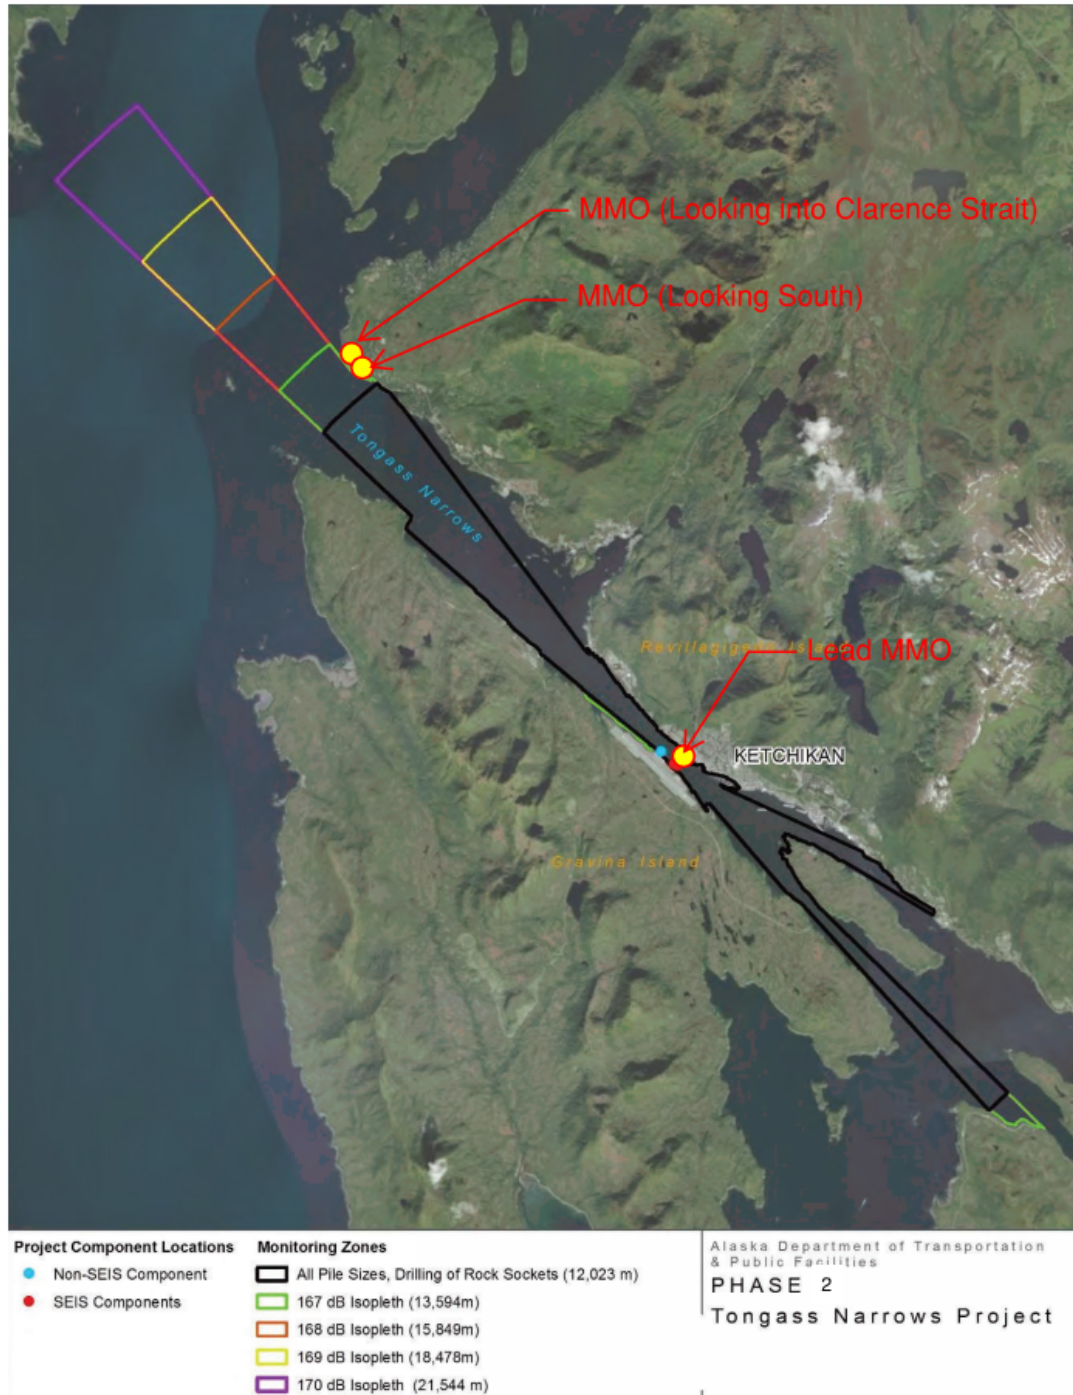
6.3 Phase 1 - Revilla: Single Hammer + Drill

Figure 5.3: Marine Mammal Monitor locations during Revilla simultaneous drilling/hammer work. One MMO on the rig; two MMOs at South Point Higgins, one looking south into Tongass Narrows and the other into Clarence Strait.

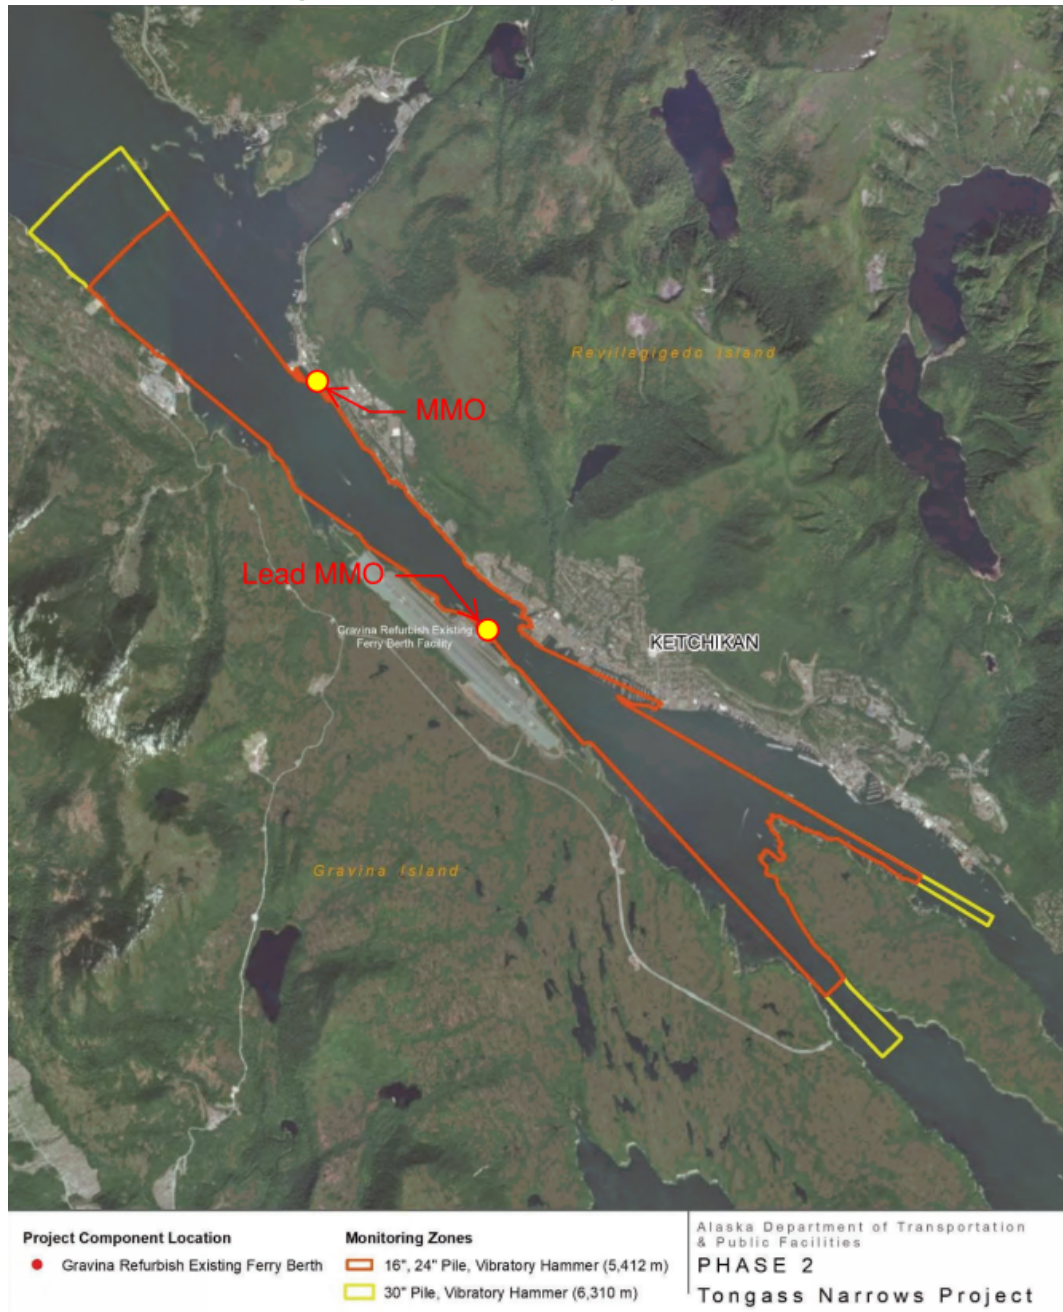
6.5 Phase 2 - Gravina: Single Hammer - Vibratory

Figure 5.5: Marine Mammal Monitor locations during Gravina vibratory work. One MMO on the rig; one MMO at the Peninsula Point (eastern edge of the TEMSCO float plane hangar).

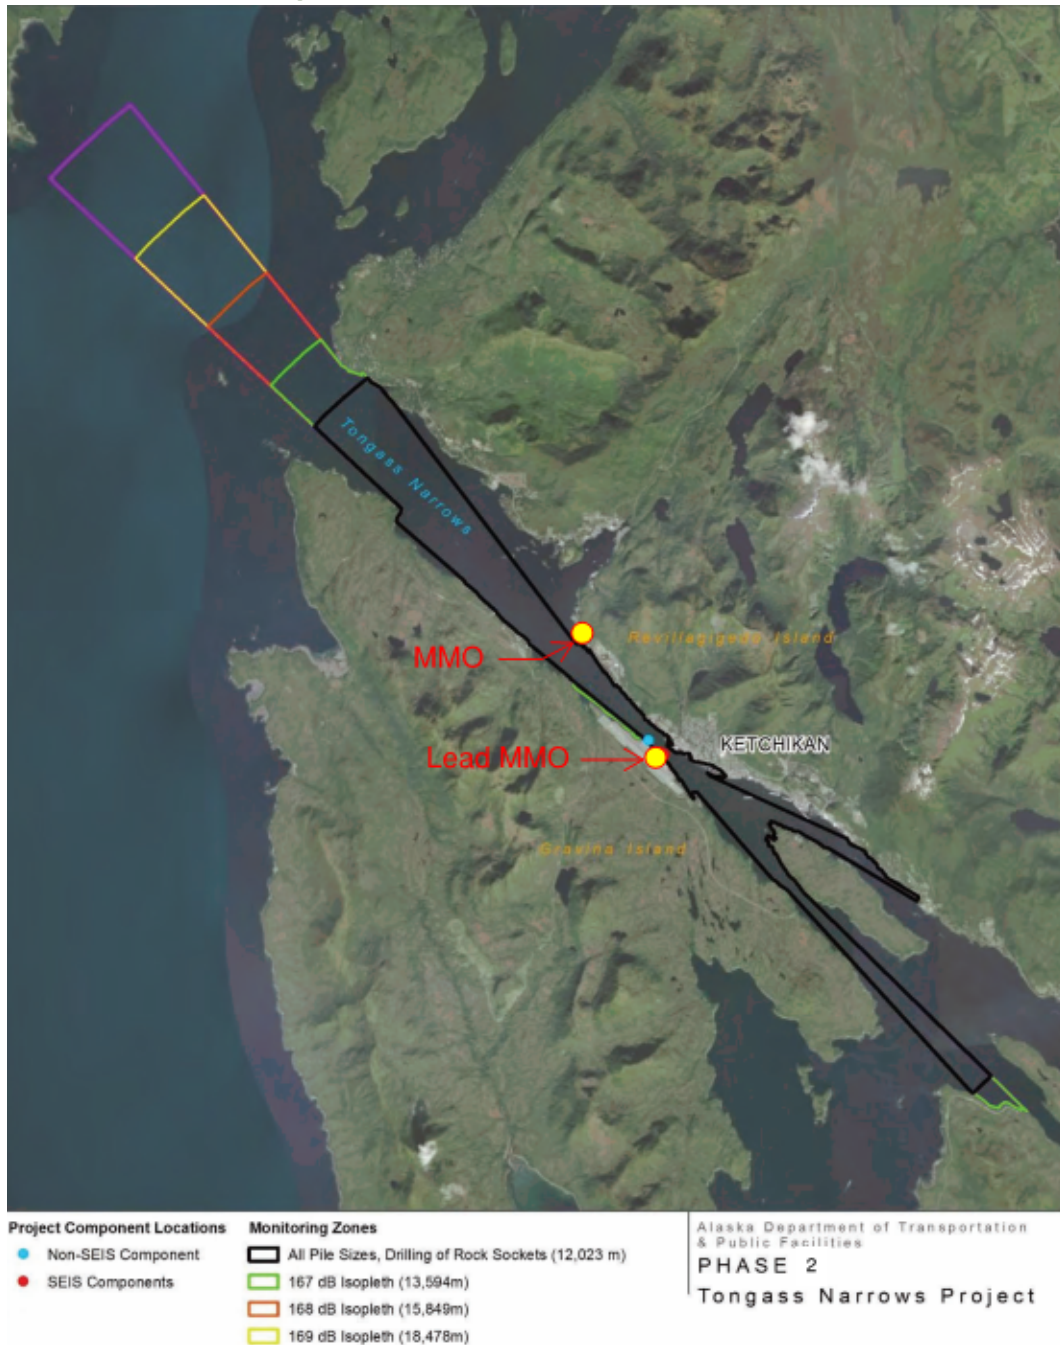
6.7 Phase 2 - Gravina: Single Hammer + Drill

Figure 5.7: Marine Mammal Monitor locations during Gravina drilling work. One MMO on the rig; one MMO at the Peninsula Point (eastern edge of the TEMSCO float plane hangar).
