Subject: Construction Monitoring Report for the Coast Boulevard Improvements Project in La Jolla California

**MONITORING REPORT
FOR THE CITY OF SAN DIEGO'S
COAST BOULEVARD WALKWAY IMPROVEMENTS**

25 July 2019 to 9 December 2018

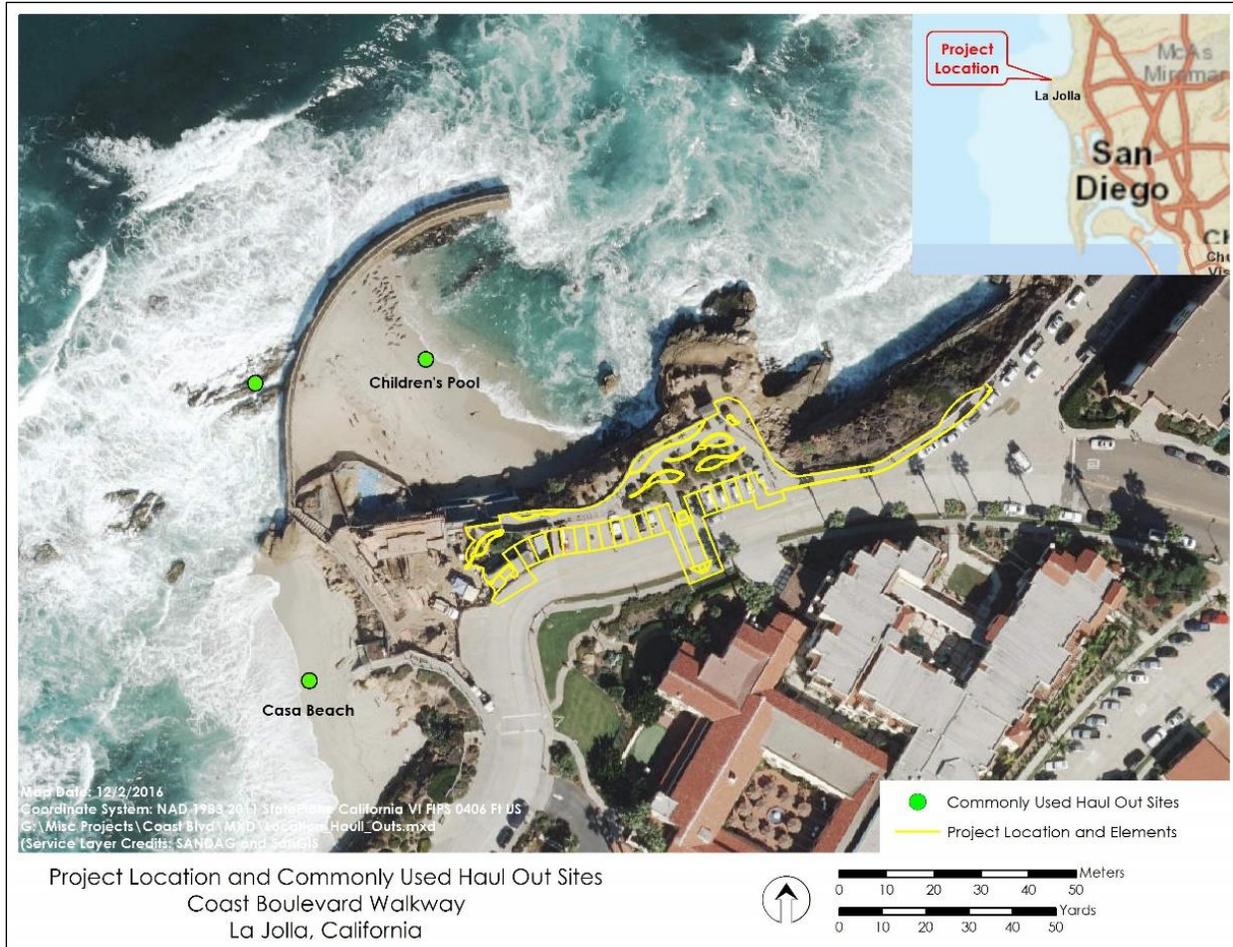
Figure 1-2. Project Location and Known Haul Out Sites in the Project Area

Marine mammals are known to frequent the beaches and exposed rocks in the Project vicinity during all times of the year (identified by the green dots in Figure 1-2). Because of the potential for marine mammals to occur in the Project area, marine mammal monitoring was utilized to assess the potential impacts from the Project, either from physical or acoustical disturbance. Three known haulout locations are associated with the Project area, with the main area of potential effect being at the Children's Pool Beach (Figure 1-2). Rocks on the eastern side of the Children's Pool breakwater wall (identified by the long curving line to the west of the Children's Pool in Figure 1-2) were also monitored. The rocks directly to the west of the breakwater were also monitored because marine mammals that were on the beach were observed to move to this location

Note: Haul out sites include beach and adjacent rocky areas

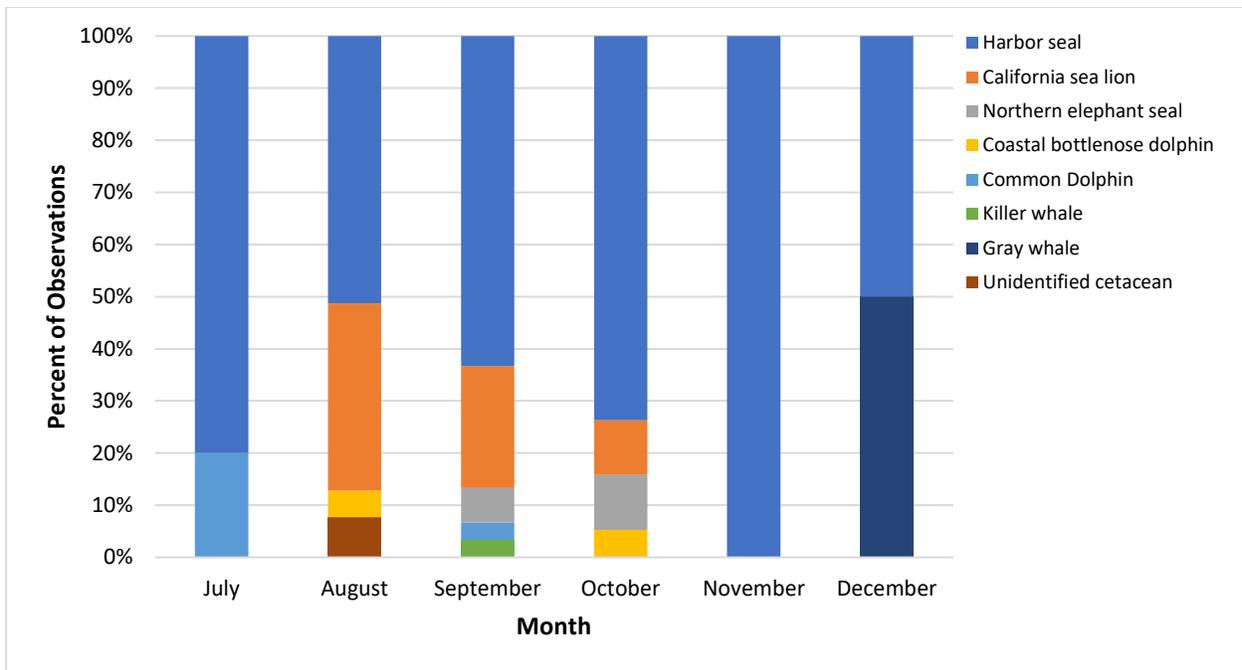
Figure 3-1. Percent of Observations of Species by Month.

There was a total of 3,391 observations (hourly and behavioral reactions) logged during the monitoring efforts. Six species of marine mammals were observed on the beach and in the surrounding waters around the Children's Pool Beach. The species observed included harbor seals, California sea lion, northern elephant seals, coastal bottlenose dolphins (*Tursiops truncatus*), common dolphins (*Delphinus sp.*), Pacific gray whales (*Eschrichtius robustus*), and killer whales (*Orcinus orca*). Unidentified large whales and dolphins were also observed but were too far away to identify to the species level. The greatest species diversity was during the month of September with five species observed (harbor seals, California sea lions, northern elephant seals, common dolphins, and killer whales), followed by August and October with four species observed (Figure 3-1). Of the Pinniped species, the harbor seal was only species observed during all monitored days, followed by the California sea lion (n=23 days) and the northern elephant seal (n=4 days). A majority of the California sea lions observed were males (46.8%), followed by females (20.3%). All of the northern elephant seals noted were juveniles. All other marine mammal species observed were seen on 3 days or less during monitoring efforts. All cetacean species were observed in the water to the west of the Children's Pool breakwater wall (Figure 3-1).

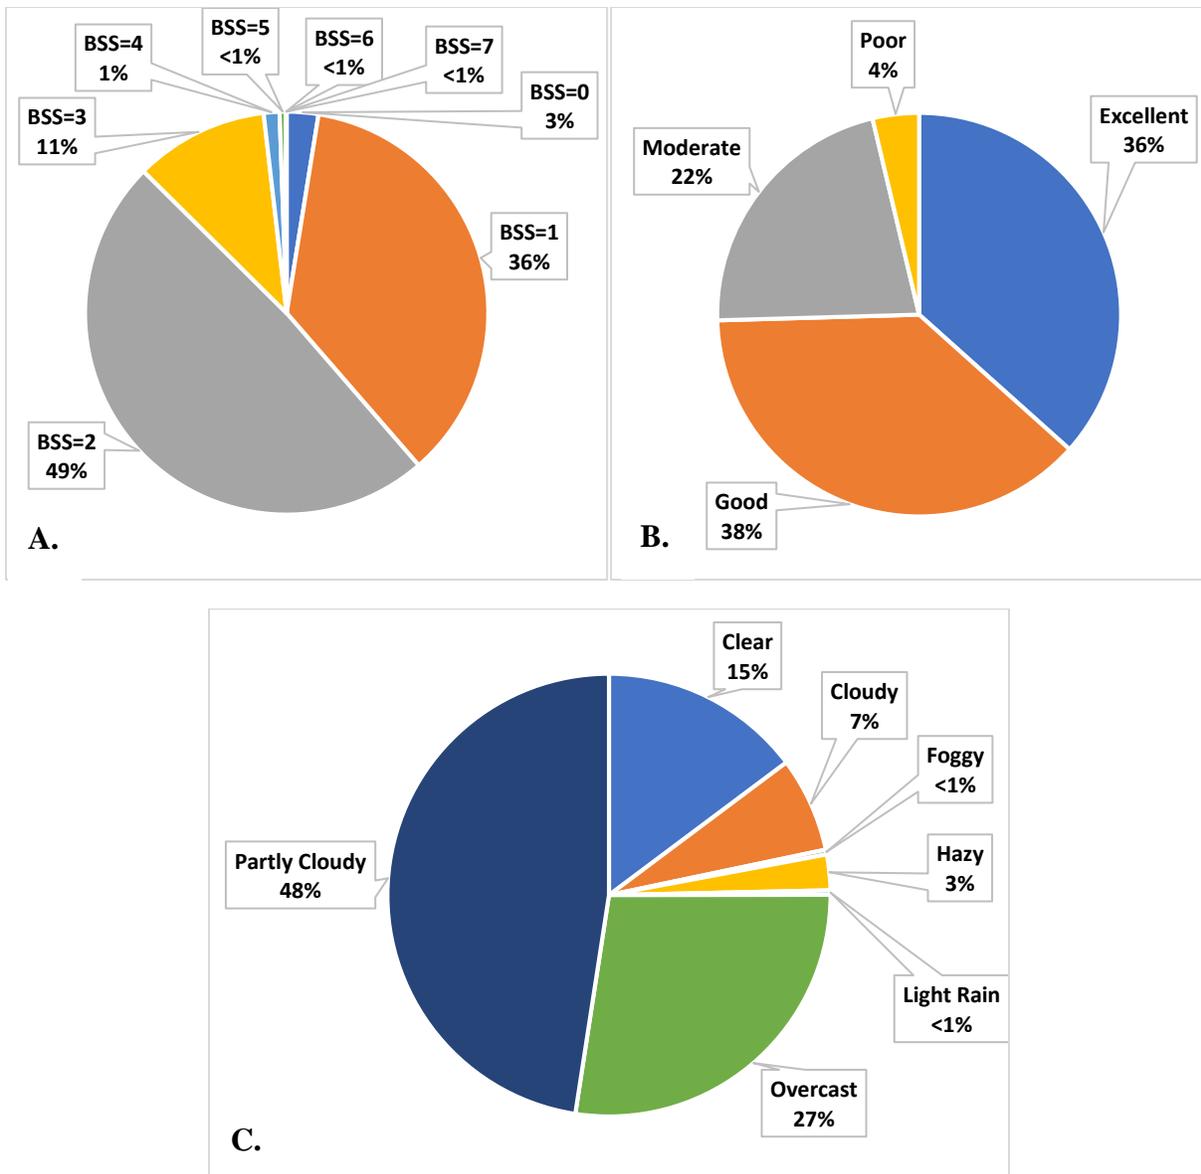
Figure 3-2. Weather Conditions in the Project Area Relative to: A. Beaufort Sea State, B. Visibility, and C. Cloud Cover

Weather conditions for monitoring were generally favorable with Beaufort Sea States (BSS), overall visibility, and cloud cover conducive to monitoring. During the monitoring effort the BSS was recorded with an average of 1.6, with a majority of the observations having BSS ratings of from 1 to 3 (95.6%; Figure 3-2a). The BSS relates wind speed to observed conditions in the area, with a dead calm classified as a BSS of 0, and hurricane force winds classified as a BSS of 13. The highest average BSS for the monitoring efforts was in November with an average BSS of 1.8, and the lowest average BSS was 1.0 in December, but both of these data points are based on a single day of monitoring during those months. When these two days are eliminated from the analysis, the average Project BSS rises to 1.7. A majority of the observations (74.6%) had visibility ratings of either Good (visibility of from 10 to 20 kilometers [6.2 to 12.4 miles]) or Excellent (visibility of greater than 20 kilometers [12.4 miles]; Figure 3-2b). Most observations (89.8%) associated with the monitoring efforts were during cloud cover of Partly Cloudy, Overcast, or Clear (Figure 3-2c).

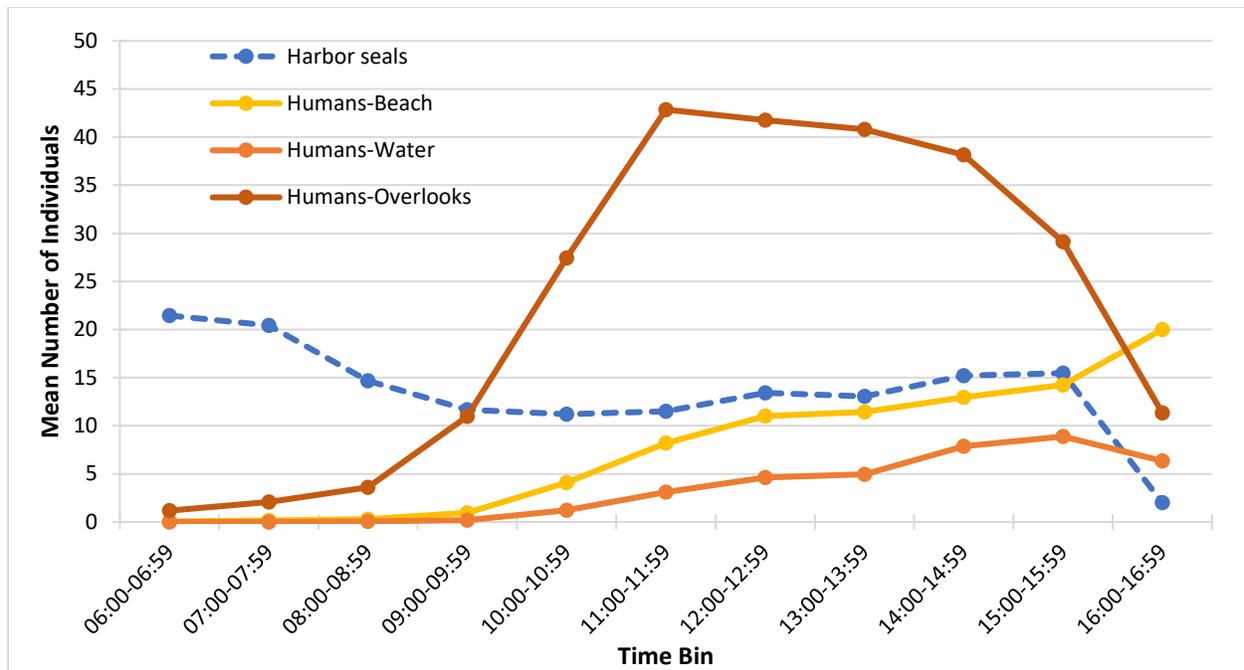
Figure 3-3. Mean Number of Humans and Harbor Seals in the Project Area per Hour.

Hourly counts were taken of the marine mammals on the beach and rocks in the Project area within the designated zones (see Figure 2-1) on the beach. From July 25th to December 9th, a total of 1,516 hourly counts were recorded during monitoring efforts over 61 days. Datasheets from two days were lost, so the 1,516 observations are based on 59 days of monitoring. Human activity in the Project area was separated into three distinct areas (overlooks above the beach, in the water, and on the Children's Pool Beach) and the number of visitors were logged in these areas. When evaluating the presence of harbor seals relative to human presence, as the average number of humans per hour in the Project area increased the number of harbor seals decreased and then stabilized before dropping at the end of the monitoring (Figure 3-3).

Human presence in the monitoring area was dominated by the number of individuals on the overlooks above the Children's Pool Beach (see Figure 3-3). When evaluating the number of humans present in areas that there may have been in direct, or incidental, contact with harbor seals (e.g., in the water, or on the Children's Pool Beach), there was a decrease in average harbor seal numbers as the human presence increased (Figure 3-5). Both the mean hourly number of humans in the water and the harbor seals in the Project area began to drop at the end of the monitoring period (during the 16:00 hour), while the mean number of humans on the beach increased. This would indicate that the mean number of humans on the beach had a greater influence on the mean number of harbor seals in the Project area than humans in the water.

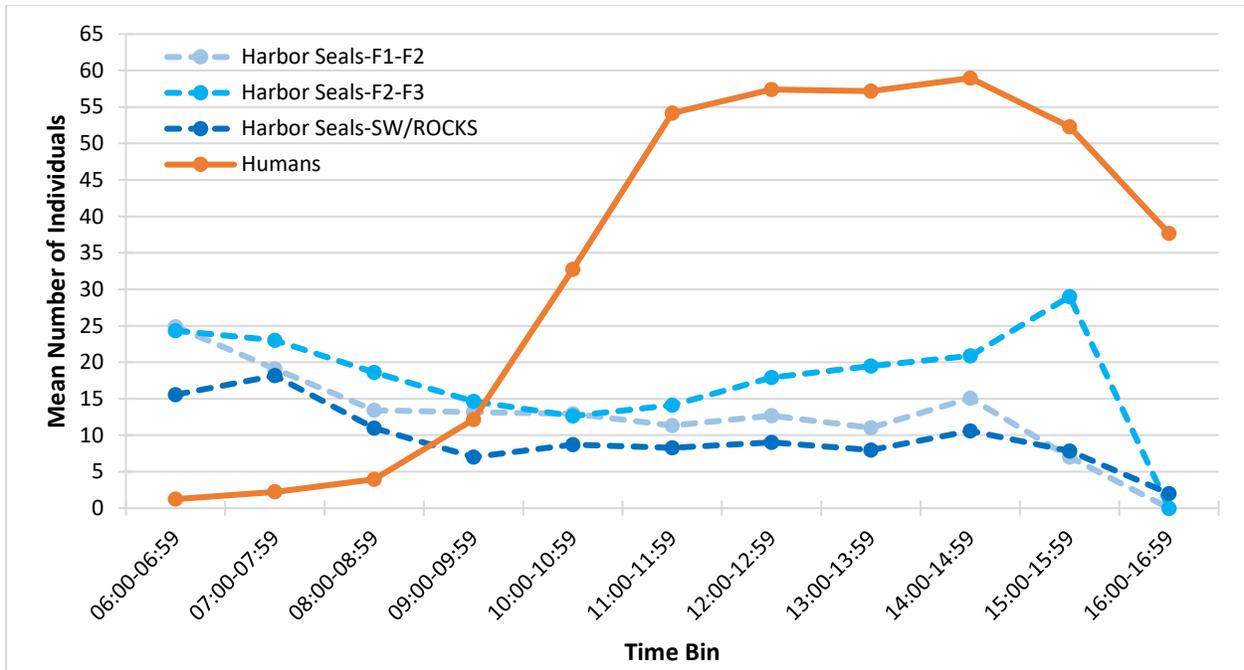
Figure 3-4. Mean Number of Humans and Harbor Seals in the Project Area per Hour and by Beach Section.

Throughout the day harbor seals generally tended to stay on the western side of the beach (F2 to F3) near the Children’s Pool breakwater rather than on the eastern side of the beach (F1 to F2; Figure 3-4). The human presence in the Project area started to increase during the 09:00 to 10:00 hour and, as there was an increase in the number of humans in the Project area (including the overlooks, in the water, and on the Children’s Pool Beach), there was a decline in the number of individuals on the eastern side of the beach (F1 to F2). Starting during the 06:00 hour, there was a steady decline in the mean number of harbor seals on the beach until numbers stabilized after approximately 10:00. The numbers of individuals in the F2 to F3 section remained relatively constant after the initial decline in numbers between 09:00 and 10:00 on the beach, with slight fluctuations at the end of the monitoring day (Figure 3-4).

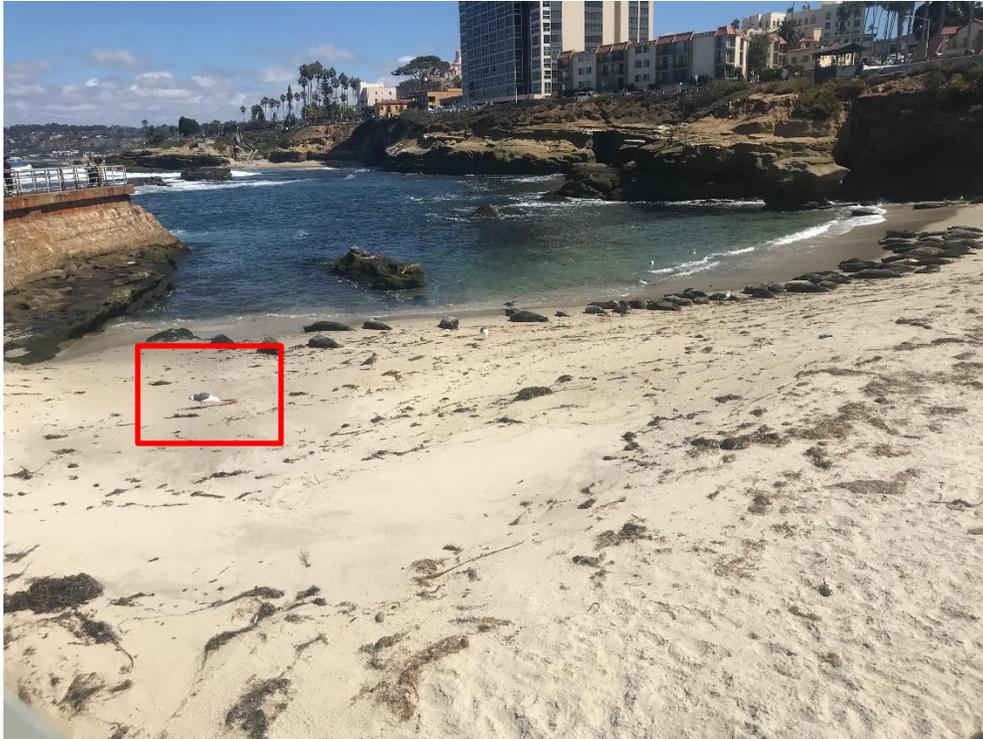
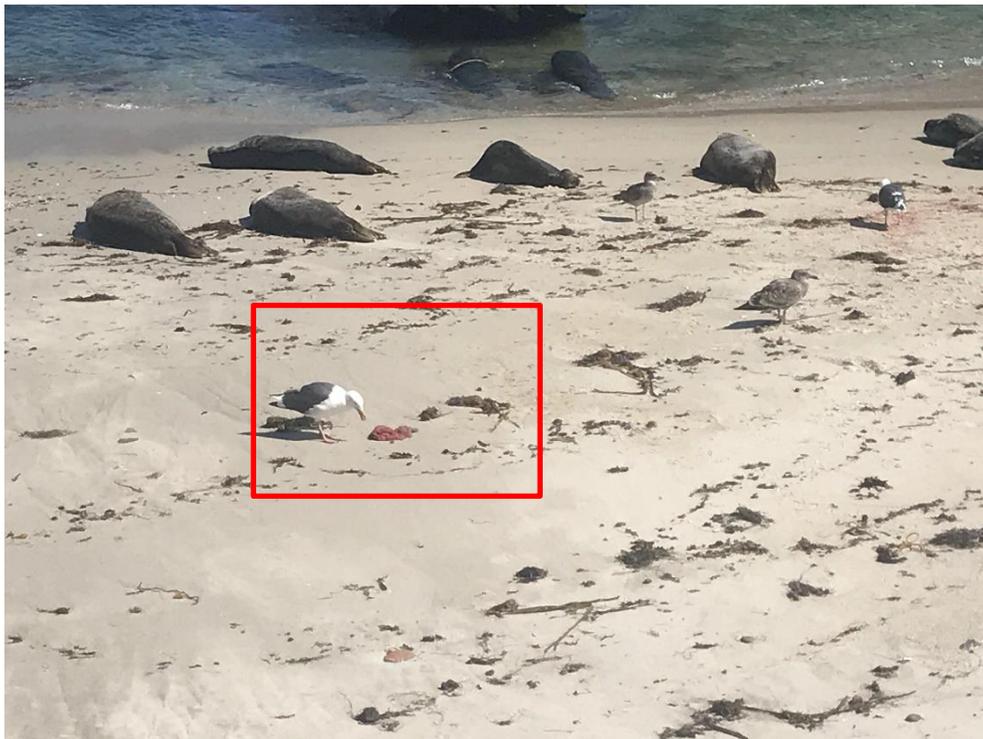
Figure A-1. Photos showing stillborn harbor seal pup at approximately 12:10 pm.

On October 5, 2018 at approximately 12:08, the Marine Species Observer (MSO) at the Coast Boulevard Project (Project) site observed western gulls (*Larus occidentalis*) converging on a spot on the beach (in the F2-F3 sector, per the monitoring plan). The MSO then noted that they were obviously pecking at something on the sand. While it is not unusual for western gulls to be on the beach, having gulls congregate in one distinct location is an unusual event, and the MSO was drawn to the activity. After observing what the gulls were pecking at through binoculars, as well as seeing a trail of blood and placenta from an adult harbor seal, it was determined that a harbor seal had just given birth to a presumably stillborn pup.

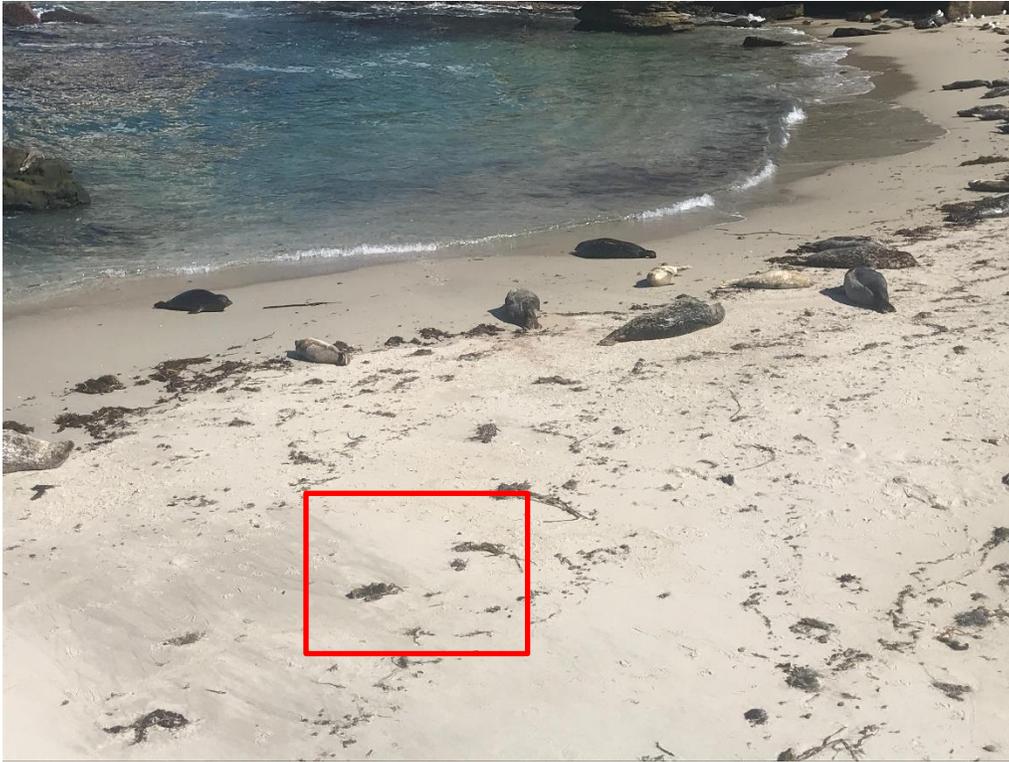
14:30 – Stillborn pup has been completely consumed by western gulls (Figure A-2).

Figure A-2. Photo showing the location of the stillborn harbor seal pup at approximately 14:30 pm.
