CROWLEY KOTZEBUE DOCK REPLACEMENT PROJECT

HYDROACOUSTIC MONITORING REPORT, REV. 1

July 2021

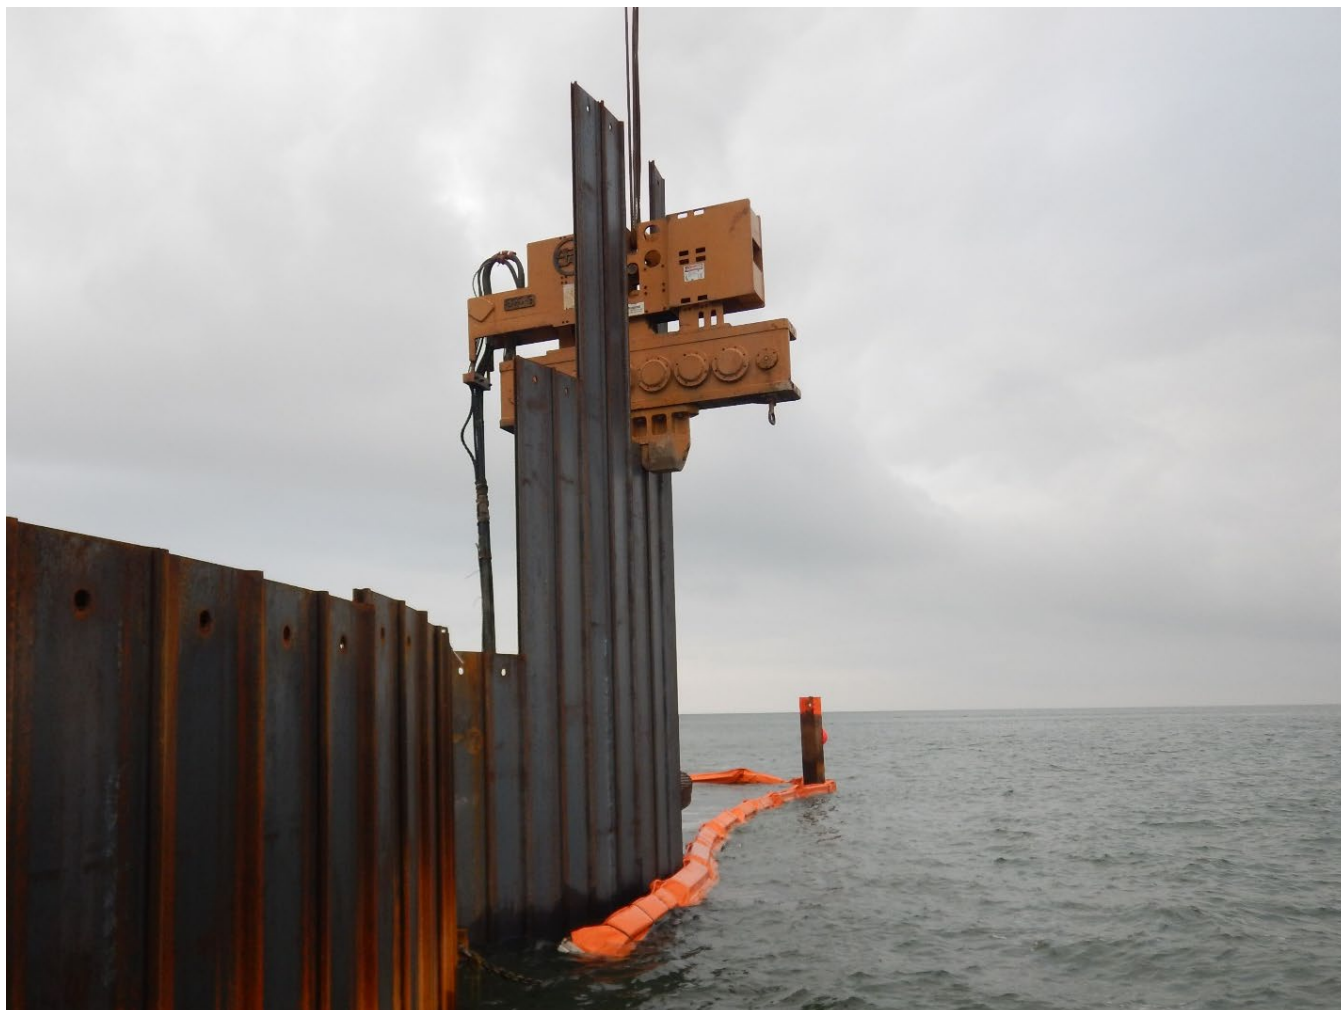
Figure 1.2. APE-200-6 Vibratory Hammer in Action.

All piles monitored were interlocking steel PS31 or PS27.5 sheet piles with 5/8th-inch-thick webs that were 40 feet in length. Piles were driven approximately 35 feet offshore from the existing dock in water depths of approximately 15 ft. All piles were driven to an elevation of -31 feet mean lower low water (MLLW) with an American Piledriving Equipment (APE) hydraulic vibratory hammer model 200-6, capable of 225 tons of driving force. Substrates in Kotzebue Sound are typically soft, comprised of sandy mud or gravelly mud. Figure 1.2 shows the APE-200-6 vibratory hammer driving interlocking sheet piles for the bulkhead.

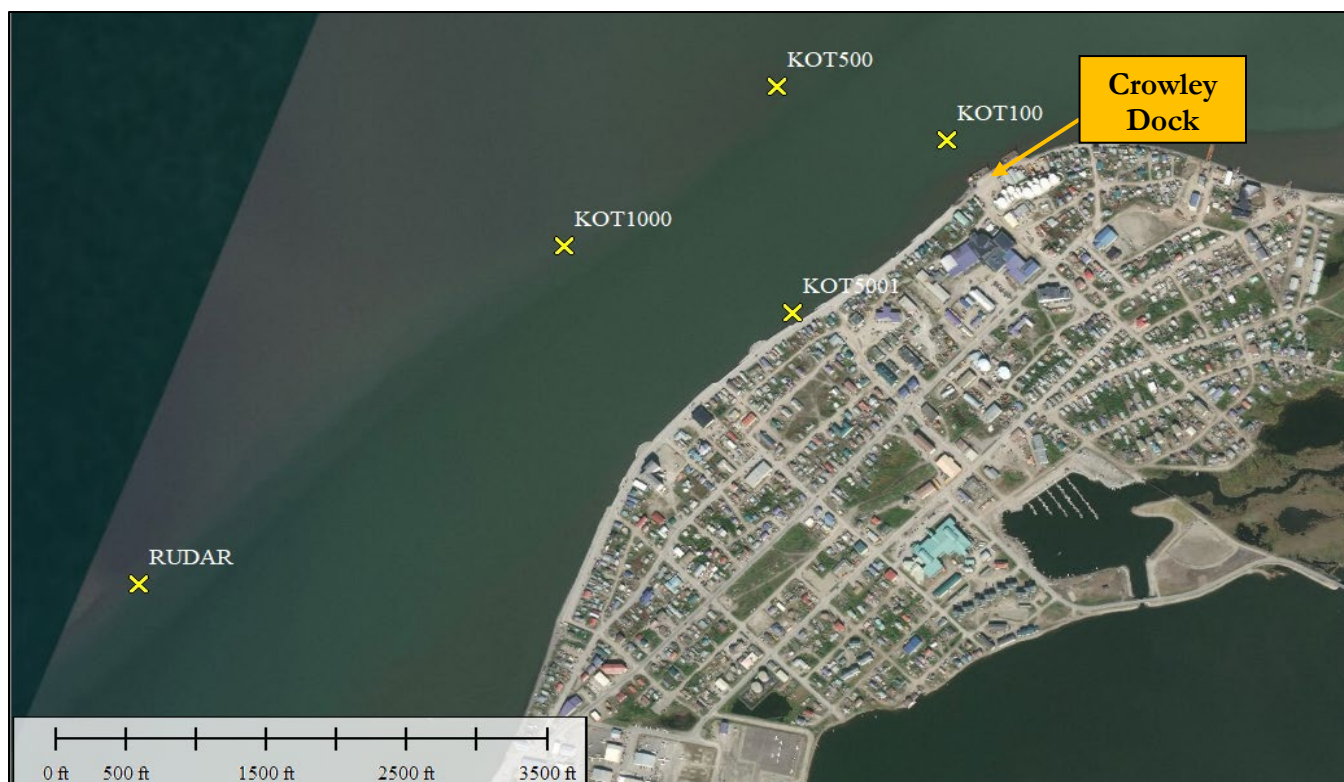
Figure 3.1. Hydroacoustic Measurement Locations (yellow crosses)

For the first measurements, the hydrophone was placed as close to 10 m as was safely possible from each pile with a clear acoustic line-of-sight between the pile and the hydrophone. Following recording at the 10-m location, additional measurements were taken offshore from the construction site at the following radii: 100 m, 500 m, and 1,000 m. The actual data collection locations are shown in Figure 3.1. The exact distance between the hydrophone and pile was recorded in the monitoring logs and was adjusted depending on safe access within the construction area during driving activities. The underwater sound levels were collected at various depths below the water surface (depending on bathymetry) at the bottom, mid-column, and at the surface.

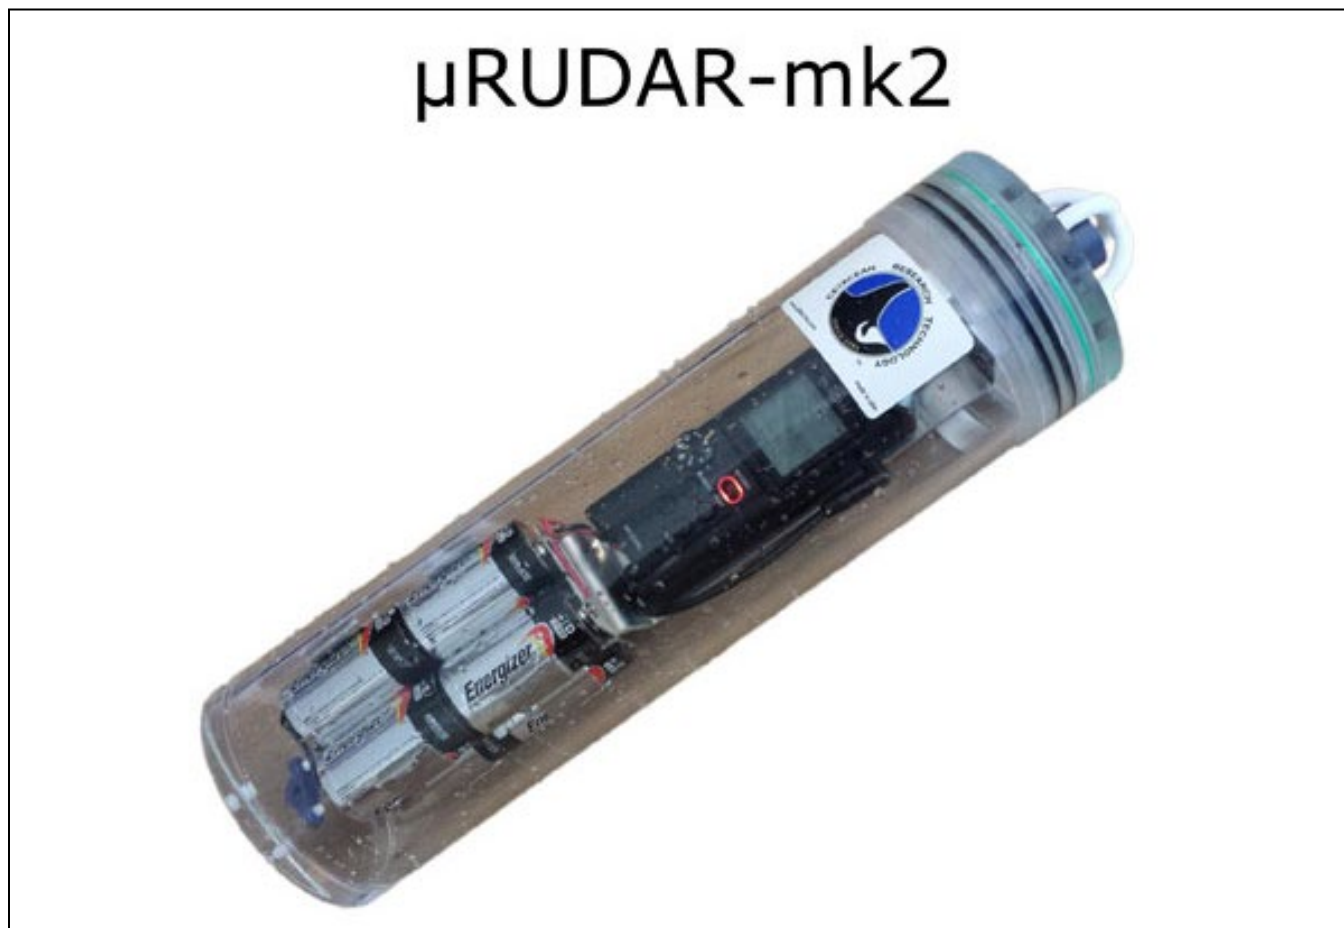
Figure 3.2. Remote Underwater Digital Acoustic Recorder (μ RUDAR-mk2™)

The micro Remote Underwater Digital Acoustic Recorder (μ RUDAR-mk2™) developed by Cetacean Research Technology consisted of a hydrophone with sensitivity of -169 dB (re: 1V/ μ Pa) and digital audio recorder (see Figure 3.2). The μ RUDAR-mk2™ was first deployed on September 15, 2020 in the water depth of about 15 feet. The unit was attached to a 50 lb. anchor with the hydrophone located in the mid water column 6 feet from the bottom. A separate 200 feet groundline was attached to a second anchor marked by the surface orange buoy for easy retrieval.

The μ RUDAR-mk2™ recorder was set to collect underwater noise at 96 kHz sampling frequency and 16-bit rate continuously for a period of 7 days. The μ RUDAR-mk2™ was redeployed at the same location for the second deployment period on September 22, 2020. The information collected by the μ RUDAR-mk2™ will be used to supplement the direct observations of the PSOs. Data from the system will be provided to NMFS for further processing.

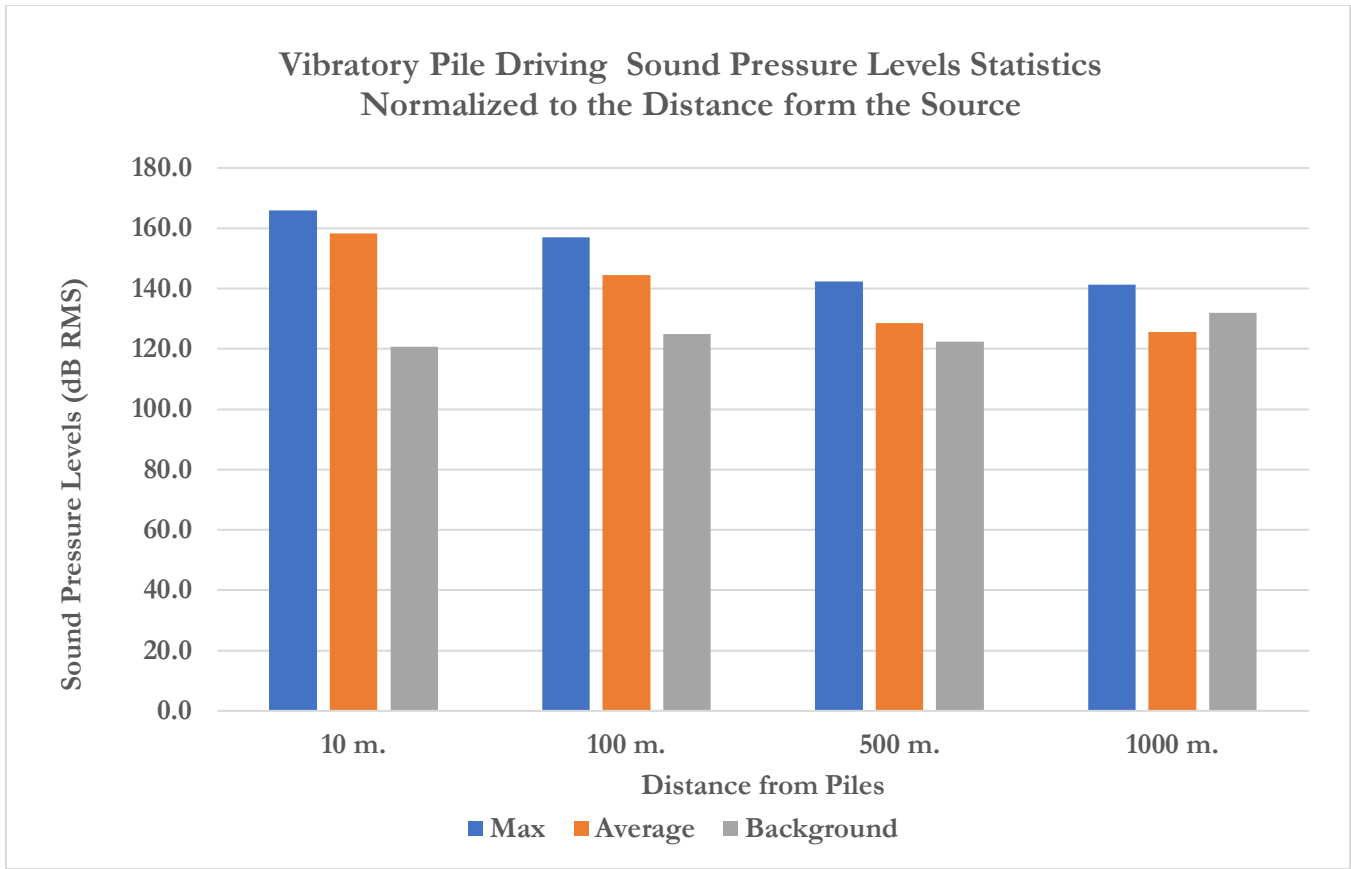
Figure 4.1. Vibratory SPL Statistics (including maximum SPL (blue), average SPL (orange) and average ambient SPL (gray))

The measured vibratory noise statistics for each pile-driving event are presented in Table 4-2 Maximum RMS pressure levels ranged from 131-166 dB RMS. Sound generated by the vibratory pile driving was dominated around 1,000 – 2,000 Hz frequency range near the source. At greater distances, lower frequencies (perhaps environmental and cable strumming noise) were dominant. The vibratory hammer noise at 1,000 m from the construction site was difficult to detect above the noise produced by current and hydrophone motion in the water (self-noise). The complete time series of the SPL for each pile-driving event, the 1/3rd-octave band frequency spectra and power spectral density (PSD) plots are provided in Appendix B.

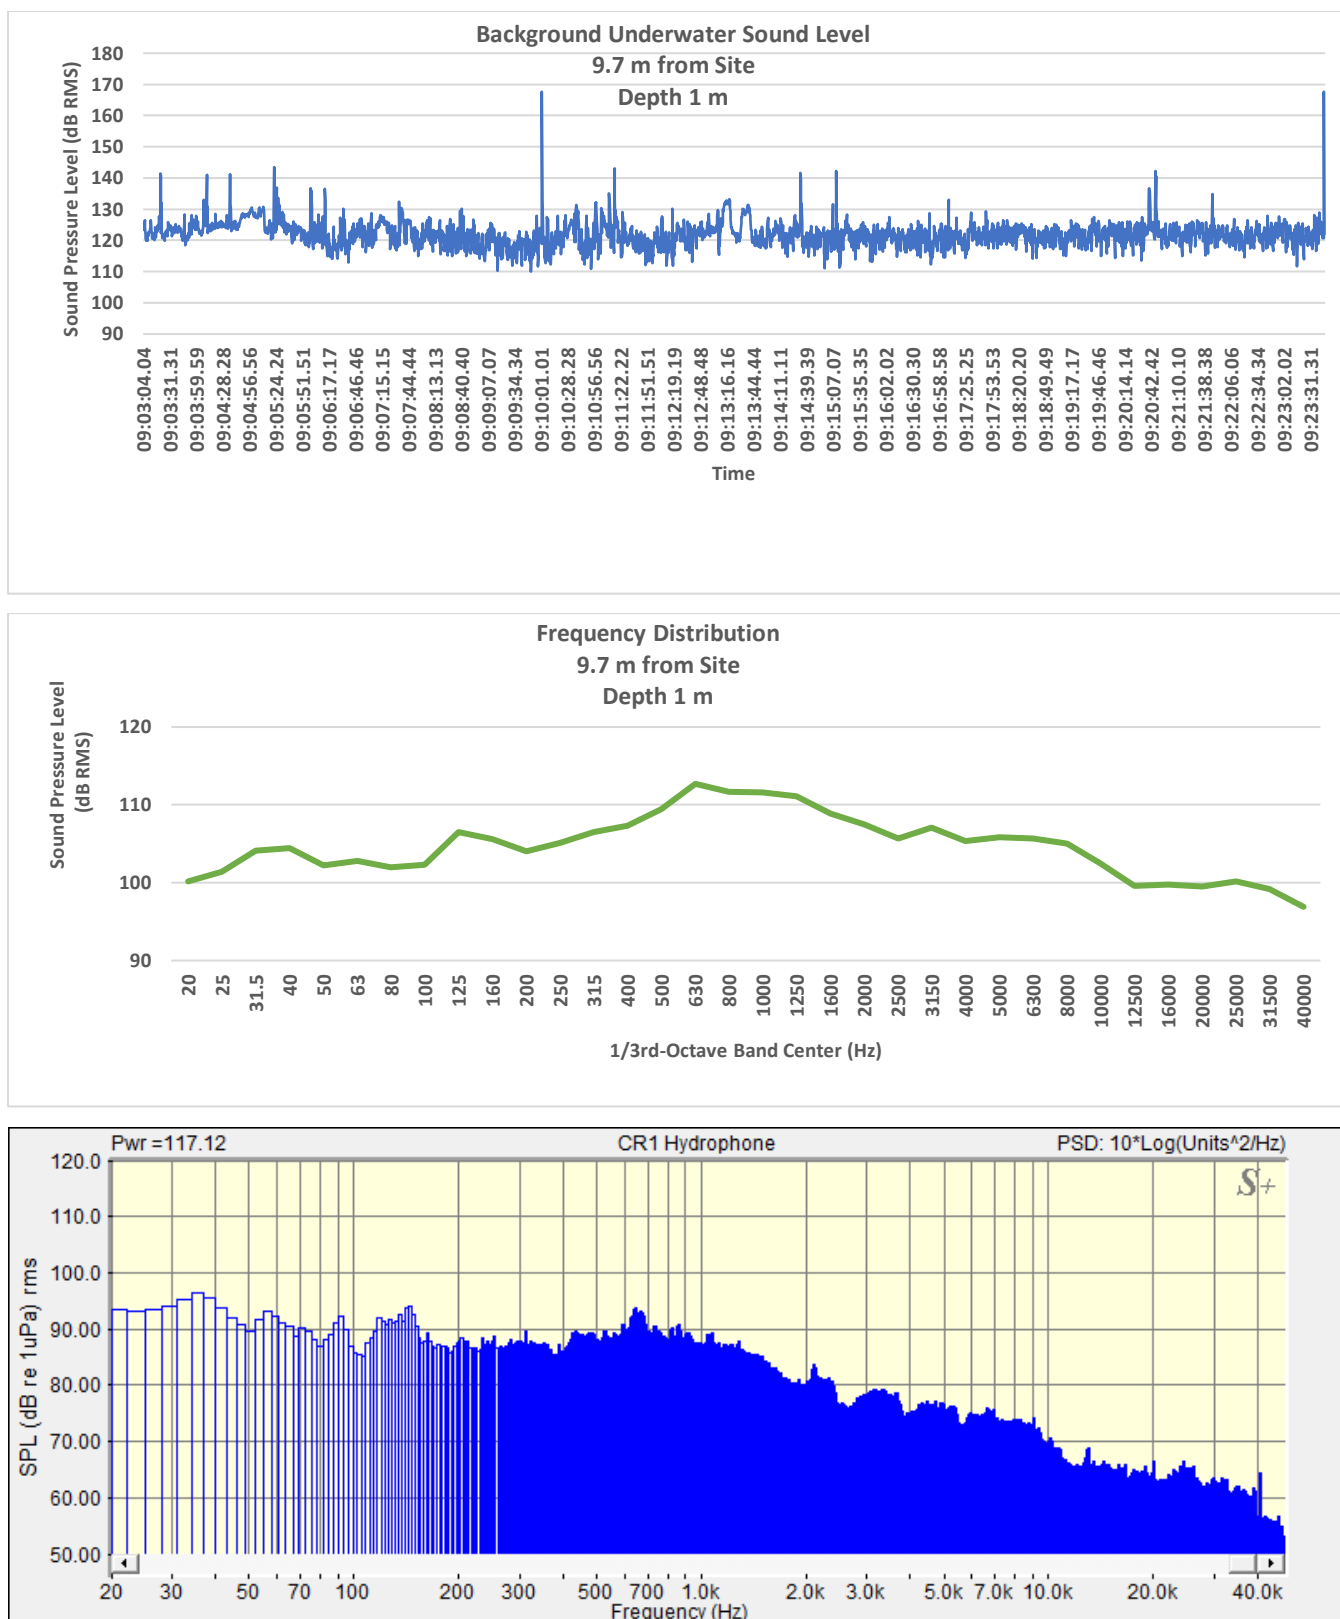
Figure A- 2. Background Sound Pressure Levels, 1/3rd-octave Band Frequency Distribution and PSD plots.
Near the Construction Site. Hydrophone Depth – 1m September 12, 2020

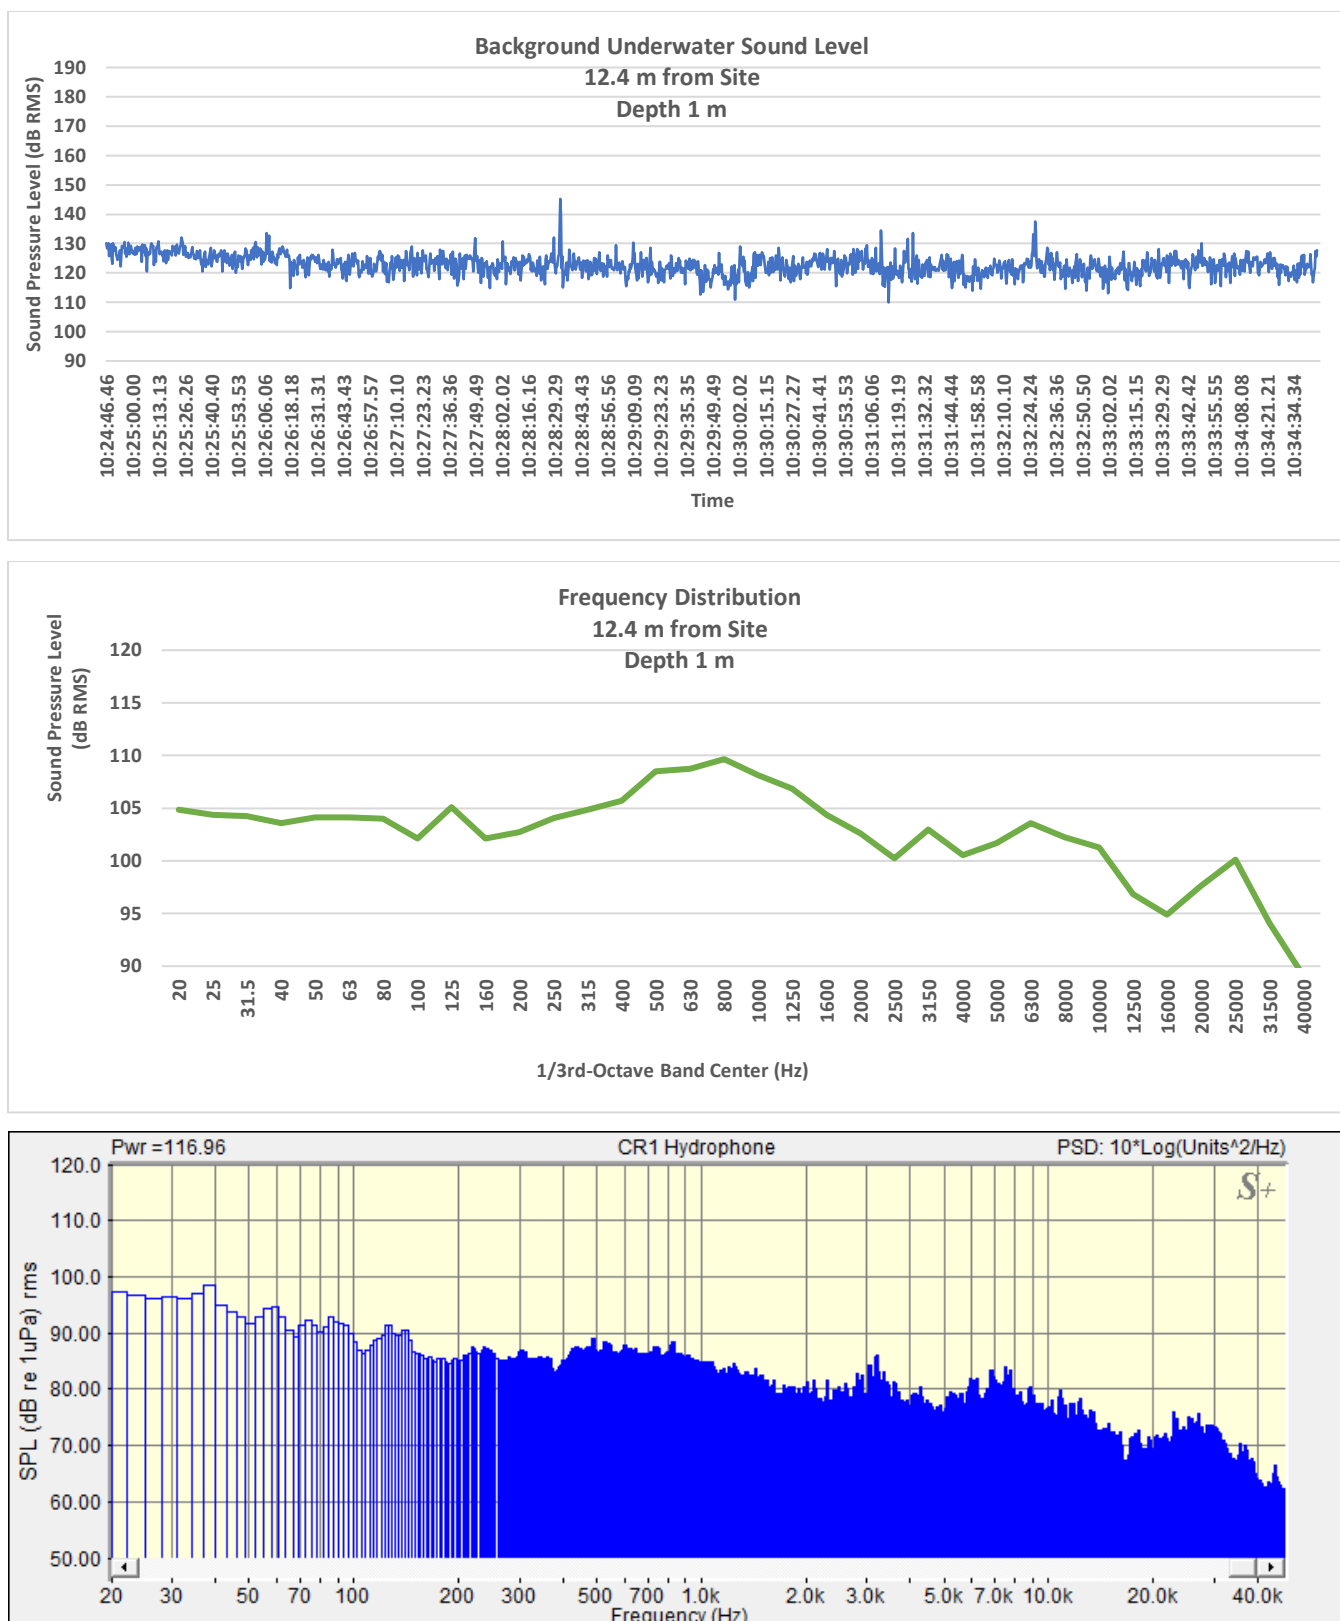
Figure A- 3. Background Sound Pressure Levels, 1/3rd-octave Band Frequency Distribution and PSD plots.
Near the Construction Site. Hydrophone Depth – 1m September 12, 2020

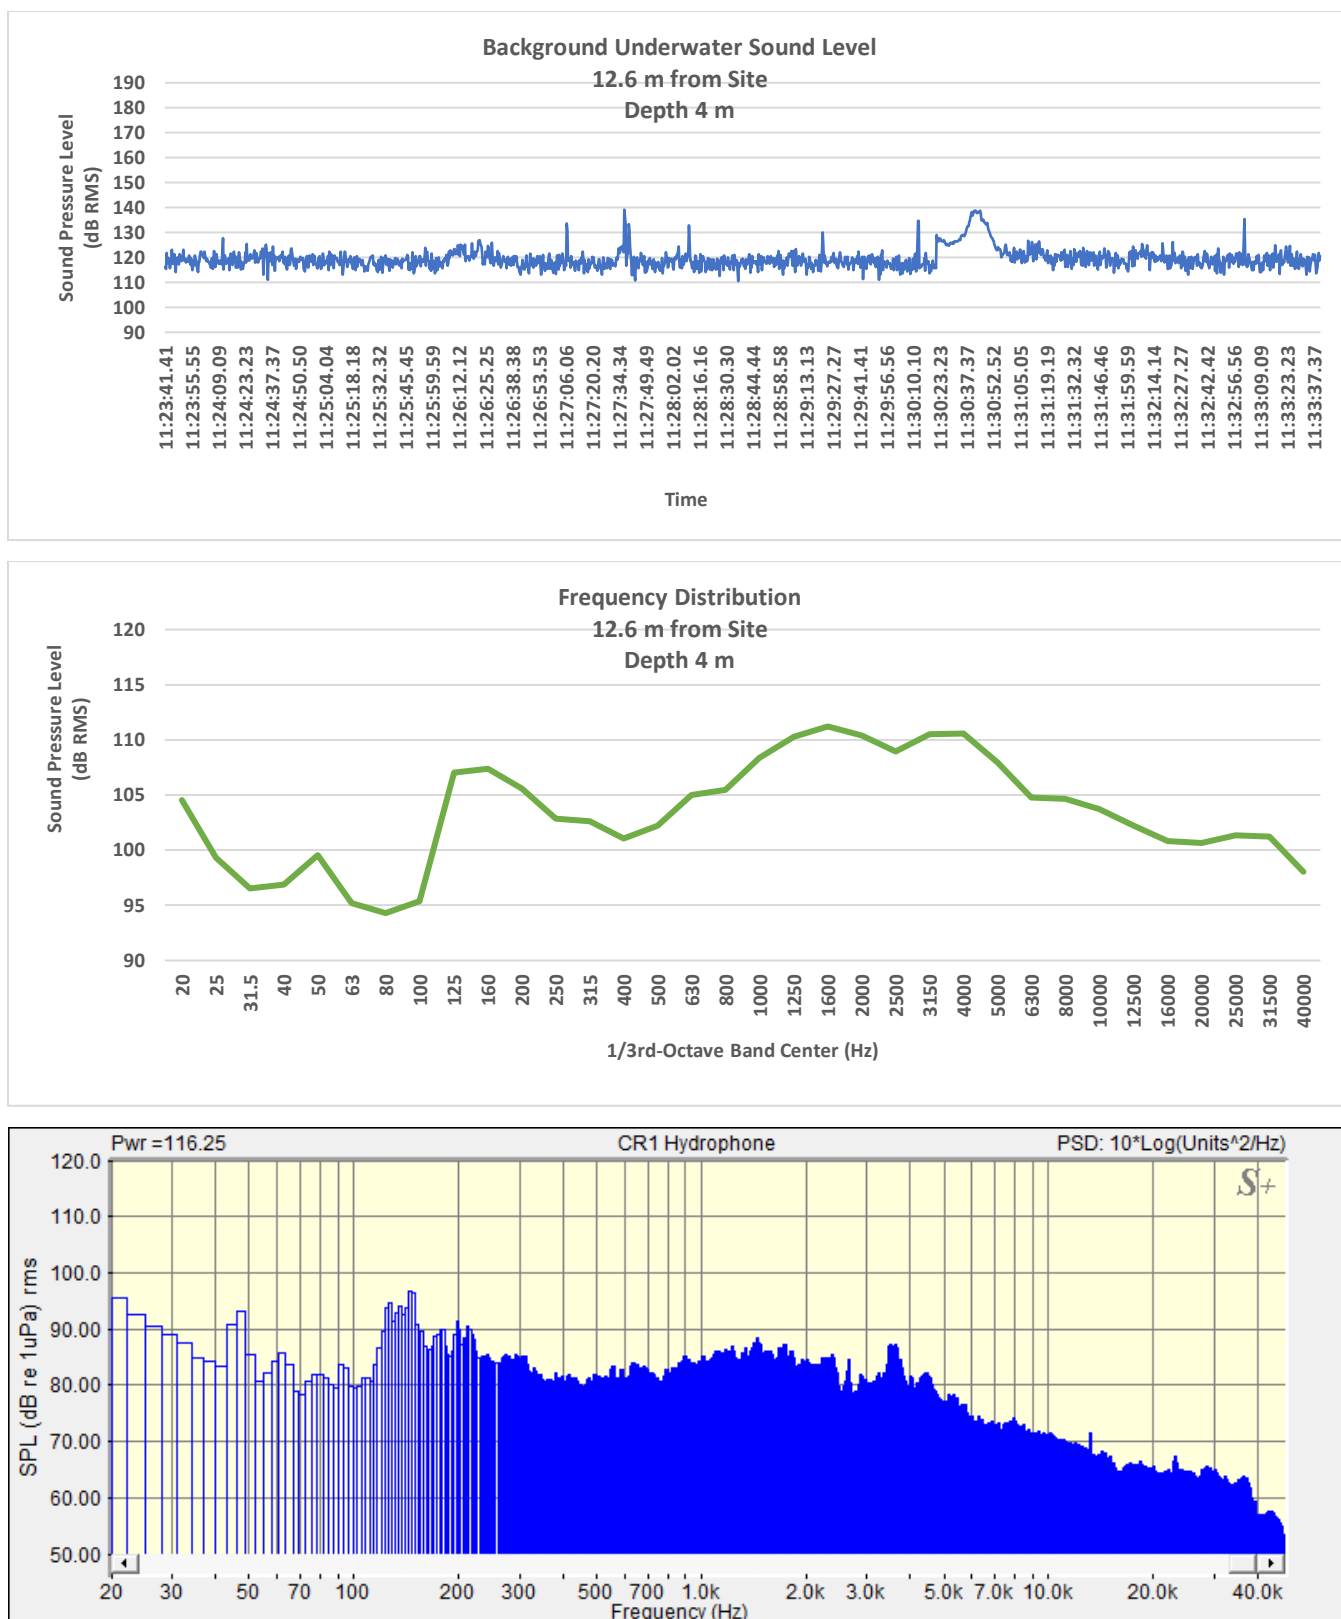
Figure A- 4. Background Sound Pressure Levels, 1/3rd-octave Band Frequency Distribution and PSD plots. Near the Construction Site. Hydrophone Depth – 4m September 12, 2020

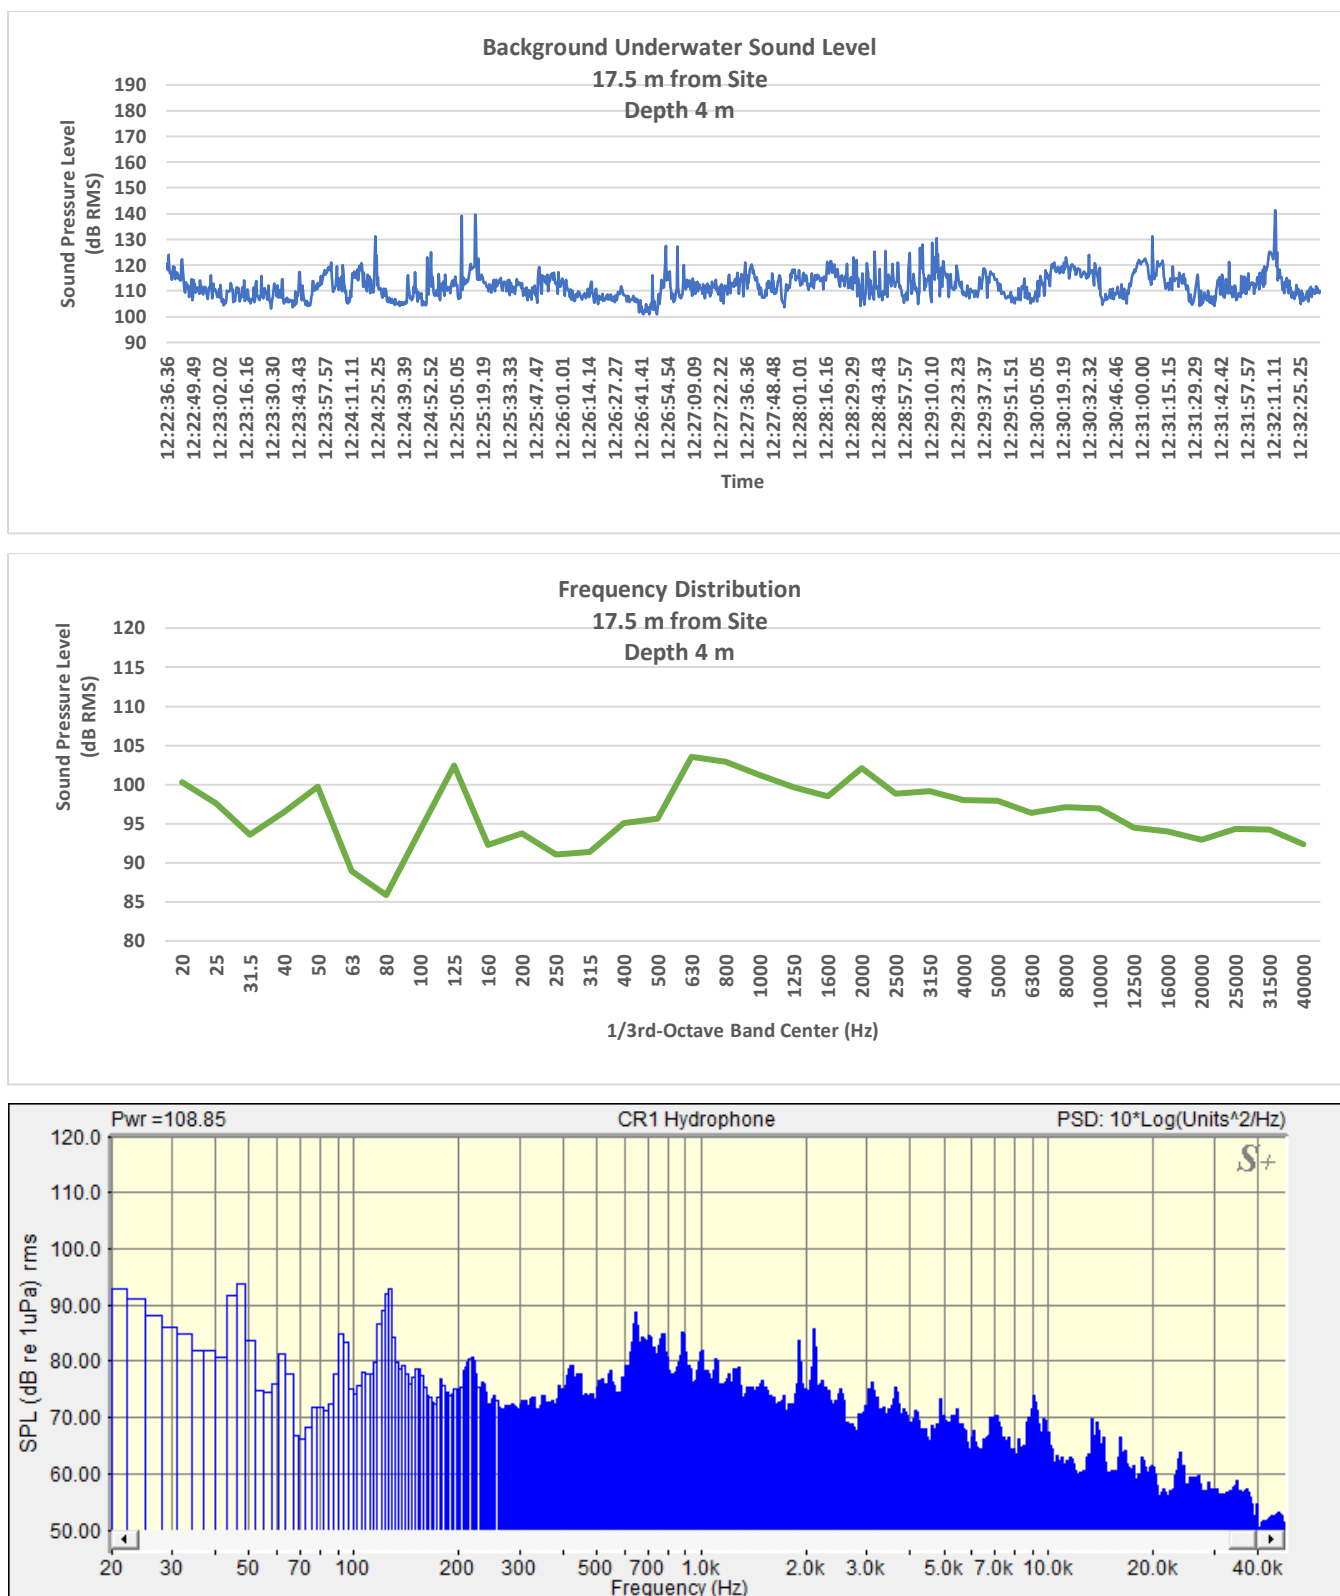
Figure A- 5. Background Sound Pressure Levels, 1/3rd-octave Band Frequency Distribution and PSD plots.
Near the Construction Site. Hydrophone Depth – 4m September 12, 2020

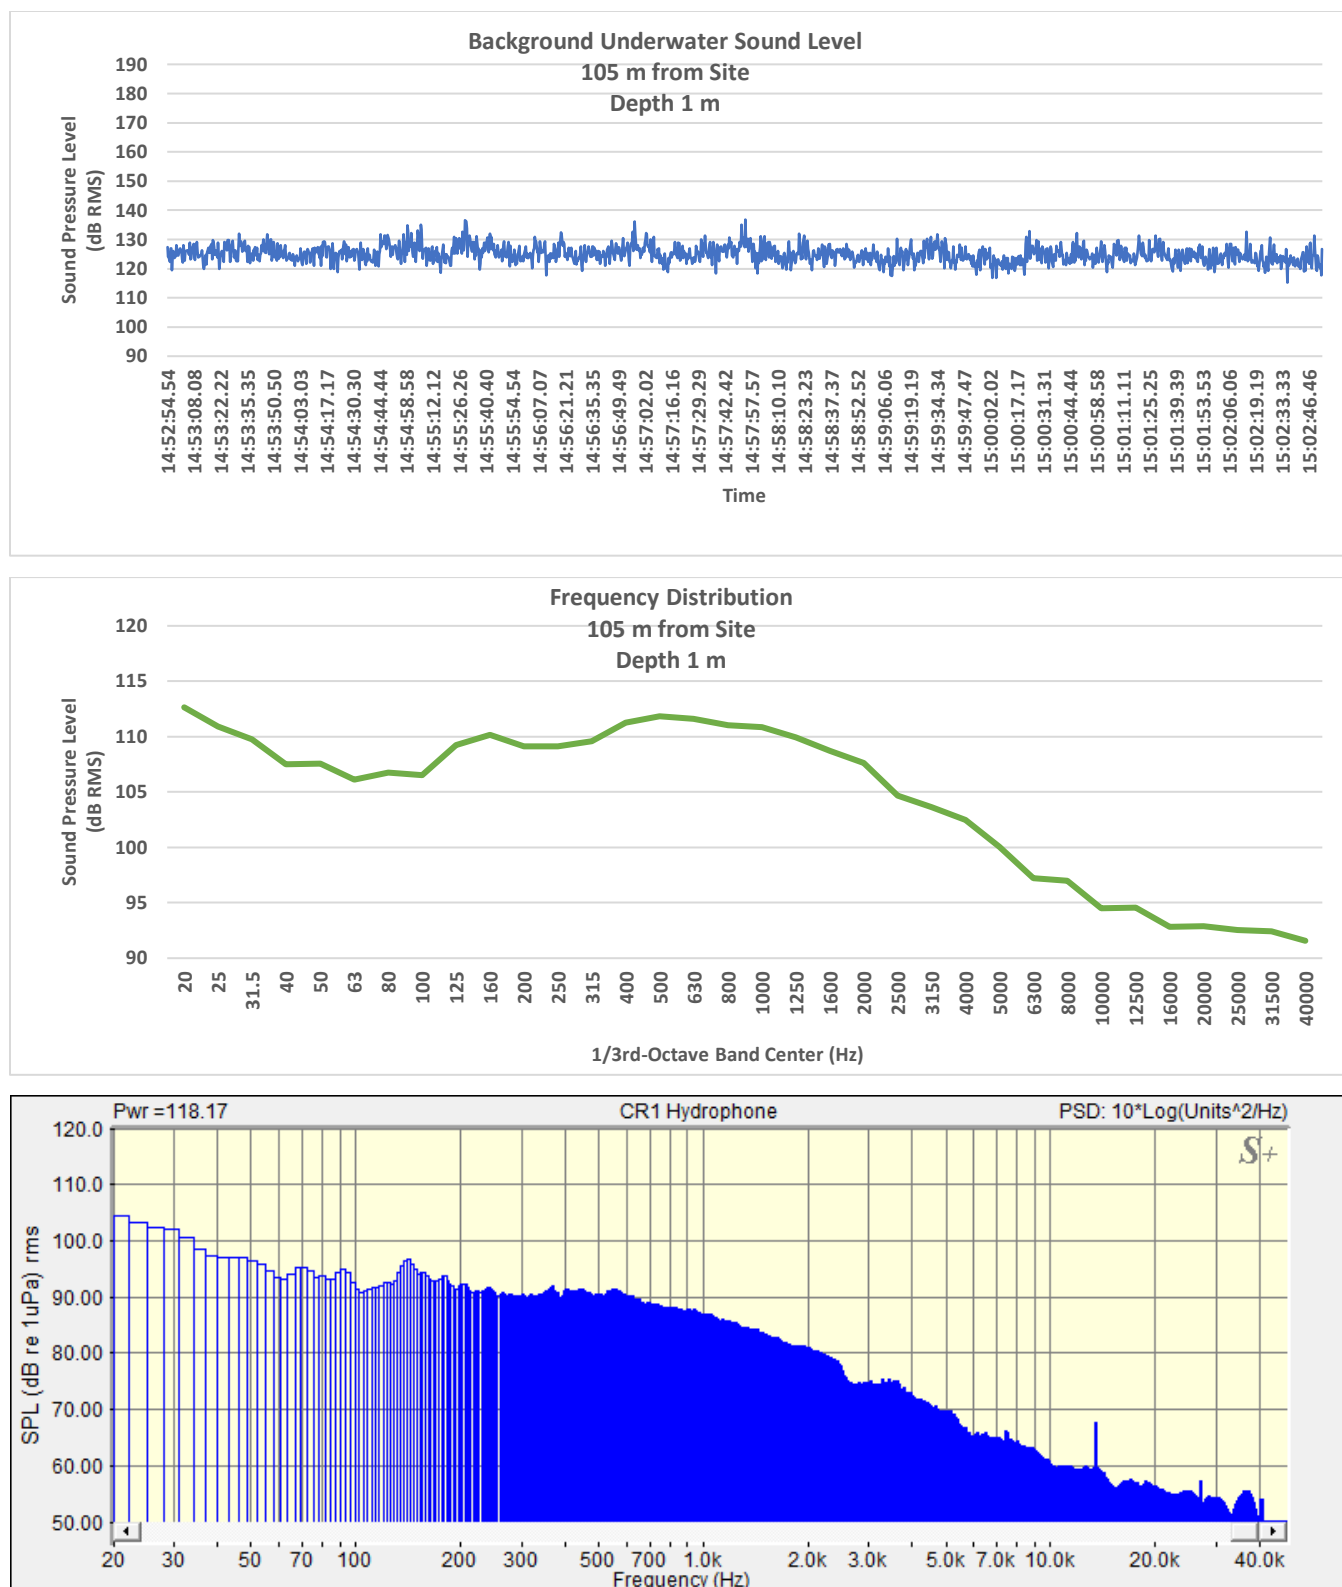
Figure A- 6. Background Sound Pressure Levels, 1/3rd-octave Band Frequency Distribution and PSD plots. 105m from Construction Site. Hydrophone Depth – 1m September 12, 2020

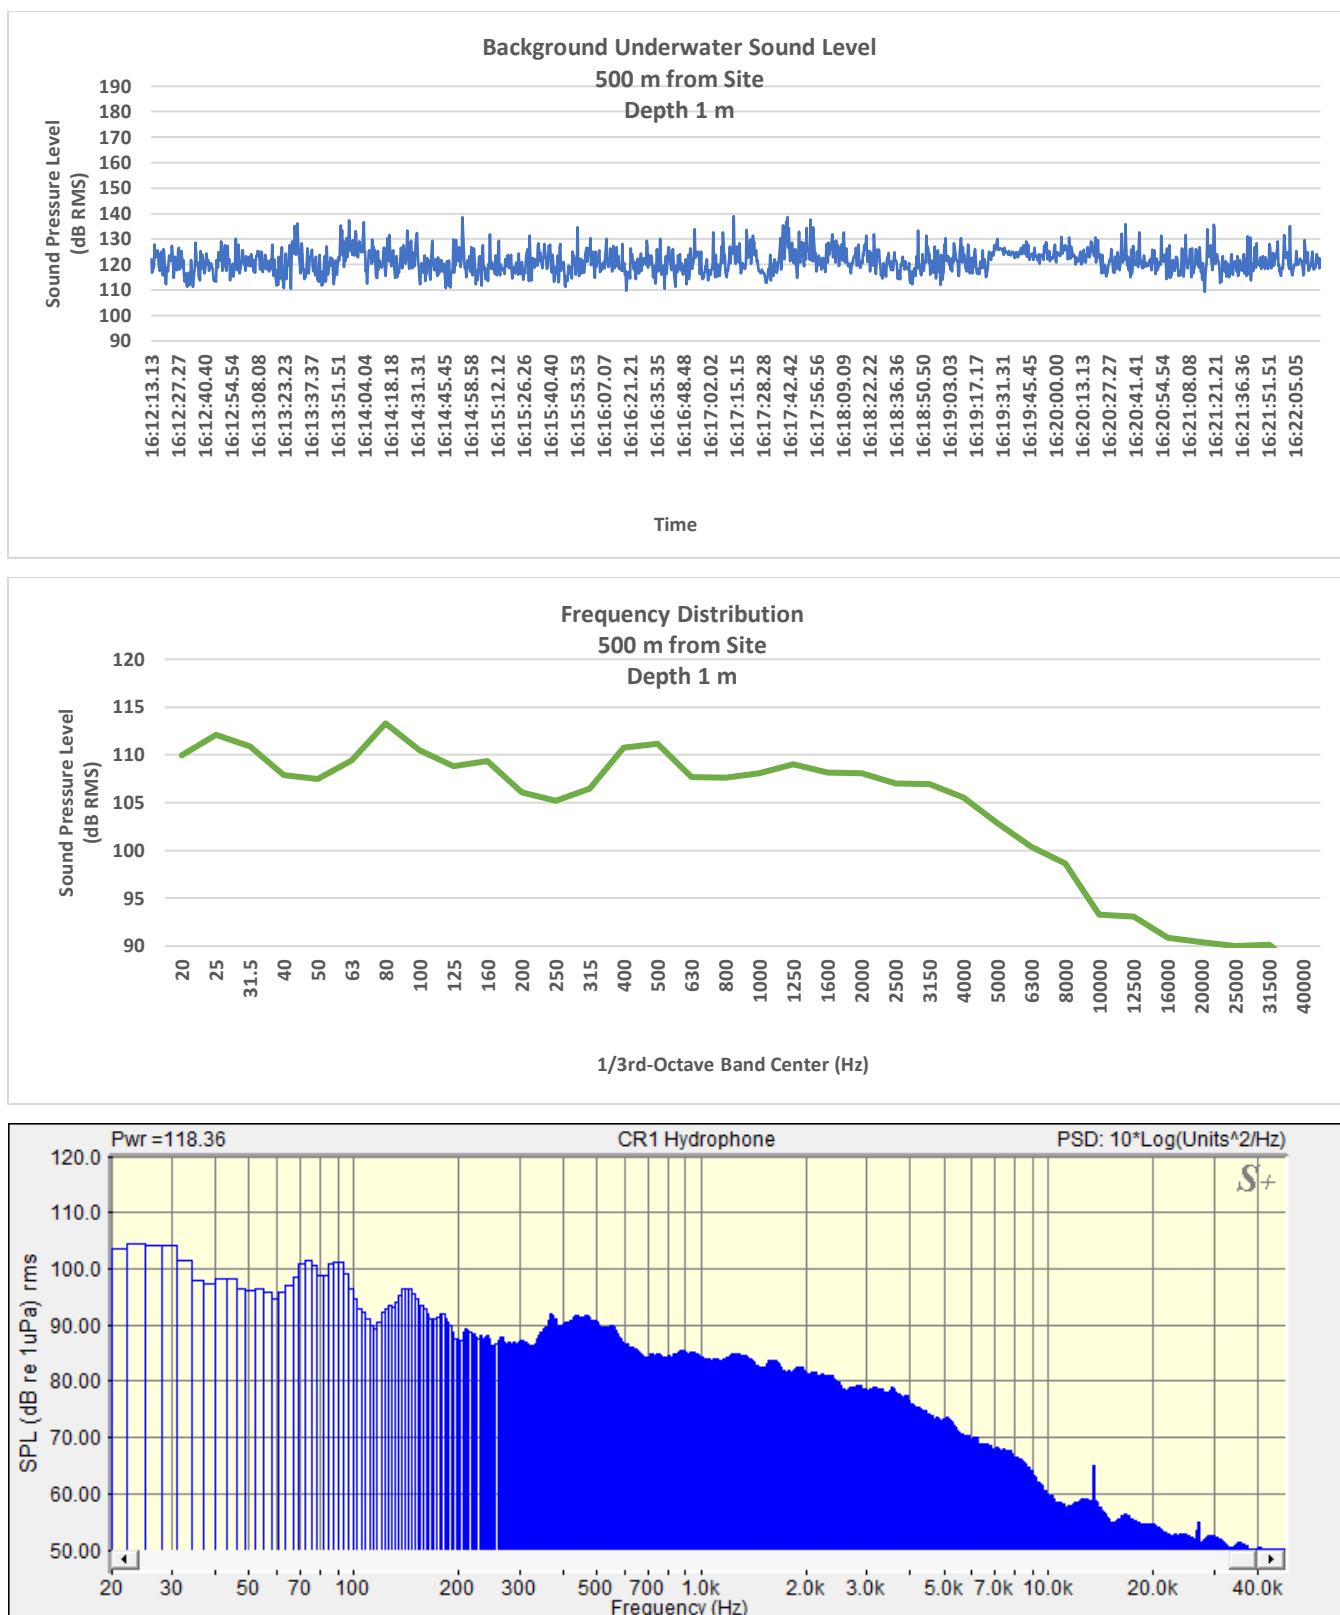
Figure A- 7. Background Sound Pressure Levels, 1/3rd-octave Band Frequency Distribution and PSD plots. 500m from Construction Site. Hydrophone Depth – 1m September 12, 2020

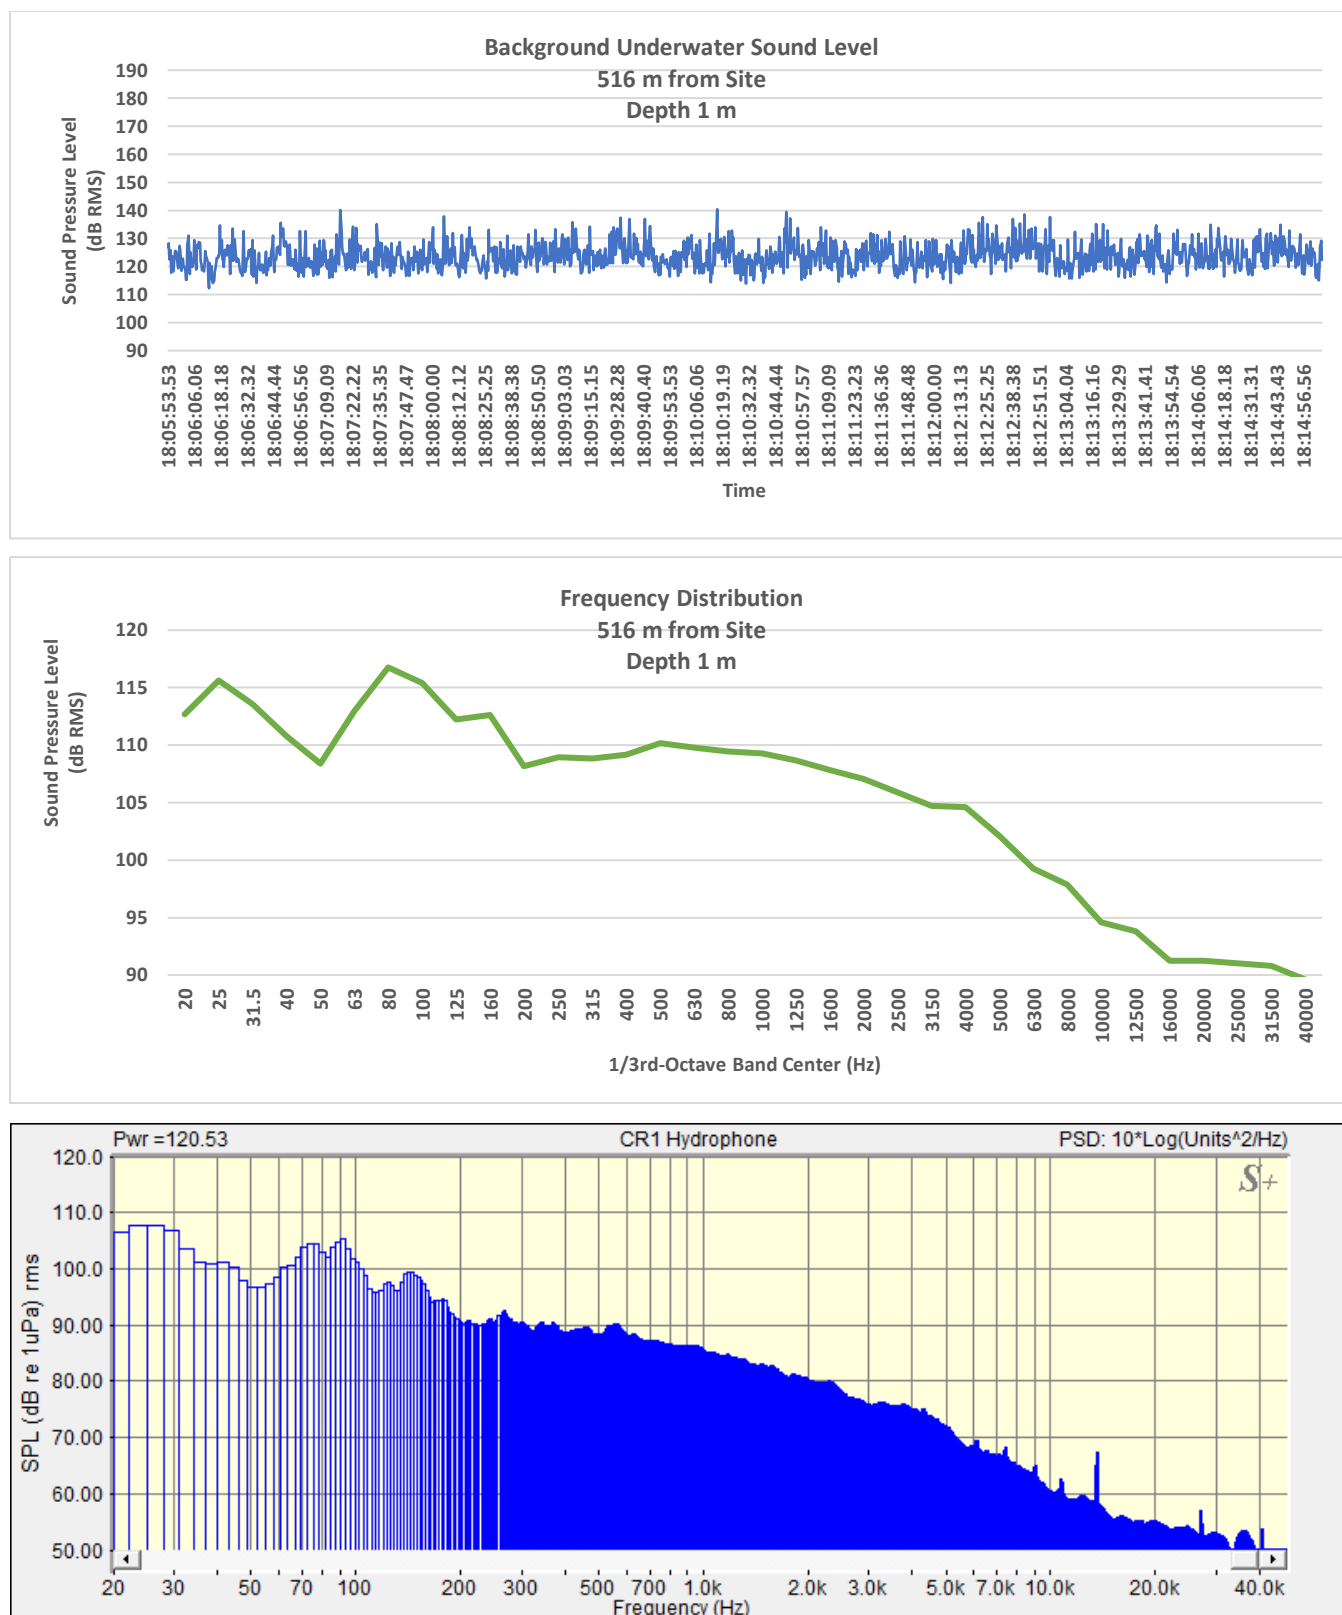
Figure A- 8. Background Sound Pressure Levels, 1/3rd-octave Band Frequency Distribution and PSD plots. 516m from Construction Site. Hydrophone Depth – 1m September 12, 2020
