CROWLEY KOTZEBUE DOCK REPLACEMENT PROJECT

HYDROACOUSTIC MONITORING REPORT, REV. 1

July 2021

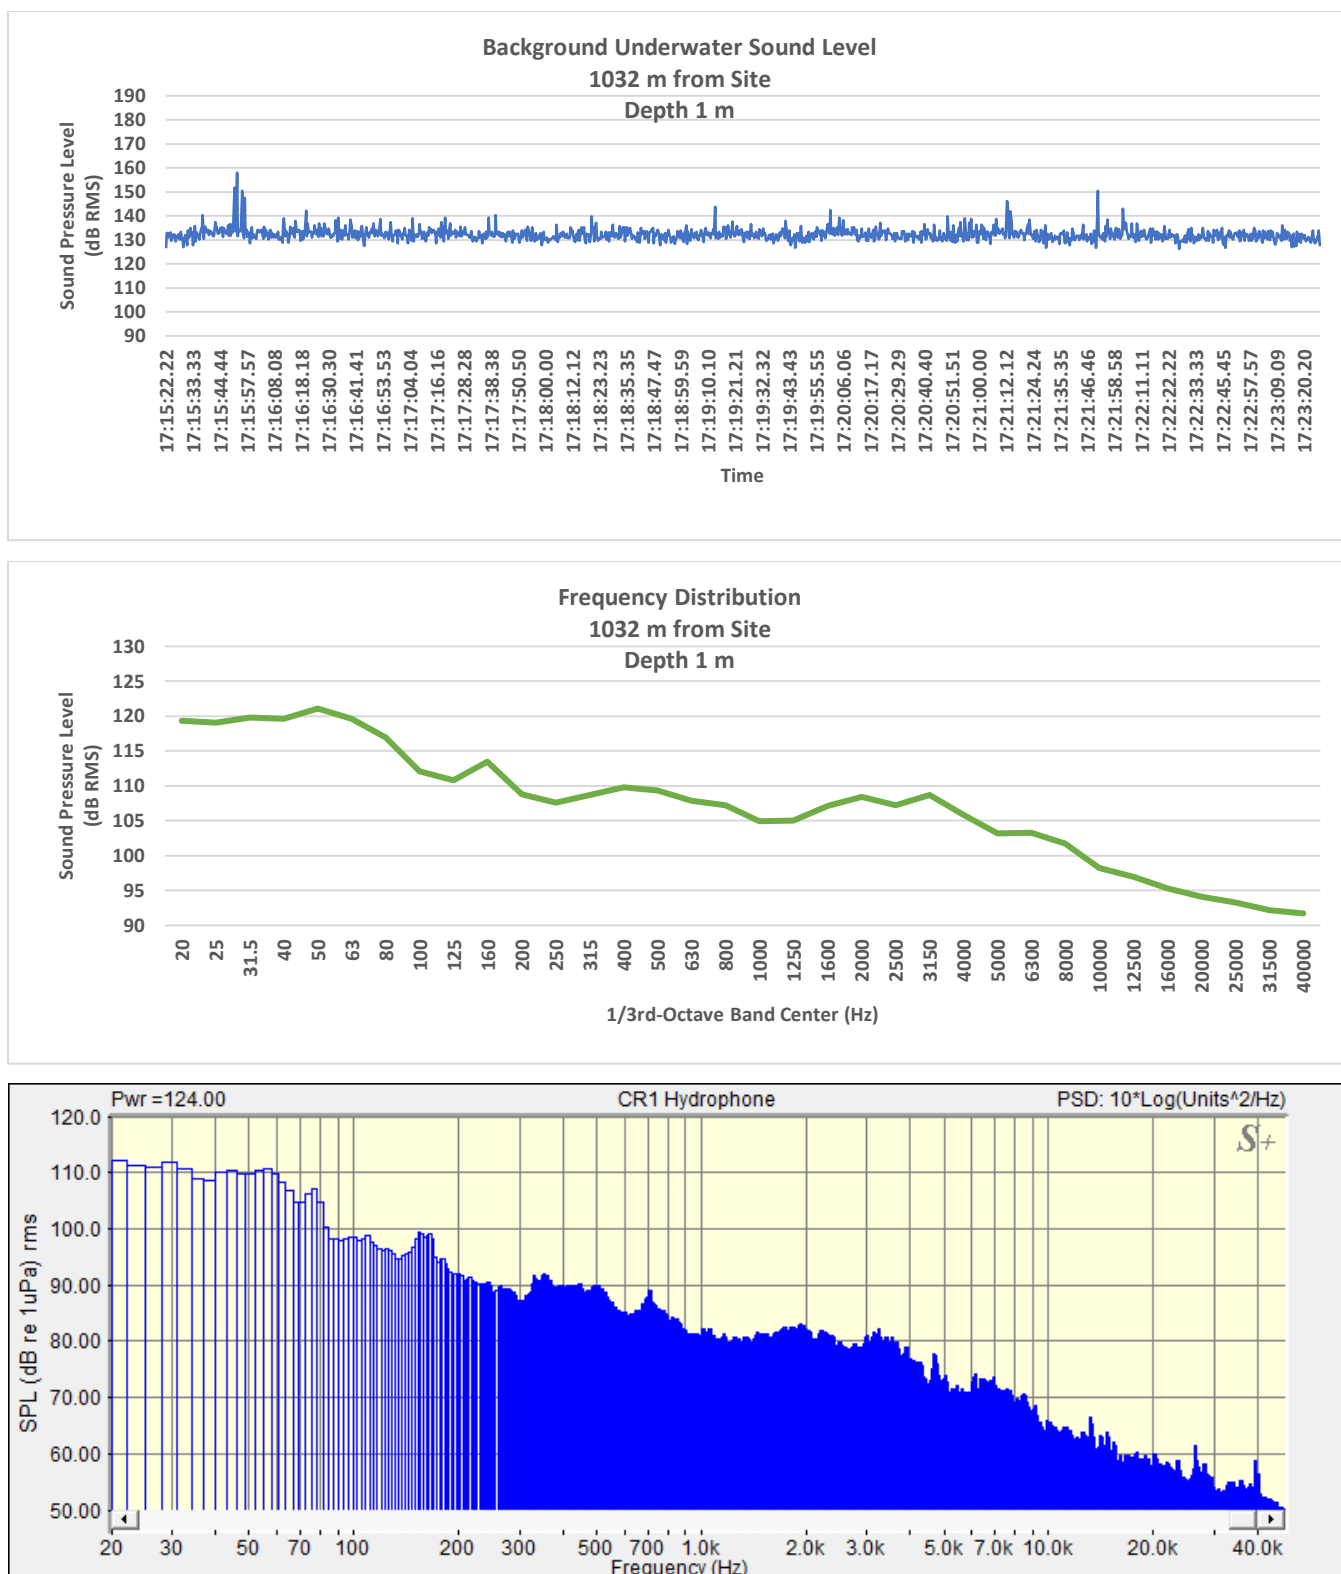
Figure A- 9. Background Sound Pressure Levels, 1/3rd-octave Band Frequency Distribution and PSD plots. 1032m from Construction Site. Hydrophone Depth – 1m September 14, 2020

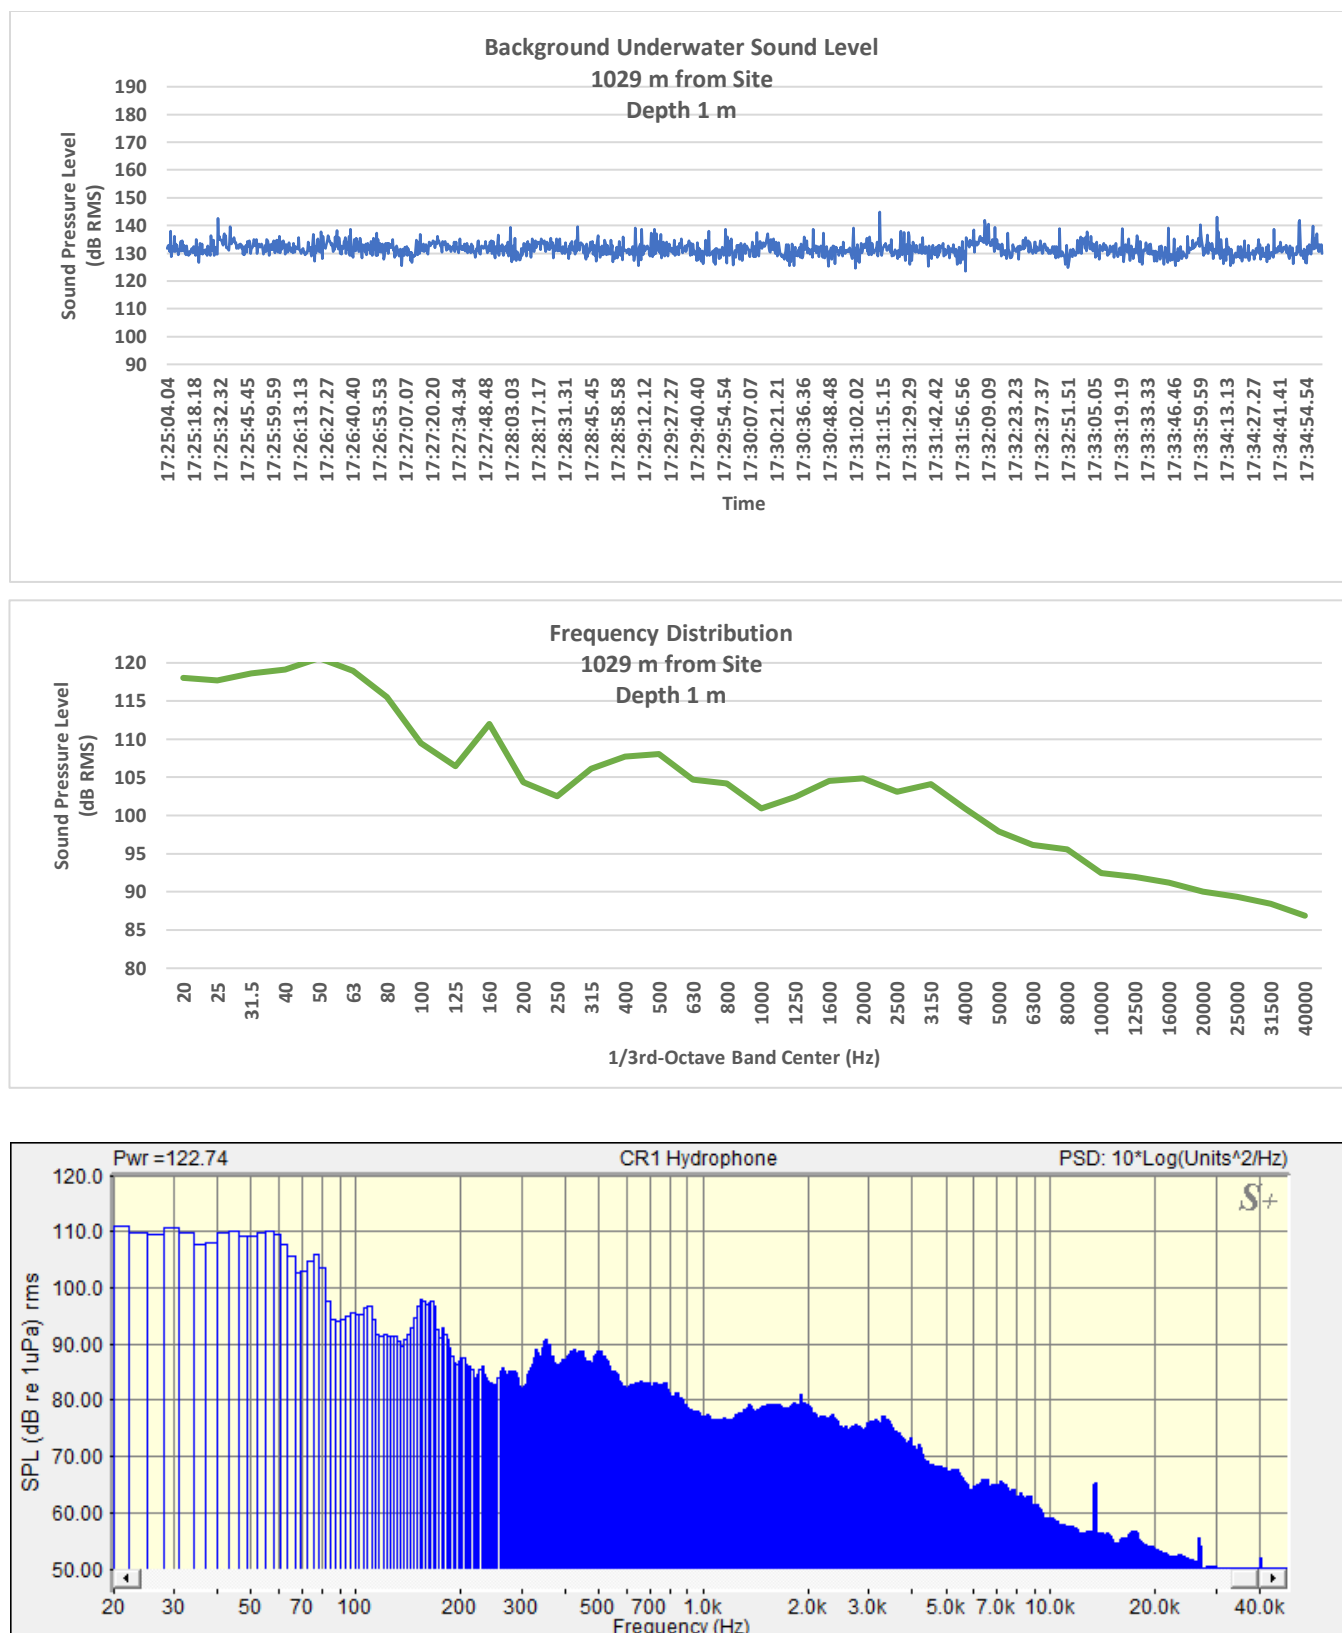
Figure A- 10. Background Sound Pressure Levels, 1/3rd-octave Band Frequency Distribution and PSD plots. 1029m from Construction Site. Hydrophone Depth – 1m September 14, 2020

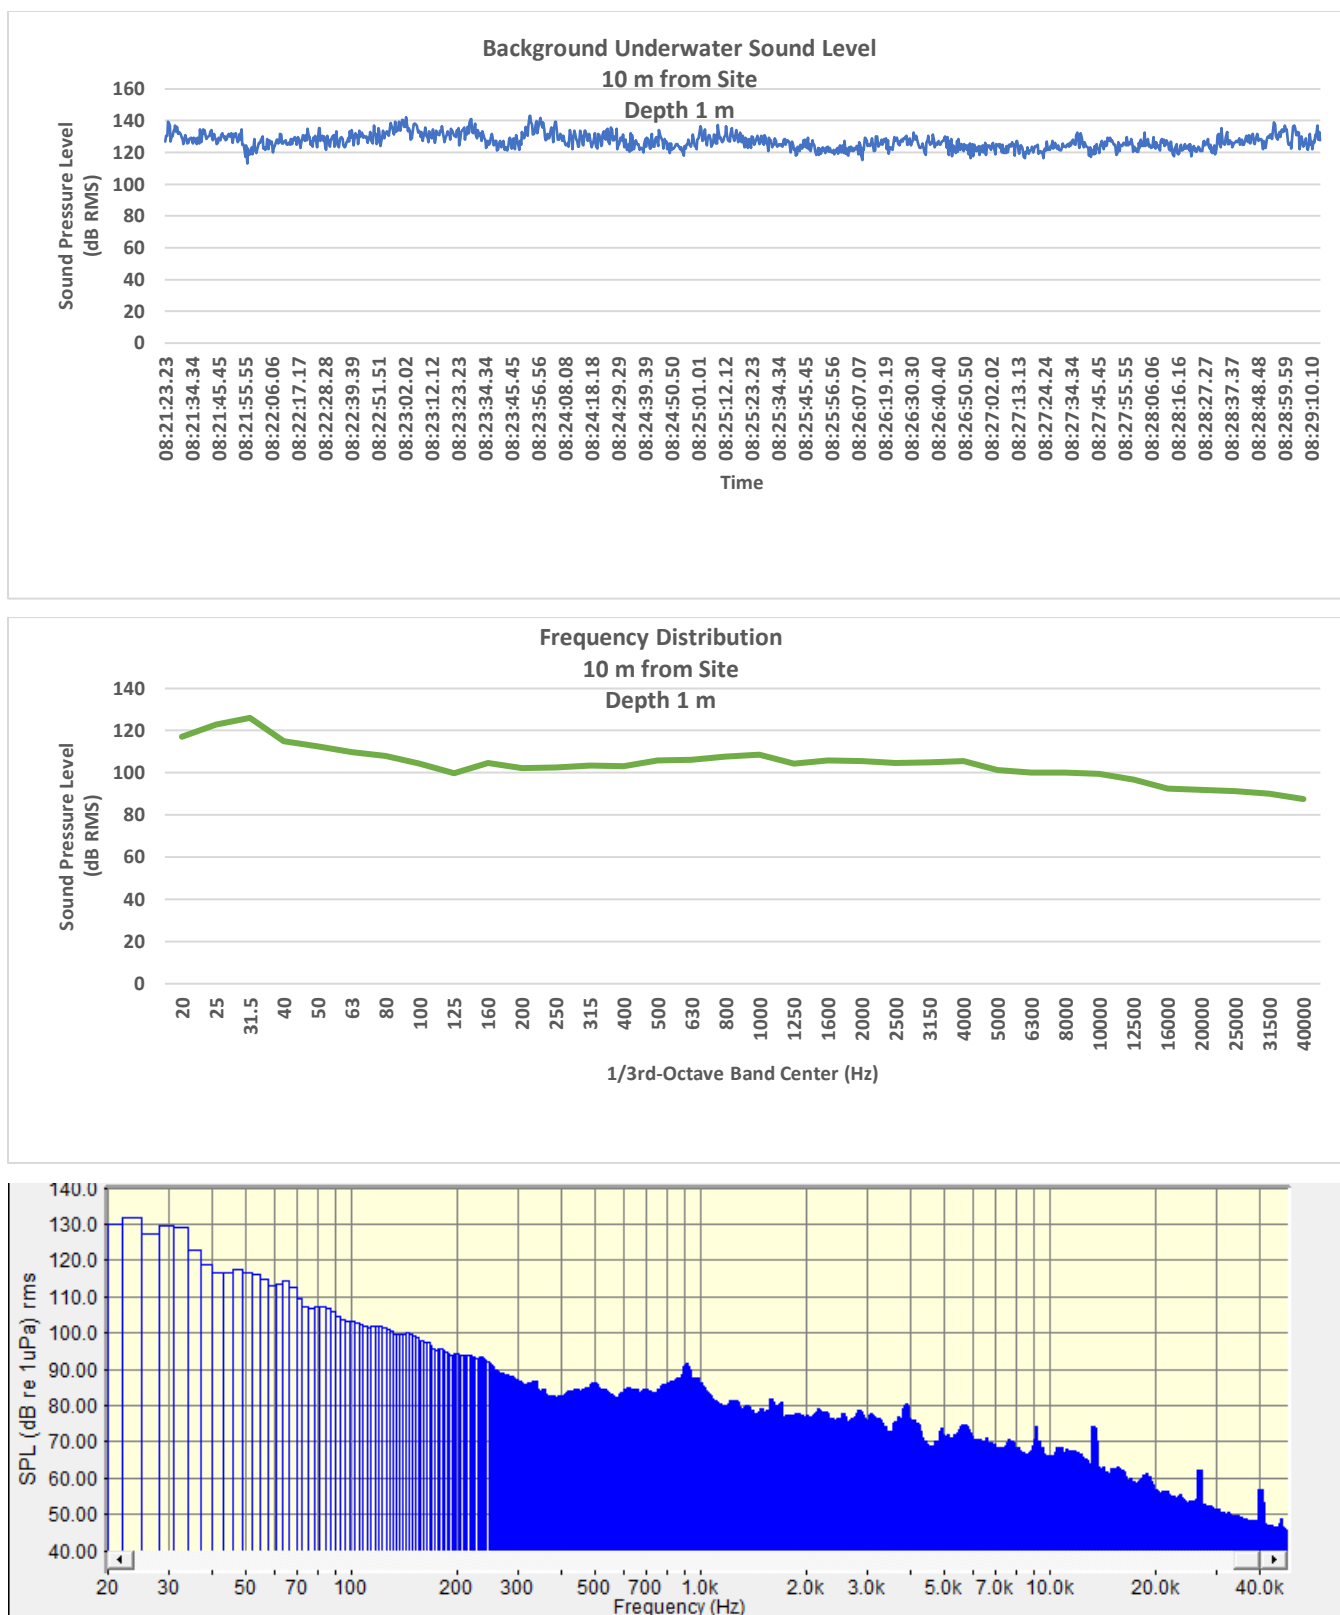
Figure A- 11. Background Sound Pressure Levels, 1/3rd-octave Band Frequency Distribution and PSD plots.
10m from Construction Site. Hydrophone Depth – 1m September 15, 2020

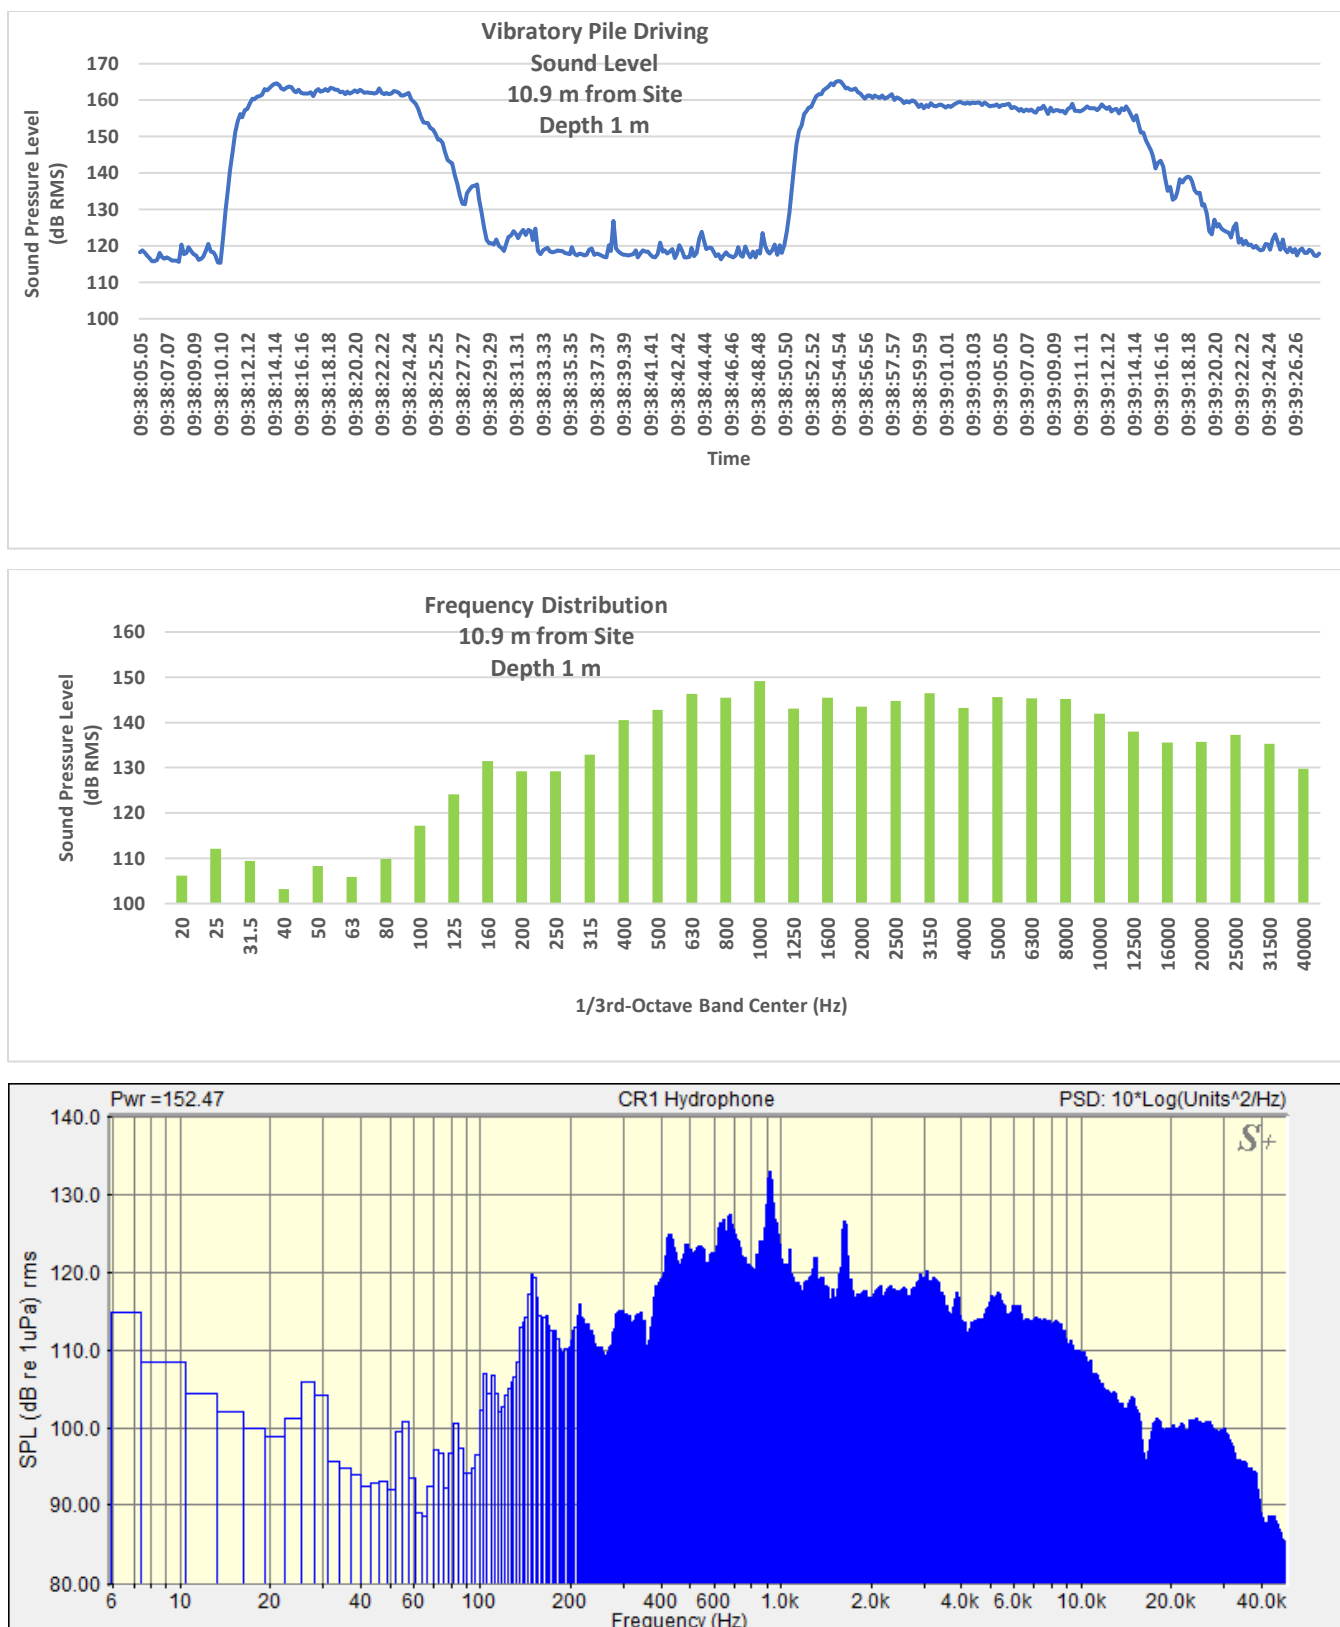
Figure B - 12. Vibratory Pile Driving Pressure Levels, 1/3rd-octave Band Frequency Distribution and PSD plots. Near the Construction Site. Hydrophone Depth – 1m. September 12, 2020

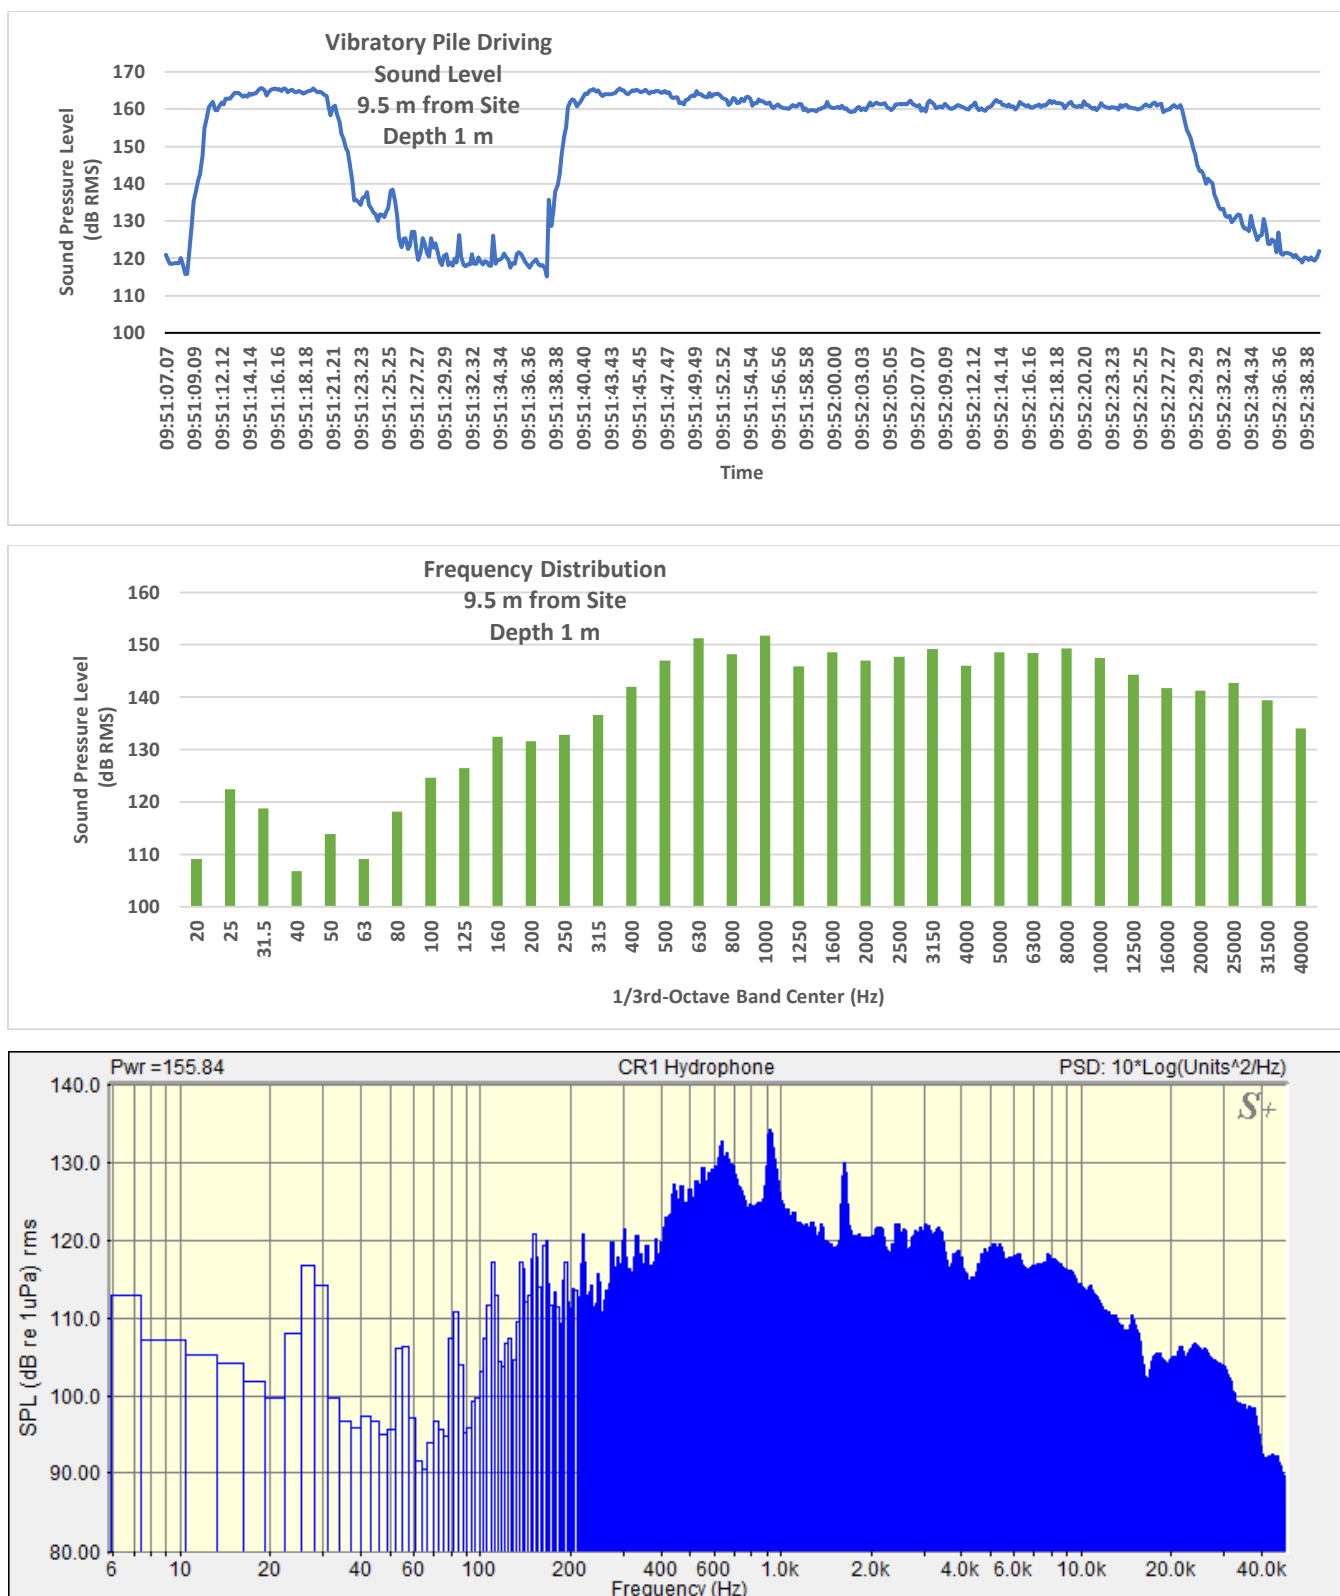
Figure B - 13. Vibratory Pile Driving Pressure Levels, 1/3rd-octave Band Frequency Distribution and PSD plots. Near the Construction Site. Hydrophone Depth – 1m. September 12, 2020

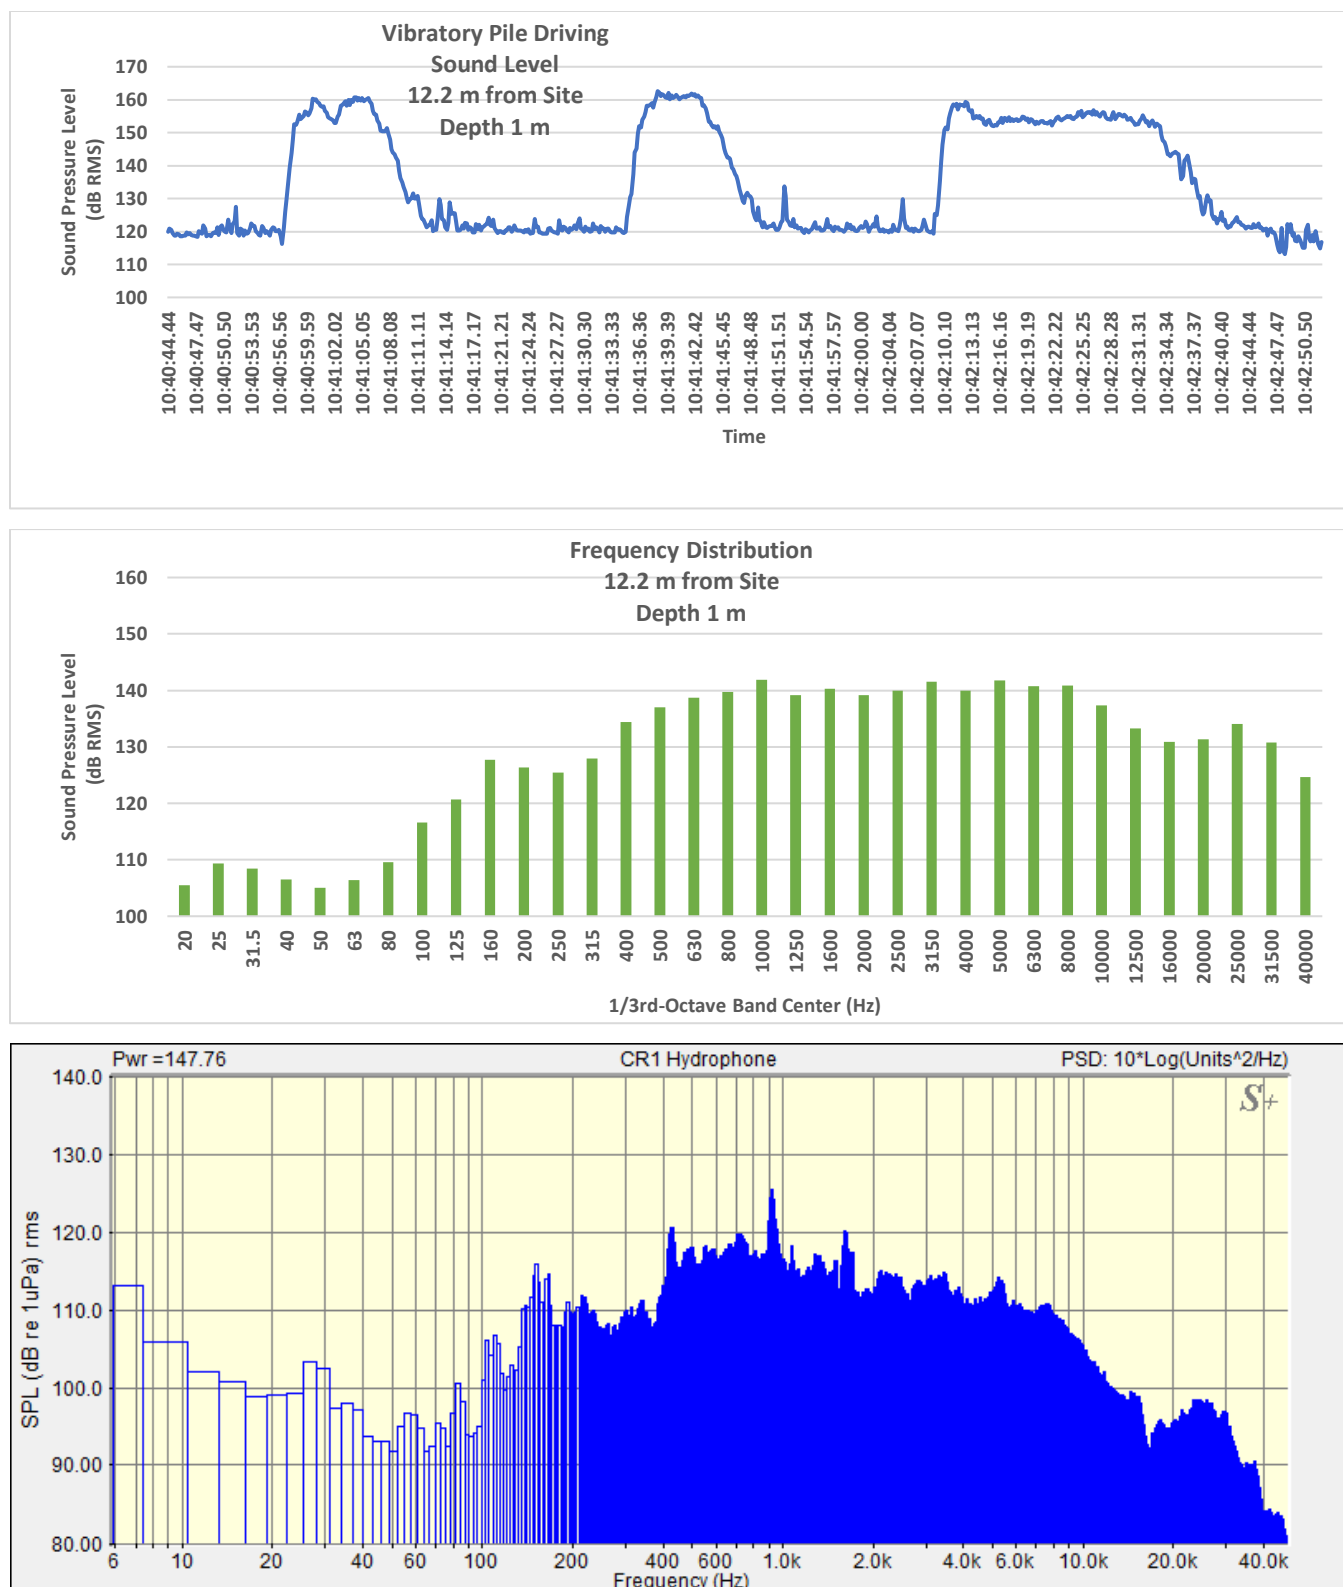
Figure B - 14. Vibratory Pile Driving Pressure Levels, 1/3rd-octave Band Frequency Distribution and PSD plots. Near the Construction Site. Hydrophone Depth – 1m. September 12, 2020

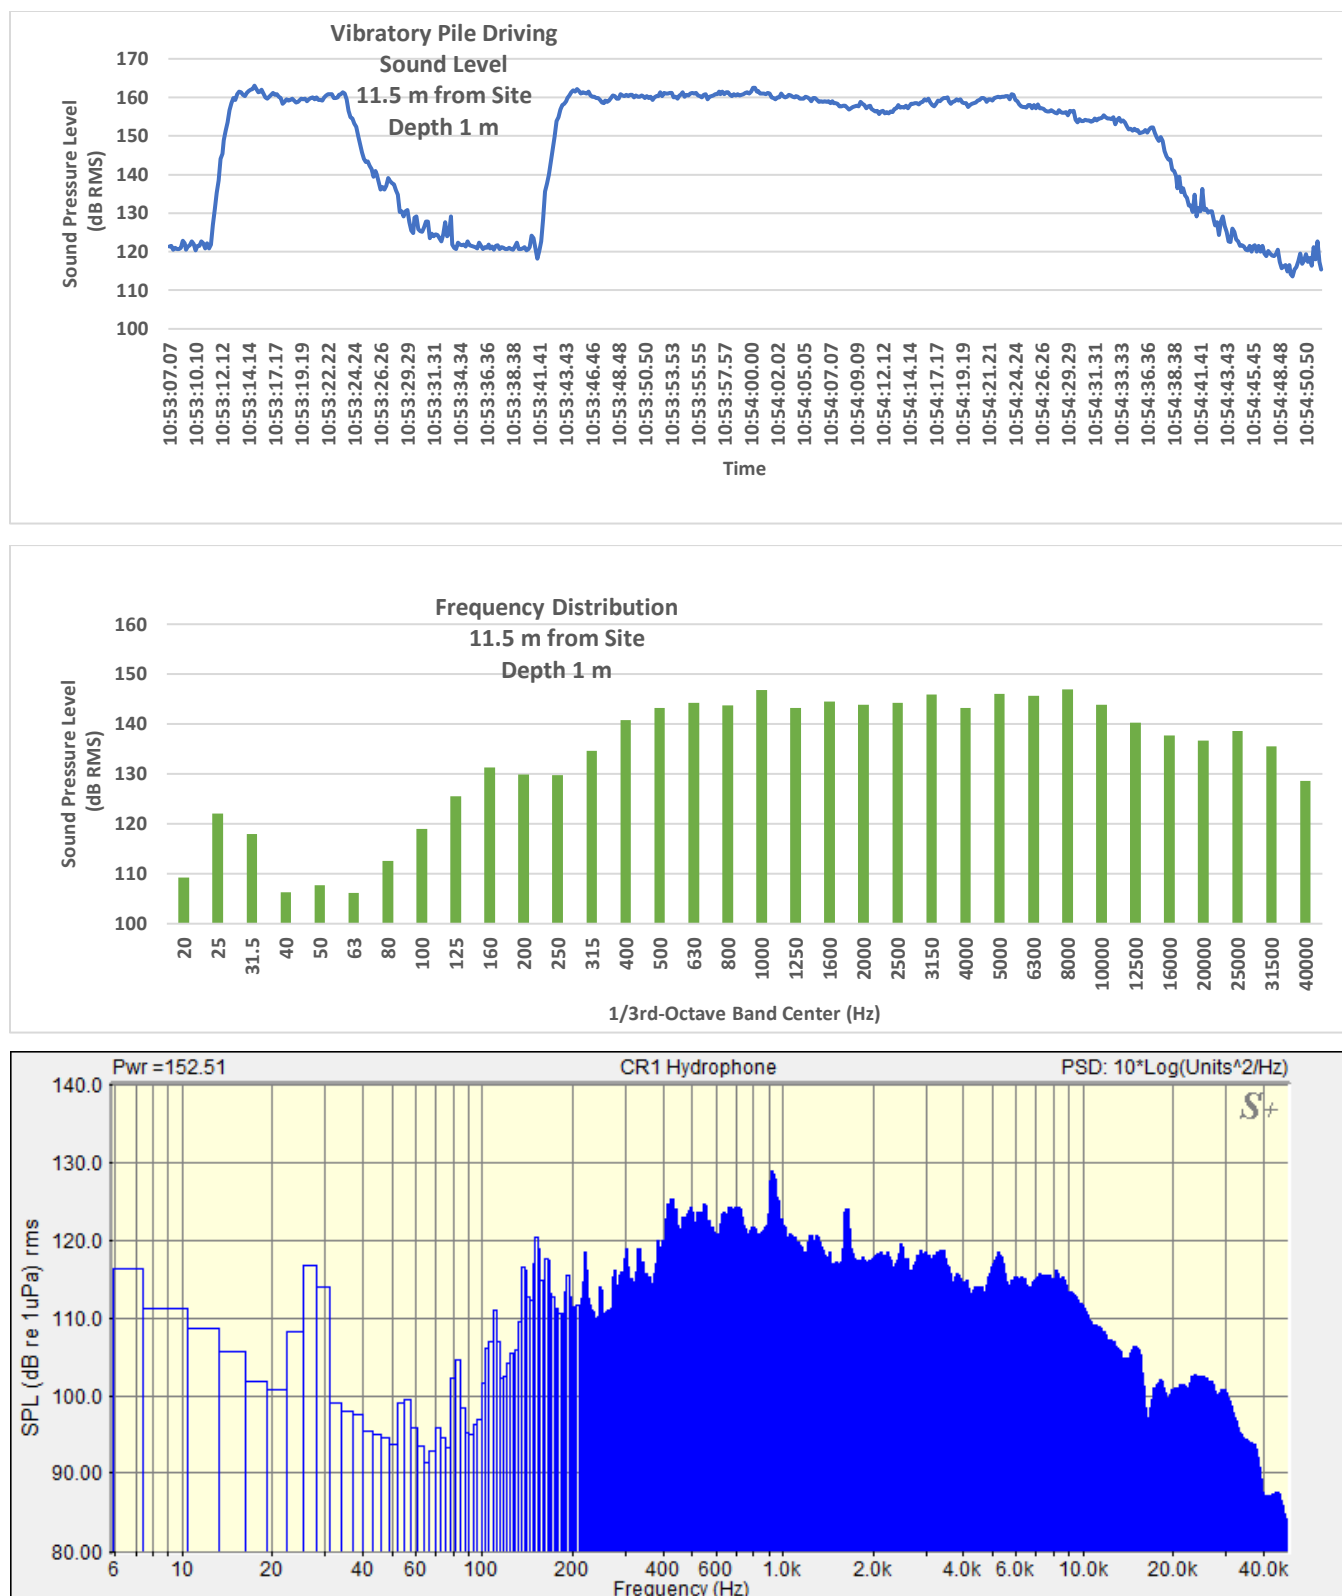
Figure B - 15. Vibratory Pile Driving Pressure Levels, 1/3rd-octave Band Frequency Distribution and PSD plots. Near the Construction Site. Hydrophone Depth – 1m. September 12, 2020

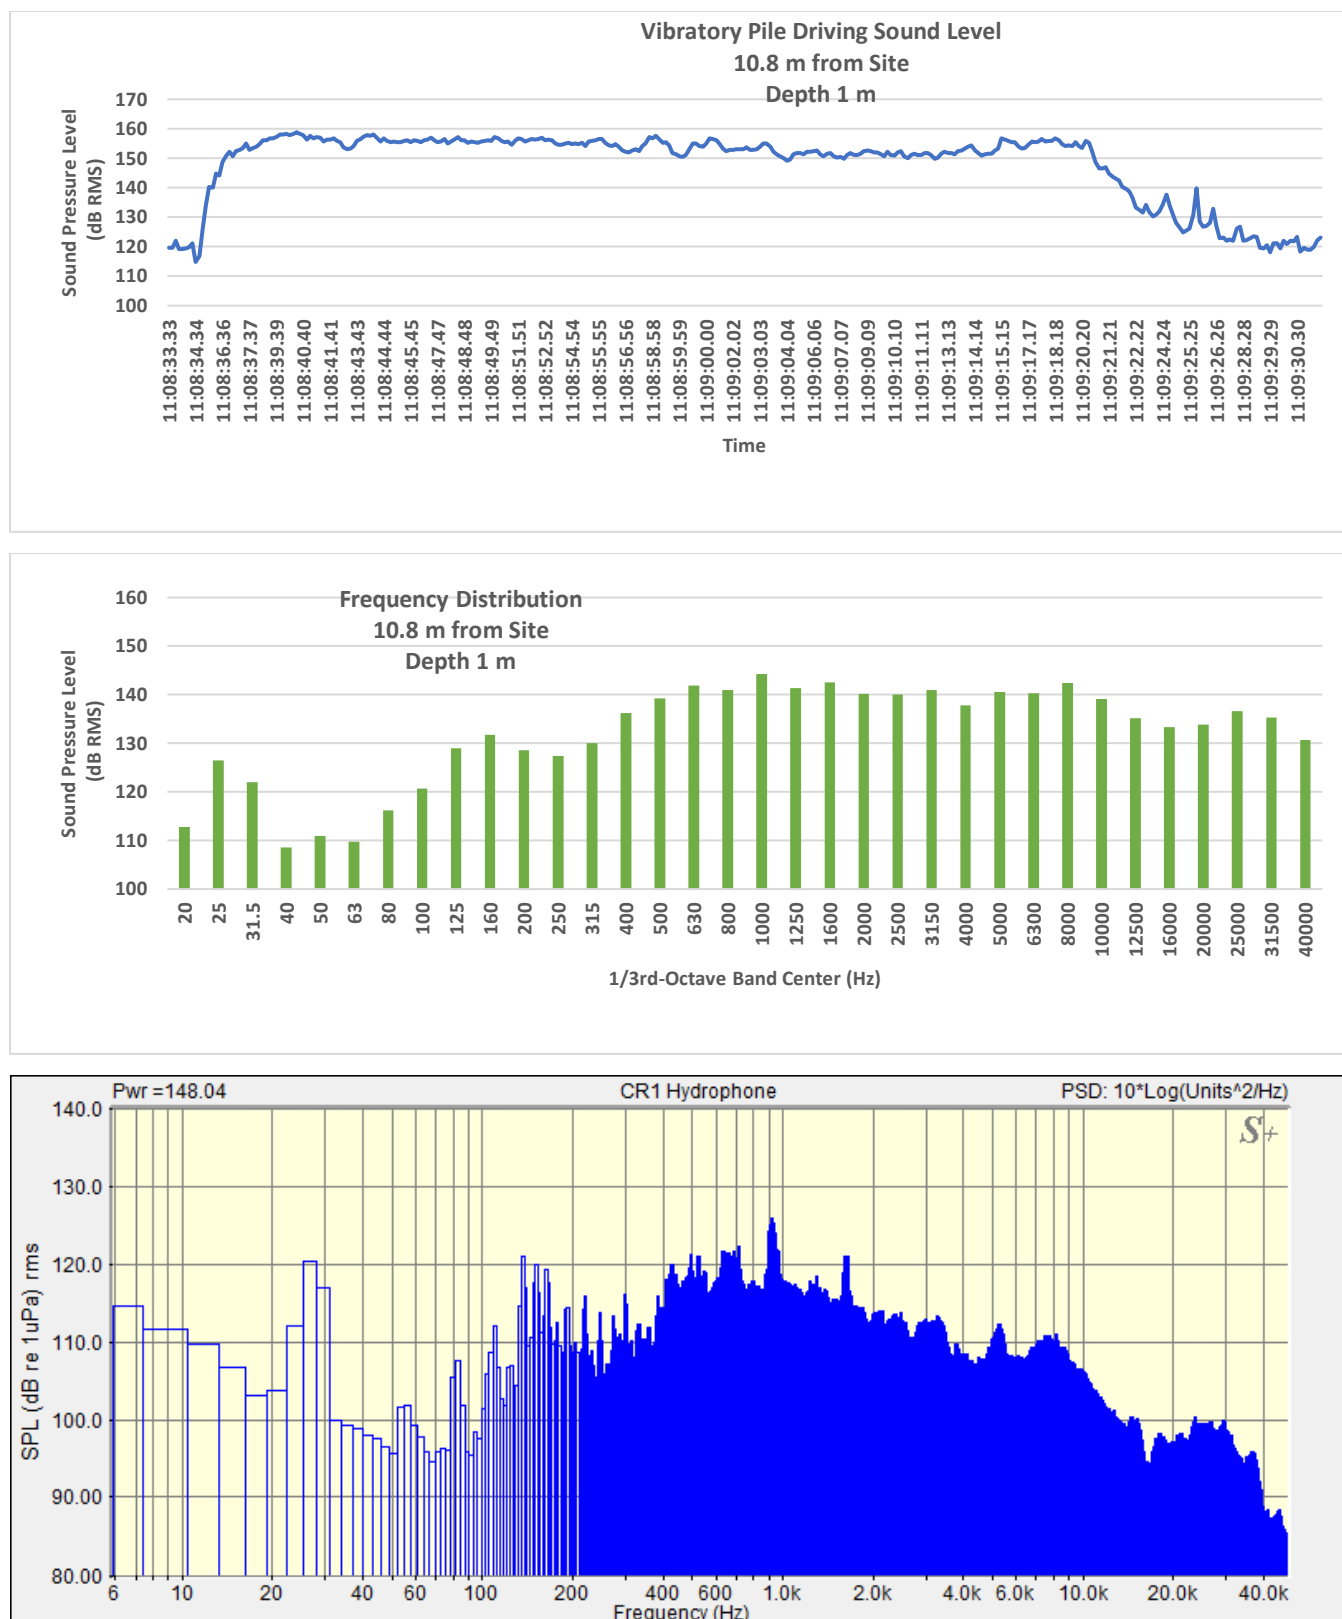
Figure B - 16. Vibratory Pile Driving Pressure Levels, 1/3rd-octave Band Frequency Distribution and PSD plots. Near the Construction Site. Hydrophone Depth – 1m. September 12, 2020

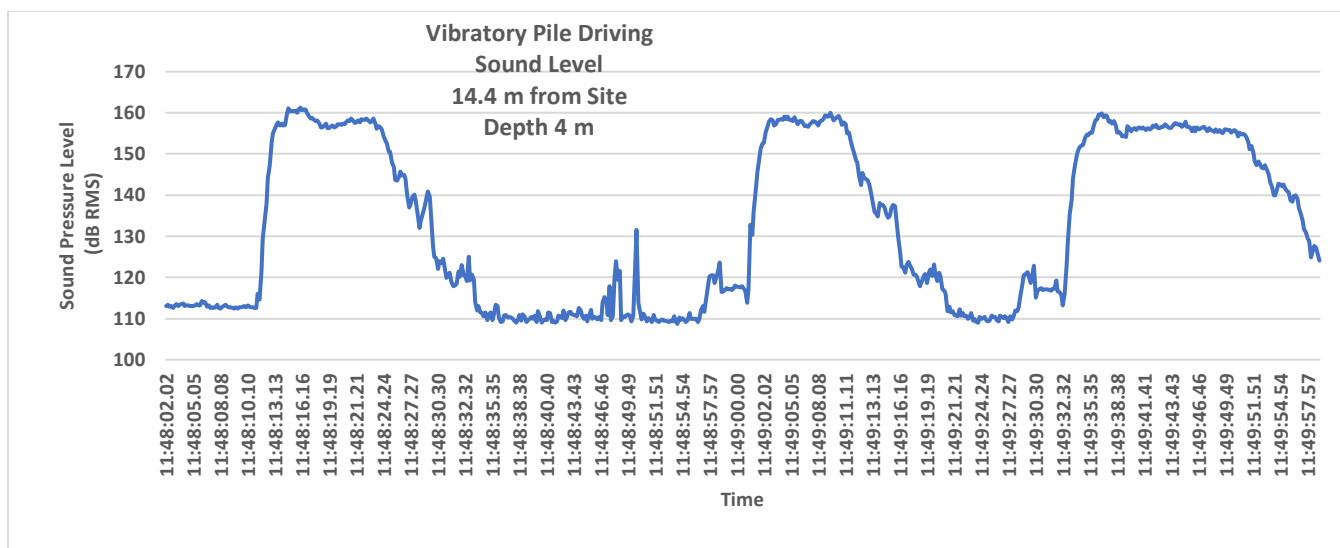
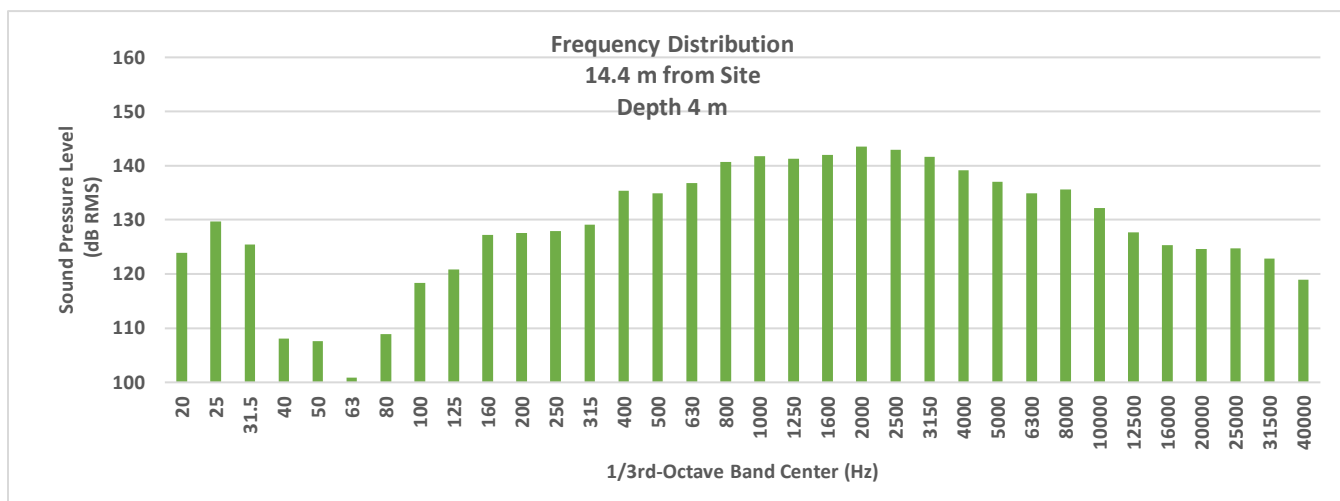
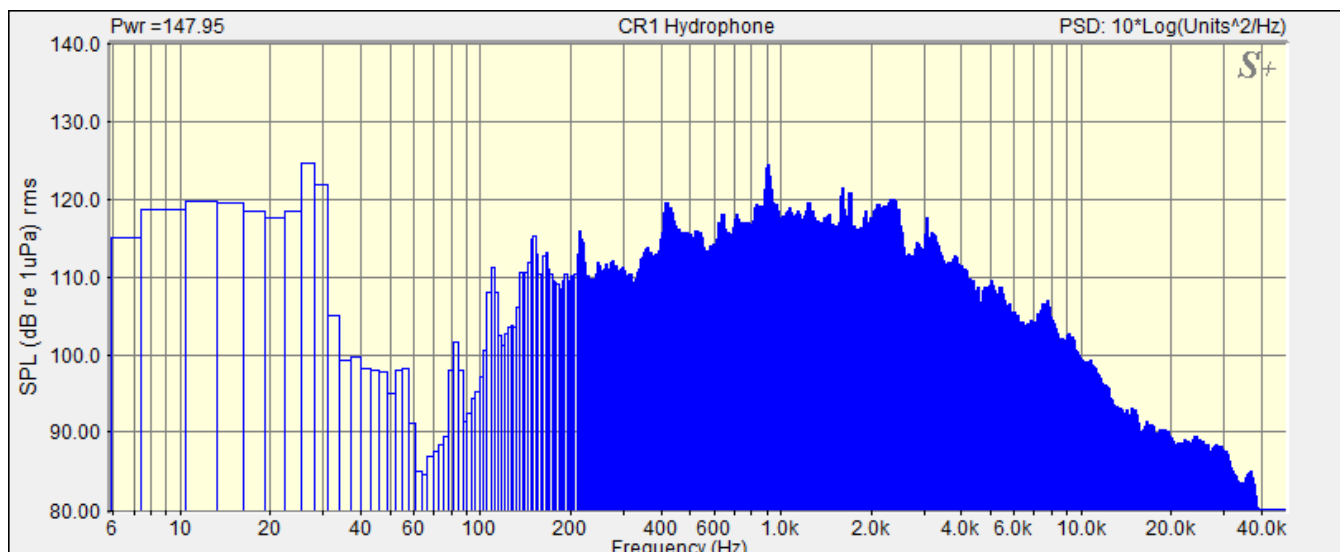
Figure B - 17. Vibratory Pile Driving Pressure Levels, 1/3rd-octave Band Frequency Distribution and PSD plots. Near the Construction Site. Hydrophone Depth – 4m. September 12, 2020

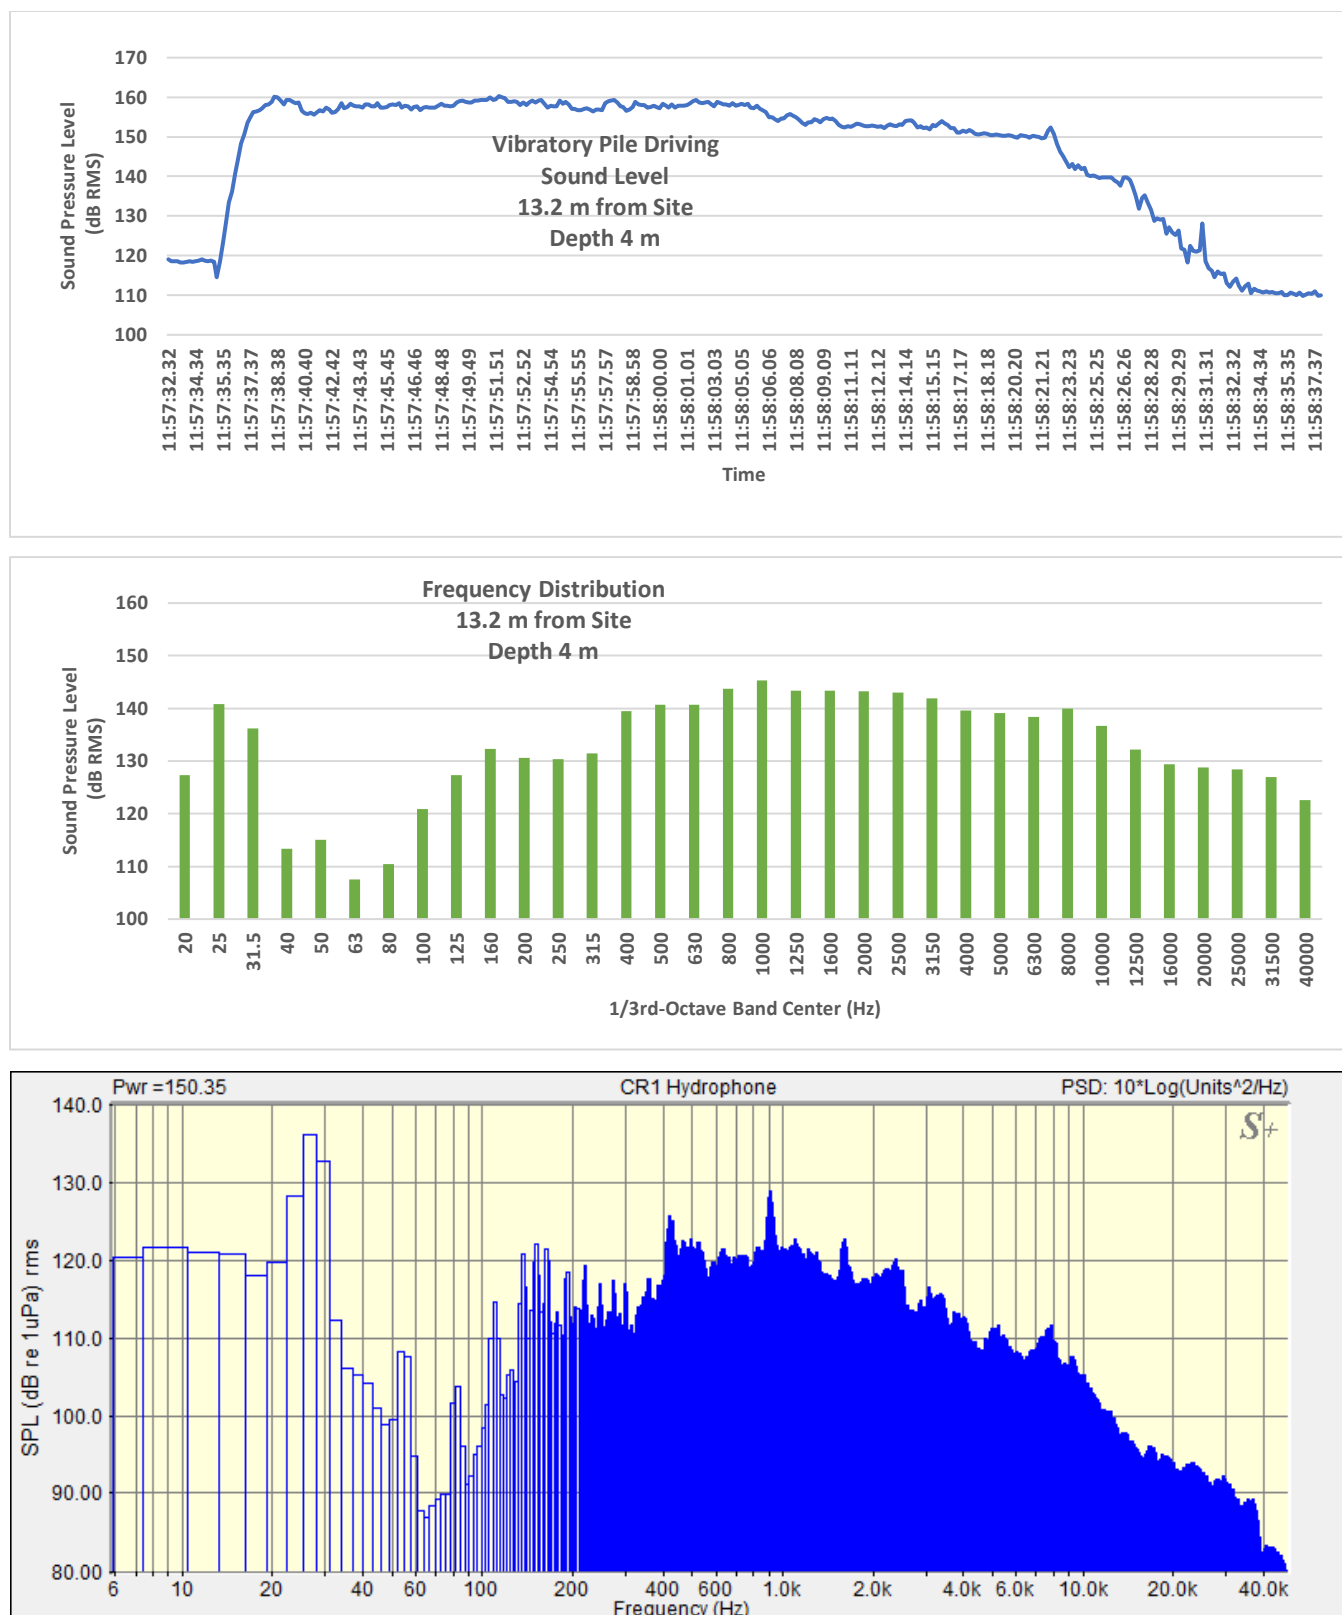
Figure B - 18. Vibratory Pile Driving Pressure Levels, 1/3rd-octave Band Frequency Distribution and PSD plots. Near the Construction Site. Hydrophone Depth – 4m. September 12, 2020
