CROWLEY KOTZEBUE DOCK REPLACEMENT PROJECT

HYDROACOUSTIC MONITORING REPORT, REV. 1

July 2021

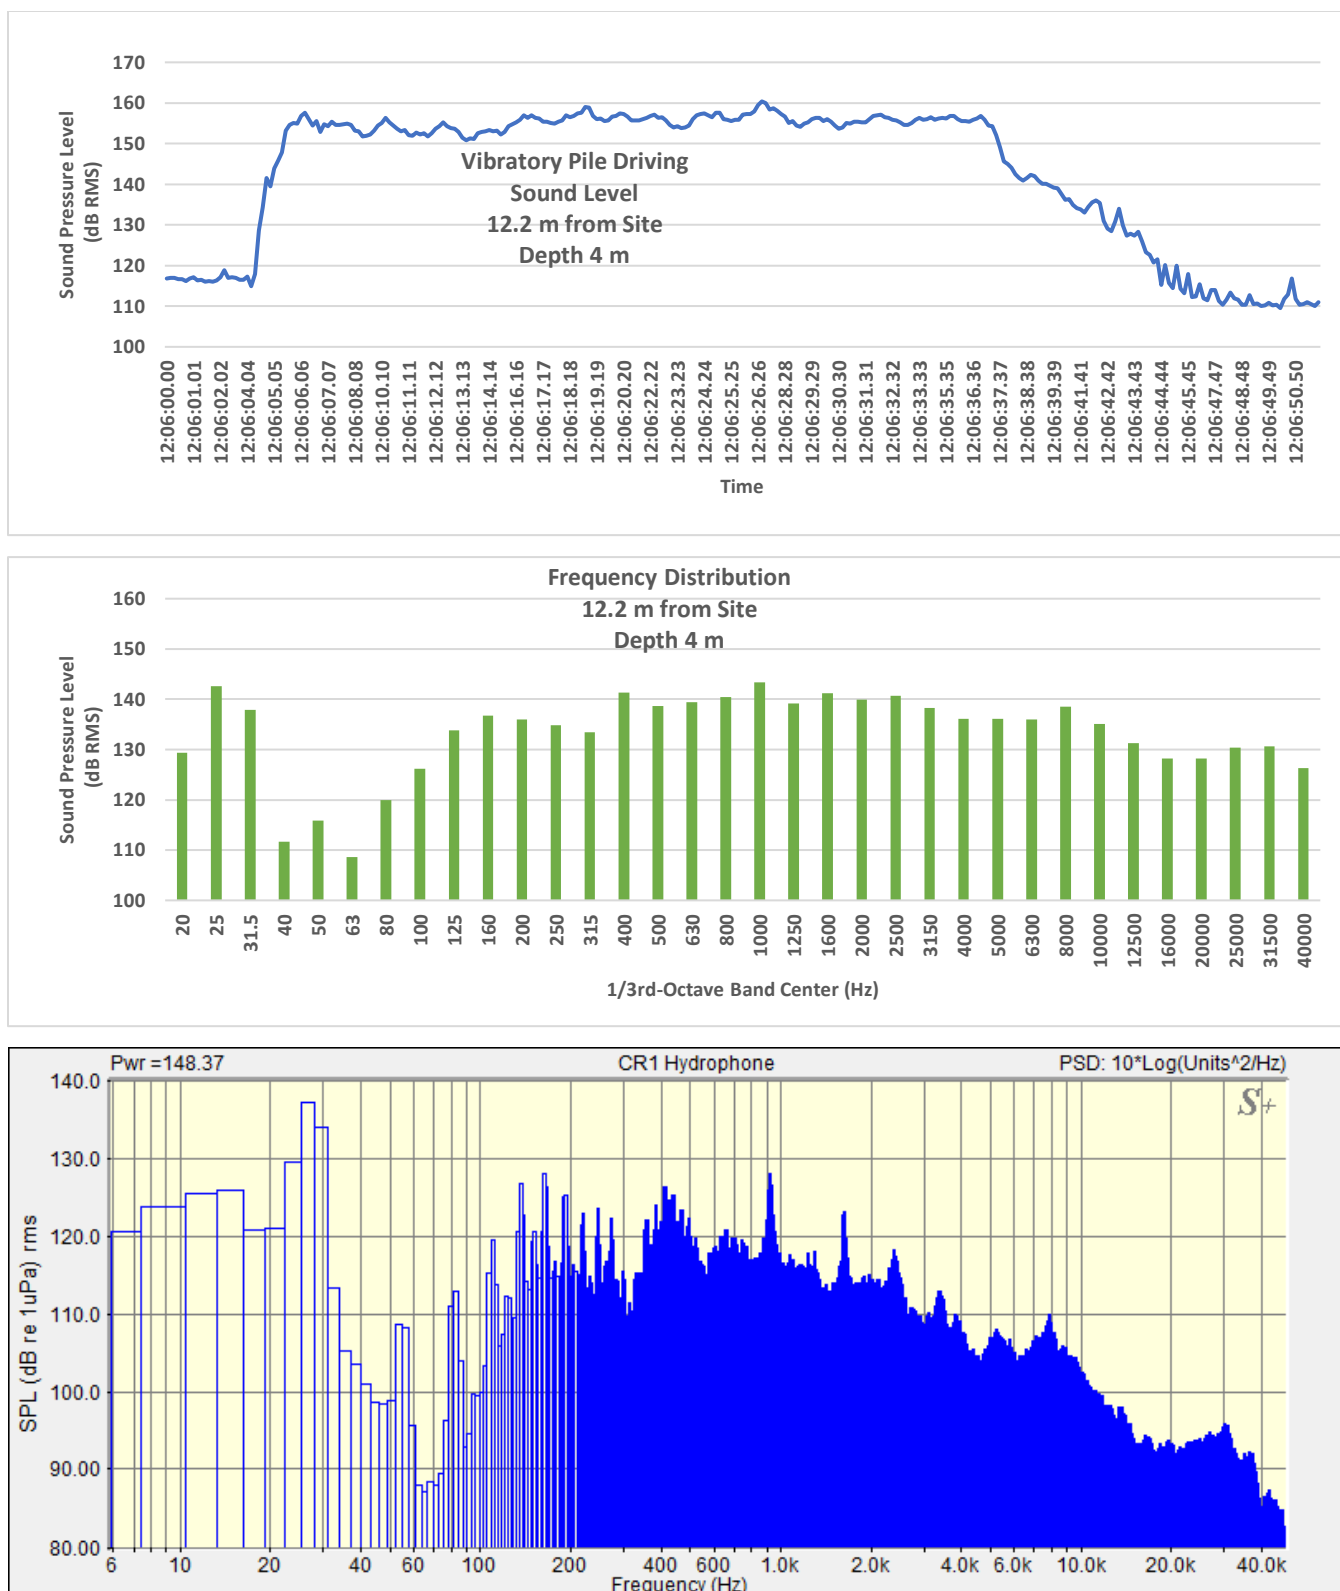
Figure B - 19. Vibratory Pile Driving Pressure Levels, 1/3rd-octave Band Frequency Distribution and PSD plots. Near the Construction Site. Hydrophone Depth – 4m. September 12, 2020

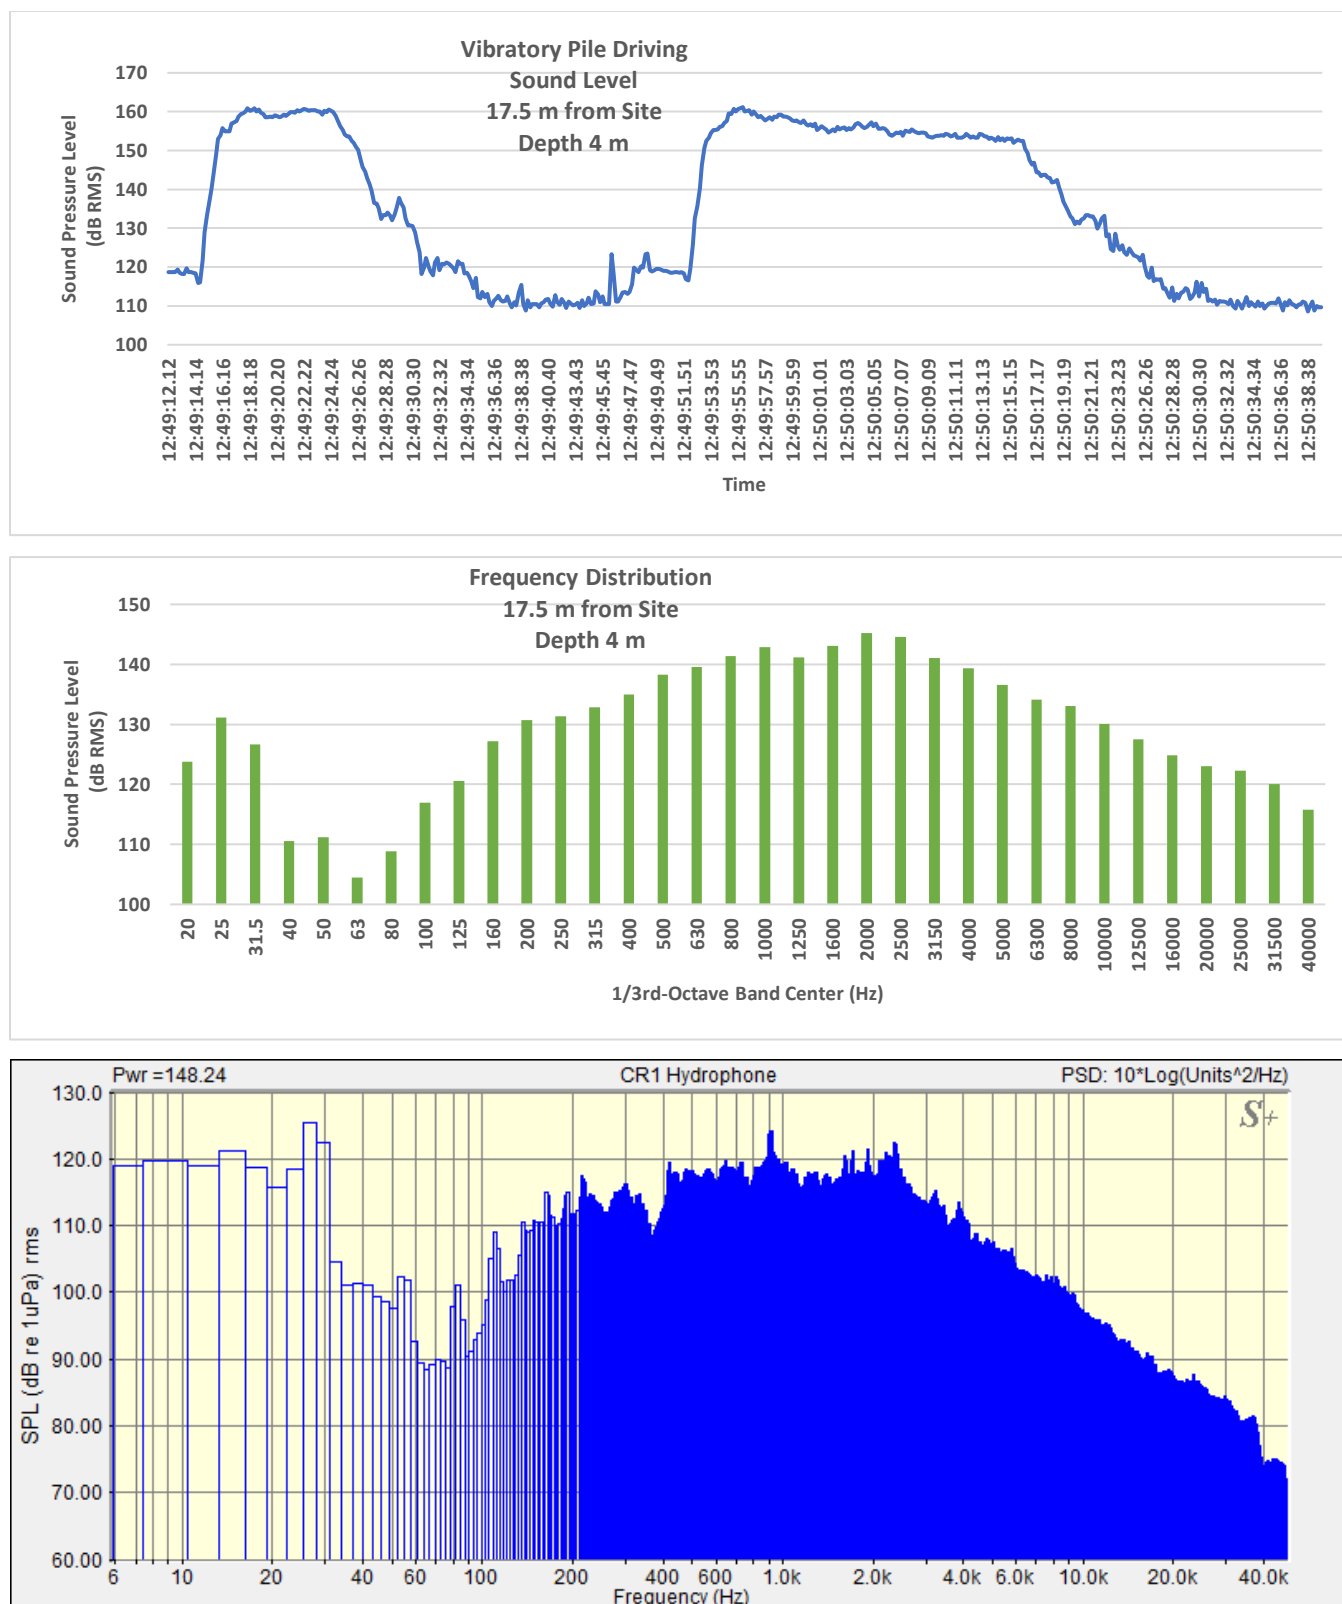
Figure B - 20. Vibratory Pile Driving Pressure Levels, 1/3rd-octave Band Frequency Distribution and PSD plots. Near the Construction Site. Hydrophone Depth – 4m. September 12, 2020

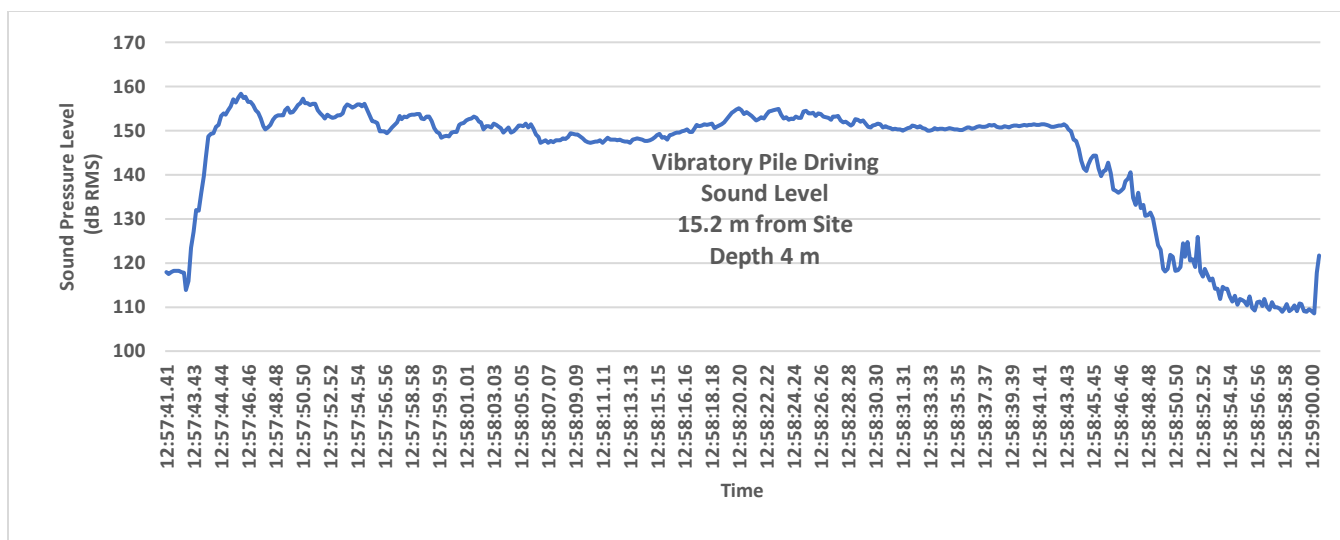
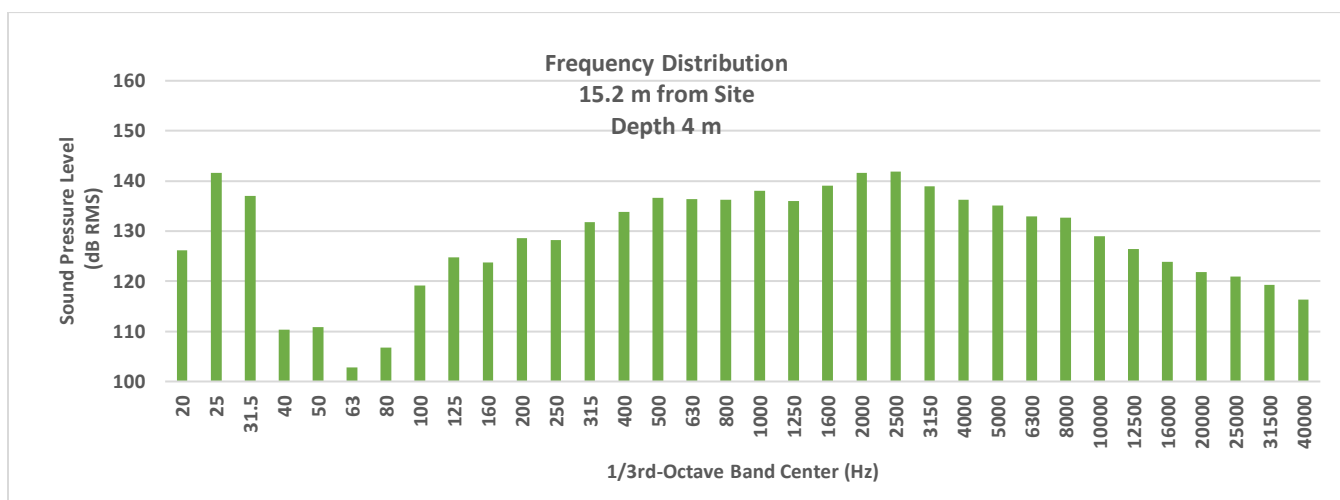
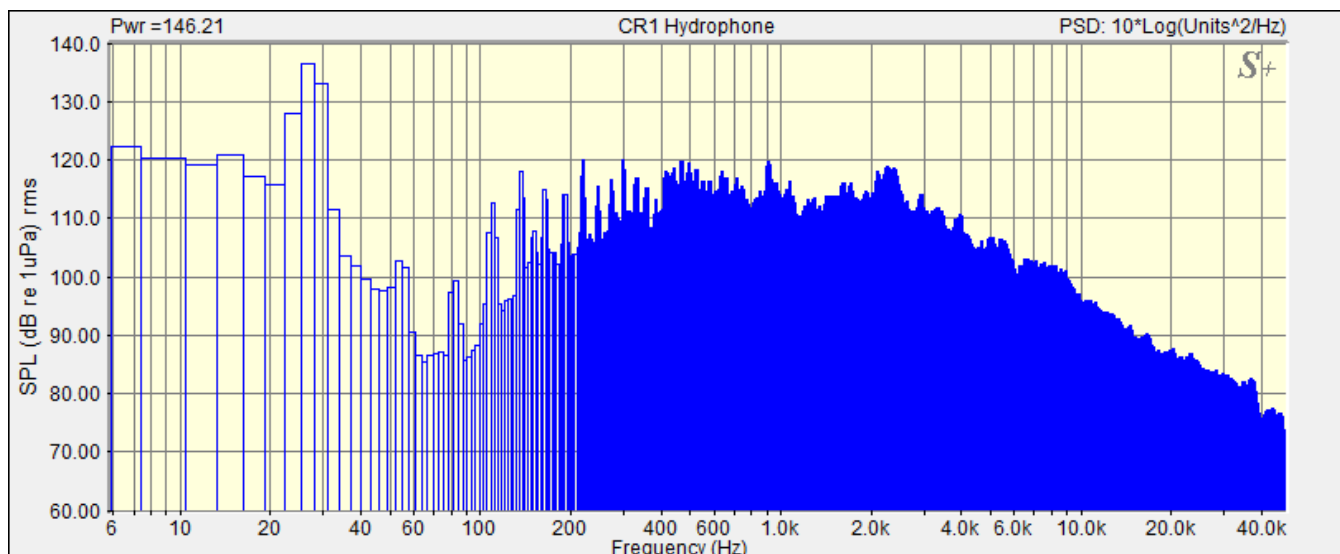
Figure B - 21. Vibratory Pile Driving Pressure Levels, 1/3rd-octave Band Frequency Distribution and PSD plots. Near the Construction Site. Hydrophone Depth – 4m. September 12, 2020

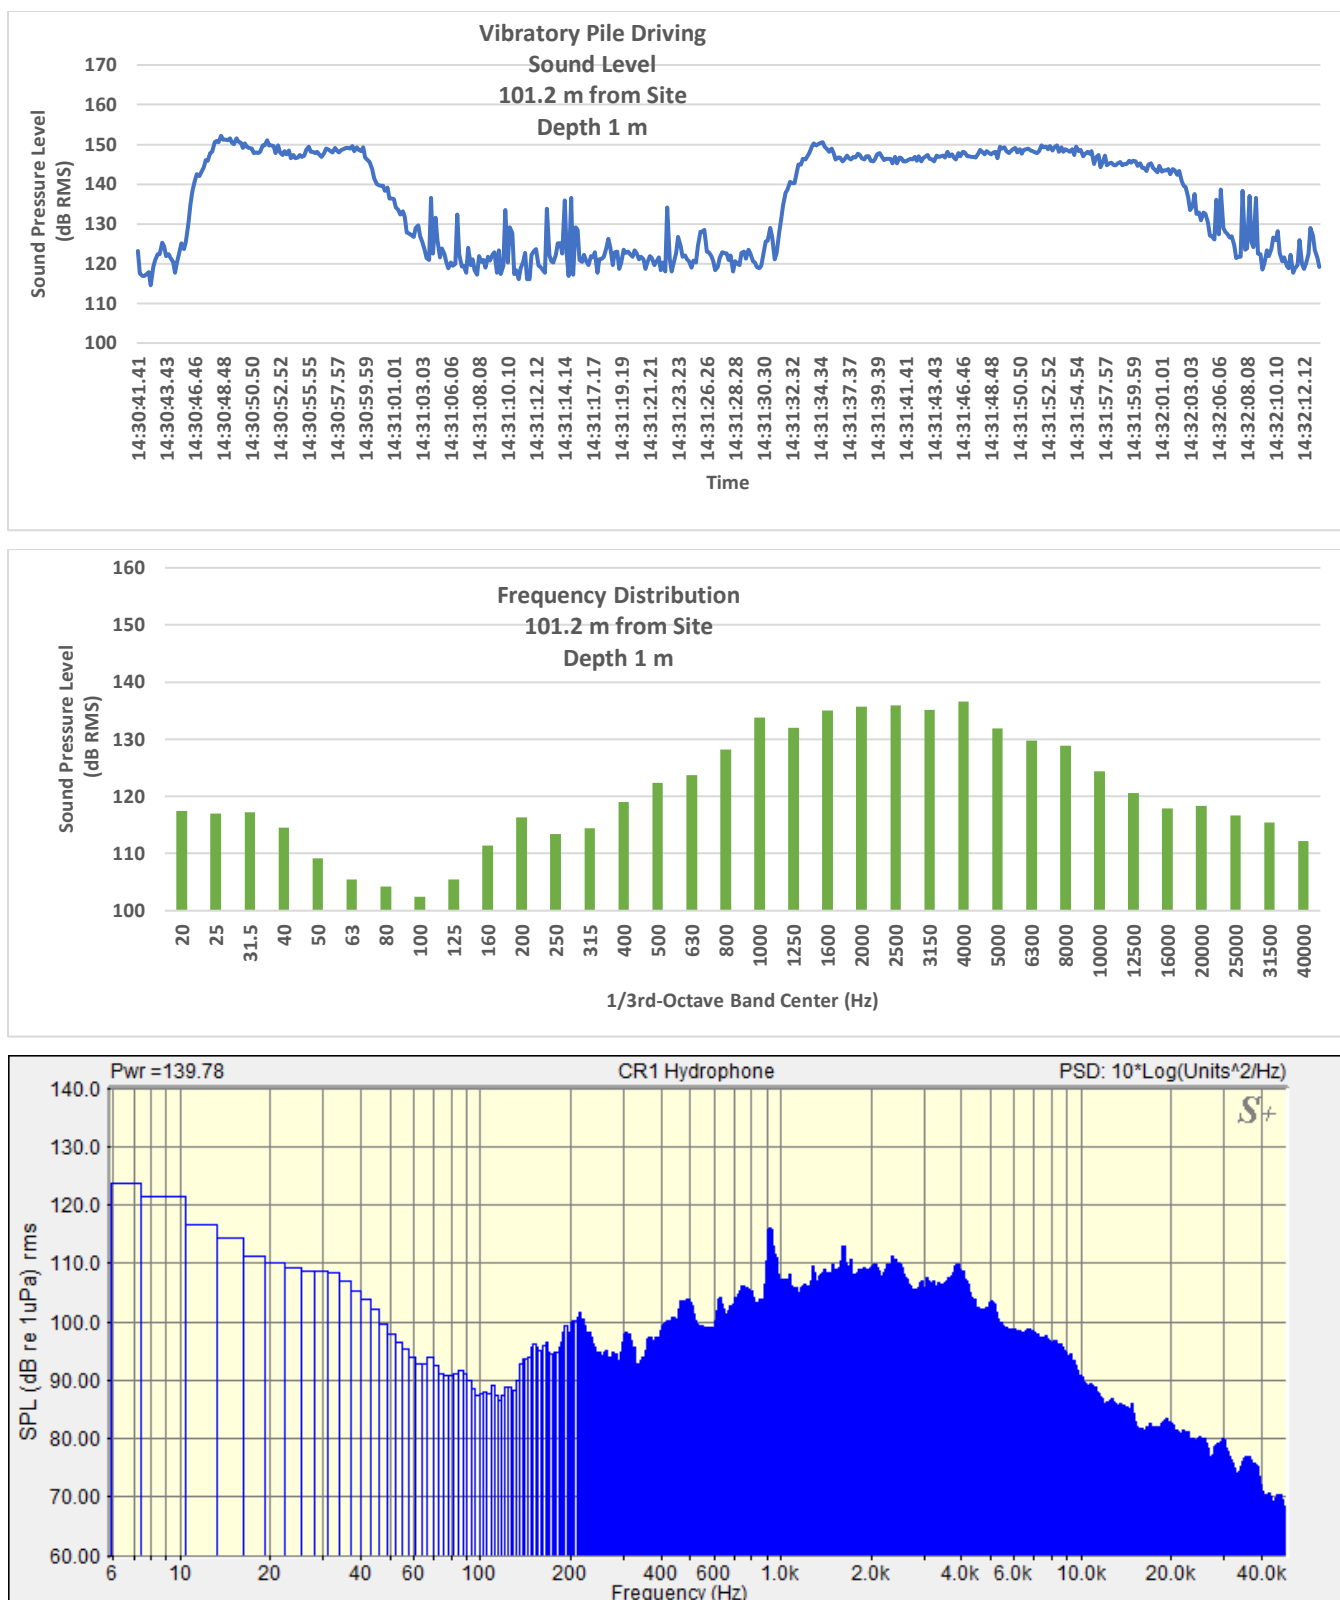
Figure B - 22. Vibratory Pile Driving Pressure Levels, 1/3rd-octave Band Frequency Distribution and PSD plots. 101.2 m from Construction Site. Hydrophone Depth – 1m. September 12, 2020

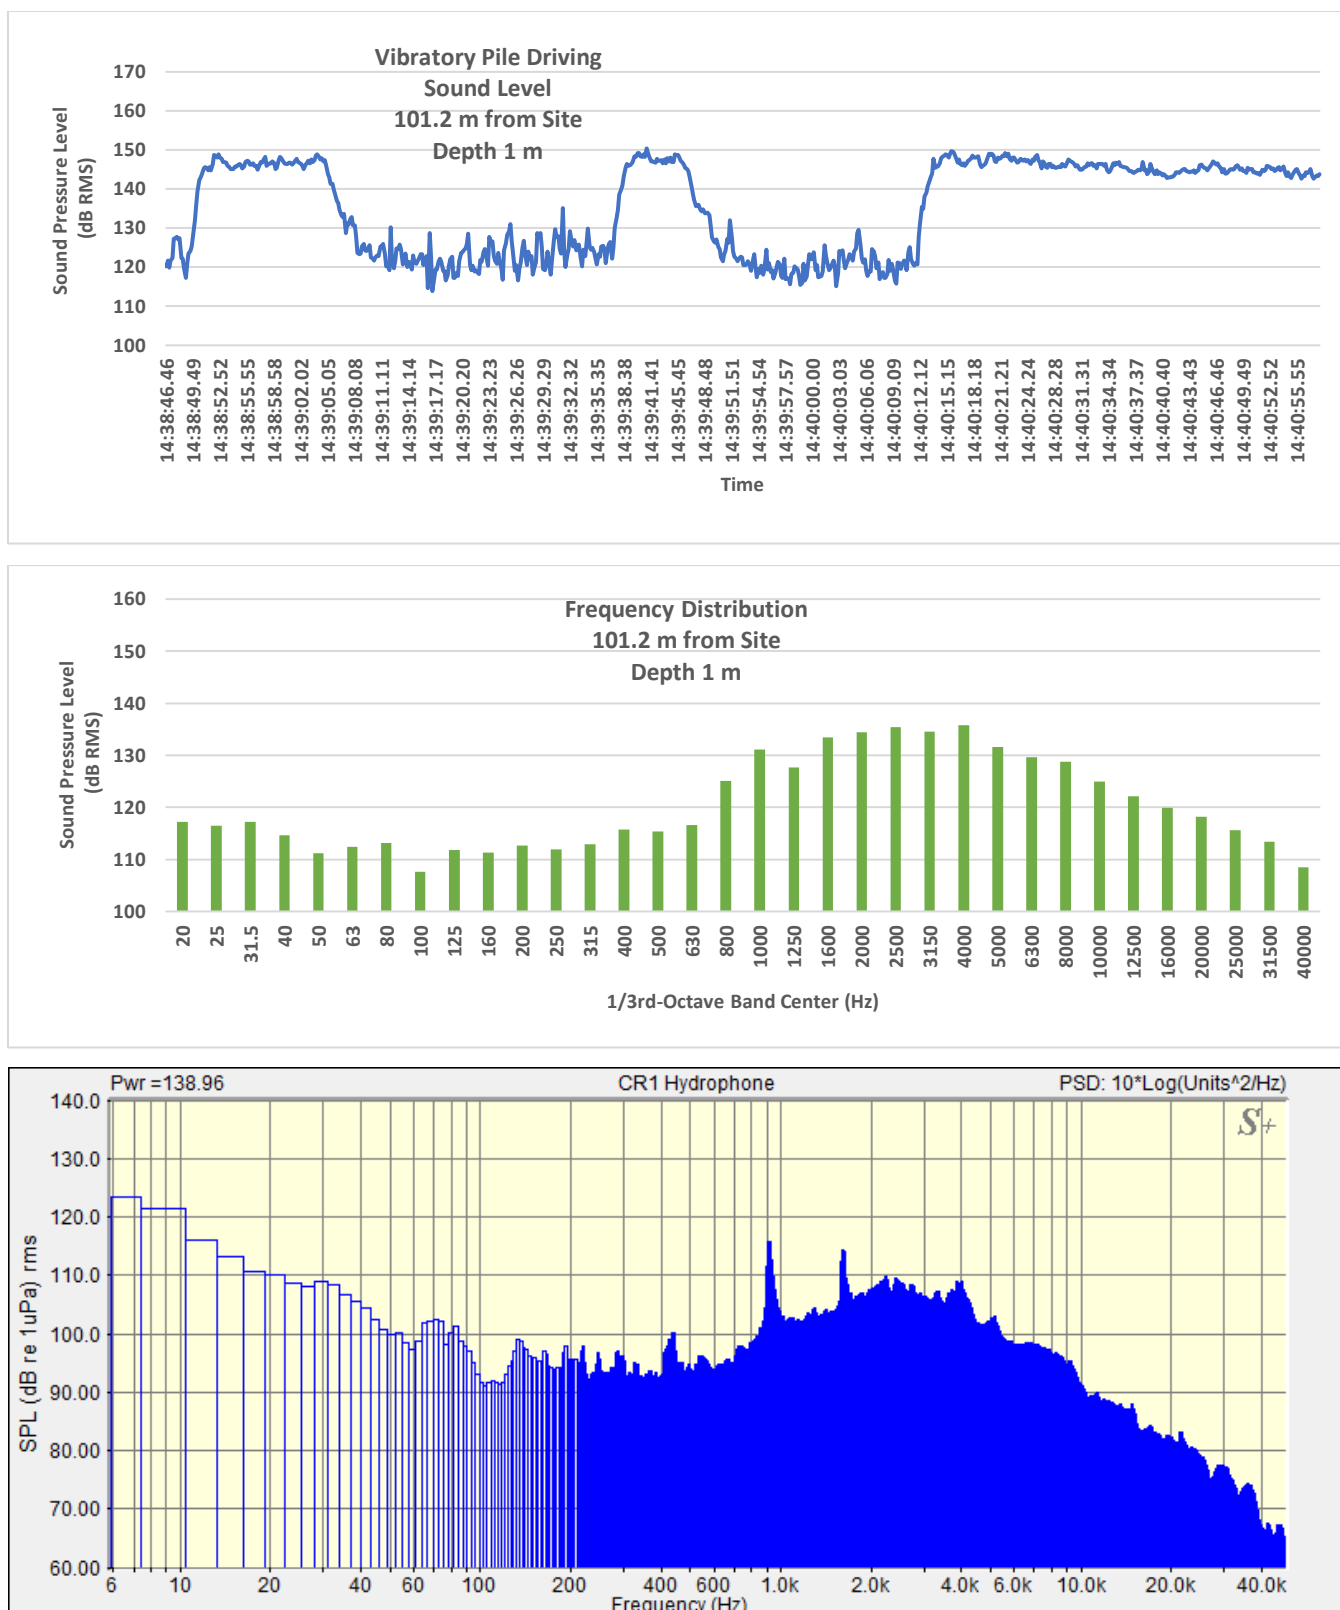
Figure B - 23. Vibratory Pile Driving Pressure Levels, 1/3rd-octave Band Frequency Distribution and PSD plots. 101.2 m from Construction Site. Hydrophone Depth – 1m. September 12, 2020

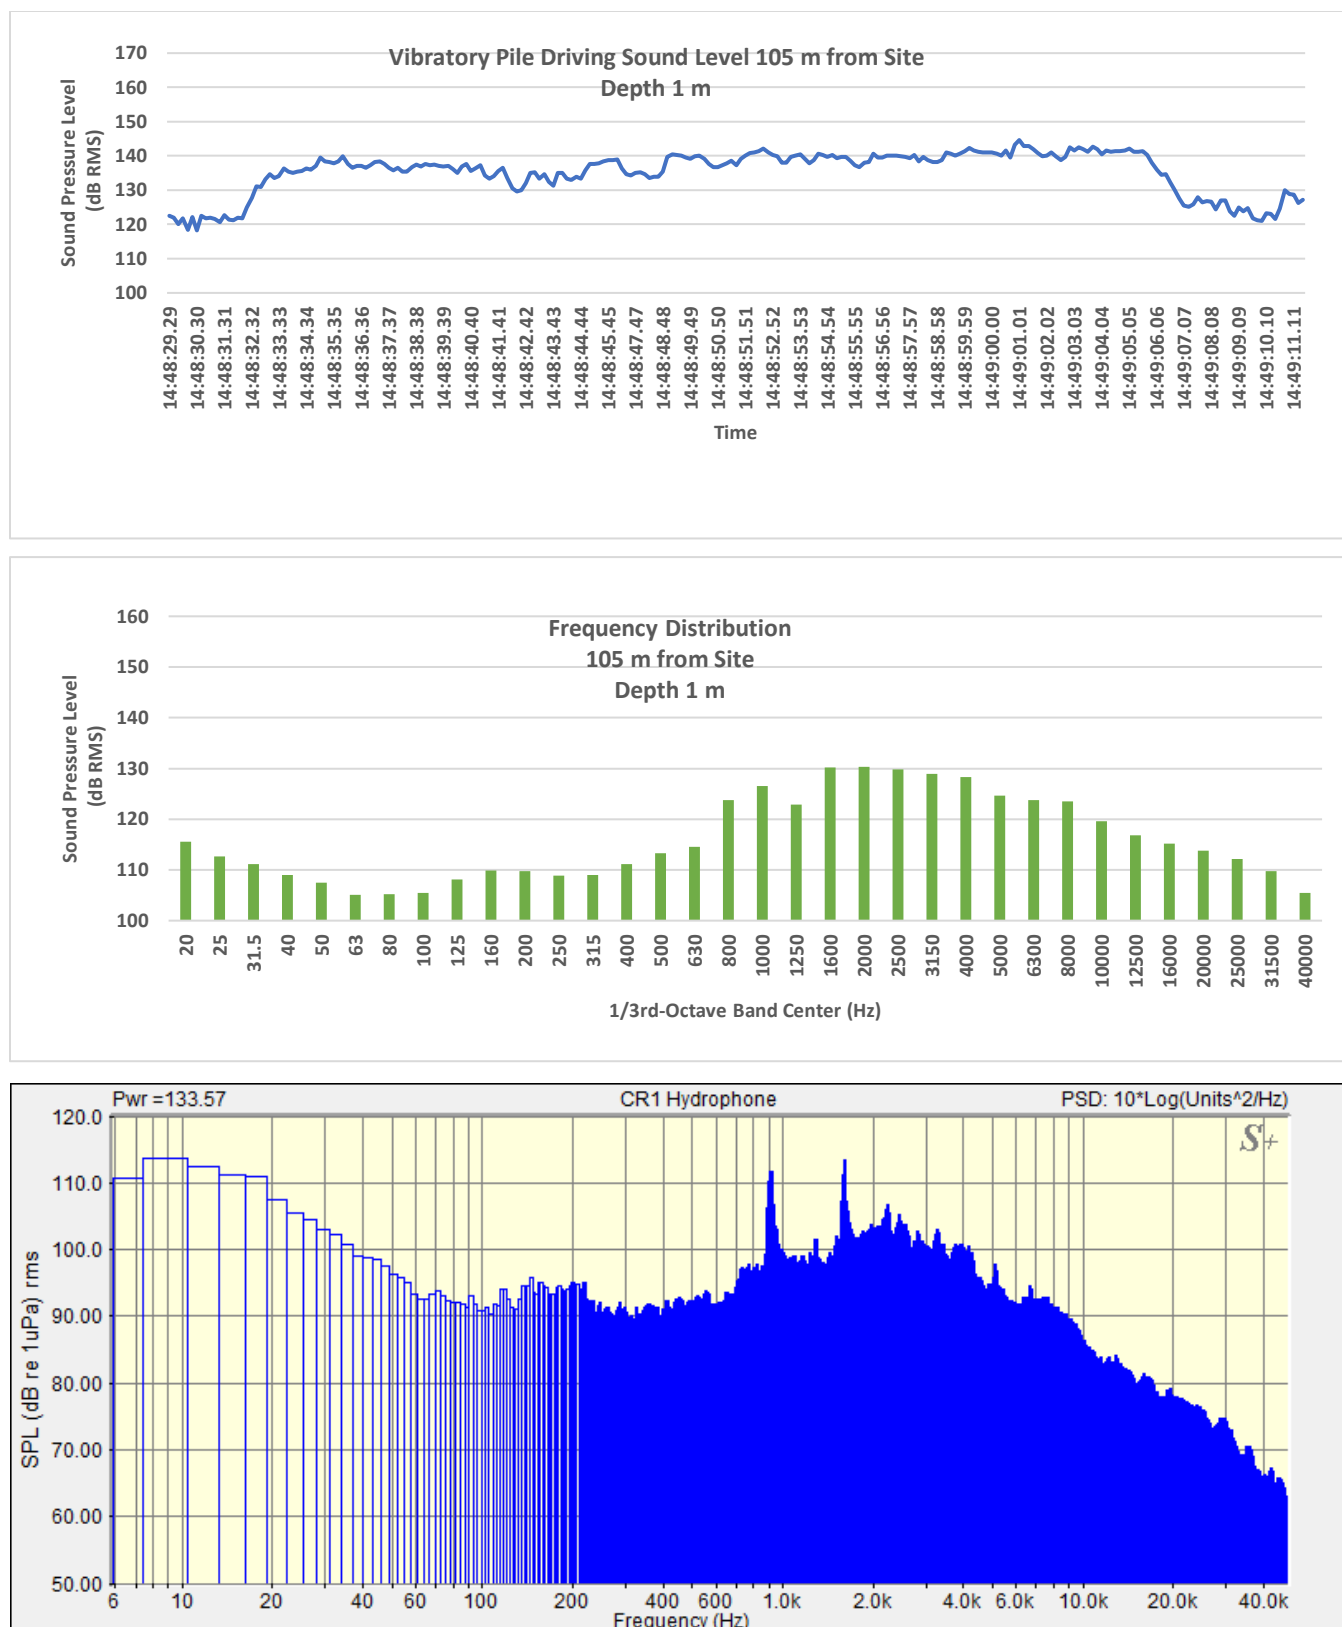
Figure B - 24. Vibratory Pile Driving Pressure Levels, 1/3rd-octave Band Frequency Distribution and PSD plots. 105 m from Construction Site. Hydrophone Depth – 1 m September 12, 2020

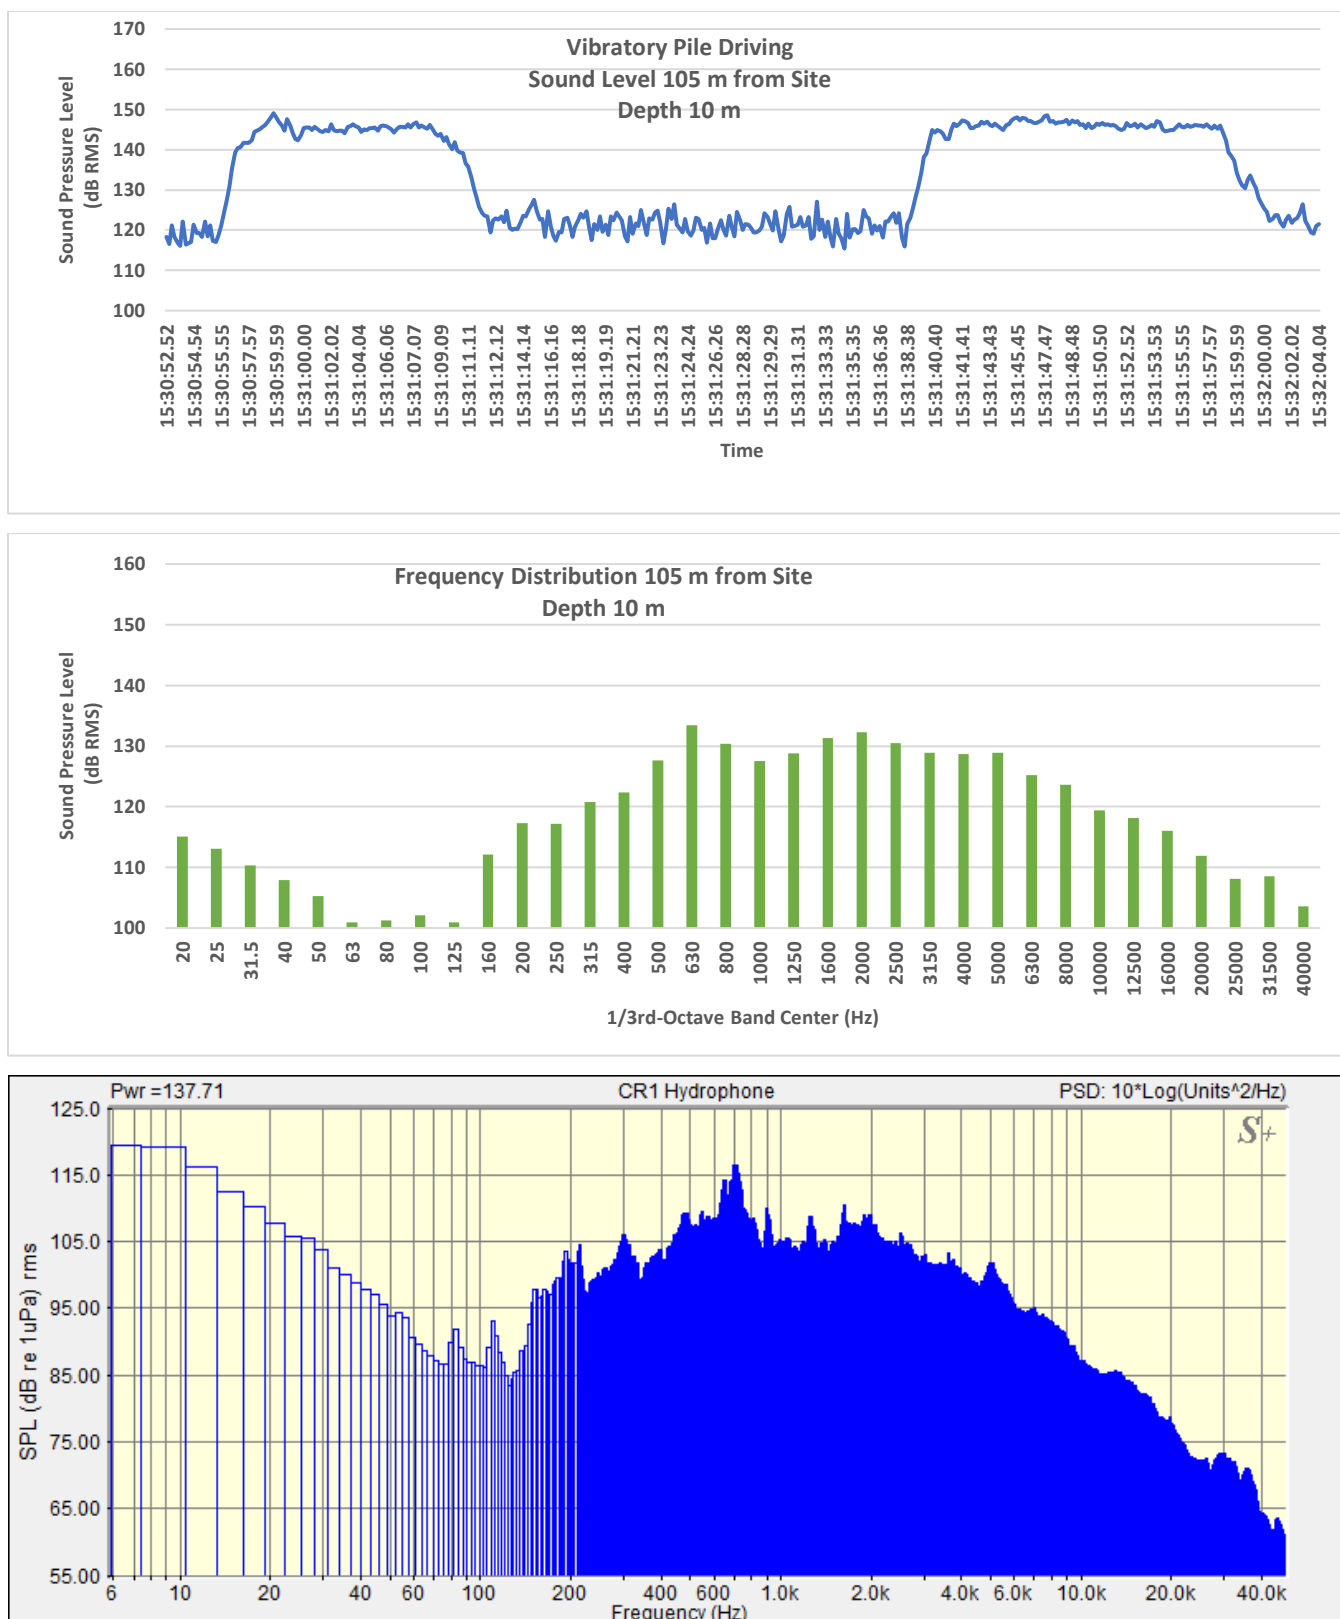
Figure B - 25. Vibratory Pile Driving Pressure Levels, 1/3rd-octave Band Frequency Distribution and PSD plots. 105 m from Construction Site. Hydrophone Depth – 10 m September 12, 2020

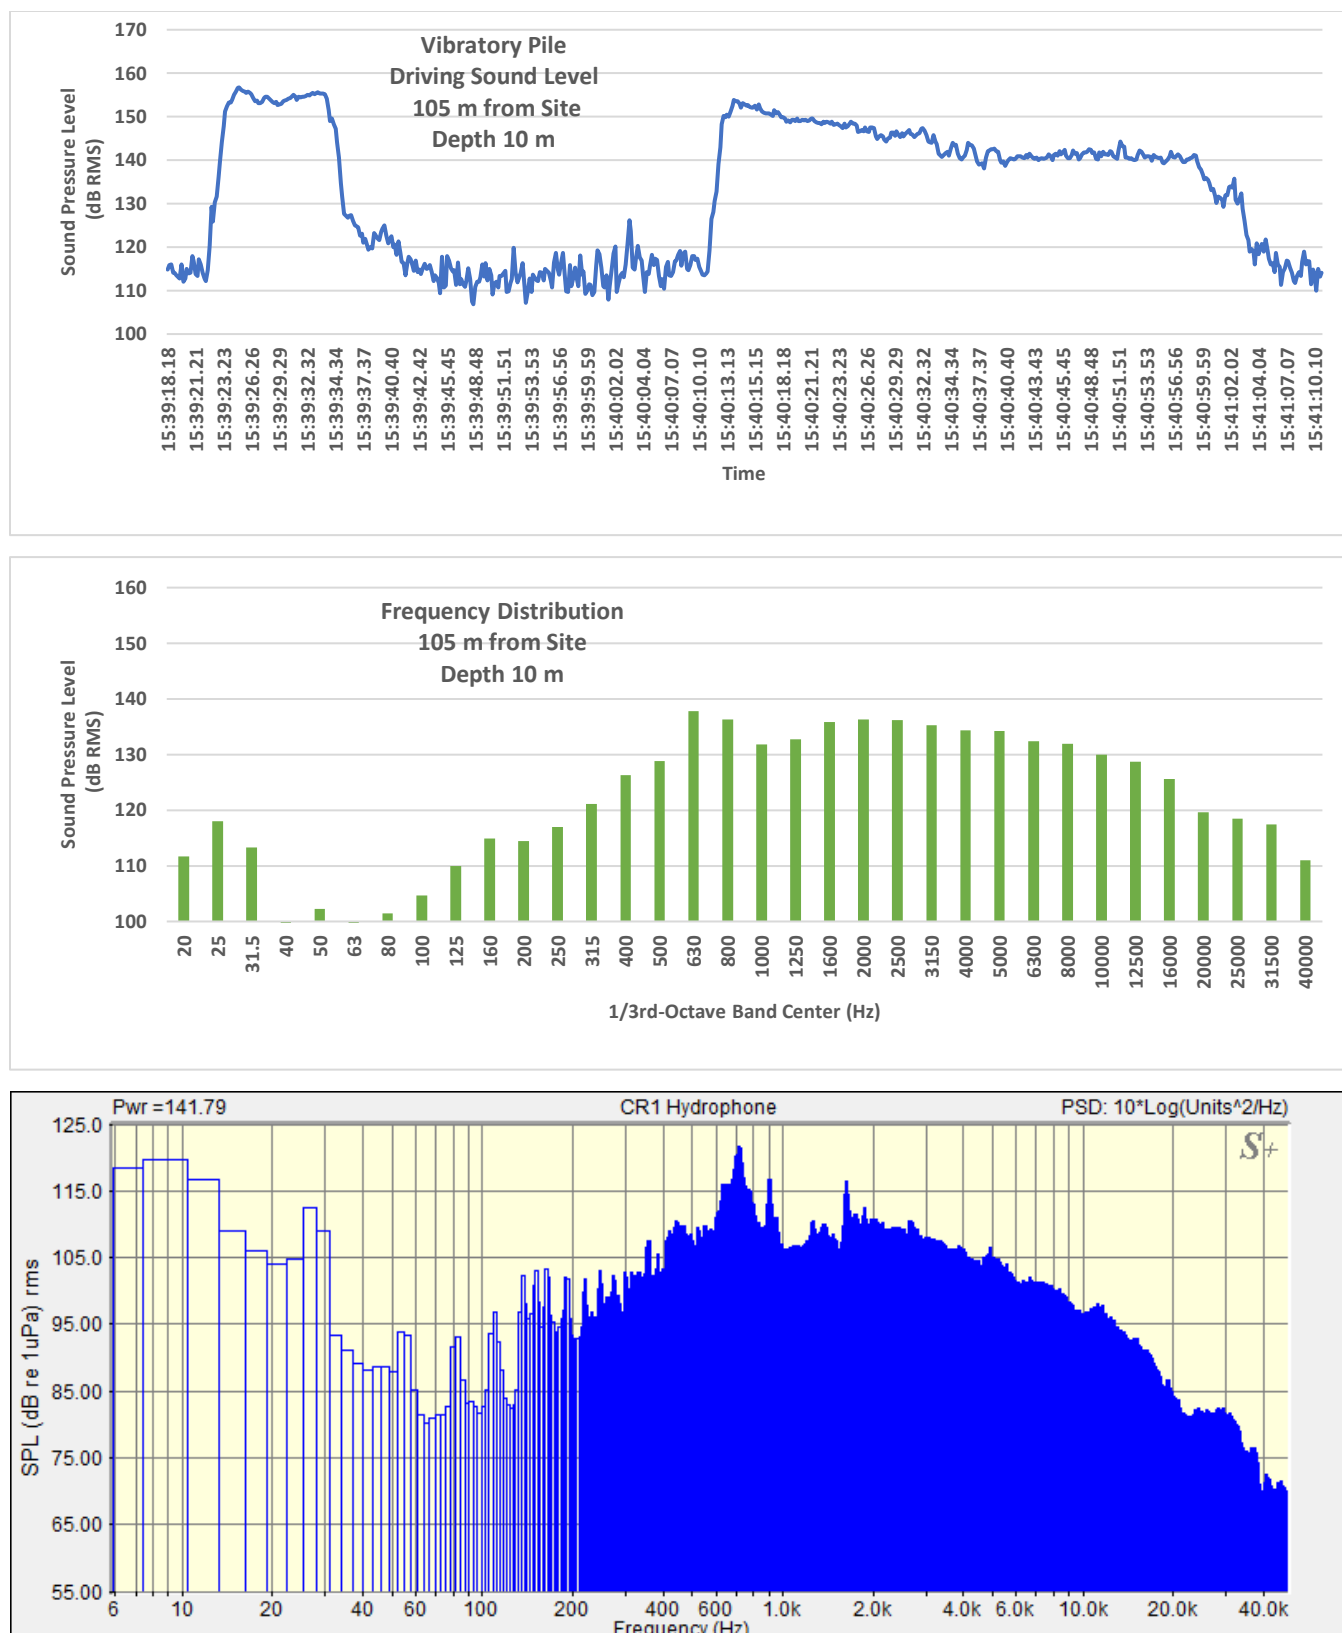
Figure B - 26. Vibratory Pile Driving Pressure Levels, 1/3rd-octave Band Frequency Distribution and PSD plots. 105 m from Construction Site. Hydrophone Depth – 10 m September 12, 2020

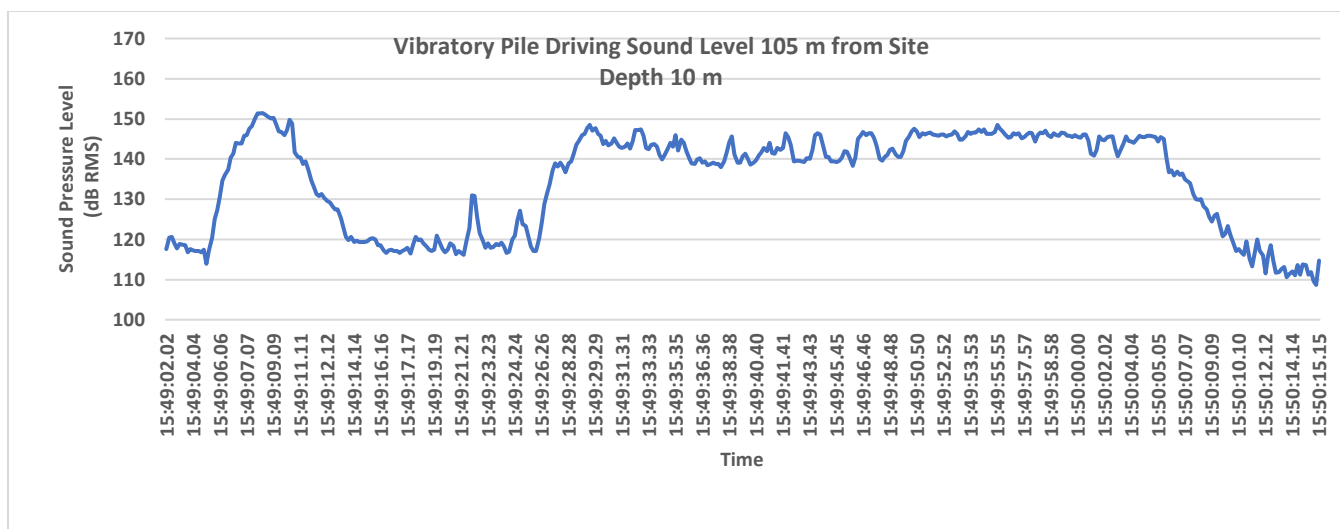
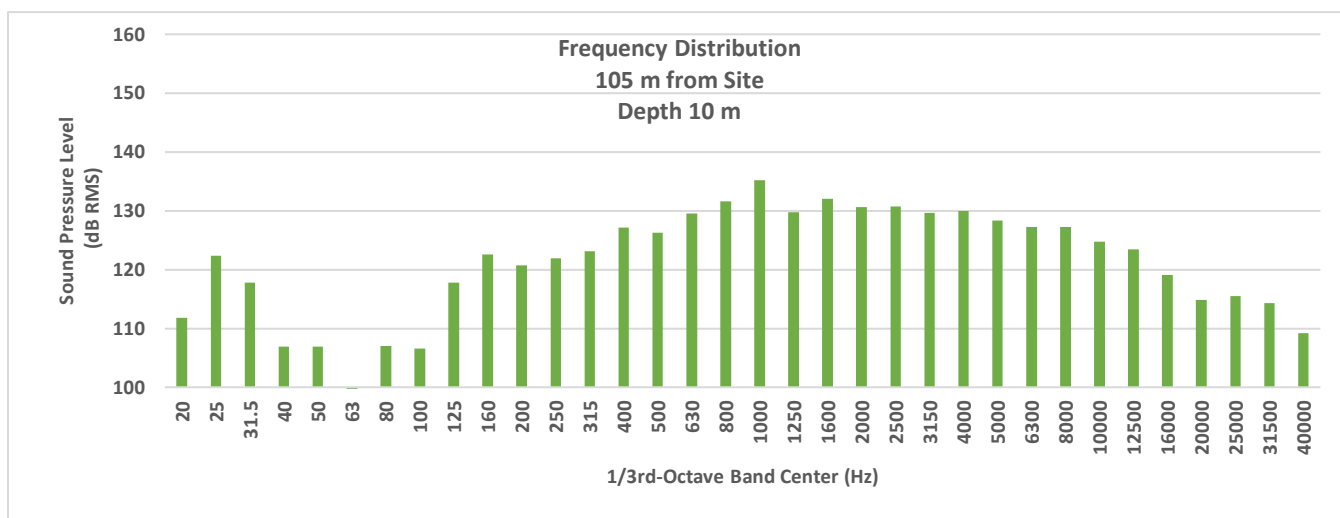
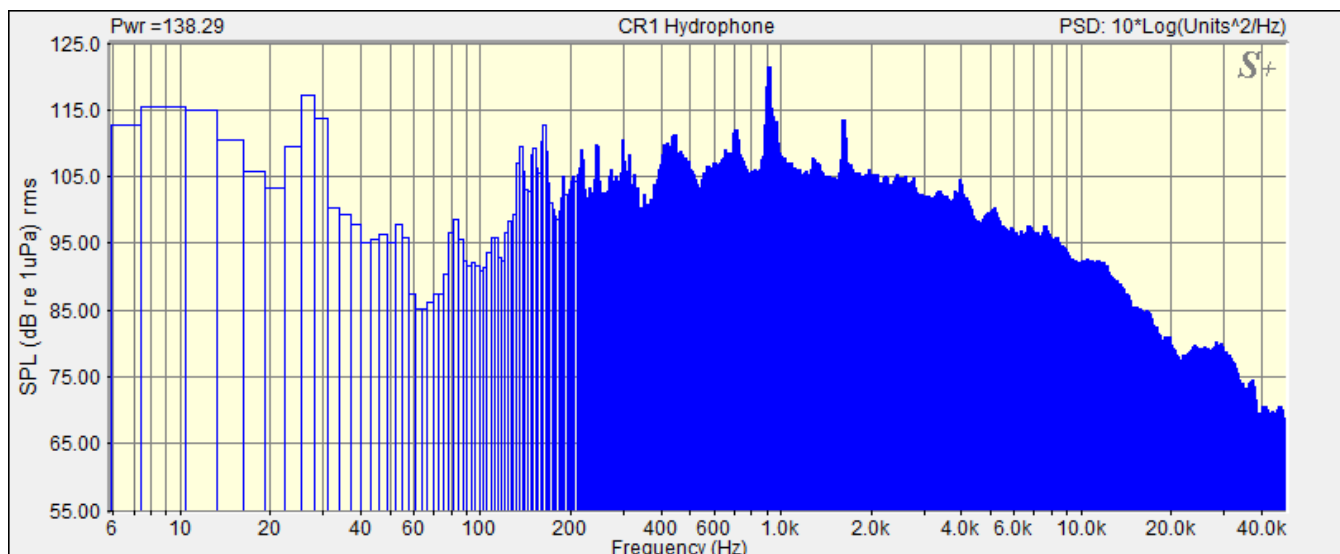
Figure B - 27. Vibratory Pile Driving Pressure Levels, 1/3rd-octave Band Frequency Distribution and PSD plots. 105 m from Construction Site. Hydrophone Depth – 10 m September 12, 2020

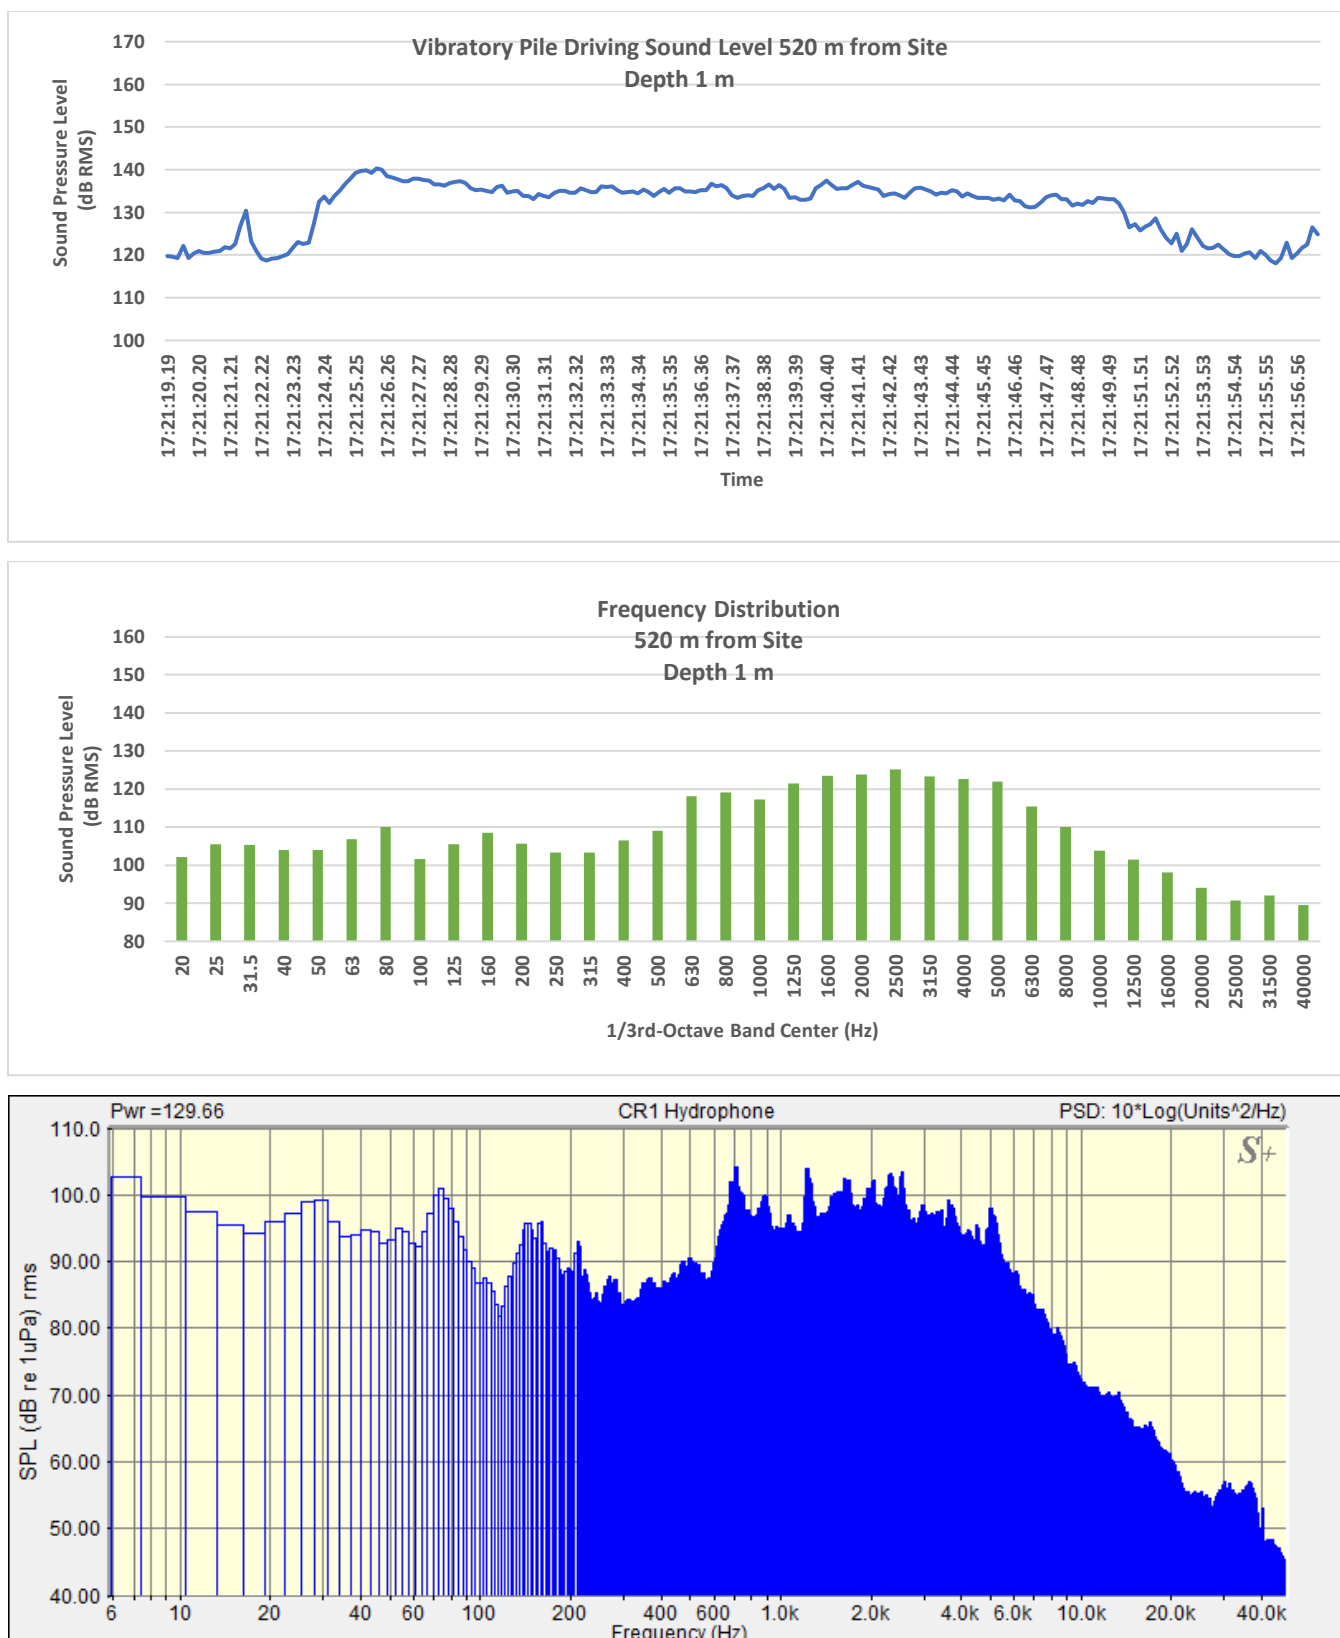
Figure B - 28. Vibratory Pile Driving Pressure Levels, 1/3rd-octave Band Frequency Distribution and PSD plots. 520 m from Construction Site. Hydrophone Depth – 1 m September 12, 2020
