CROWLEY KOTZEBUE DOCK REPLACEMENT PROJECT

HYDROACOUSTIC MONITORING REPORT, REV. 1

July 2021

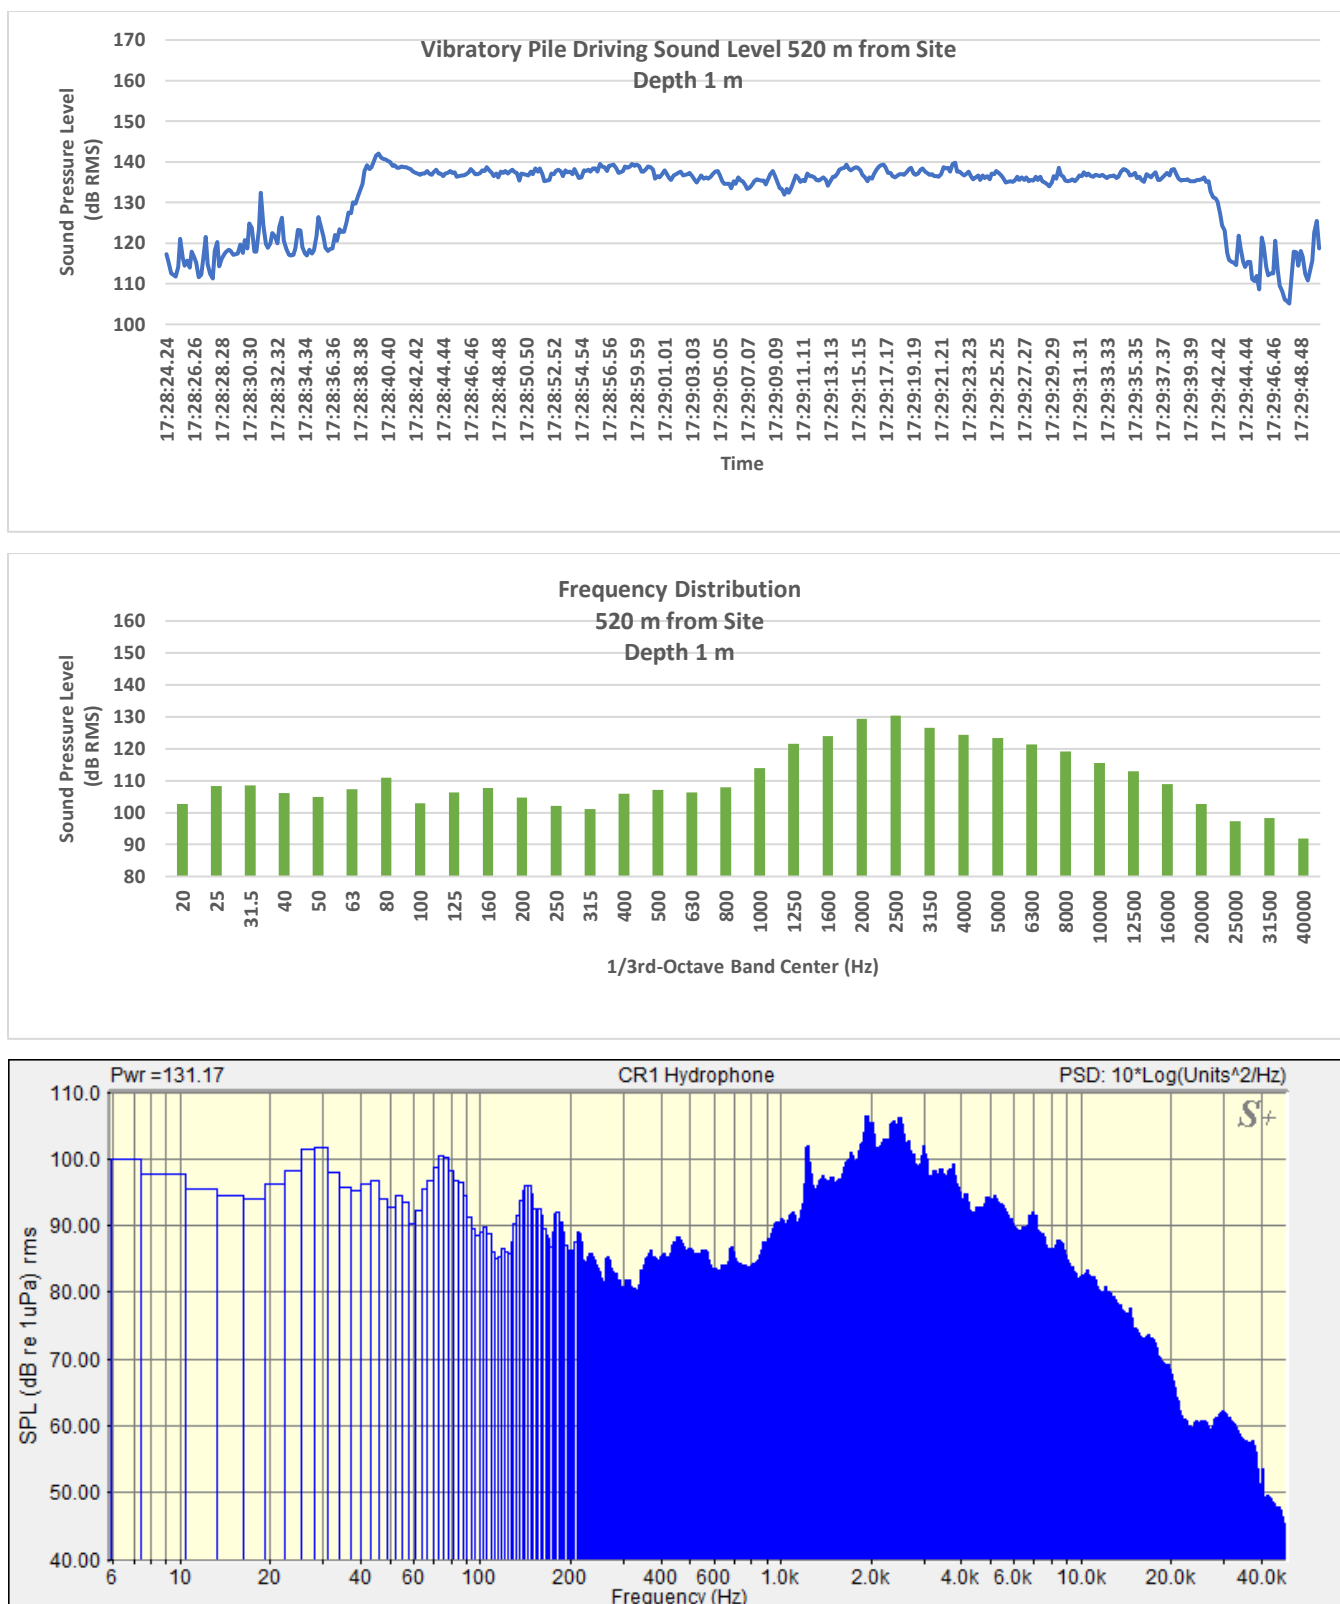
Figure B - 29. Vibratory Pile Driving Pressure Levels, 1/3rd-octave Band Frequency Distribution and PSD plots. 520 m from Construction Site. Hydrophone Depth – 1 m September 12, 2020

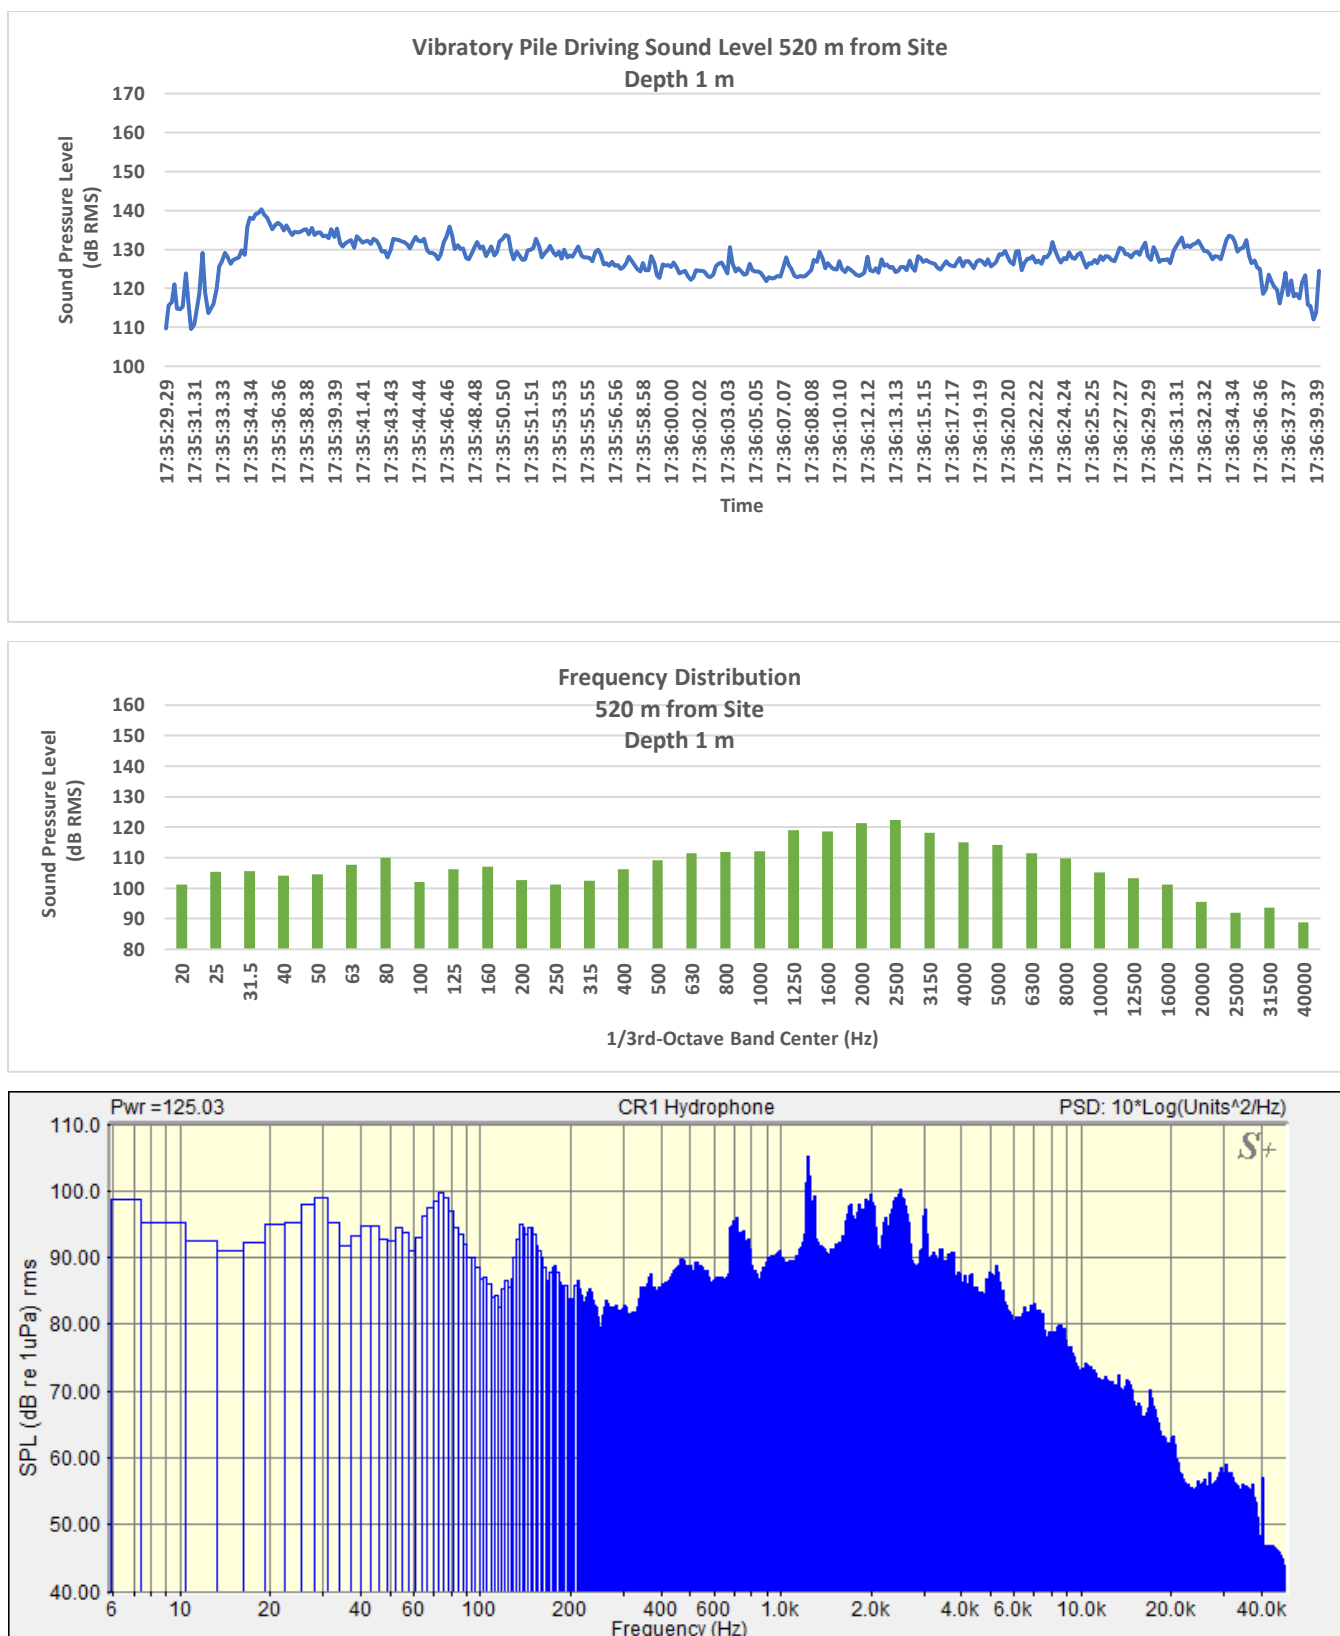
Figure B - 30. Vibratory Pile Driving Pressure Levels, 1/3rd-octave Band Frequency Distribution and PSD plots. 520 m from Construction Site. Hydrophone Depth – 1 m September 12, 2020

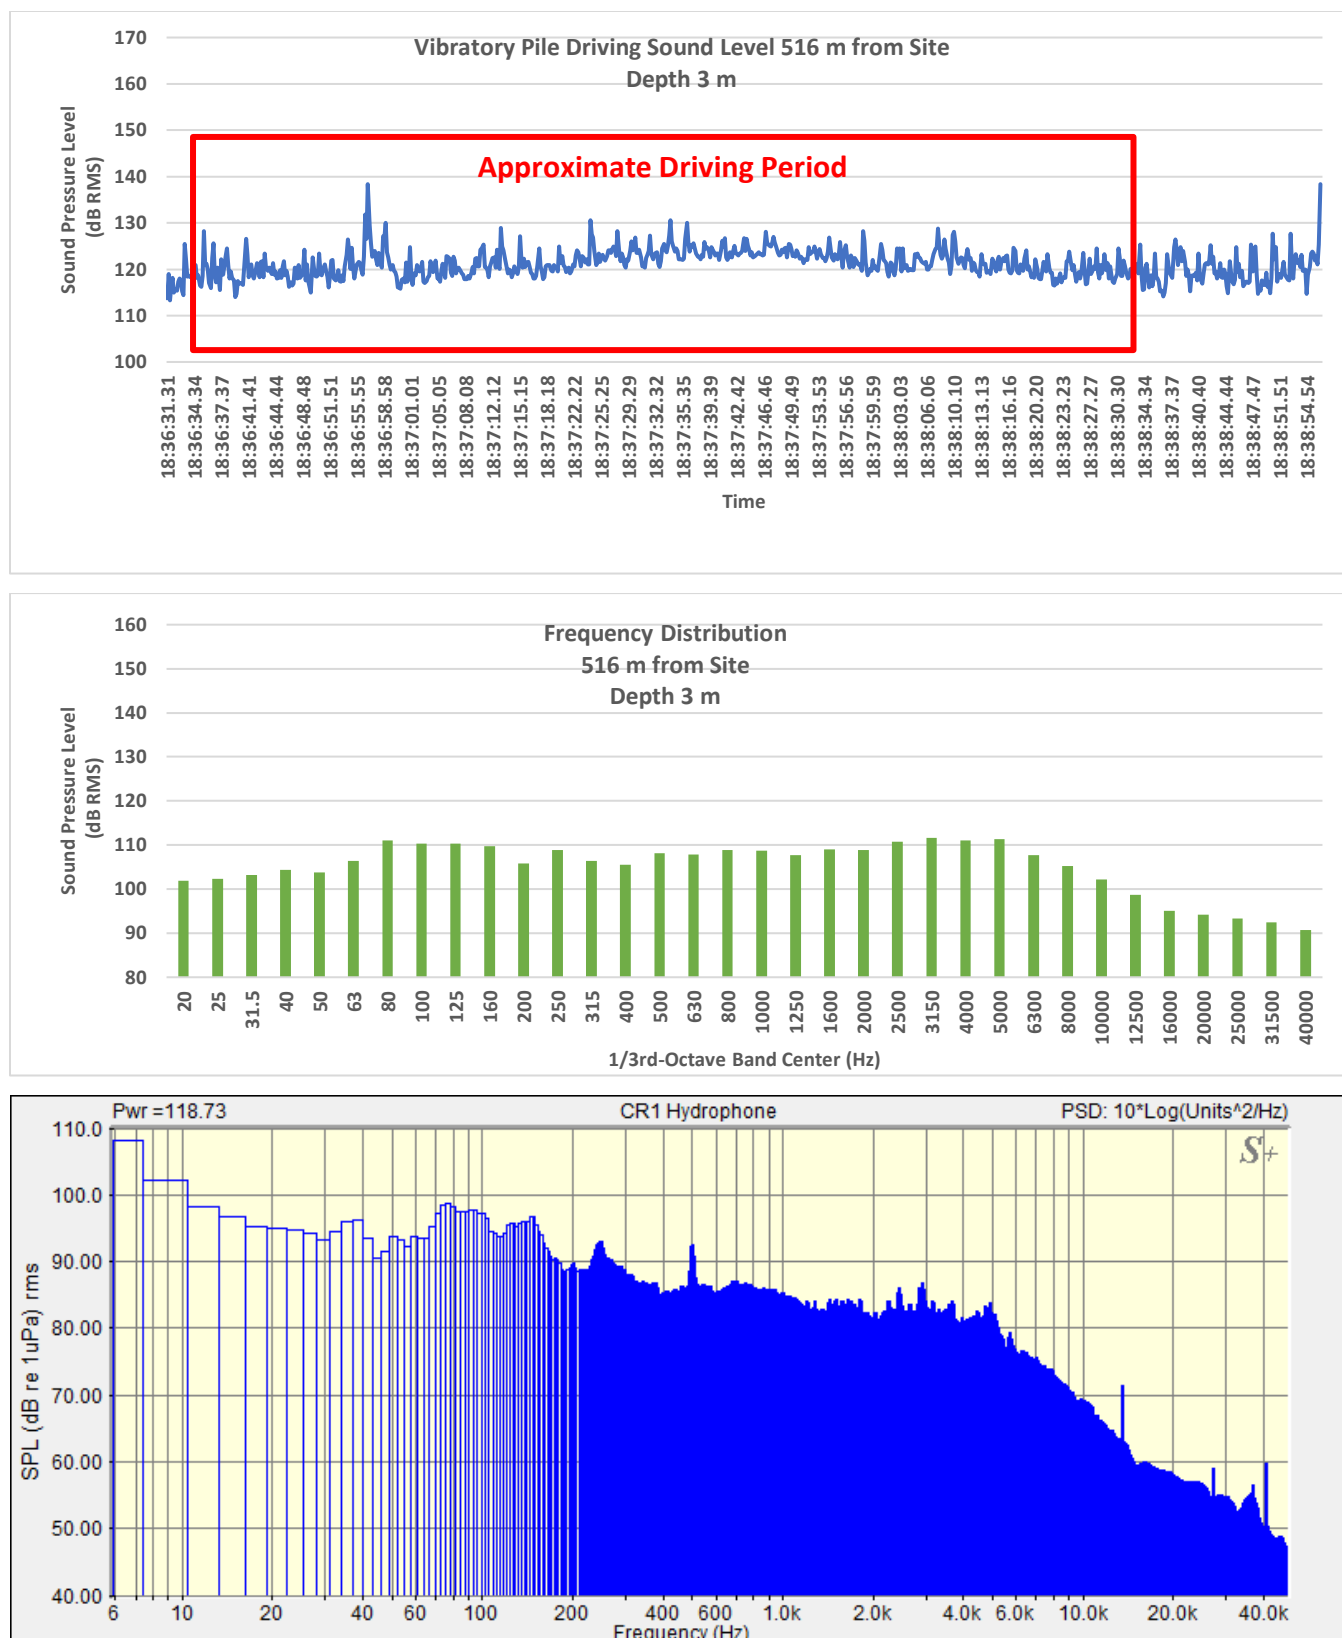
Figure B - 31. Vibratory Pile Driving Pressure Levels, 1/3rd-octave Band Frequency Distribution and PSD plots. 516 m from Construction Site. Hydrophone Depth – 3 m September 12, 2020

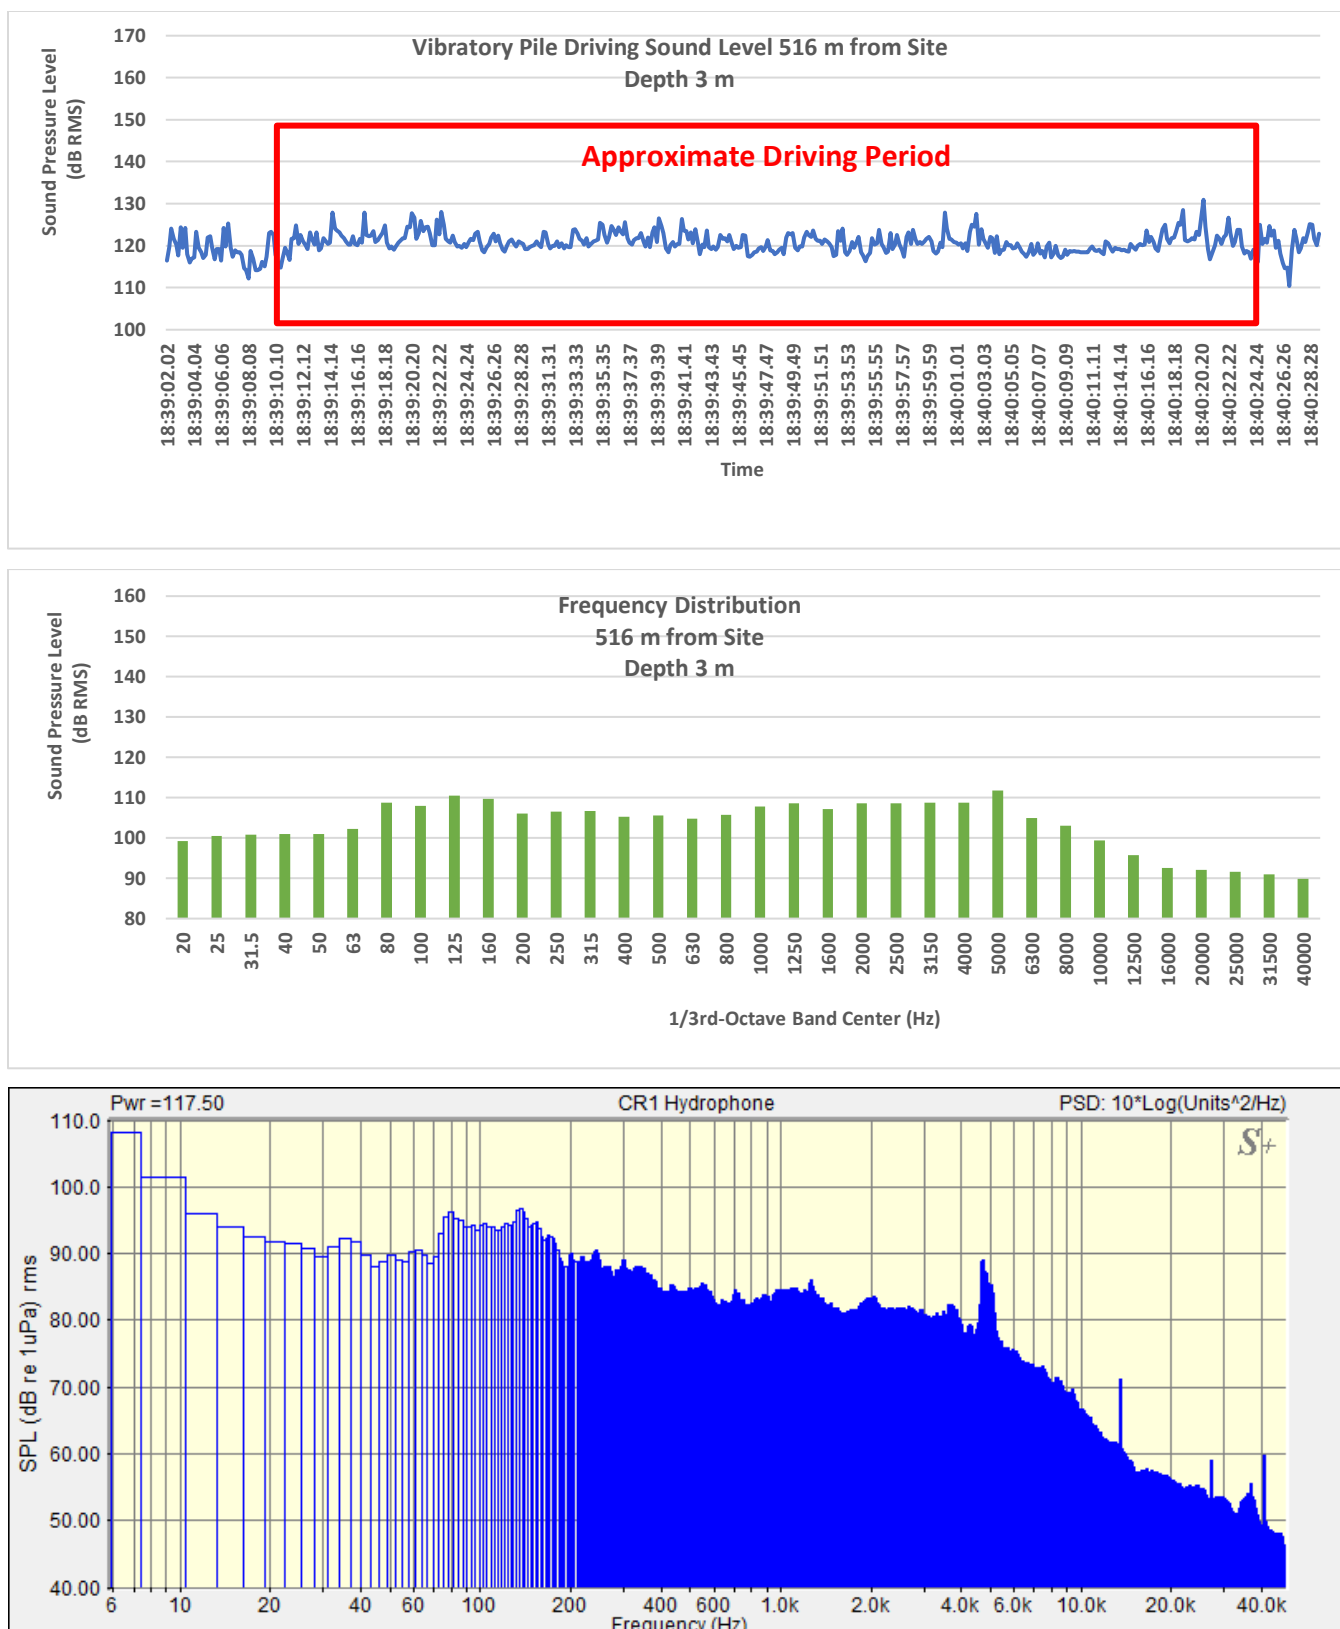
Figure B - 32. Vibratory Pile Driving Pressure Levels, 1/3rd-octave Band Frequency Distribution and PSD plots. 516 m from Construction Site. Hydrophone Depth – 3 m September 12, 2020

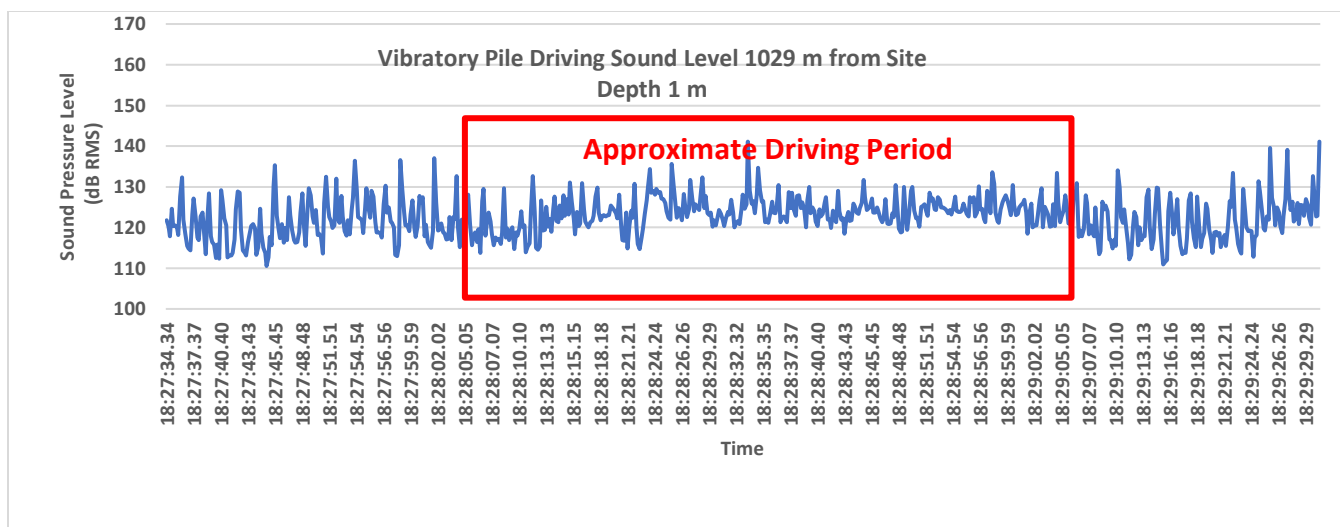
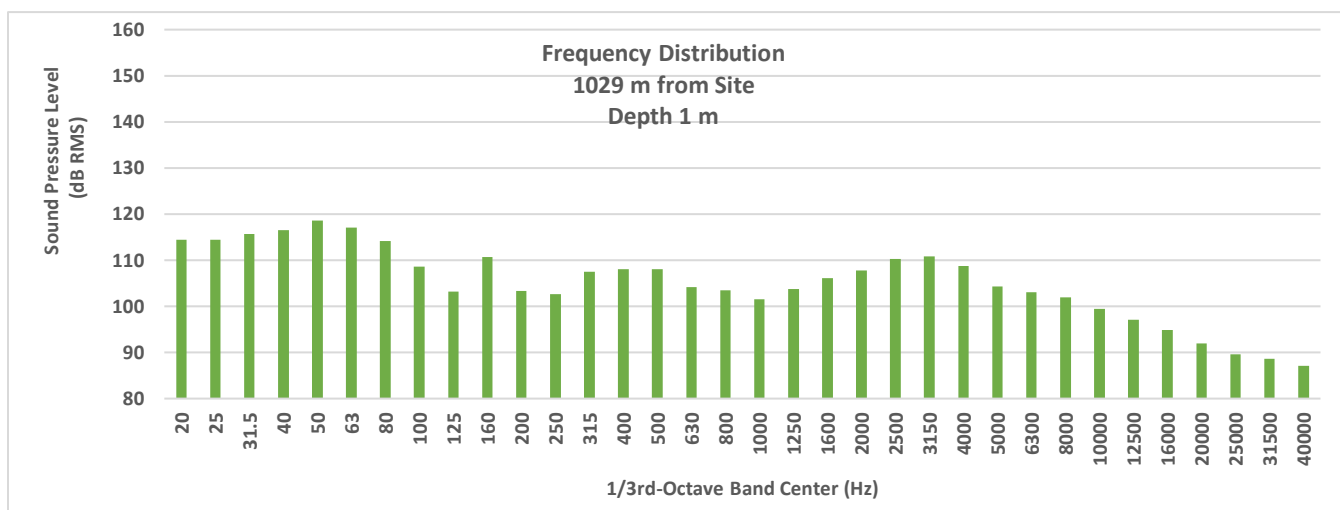
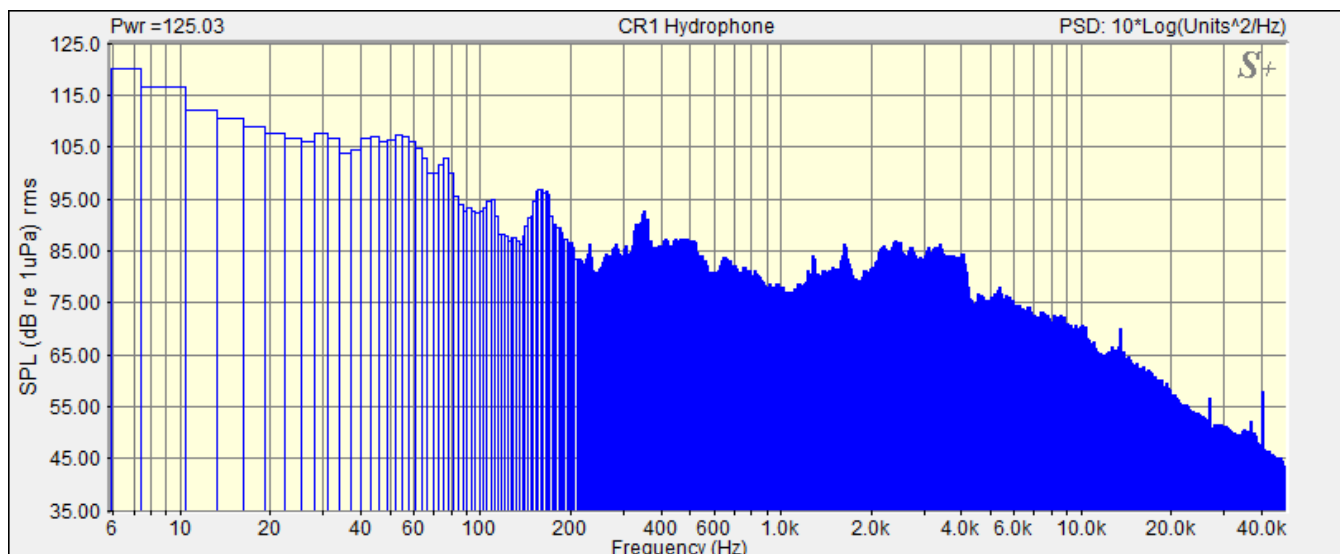
Figure B - 33. Vibratory Pile Driving Pressure Levels, 1/3rd-octave Band Frequency Distribution and PSD plots. 1029 m from Construction Site. Hydrophone Depth – 1 m September 14, 2020

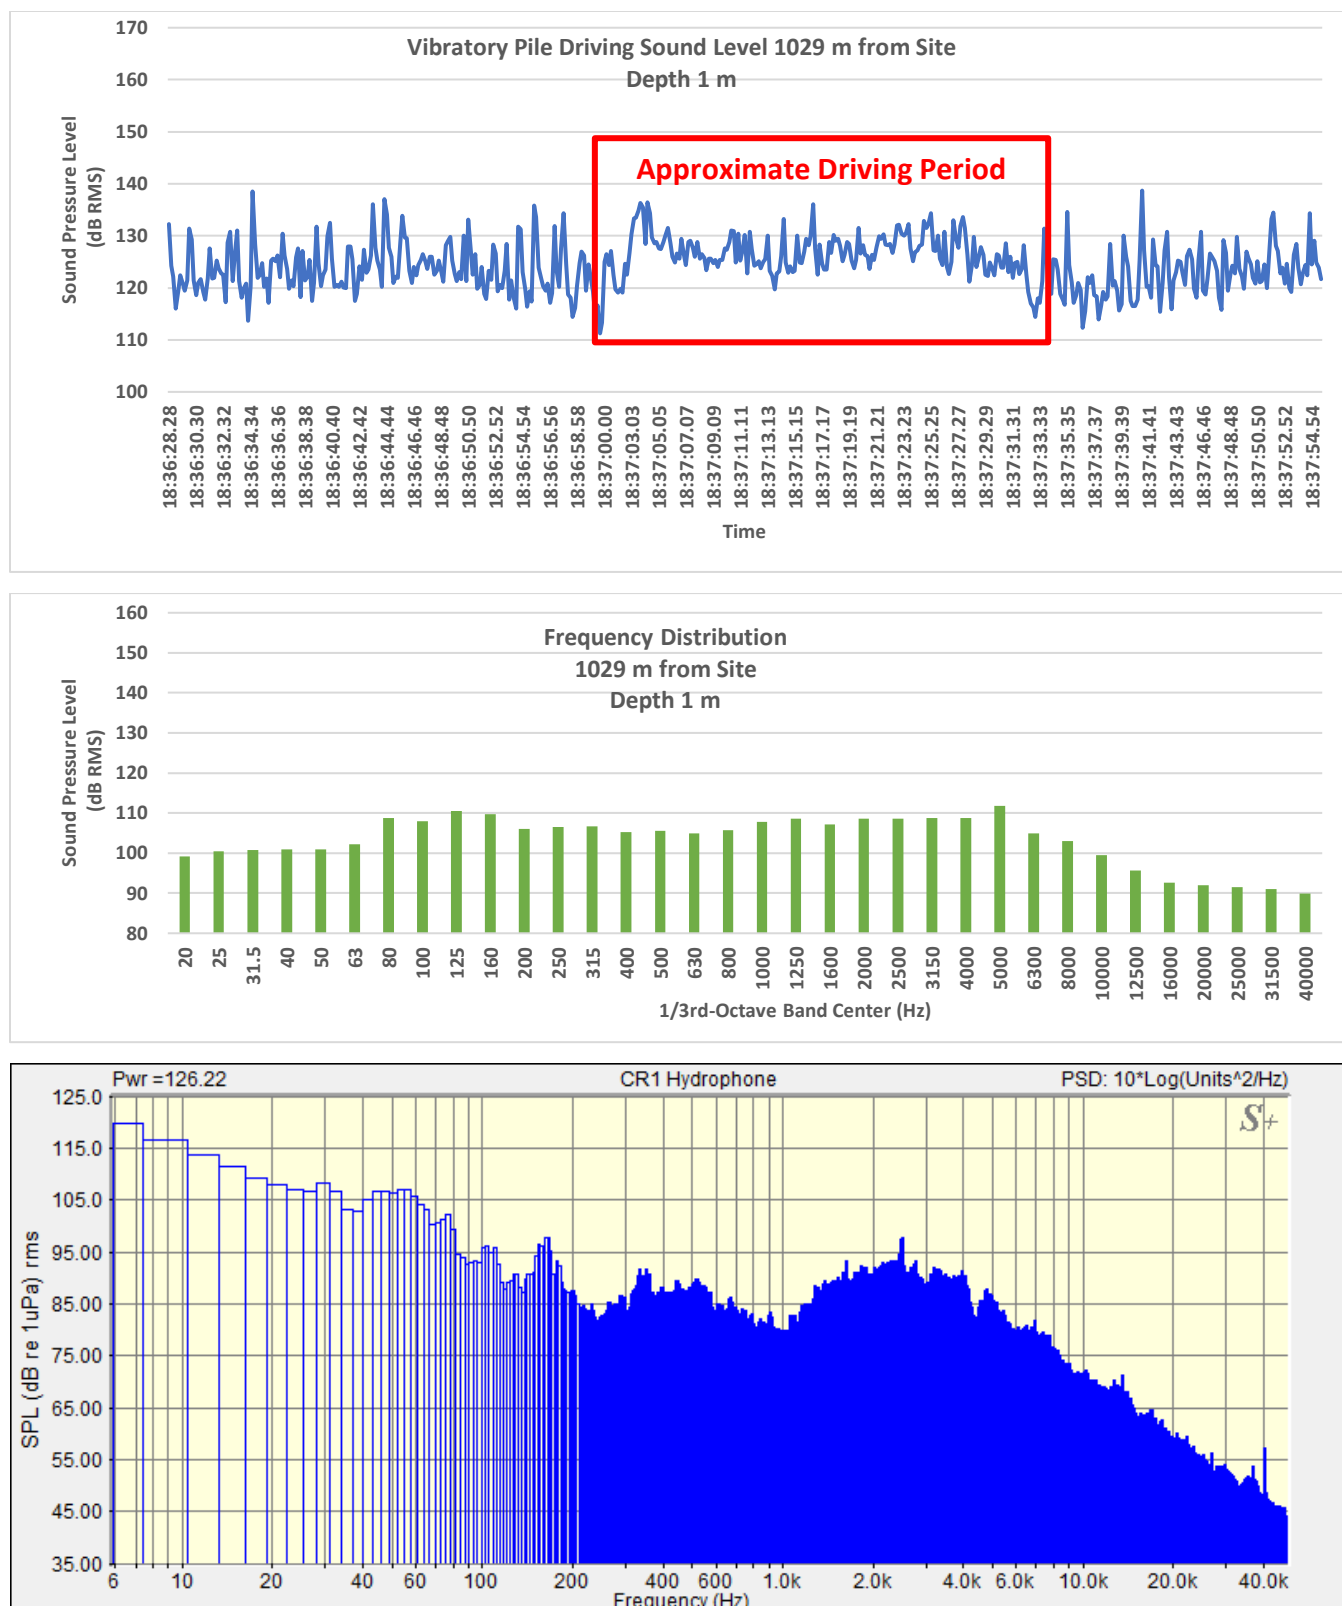
Figure B - 34. Vibratory Pile Driving Pressure Levels, 1/3rd-octave Band Frequency Distribution and PSD plots. 1029 m from Construction Site. Hydrophone Depth – 1 m September 14, 2020
