Subject: Annual Marine Mammal Monitoring Report - Alameda Marina Shoreline
Improvement Project 2020-2021

Alameda Marina Shoreline Improvement Project- Marine Mammal Monitoring 2020-2021 Annual Report

October 15, 2021, First Draft
December 2, 2021, Address NMFS Comments

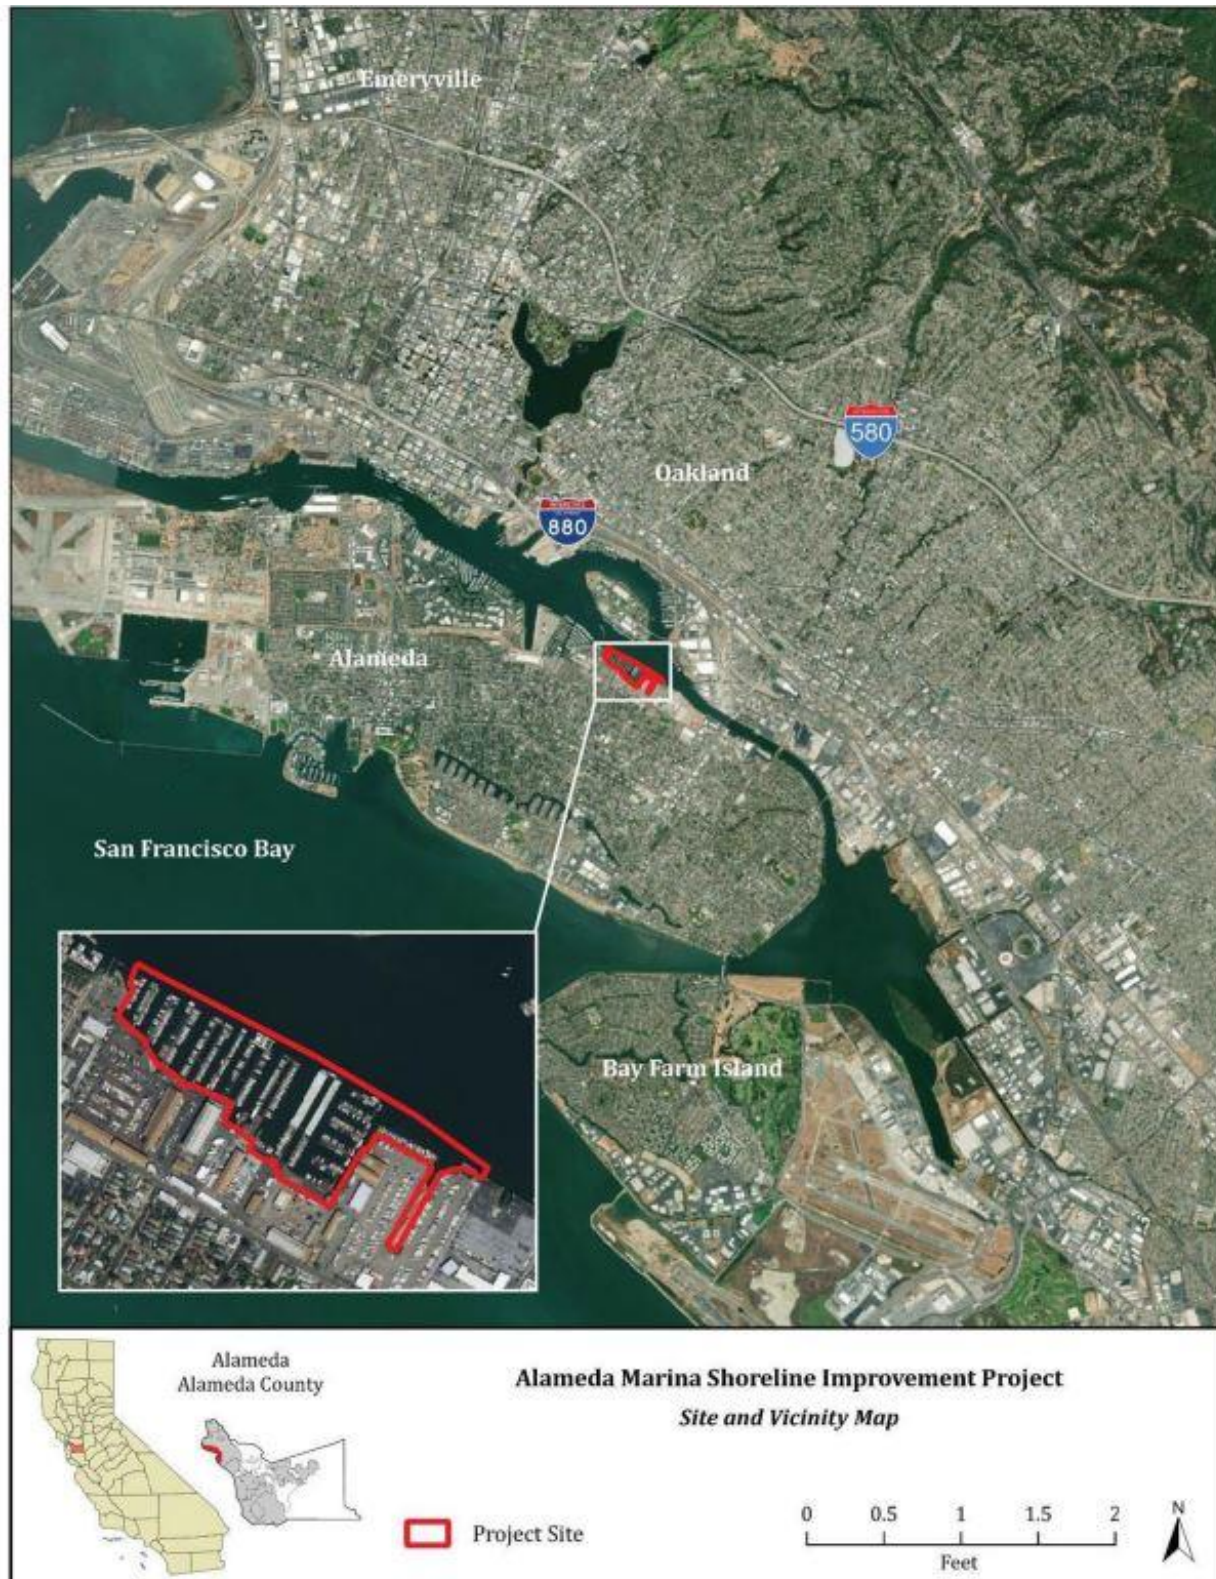
Figure 1 - Aerial map of Alameda Marina Project (Haase 2019)

The Alameda Marina Shoreline Improvement Project (Project) is located on a 20.9-acre area along the Oakland Estuary (Estuary) in the City of Alameda, California (Figure 1). The aim of the Project is to update existing marina facilities, create a new waterfront park, and improve seismic and climate resiliency. Project activities include riprap removal and placement, seawall maintenance, wharf refurbishment, outfall installation, marina reconfiguration, and a boat hoist installation and removal, and other activities associated with mobilization and demobilization. In-water pile driving, both with impact and vibratory hammers, and pile removal are integral to many phases of construction.

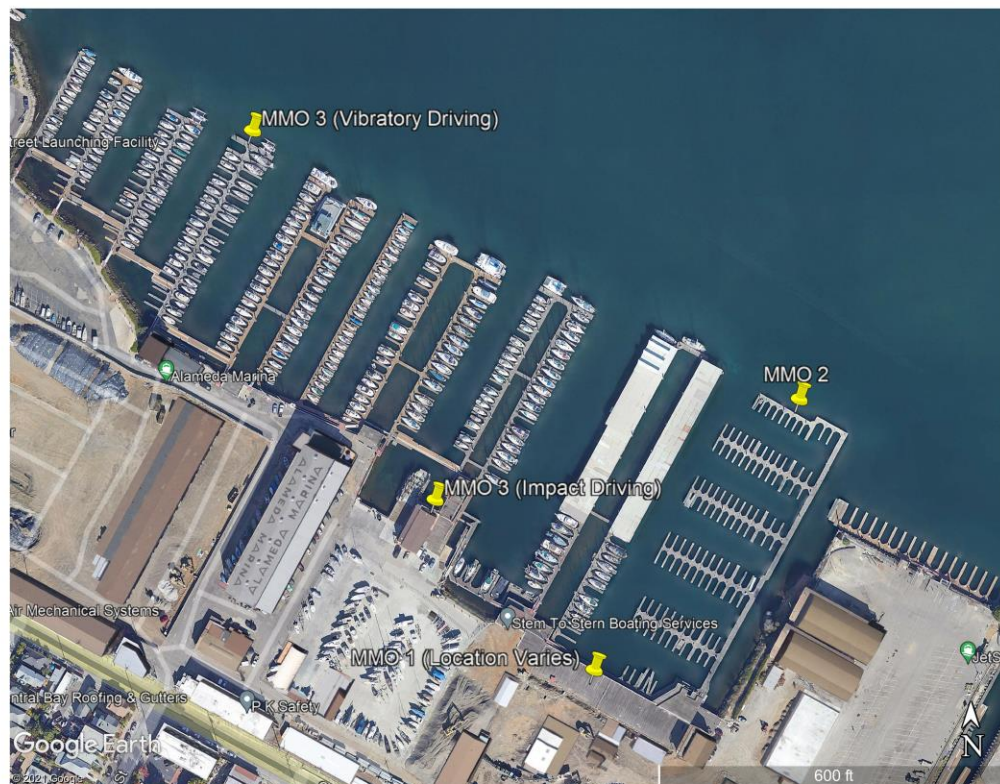
Figure 2 - MMO stations for pile driving/removal activities

Impact driving and vibratory driving were monitored by three MMOs. The lead observer (MMO 1) was stationed at the active pile driving rig or at the best vantage point practicable to monitor the MMEZs for marine mammals and implement shutdown and delay procedures when applicable through communication with the crane and hammer operators (Figure 2). MMO 1 was in constant radio contact with the second MMO (MMO 2) and third MMO (MMO 3) for the purposes of tracking and monitoring observed marine mammals. MMO 1 monitoring was predominately conducted from the Promenade Wharf (~5m elevation, Figure 3), with some monitoring conducted from the balcony of Building 14 (~15m elevation). These monitoring stations provided complete visual coverage of all MMEZs. Portions of the MMZs within Alameda Marina were obscured from MMO 1 by vessels parked in the surrounding boat slips. MMO 2 and MMO 3 were able to provide supplemental coverage of the obscured MMZs from their respective monitoring stations.

The second MMO (MMO 2) was positioned at the terminus of Pier 1 on a platform approximately .3 meters above water level and, depending on the location of construction activity, 170m-200m from the work area. This position provided an unobstructed view of the estuary channel between the marina and the Coast Guard island, all Level A MMEZs and most Level B MMZs. As with MMO 1, MMZs within Alameda Marina were obstructed from view to MMO 2 due to parked vessels, however MMO 1 and MMO 3 provided supplemental visual coverage of MMZs within the marina.

A third MMO (MMO 3) was used to assist with observation of the Level B MMZs for vibratory driving (11/18/2020 – 11/30/2020 and 7/16/2021-7/19/2021) and for supplemental MMEZ and MMZ coverage during impact driving (1/4/2021 - 1/13/2021). During vibratory driving, MMO 3 was positioned at the terminus of pier 7 on a platform approximately .3 m above water level, with an unobstructed view of the estuary channel. Depending on the location of driving, this monitoring position was 250m - 290m from the driving locations. From this position, MMO 3 was also able to monitor areas of the marina that were obstructed from view to the other MMOs by vessels parked in slips. During impact driving, MMO 3 was positioned on the balcony of Building 14 (~15m elevation, 100-150m from driving) which provided supplemental coverage of the MMEZs and MMZs within the marina.

During vibratory driving, the use of three MMOs, rather than two (as recommended in the IHA) was found to allow for greater visual coverage of the MMZs. This was especially true for MMZs within the marina, as vessels parked in slips created numerous visual obstacles, making it difficult to effectively evaluate MMZs within the marina for mammal presence. Further, the monitoring station suggested for MMO 2 in the IHA (barge docked at pier 5) was no longer present and the vessel replacing it was not accessible to the monitoring team.

Conversely, the presence of MMO 3 during impact pile driving for 16-inch concrete piles was found to be largely redundant given the relatively compact monitoring zones for this work. All MMEZs and MMZs were effectively covered by MMO 1 and MMO 2 during this work. Future impact driving for similar pile types will likely only necessitate 2 MMOs.
