Punta Gorda Lighthouse Stabilization Project

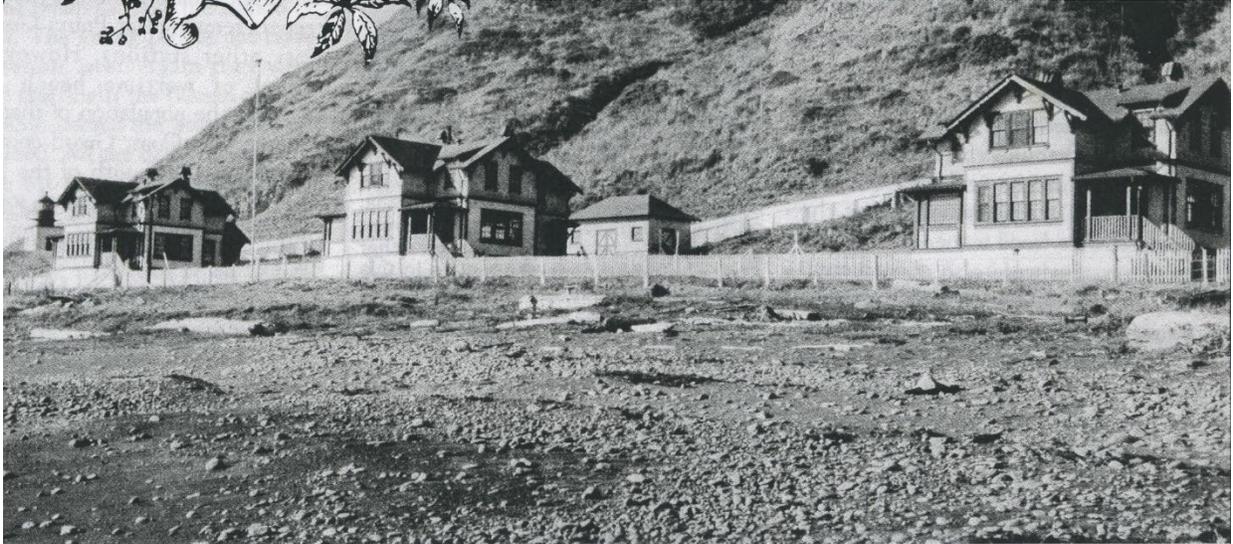
Figure 1. The Punta Gorda Light Station during the operational period. The three houses provided the lighthouse keepers, their families, and military personnel shelter from the frequent harsh winds and rain. The lighthouse and oil house are the only buildings still standing. Notice the rocky shore in front of the residences. The rocky area in the foreground is currently covered with sand.

Punta Gorda circa 1930. The tower can be seen just left of the last keeper's house. USLHS photo.

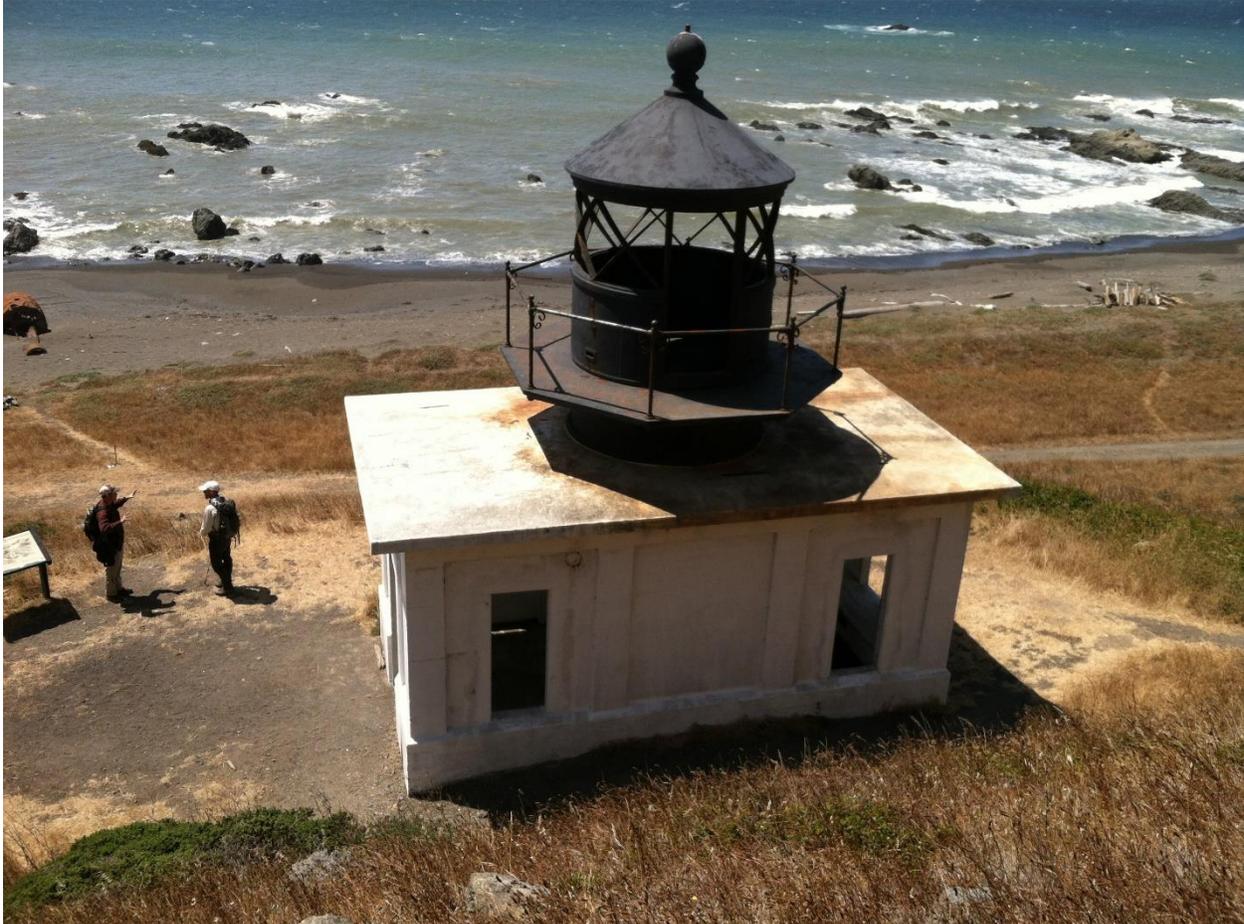
Figure 4. The Punta Gorda Lighthouse during a 2016 site visit.

Despite occasional maintenance by BLM staff and lighthouse advocates, the PGL buildings need extensive repairs. Both of the remaining buildings are constructed of reinforced concrete. The lighthouse building has a metal second story that once housed the lens. The concrete has experienced spalling where large chunks of the walls and ceiling break off due to water intrusion followed by expansion of rusty reinforcement steel (re-bar). The northern portion of the oil house foundation has cracked and separated from the rest of the structure. Finally, anything constructed of metal has experienced substantial corrosion. The major metal pieces include the second story of the lighthouse, the second story access stairs, and above ground oil storage tanks. A portion of the marine terrace east of the Lost Coast Trail north would be designated and fenced for support of construction activities: parking vehicles, storing tools and materials, fuel storage and containment etc. A map of the proposed fenced area is included in Appendix A. The fence would be erected in a way that will exclude elephant seals from moving into the work zone. It may be necessary to erect the fence in sections over time if elephant seals are present in the area. The fence would be moved as the elephant seals move out of the work area.

Correcting the deficiencies in the building will require several separate operations. The first stage will consist of lead paint remediation and demolition of the failing concrete and re-bar followed by treating the remaining structure to prevent further corrosion. The roof of the oil house will be completely demolished along with the northwestern corner of the oil house foundation. Numerous other small concrete repairs will also occur simultaneously. The demolition will use gas powered construction saws, various jack hammers, heavy equipment (likely a backhoe or small excavator), saws, and hand tools.

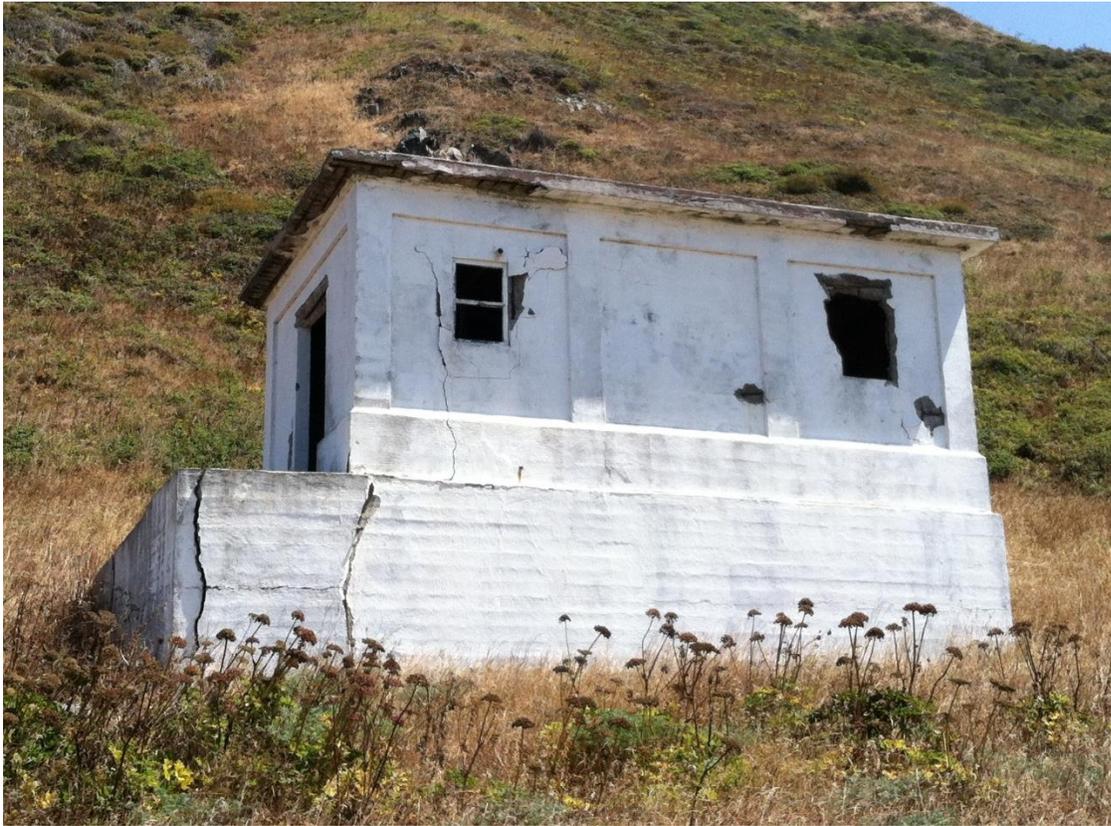
Figure 5. The condition of the oil building at Punta Gorda during a site visit in August 2016.

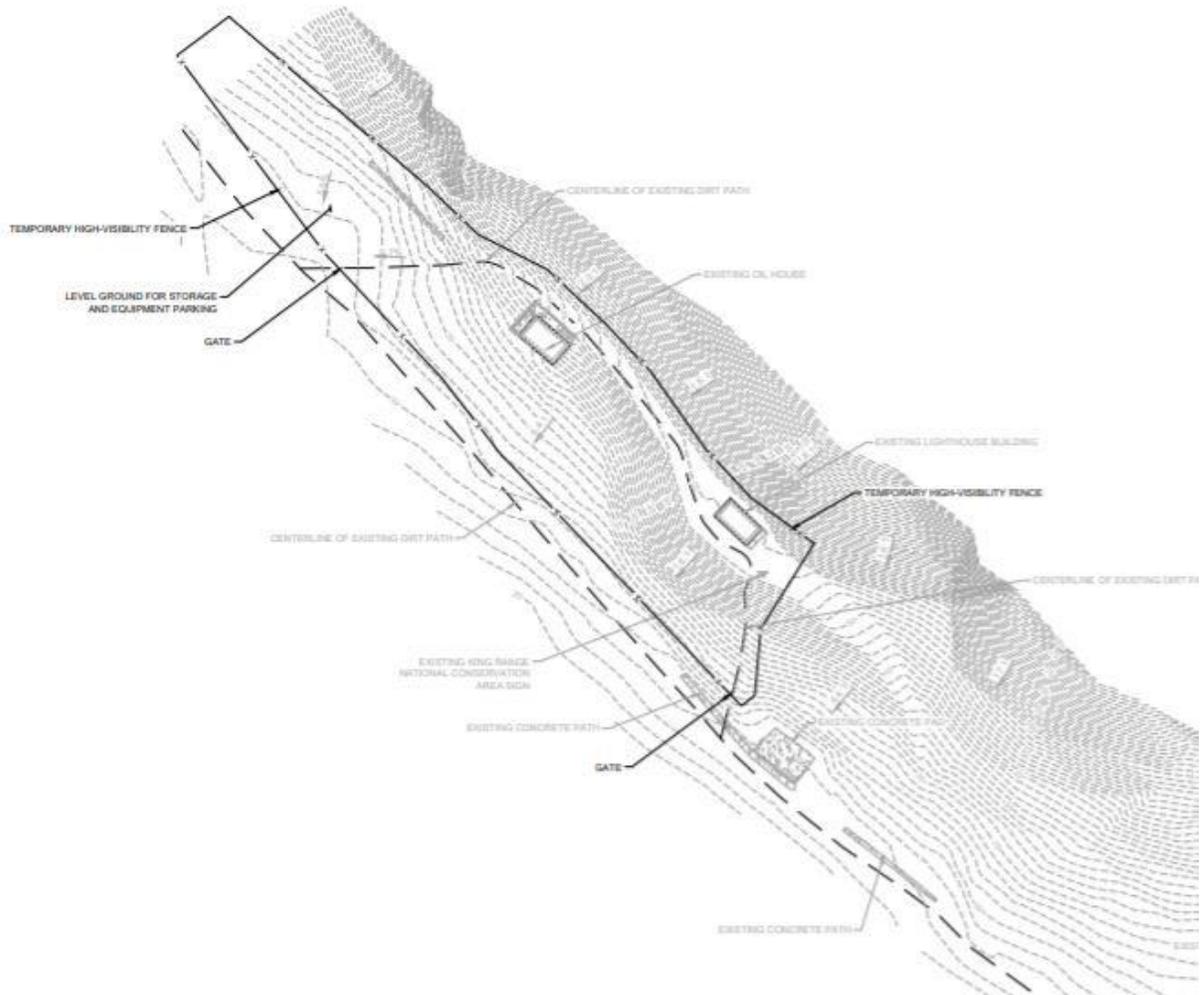
Map 1. Project perimeter. The solid line represents proposed fencing. The dashed line represents the Lost Coast Trail.

We expect the work crew to work 8-10 hours per day, Monday-Friday. However, weekend work may be necessary intermittently to meet work schedule objectives. An area will be fenced to store and secure supplies and equipment. The area designated for storage will be east of the Lost Coast Trail where the seals have not been observed (365106e, 4456365n UTM Zone 10N). A sight plan is included in Appendix A.
