South Fork Wind Farm COP Survey 2017
Protected Species Observer Technical Report

Prepared by: A.I.S. Inc.

Prepared for: Deepwater Wind New England, LLC

South Fork Wind Farm COP Survey 2017
Protected Species Observer Mitigation Report

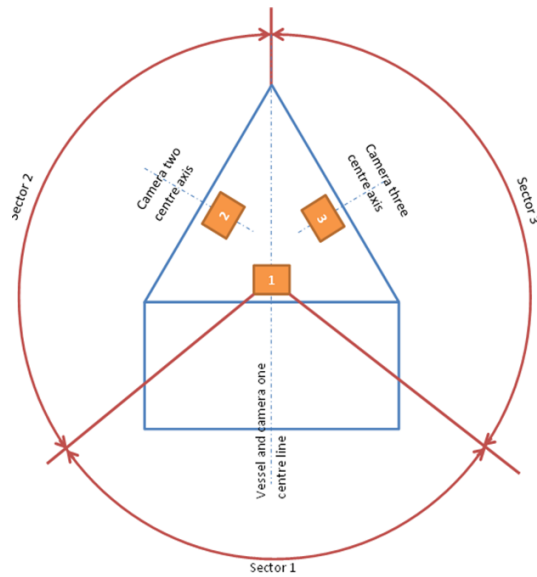
Figure 2 Camera system configuration illustrating 360-degree coverage

During periods of darkness or limited visibility (e.g. fog, heavy rain, poor lighting conditions), thermal imaging cameras will be used to supplement PAM operations. Three camera systems, each providing 120-degrees of coverage, will be positioned at a location high on the vessel and in an area with minimal obstruction to ensure 360-degree coverage of the area surrounding the vessel including the exclusion zone. The PSO will monitor images received from the high definition thermal imaging cameras on display screens. An iPad will also be available for monitoring of the camera displays over a wireless connection.

Thermal cameras were very effective and had multiple benefits in addition to allowing the PSO to view protected species at a greater distance than with night vision monoculars. Having three cameras stationed for a 360 degree view surrounding the vessel with a central monitoring station allowed for one PSO to monitor all three cameras and allowed for longer uninterrupted breaks in the PSO schedule for rest. When one camera malfunctioned in September, causing the PSO scheduled to be revised to have two PSO monitoring during nighttime hours, this caused increased fatigue among the PSO team. We were unable to develop a schedule with the given parameters for 4 PSO with 2 on watch continuously 24/7 that allowed for enough uninterrupted time off to catch up on sleep effectively. The use of thermal cameras for future work requiring monitoring 24/7 would be the preferred method to reduce the number of PSO in situations where space is already limited and helped to reduce overall fatigue by creating better scheduling.

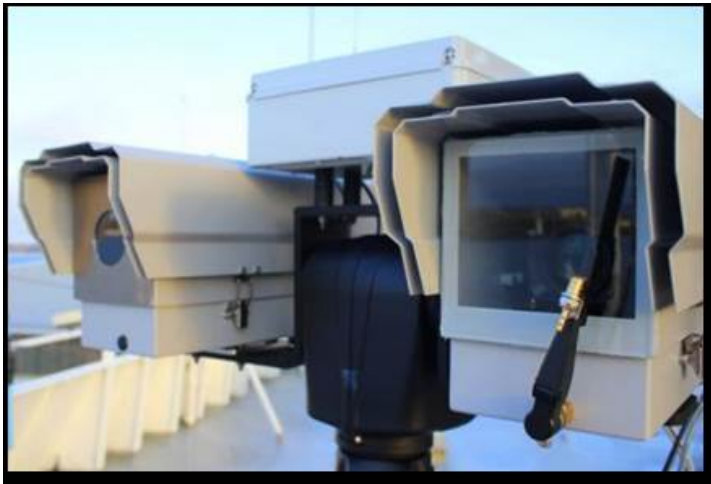
Figure 3 HD and Thermal Imaging Camera

In addition, the following equipment will be included with the Seiche thermal imaging system located on the Fugro Enterprise. Each pan and tilt module makes up a wholly separable Remote High-definition Visual Monitoring (RHVM) system consisting the following:

- Pan and tilt head with two cameras (one HD visual camera and one IR camera)
- Cat7 link to display system
- Display system consisting of one screen per RHVM system
- Overlay of mitigation zone circle/ellipse on both images
- Image stabilization in software such that all images are real time with the horizon horizontal in the displayed image
- Option to stop scan and control pan and tilt manually
- Computer system and software control panel
- Data storage

The system uses one screen per RHVM system to display images from both thermal and visual cameras. Depending on individual preference, a user can choose to view only thermal or visual images at a time to get higher resolution. Images displayed simultaneously will be at smaller resolution.

Early on in the survey, there was some trouble with buildup of condensation inside the thermal and HD camera housing. This required the PSO team to periodically clear the condensation manually. Seiche personnel suggested the use of silica packets to wick moisture out of the air proactively. This greatly reduced the need to manually clear the condensation from the housing. Additionally, there was some buildup of condensation within the connections early on during the survey. This was remedied by adding additional tape to the connections to reduce the chances that water would penetrate.

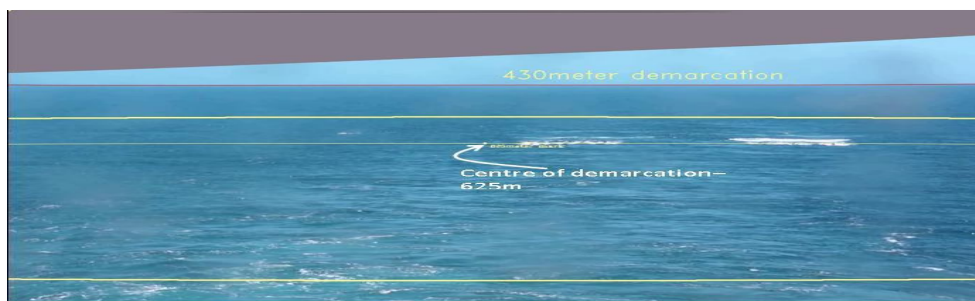
Figure 4 Horizon Detection and Demarcation Zone around Seismic Guns

The images are stabilized in software using horizon detection and an inertial measurement unit. Graphics are drawn on the images to demarcate the mitigation zone on the sea surface. In addition, a mouse pointer system enables distance determination to any point on the image.

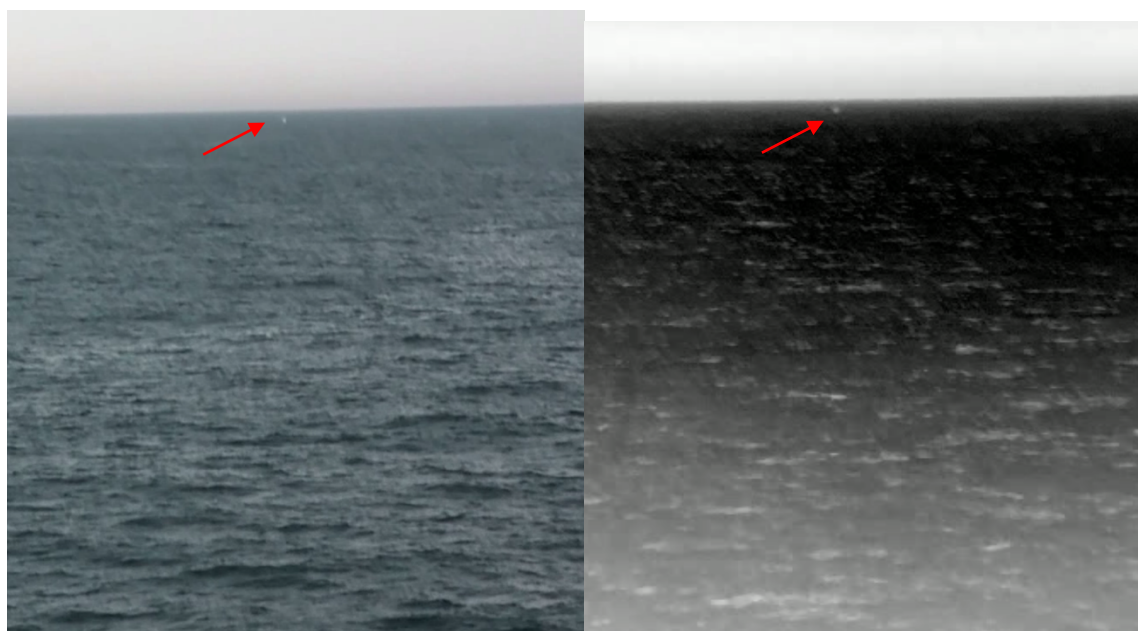
Figure 6 HD and Thermal Images of a blow visually confirmed at 3500m.

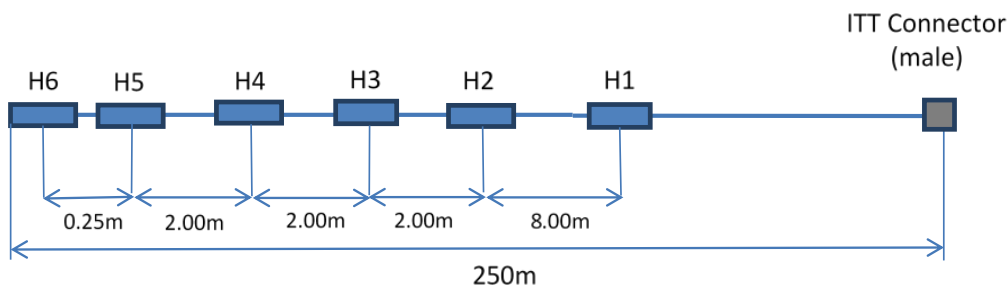
Figure 7 Set Up of the 6 Hydrophone Array Cable

respectively. These three pairs of hydrophones provide the capability to detect the full range of marine mammal vocalizations anticipated to be encountered during the survey.

Simulation exercises were carried out using the PAMGuard software to verify that the within-pair separation provides consistently accurate bearings to a range of marine mammal vocalizations. Test signals used in these exercises simulated right whale up-calls, broadband sperm whale clicks, delphinid whistles, and narrow band high frequency harbor porpoise clicks. Anecdotal reports from surveys utilizing Seiche PAM systems with simultaneous visual and acoustic monitoring indicate that the acoustic range estimates have been sufficiently accurate for decision-making on whether vocal animals are within or beyond a 500m mitigation zone.

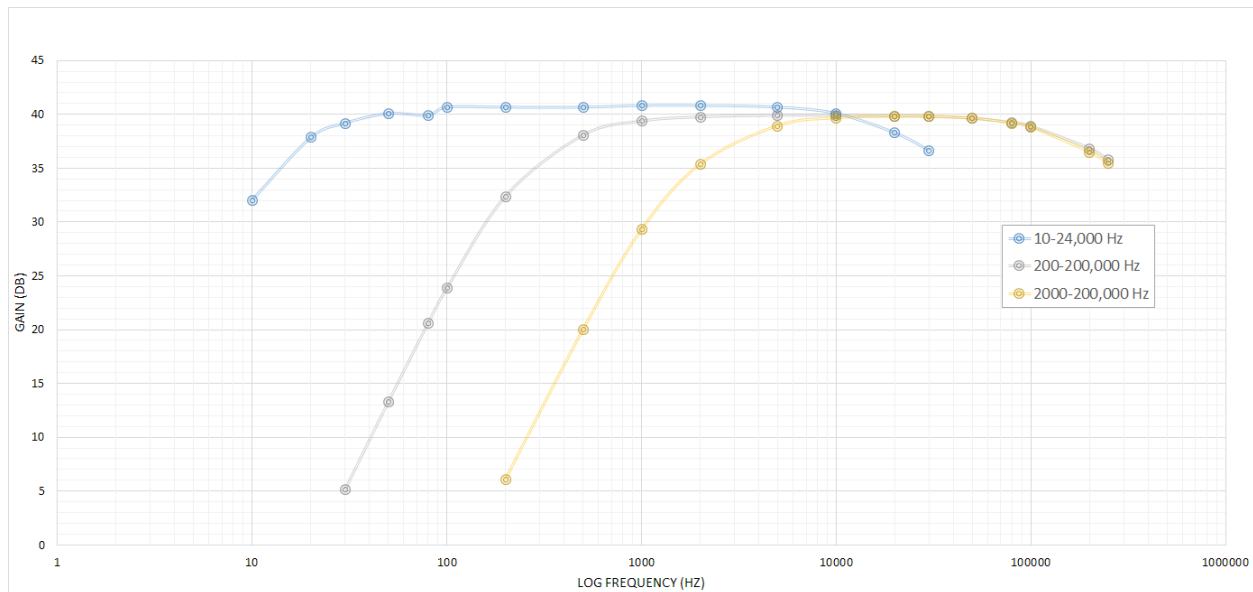
Figure 8 Frequency Response Curve of the Three Types of Hydrophones in the 6 Hydrophone System

Frequency response curves provide a standard for demonstrating hydrophone sensitivity over a range of frequencies. A flat response between the frequencies of interest is desirable, indicating consistent sensitivity across the band of interest. The frequency response curves provided were generated from 10Hz to 24kHz, 200Hz to 200kHz, and 2kHz to 200kHz hydrophone elements (including pre-amps) of a Seiche towed array and are representative of the response curves for the arrays that will be deployed for the survey. The frequency response curves for each element within the arrays (main system and spare) used on the survey will be generated as part of the calibration process prior to their dispatch.

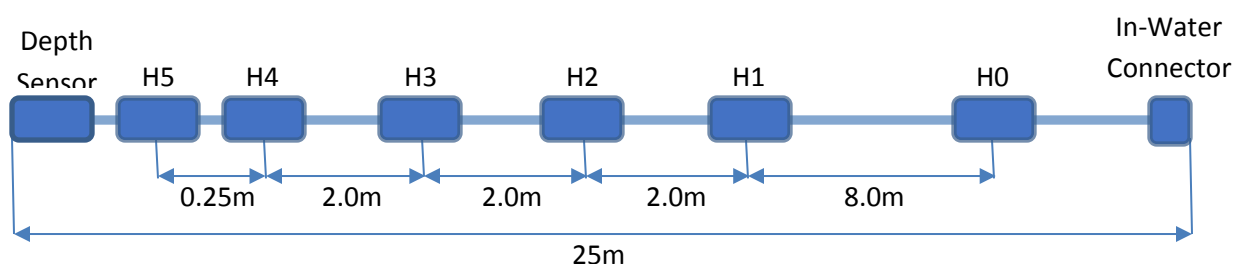
Figure 1 Array configuration with hydrophone separation distances and position of the depth sensor.

The 255m hydrophone array contained six hydrophone elements, two low frequency elements with a frequency response of 10Hz to 200kHz (H1 and H2), two ultra-broadband elements with a frequency response of 200Hz to 200kHz (H2 and H3), and two broadband elements with a frequency response of 2kHz to 200kHz (H4 and H5; Figure 1). The frequency responses for the hydrophones represent the flat response between the two 3dB points. The hydrophones remain sensitive beyond the minimum and maximum frequencies quoted; however, the gain begins to roll off as the frequencies move above or below these values. Hydrophone sensitivity was -166dB re 1V/ μ Pa for the broadband elements and -157dB re 1V/ μ Pa for the low frequency and ultra-broadband elements. In addition to the hydrophone elements, the array cable also contained a depth sensor.

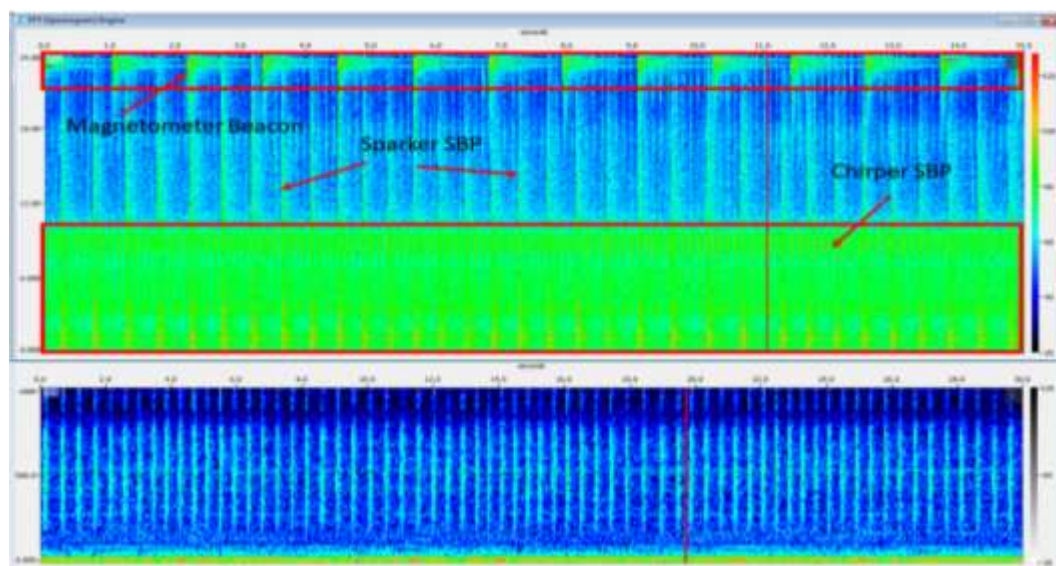
Figure 2 PAMGUARD spectrogram with the various acoustic sources identified.

Filters to remove unwanted or interfering signals were not incorporated. The acoustic sources were too broad in frequency to remove without also removing significant bands of interest for marine mammal detection. The chirper sub-bottom profiler saturated much of the signal below 10kHz, while the sparker sub-bottom profiler produced a broadband signal with energy in excess of 24kHz (Figure 2). The magnetometer beacon and multi-beam echo sounder also contributed to the soundscape; however, these sources were of narrower bandwidths at larger, albeit still short, duty cycles than the two sub-bottom profilers.

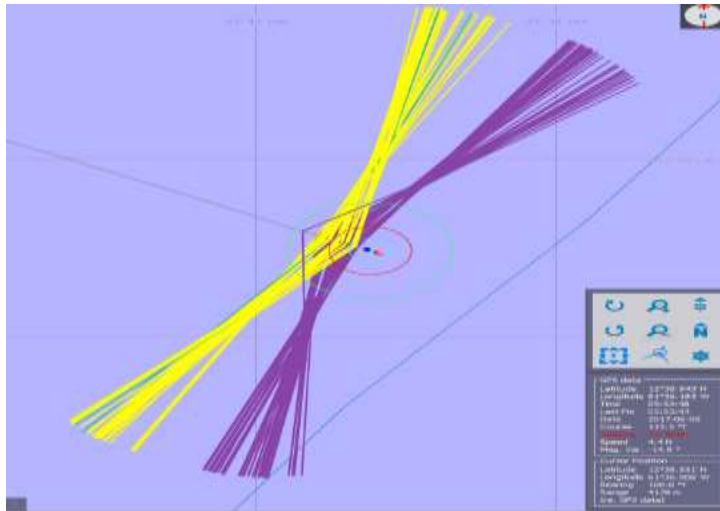
Figure 3 Two localizations (not from the current survey) shown on the map display.

The click detector, whistle and moan detector, and clip generator modules in PAMGUARD may all be used for localization based on target motion analysis (TMA). The two detectors and clip generator use cross-correlation to match the occurrence of a signal on different hydrophone channels and calculate a bearing angle to the signal from the time of arrival differences (TOADs) between the hydrophones in the pairing. When a detection event is long enough, a series of bearings to the vocalizing marine mammal will be plotted on the map display as the vessel advances along the survey line and the animal remains at approximately the same location. These bearing lines will begin to converge, providing an estimated position to the marine mammal (Figure 3).

The use of TMA for localizing marine mammals requires the animal to be stationary or moving slowly relative to the vessel. A long series of vocalizations must also be confidently assigned to an individual animal or very close group of animals. The process works well for sperm whales and singing humpback whales. However, because delphinids are fast moving and change position rapidly, the use of TMA to estimate distance is very difficult.

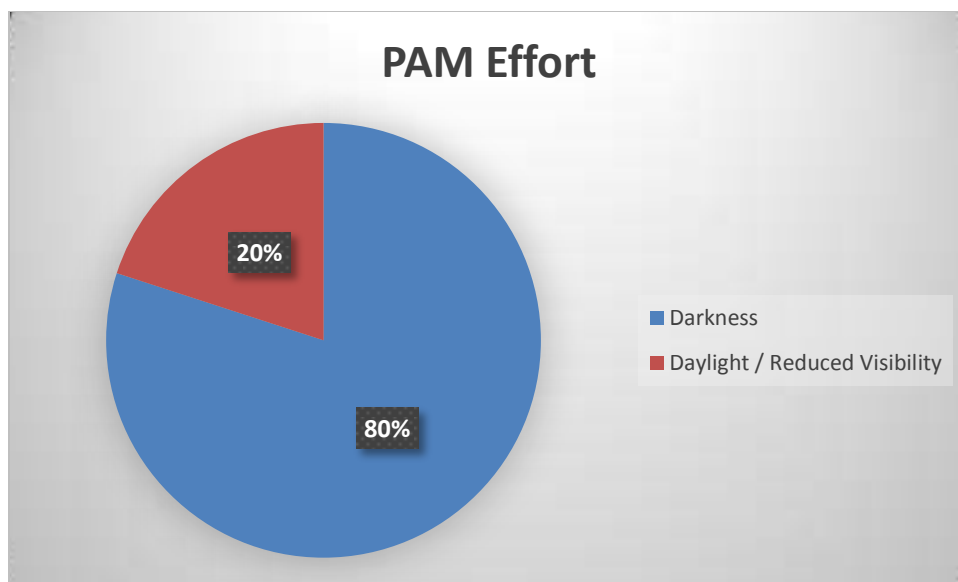
Figure 4 Percentage of acoustic monitoring during the hours of darkness and reduced daylight visibility on board the Fugro Enterprise.

The total PAM monitoring effort carried out from June 15th to November 9th, 2017 on the Enterprise was 995 hours (rounded to the nearest hour). This equated to approximately 80% of PAM effort during the normal monitoring hours of darkness, and 20% effort concentrated during periods of reduced daylight visibility (Figure 4). Persistent fog on a few days during the survey resulted in the two PAM operators having to work the full 24 hours (12 hours each). On these days, there was a high risk of fatigue due to short, interrupted rest periods.

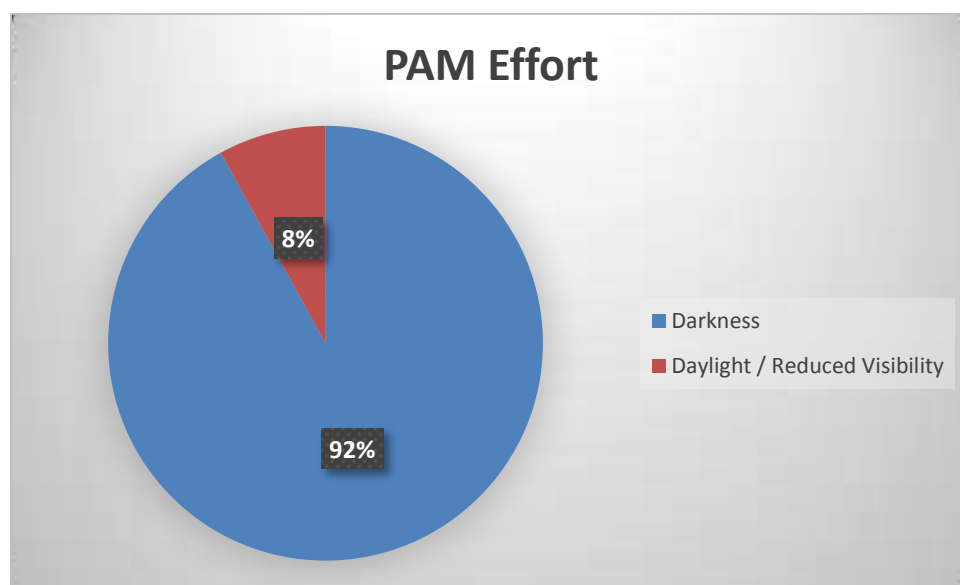
Figure 5 Percentage of acoustic monitoring during the hours of darkness and reduced daylight visibility onboard the Megan Miller.

The total PAM monitoring effort carried out from November 1st to December 30th, 2017 on the Megan Miller was 215 hours and 47 minutes. This equated to approximately 92% of PAM effort during the normal monitoring hours of darkness, and 8% (16 hours 15 mins) effort concentrated during periods of reduced daylight visibility. (Figure 5)

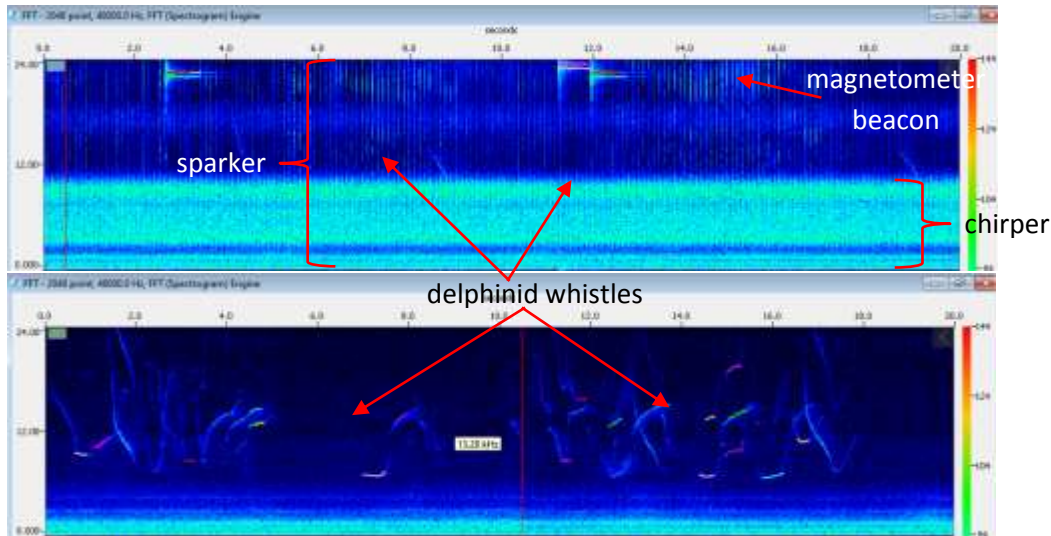
Figure 6 PAMGUARD spectrograms from the same delphinid detection event, with the acoustic sources active on the top panel and the acoustic sources inactive on the bottom panel.

The two sub-bottom profilers (sparker and chirper) used for the HRG survey generated a wide band of noise that made detection of cetacean vocalizations below 10kHz challenging. When one or both sources were active, cetacean vocalizations below 10kHz were essentially masked for detection by the operators and therefore reduced the detection capabilities of the system (Figure 4). Aural monitoring was also difficult for long periods; therefore, the operators would often alternate between periods with the headphones over their ears and with the headphones around the neck, just below the ears.

Filtering of the sound sources was not possible due to the wideband nature of the acoustic sources. Removing the sound sources from the raw signal would have also removed signals of interest below 10kHz. Reducing the source activity or ‘shot point’ interval for the various acoustic sources may have lessened the effect; however, this was not tested, and the intervals used were necessary to accomplish the goals of the survey.
