# Robert Miner Dynamic Testing of Alaska Inc.

Dynamic Measurements and Analyses for Deep Foundations

Re: Sound Source Verification  
Down-hole Hammer Operation, August 13 & 15, 2018  
Vibratory Hammer Operation, August 15, 2018  
Biorka Island Dock Replacement Project, Southeast Alaska

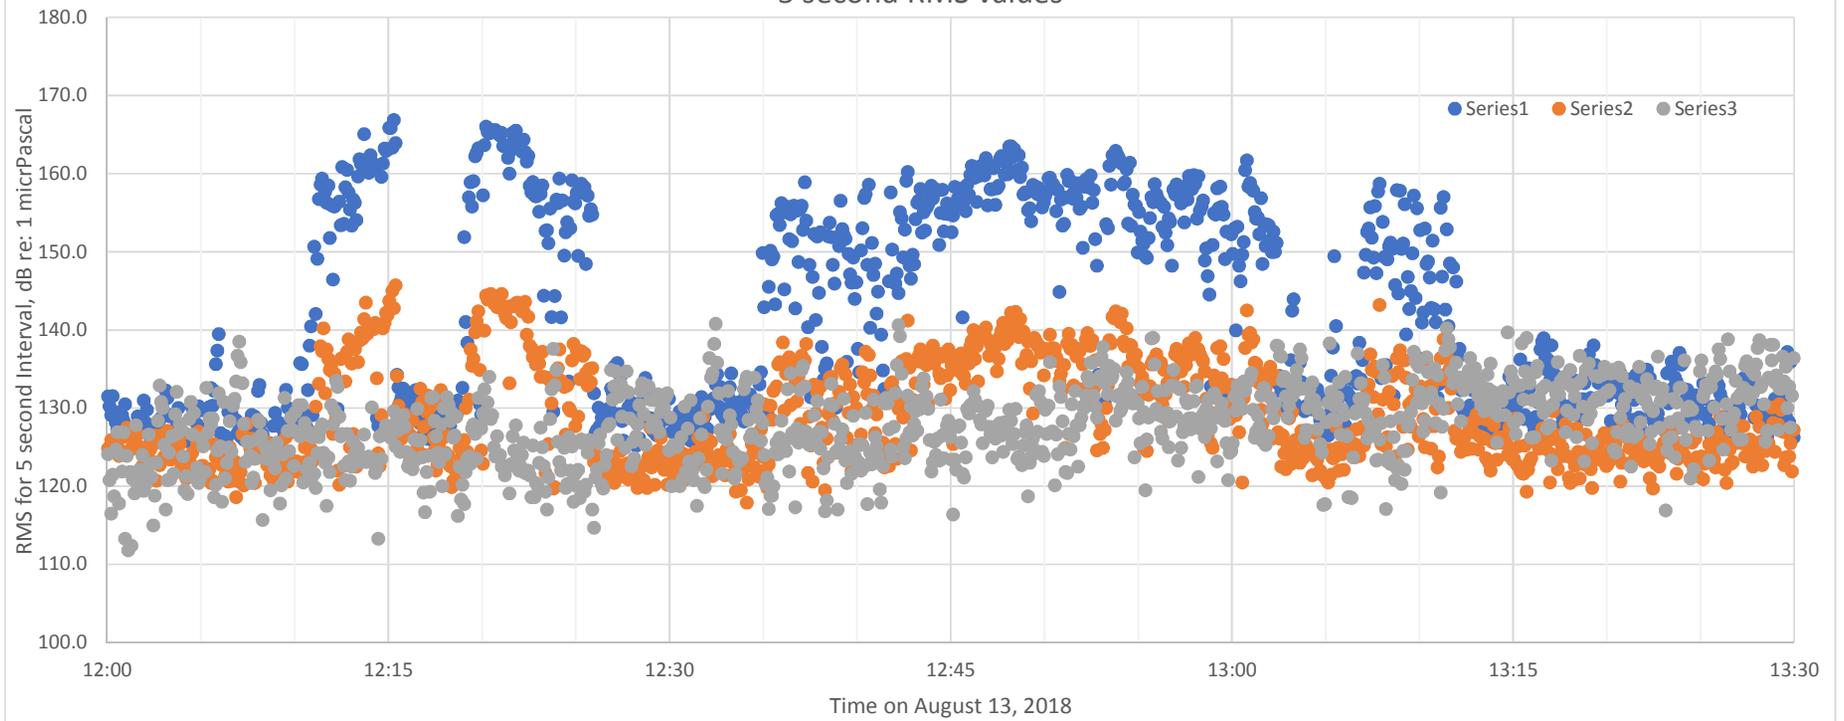
Down Hole Hammer, Pile F14  
5 second RMS values

Attached figures presents  $RMS_5$  values at the various hydrophone locations as the down-hole hammer drove Pile F14 on August 13 and Pile E14 on August 15

For Pile F14 driving occurred within a period of approximately 60 minutes, with intermittent pauses such that actual driving time totaled approximately 45 minutes. Within the figure the 10, 200 and 1200 m locations are indicated as Series 1, 2 and 3, respectively. When driving started at approximately 12:10 PM the levels at 10 m gradually rose from prior ("ambient") levels of approximately 130 dB to levels of 159 to 167 dB, and then the hammer was halted for approximately 5 minutes. During subsequent driving the levels at 10 m typically ranged from 147 to 164 dB.  $RMS_5$  values at the 200 m location followed a very similar pattern, but with significantly lower levels. The  $RMS_5$  measurements at the 1200 m distance do not appear to rise during hammer operation. The 1200 m location does show a slight trend of increasing levels overall during the 1.5 hours depicted in the figure. We attribute this slight increasing

trend to the gradually building sea swells, a condition which was sufficiently severe that it warranted a halt in construction activity on the crane barge within Symonds Bay.

Based on the measurements and computed  $RMS_5$  values for Piles F14 and E14 we consider a level of approximately 158 dB RMS (re:1 microPascal) to be a characteristic RMS level at the 10 m location during operation of the down-hole hammer. The maximum  $RMS_5$  was 167 dB and 165 dB for Piles F14 and E14, respectively. Calculations of  $RMS_{30}$ , for a 30 second period indicated peak levels of 165.3 and 160.1 dB for piles F14 and E14, respectively, and further support a value of 158 dB as characteristic for the 10 m location during sustained hammer operation. While a level of 158 dB appears reasonable for characterizing sustained operation, we note that in practice hammer operation was quite intermittent; the mean or average values during all driving is likely to be close to 153 dB if the longer periods of hammer stoppage are excluded, and close to 150 dB if the entire period from initial start to final stop is considered.

At the 1200 m location the time series data occasionally contain discernable signals within the marked ambient signal that can be readily identified as those from the down-hole hammer. However, within most of the time series data the hammer signals could not be identified and when the hammer operated the  $RMS_5$  levels did not increase discernibly, as show in the figures for Piles F14 and E14. Because background levels were likely elevated by the heavy swells on August 13 and 15, it is possible, and perhaps likely, that on a calmer day the 1200 m location would show a small but discernable increase in RMS levels during down-hole hammer operation.

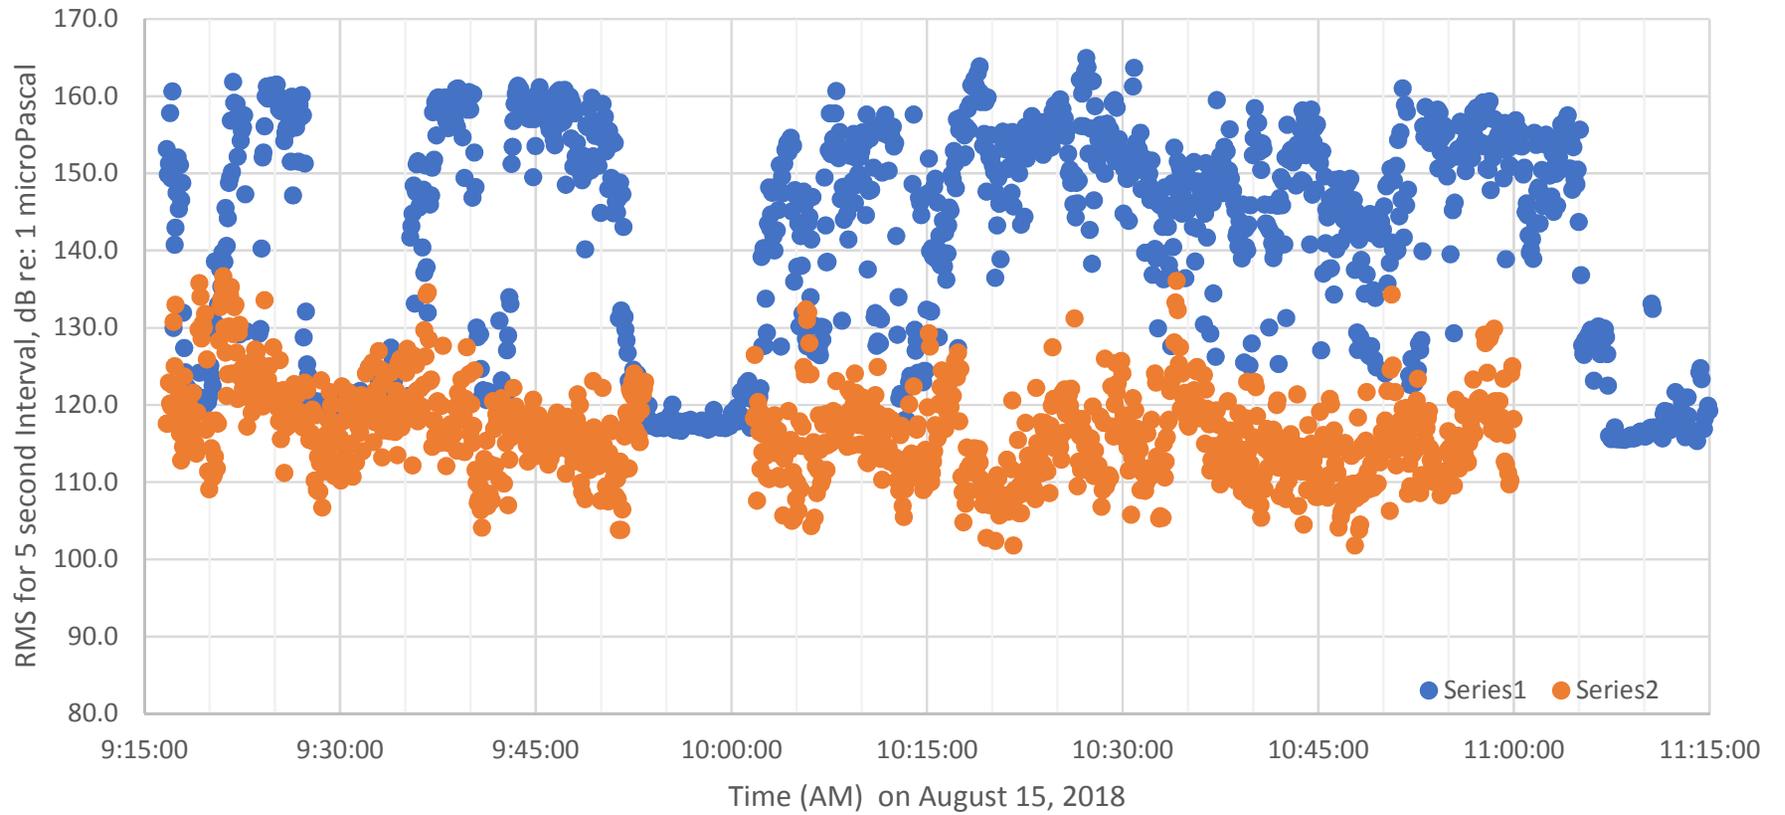
### Downhole Hammer, Pile E14 5 Second RMS Values

For Pile E14 driving occurred intermittently within a period of approximately 110 minutes, with hammer operation totaling approximately 90 minutes. In the attached figure for Pile E14 the 10 and 1200 m locations are labeled as Series 1 and 2, respectively. At the 10 m location the  $RMS_5$  levels during hammer operation were typically between 142 and 162 dB, with peak values of 165 dB. The  $RMS_5$  levels at 1200 m did not appear to rise during hammer operation. The apparent trend of gradually decreasing average  $RMS_5$  levels at the 1200 m location may be attributed to the gradual decline in the sea state following the severe swells of late August 13 and August 14.

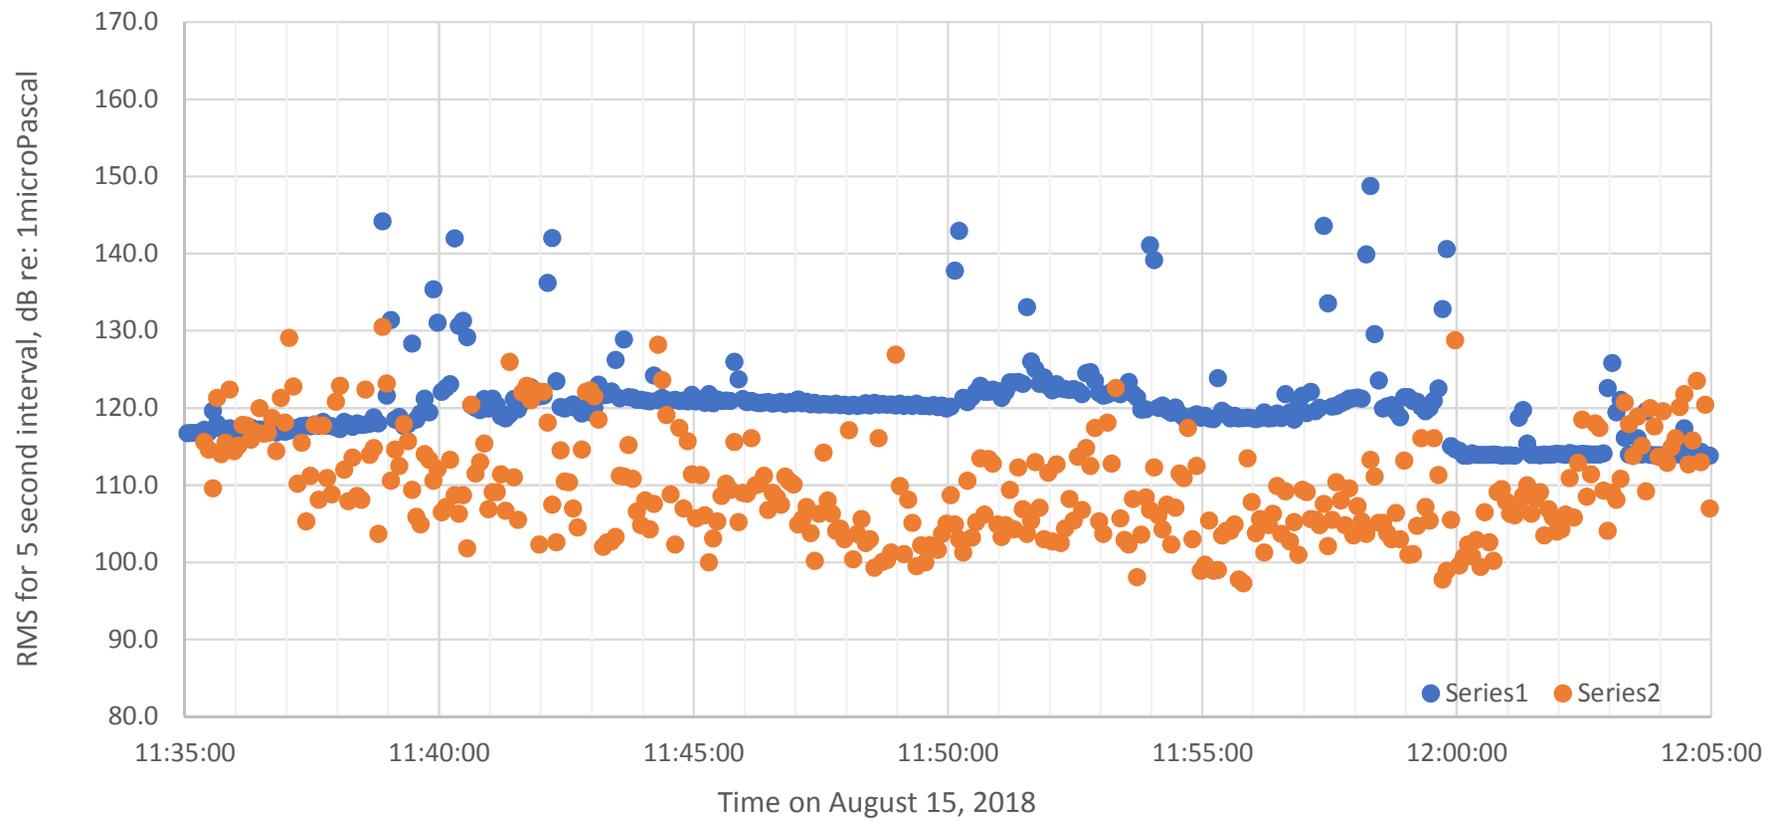
### Vibratory Hammer, Piles D14, F14, D12 & E12 5 Second RMS values

One attached figure presents the computed  $RMS_5$  values for the period of approximately 20 minute length during which Piles D14, F14, D12 and E12 were proofed. Within that figure the 10 m and 1200 locations are labeled as Series 1 and 2, respectively. Hammer operation on each pile was very brief but times of hammer operation may be precisely identified by review of the time series (wave form) data that reveals the characteristic signal. Table 1 contains a summary of the times of driving and the associated results for the 10 m location; the  $RMS_5$  levels range from 139 to 149 dB during vibratory driving. As mentioned above it is customary to characterize source levels for vibratory driving using a 30 second RMS integration limit. However, given the very brief use of the vibratory hammer on this project we used a 5 second limit; use of a 30 second limit would yield significantly lower RMS values.

During the period that the hammer was used the ambient  $RMS_5$  level at the 10 m location was very close to 120 dB. The slightly lower apparent ambient levels just prior to 11:40 AM and just after 11:58 AM probably reflect that fact that the large hydraulic power pack that energized the hammer operated on the deck of the work barge during hammer operation. Isolated high  $RMS_5$  values outside the period of hammer operation likely reflect placement of the hammer onto the various piles.

At the 1200 m location the  $RMS_5$  data do not increase discernibly during hammer operation. These data are consistent with the results for the down-hole hammer, wherein activity that produced higher  $RMS_5$  levels at the 10 m location were not discernable at the 1200 m location.

Table 1. Summary of Results for the ICE 22B Vibratory Hammer			
Pile	Start Time HH:MM:SS	End Time HH:MM:SS	Computed $RMS_5$
D14	11:42:12 AM	11:42:17	142 dB
F14	11:50:11 AM	11:50:15	143 dB
D12	11:53:59	11:54:06	139 dB
E12	11:57:23	11:57:28	144 dB
E12	11:58:14	11:58:22	149 dB
