*San Francisco–Oakland Bay Bridge
East Span Seismic Safety Project*

**Marine Foundation Removal Project
2017 Post-Blast Marine Mammal Report**

California Department of Transportation

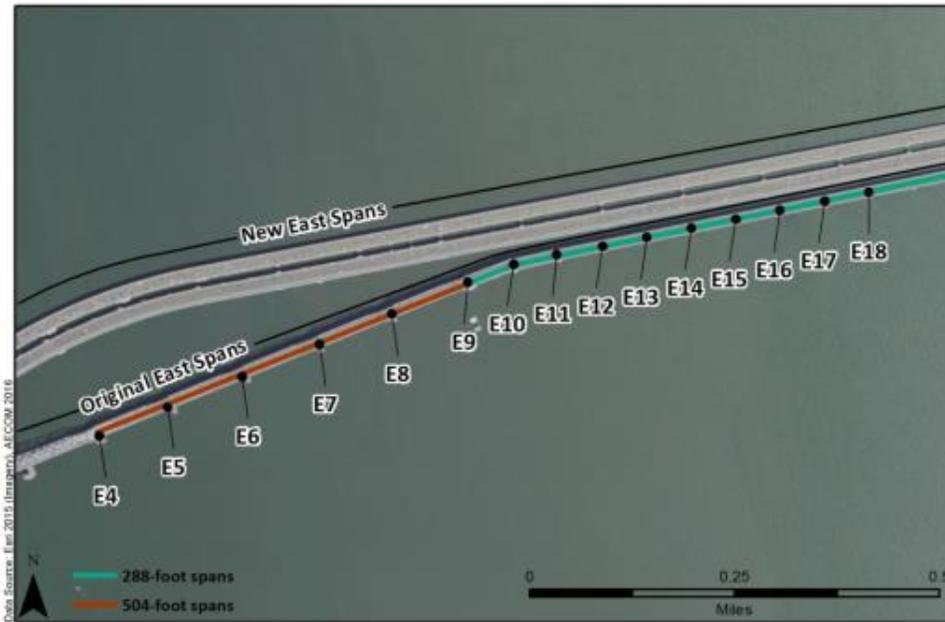
Figure 1-1. Locations of Original East Span Marine Foundations, Piers E4 to E18

(Figure 1-1). The elevation of the new east span in relation to the original east span is shown in Figure 1-2. Approximate locations of each pier are shown in Table 1-1.

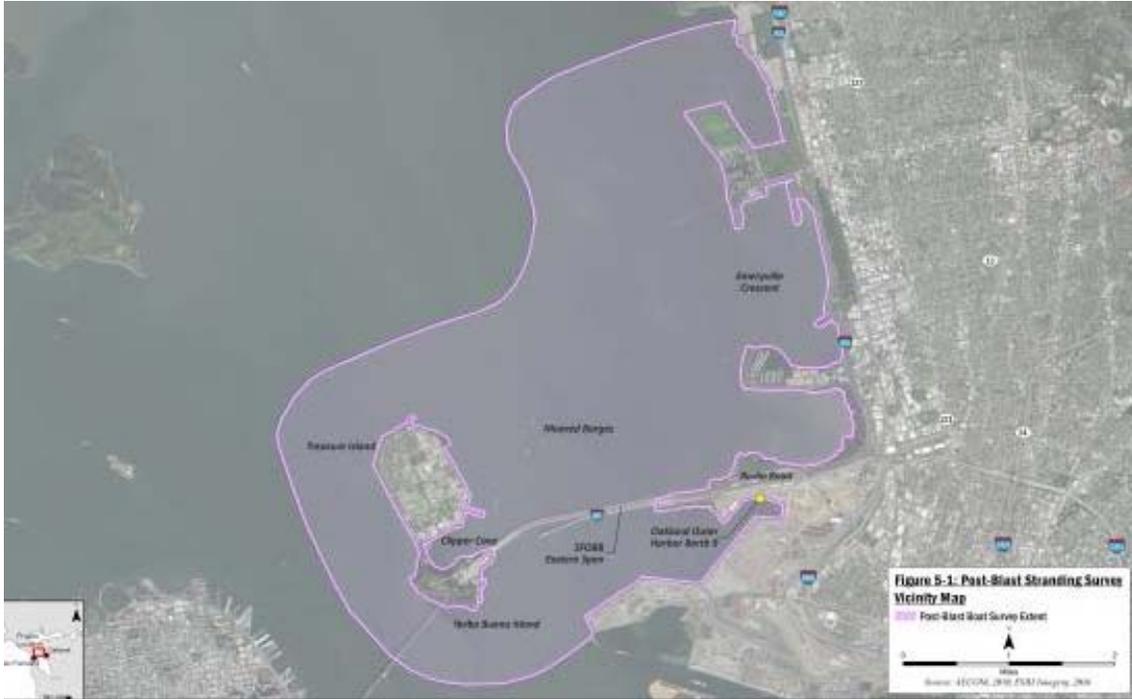
Figure 3-1. Stranding Survey Area

Stranding surveys were conducted by boat and along the shoreline in the vicinity of the SFOBB new and original east spans (Figure 4-1). Boat surveys were conducted from Oakland Outer Harbor Berth 9 to Clipper Cove, counter-clockwise around Treasure Island and YBI. From YBI, the boat surveys included the moored barges on the north side of the new span, along the old east span piers, northeast toward Richmond, the Emeryville breakwater, and the Emeryville Crescent, before returning to Berth 9. Each survey path varied slightly, depending on field and tide conditions. Land surveys were conducted along the shoreline at the OTD, at the Emeryville Crescent, and along the shoreline north of the Oakland toll plaza and SFOBB approaches. The shoreline includes two stretches of sandy beach, riprap, and portions of Radio Road, which runs parallel to the north side of Highway 80 west-bound.
