# 2019 Annual Biological Monitoring and Mitigation Compliance Report

Chevron Long Wharf Maintenance and Efficiency Project

Chevron Products Company

January 15, 2020

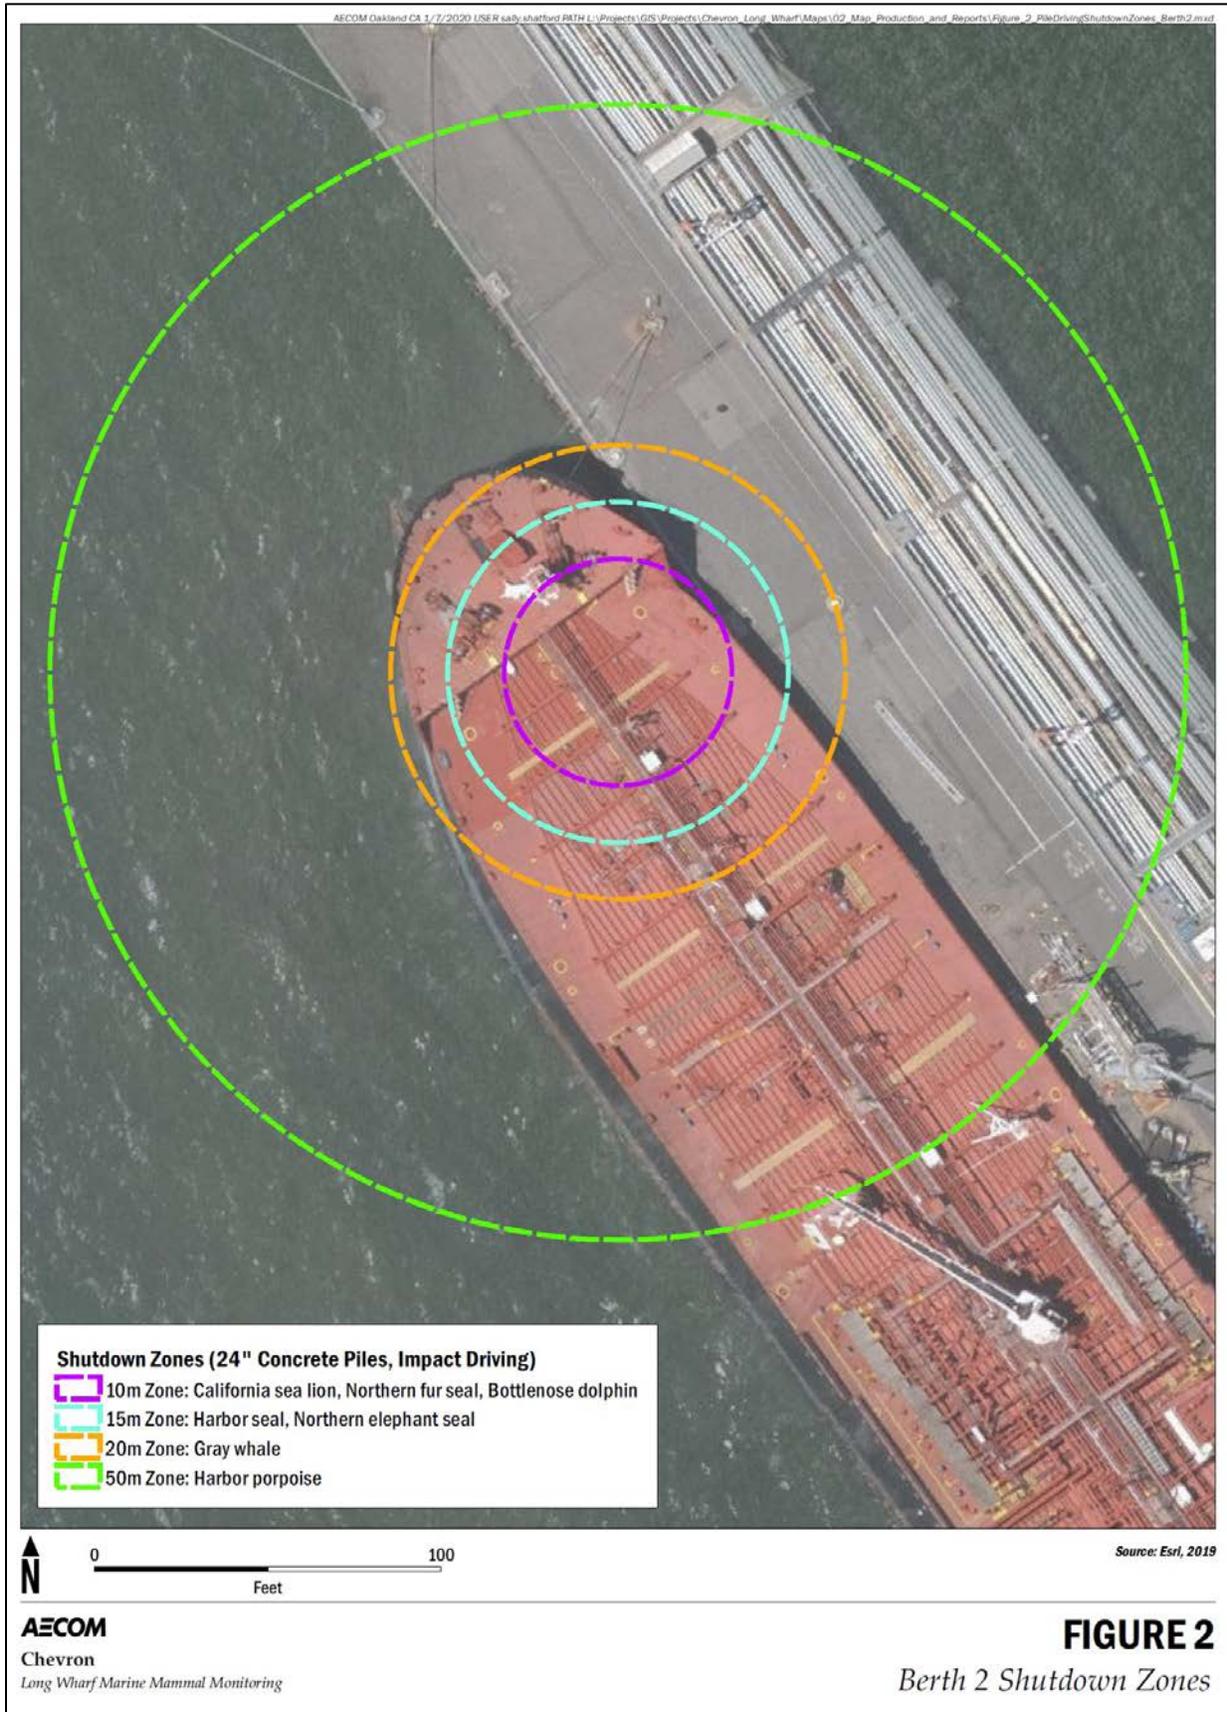
Figure 2. Pile Driving Shutdown Zones at Berth 2

On June 6, impact driving of a 24-inch concrete pile was held until the MMOs confirmed that a harbor seal was outside of the shutdown zone. The shutdown zones implemented at Berths 2 and 4 are shown in Figures 2 and 3.

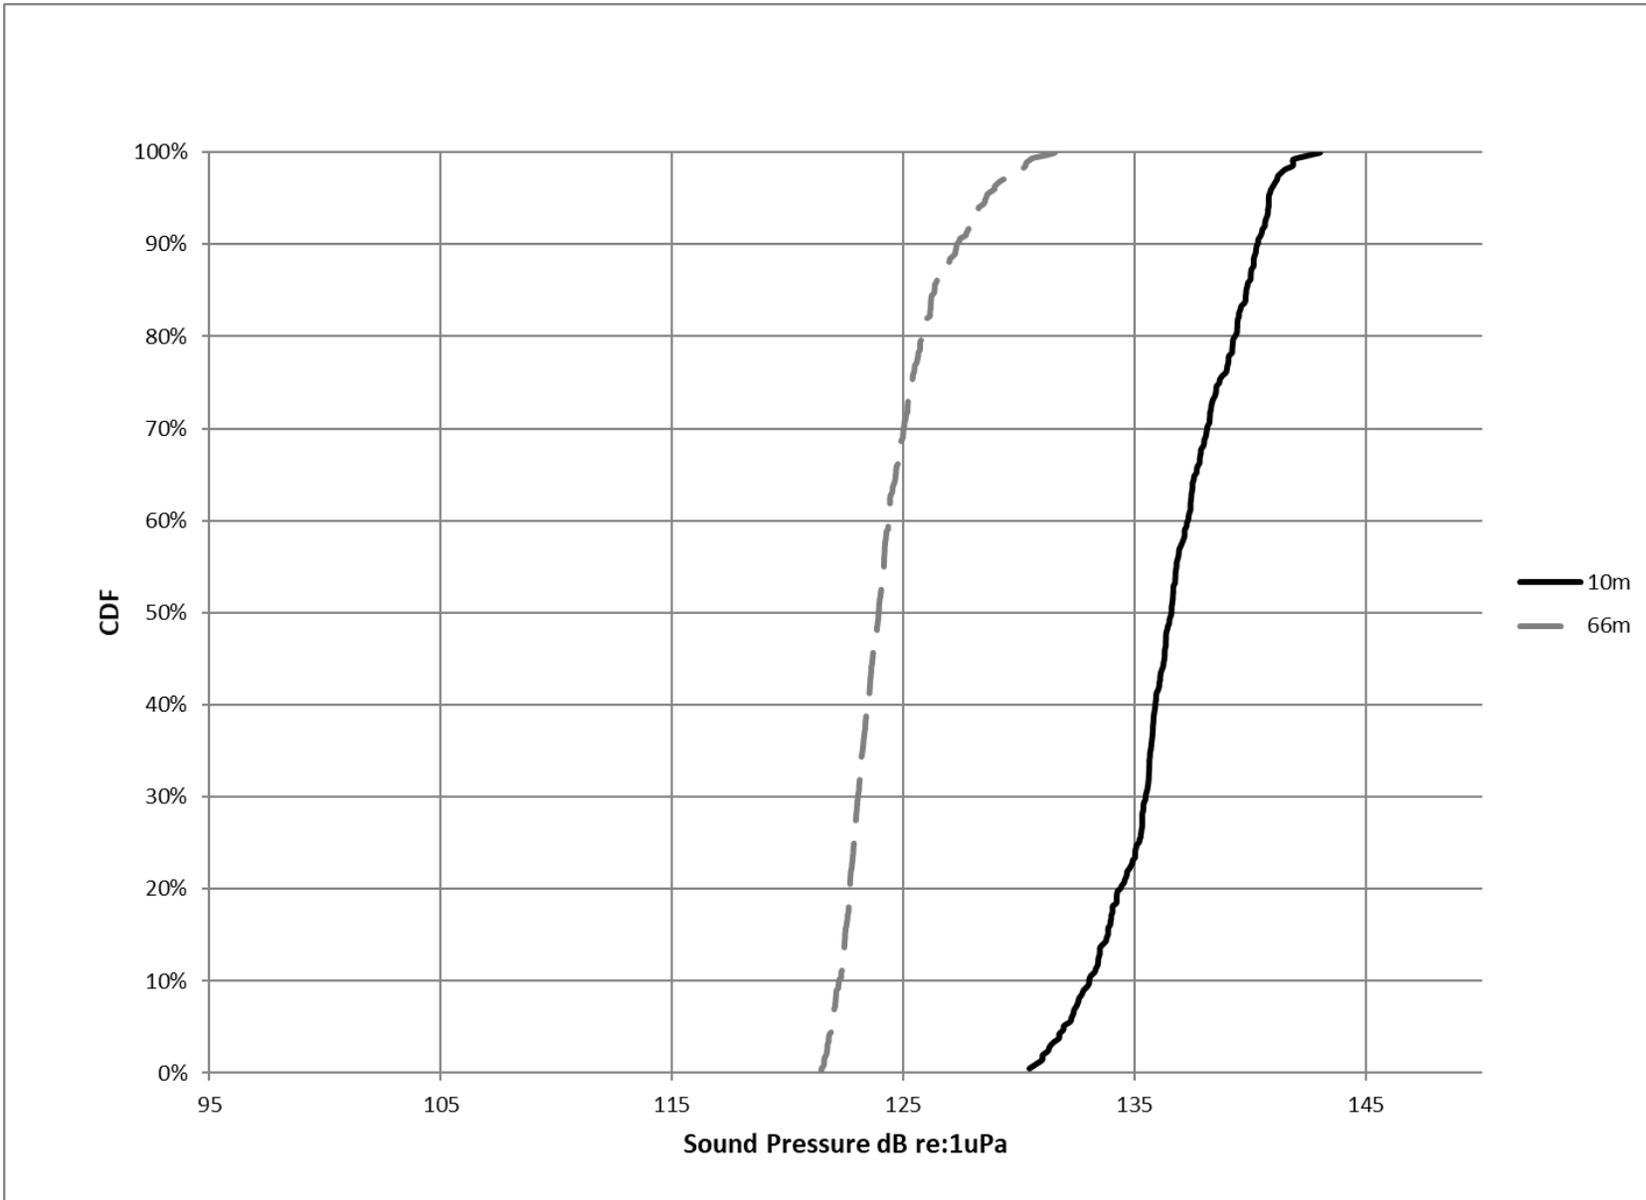
Figure A-1. CDF of Background/Ambient RMS SPL at Hydrophone Positions on June 5<sup>th</sup>, 2019

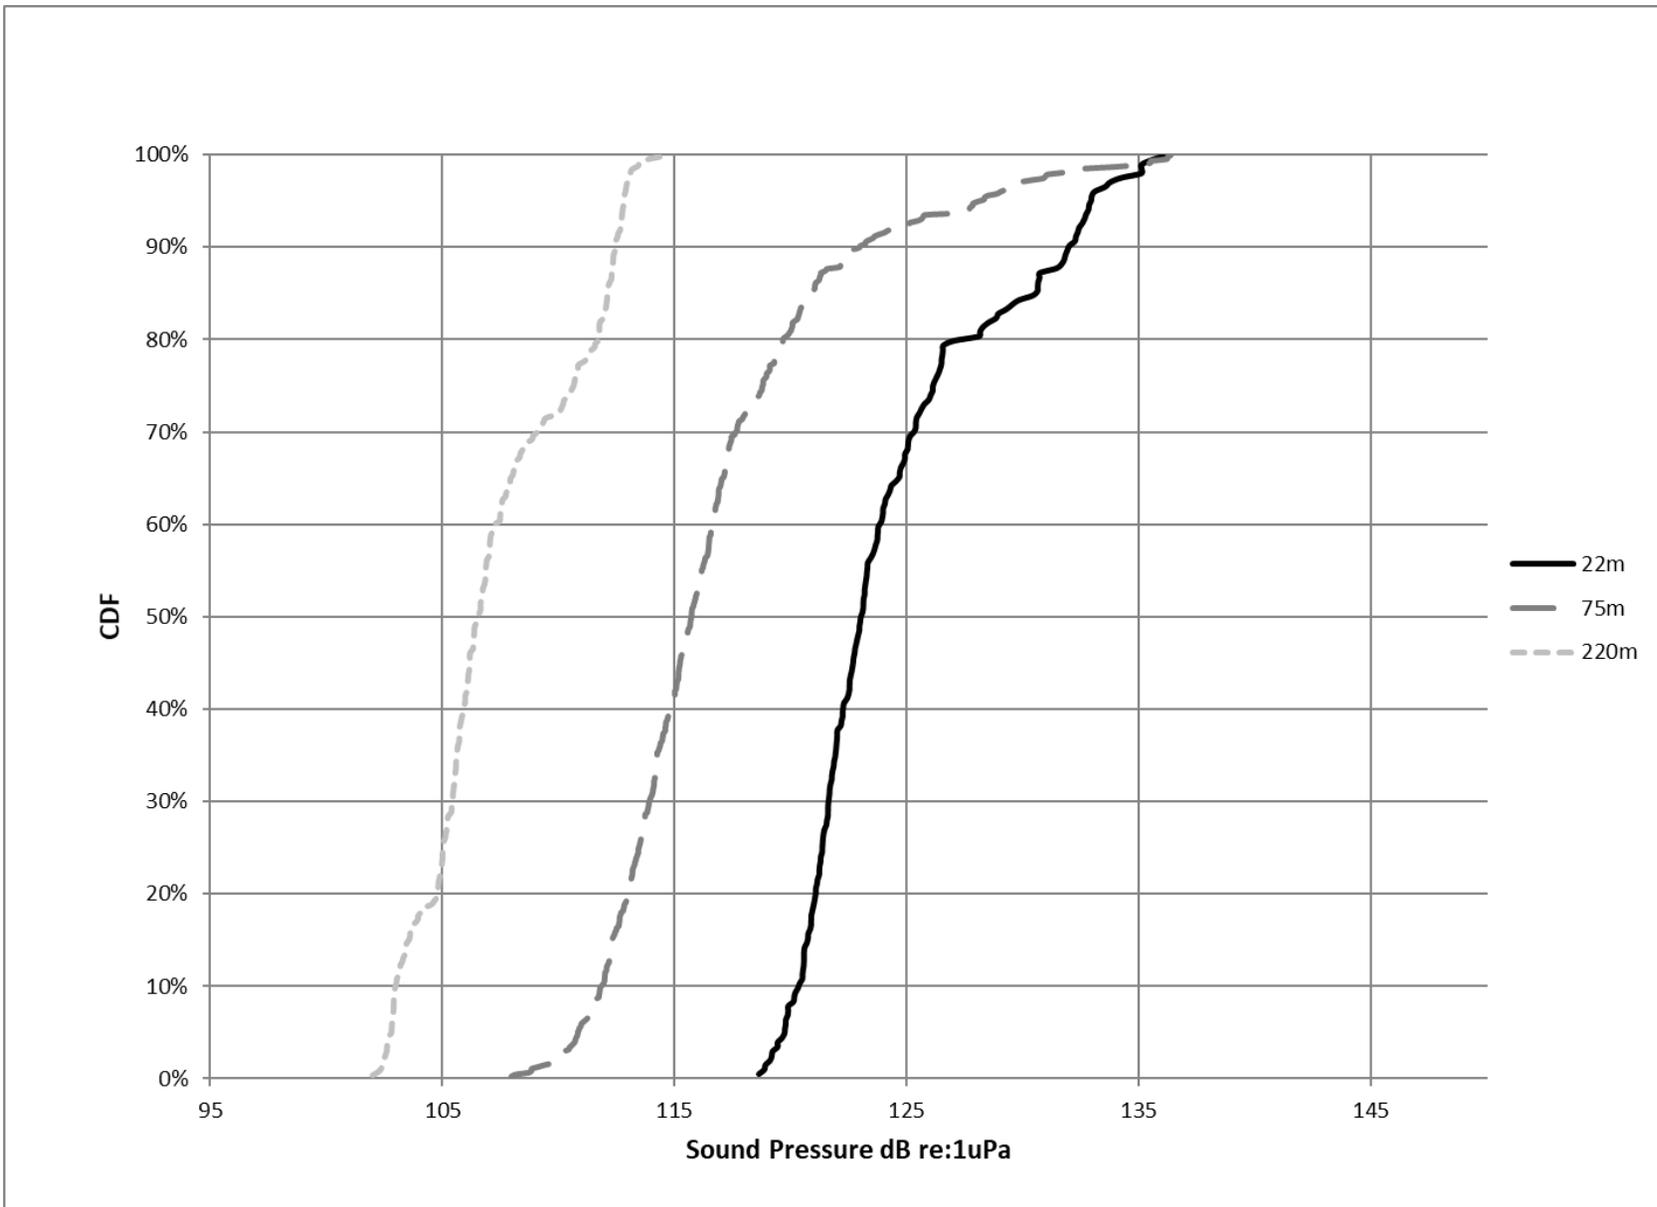
Figure A-2. CDF of Background/Ambient RMS SPL at Hydrophone Positions on June 21<sup>st</sup>, 2019

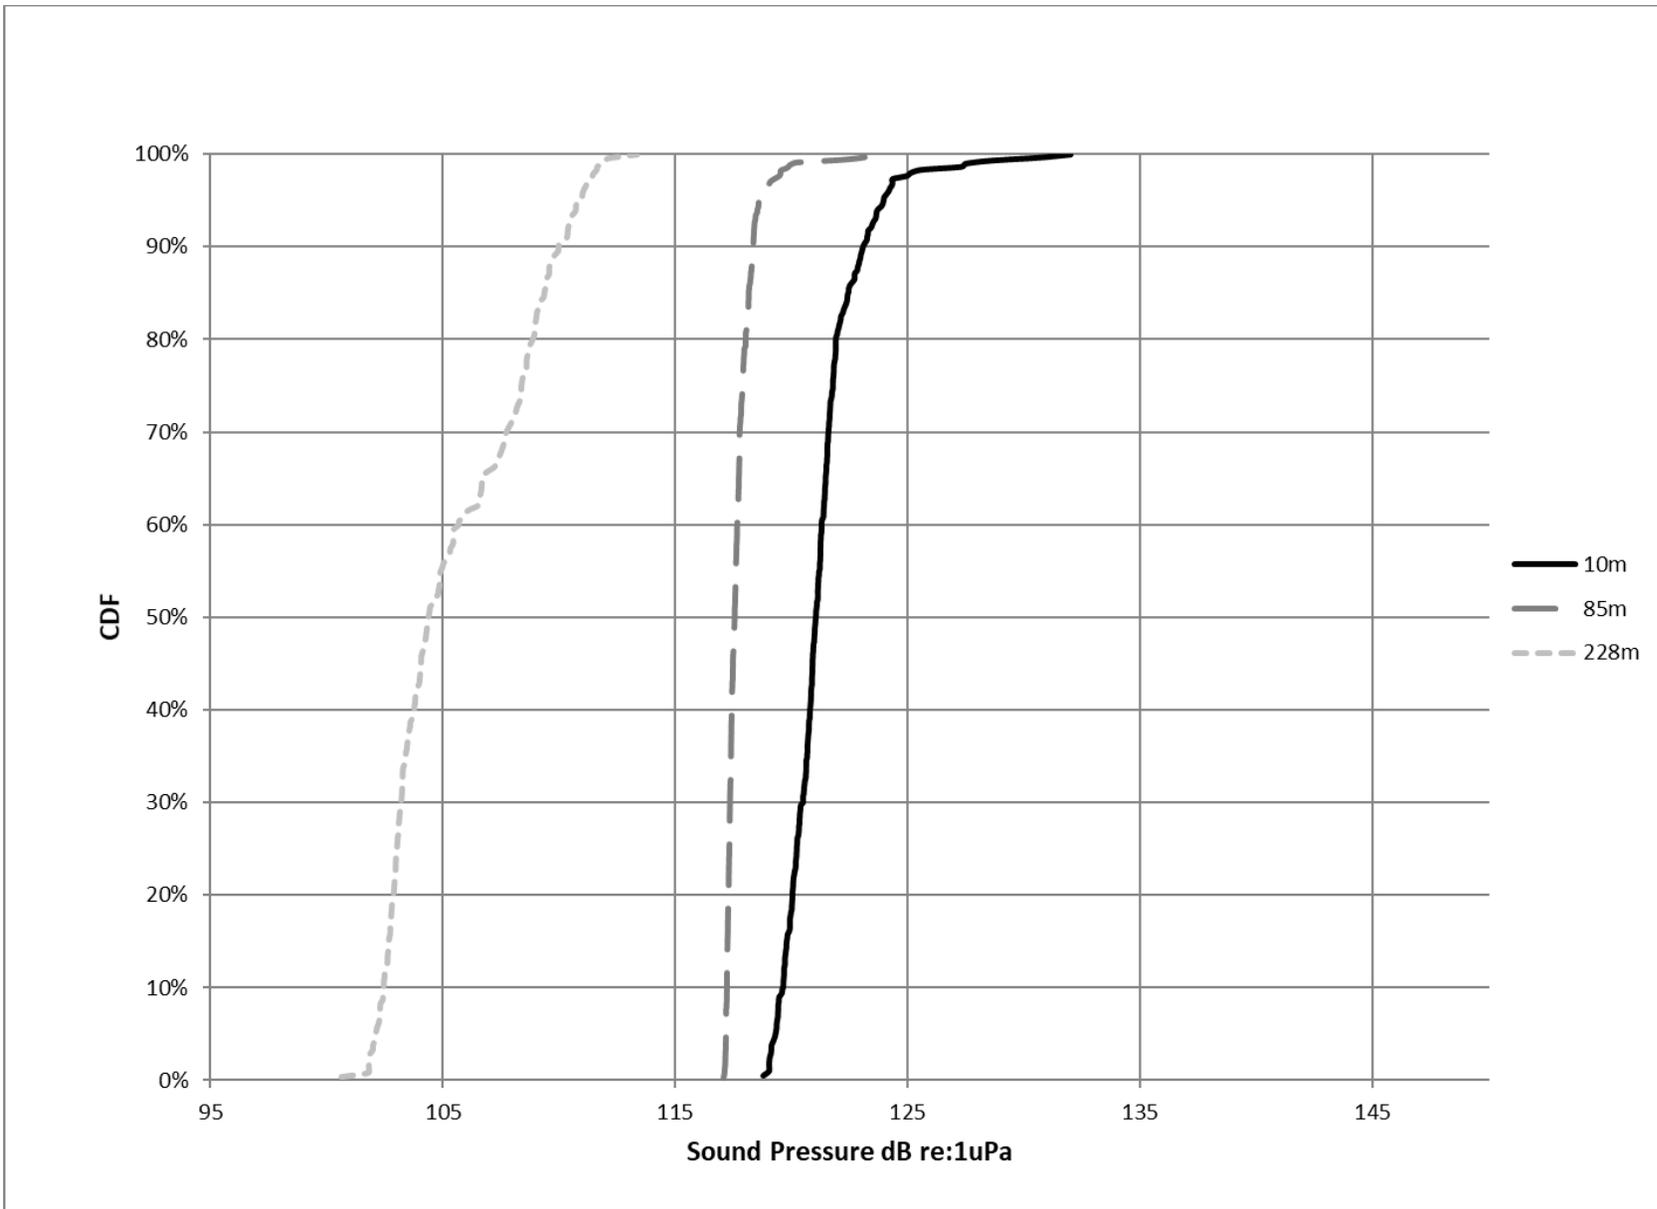
Figure A-3. CDF of Background/Ambient RMS SPL at Hydrophone Positions on August 22<sup>nd</sup>, 2019

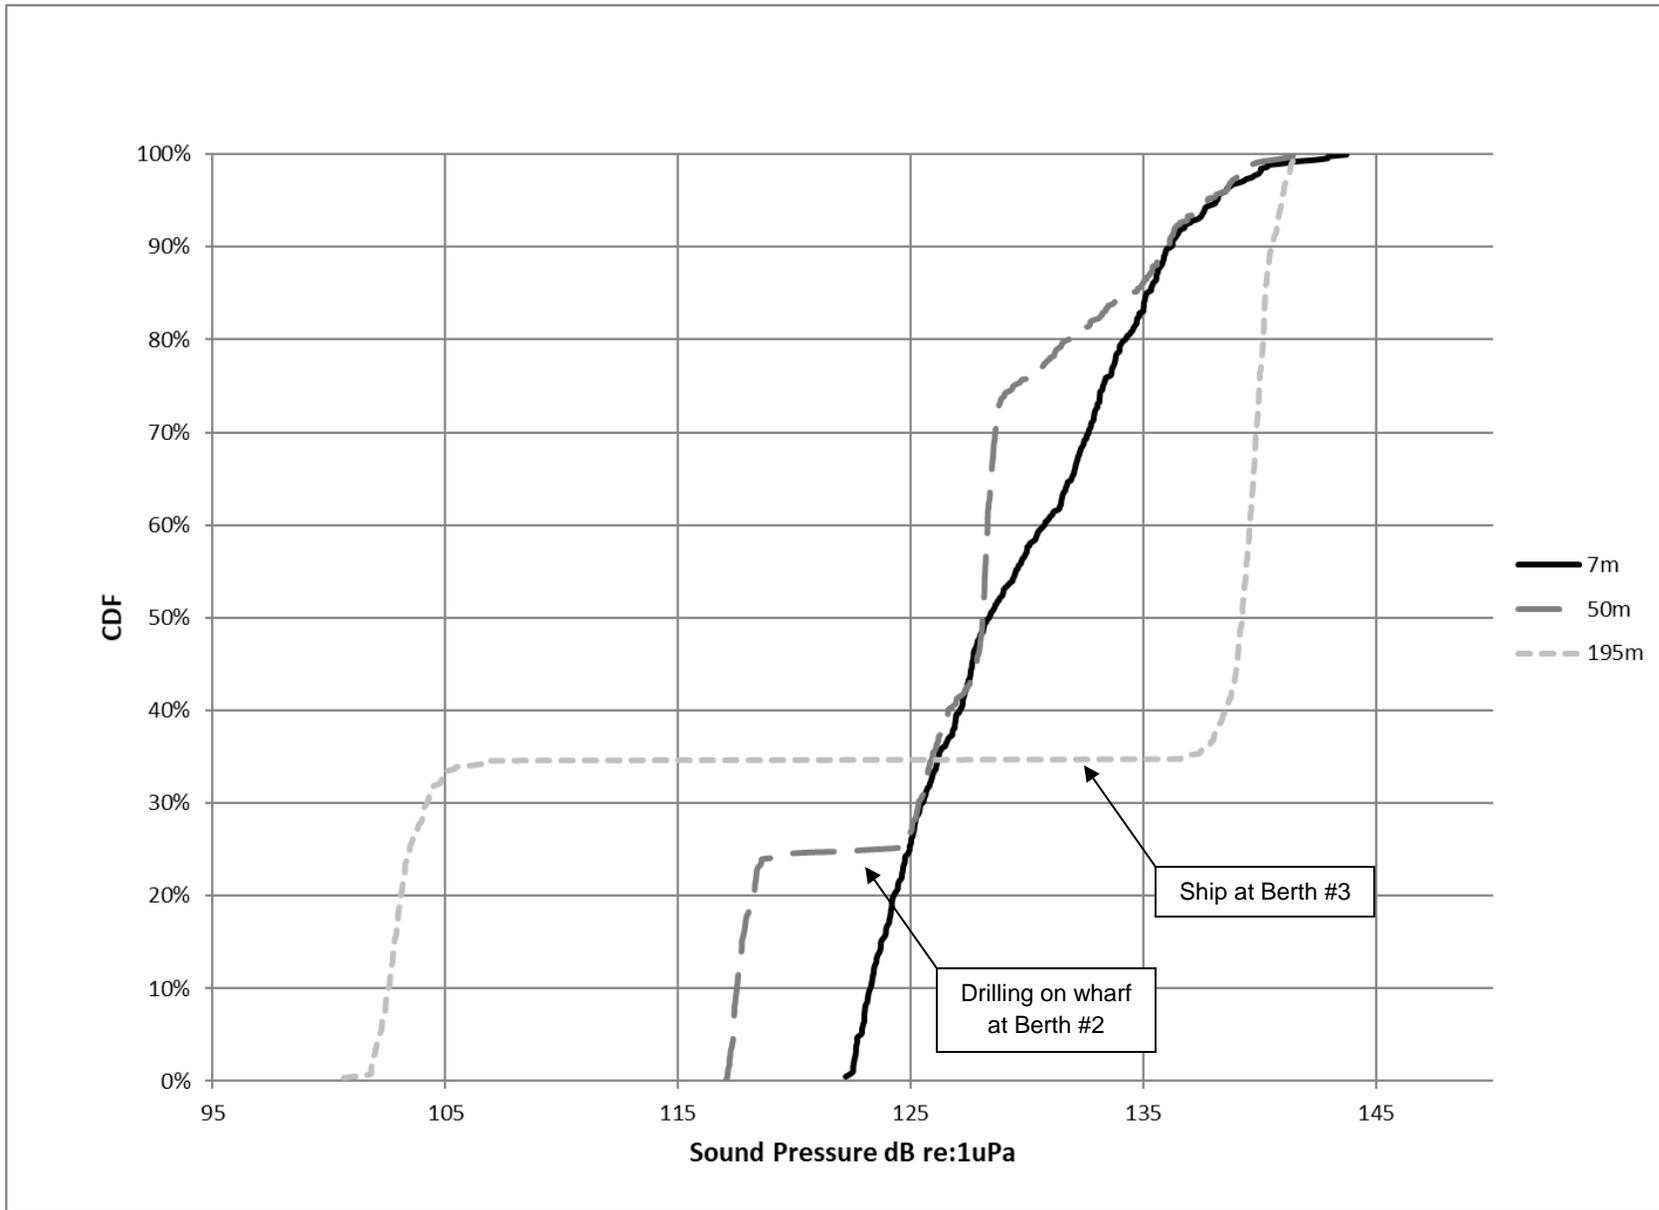
Figure A-4. CDF of Background/Ambient RMS SPL at Hydrophone Positions on October 3<sup>rd</sup>, 2019

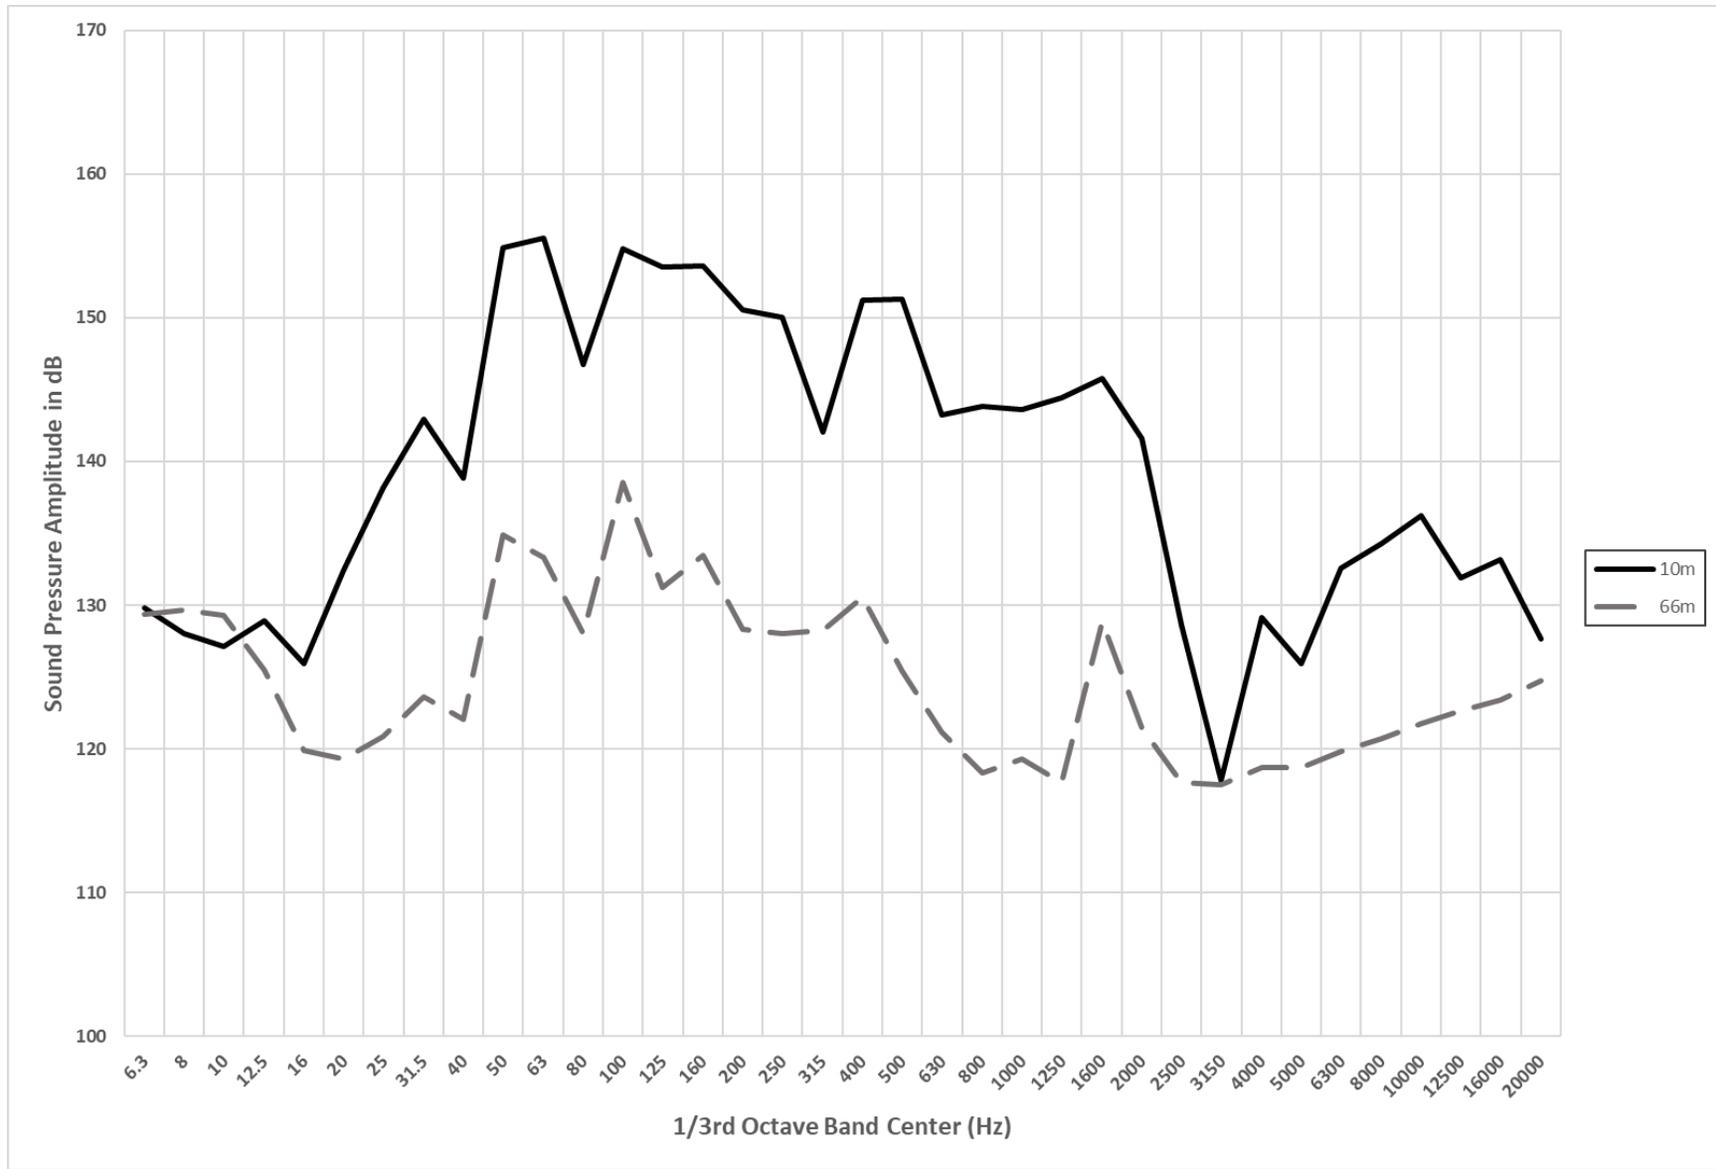
Figure B-1. 1/3 Octave Band Plot of Median LZI over Eight Pile Strikes During the Installation of a 24-inch Concrete Pile with a Diesel Impact Hammer on June 5<sup>th</sup>, 2019

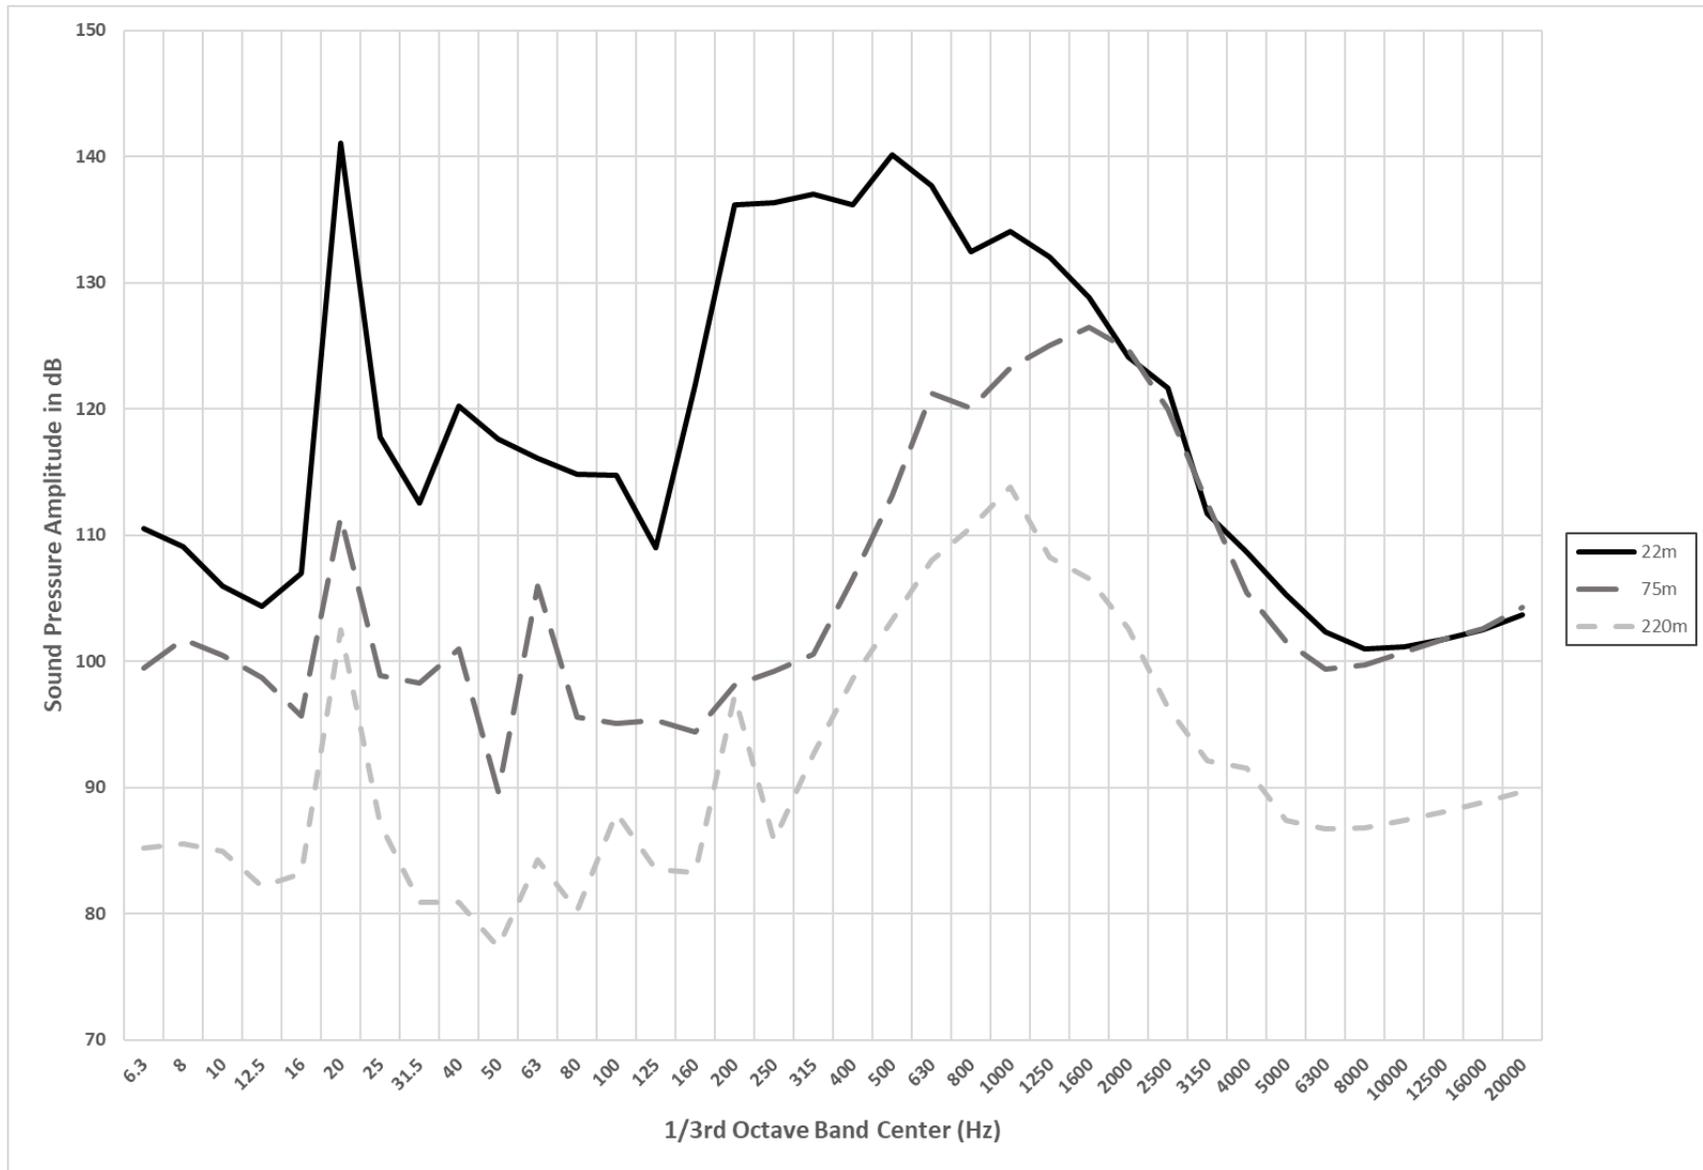
Figure B-2. 1/3 Octave Band Plot of Median LZeQ over One Minute During the Installation of 20-inch Steel Pile #1 with a Vibratory Hammer on June 21<sup>st</sup>, 2019

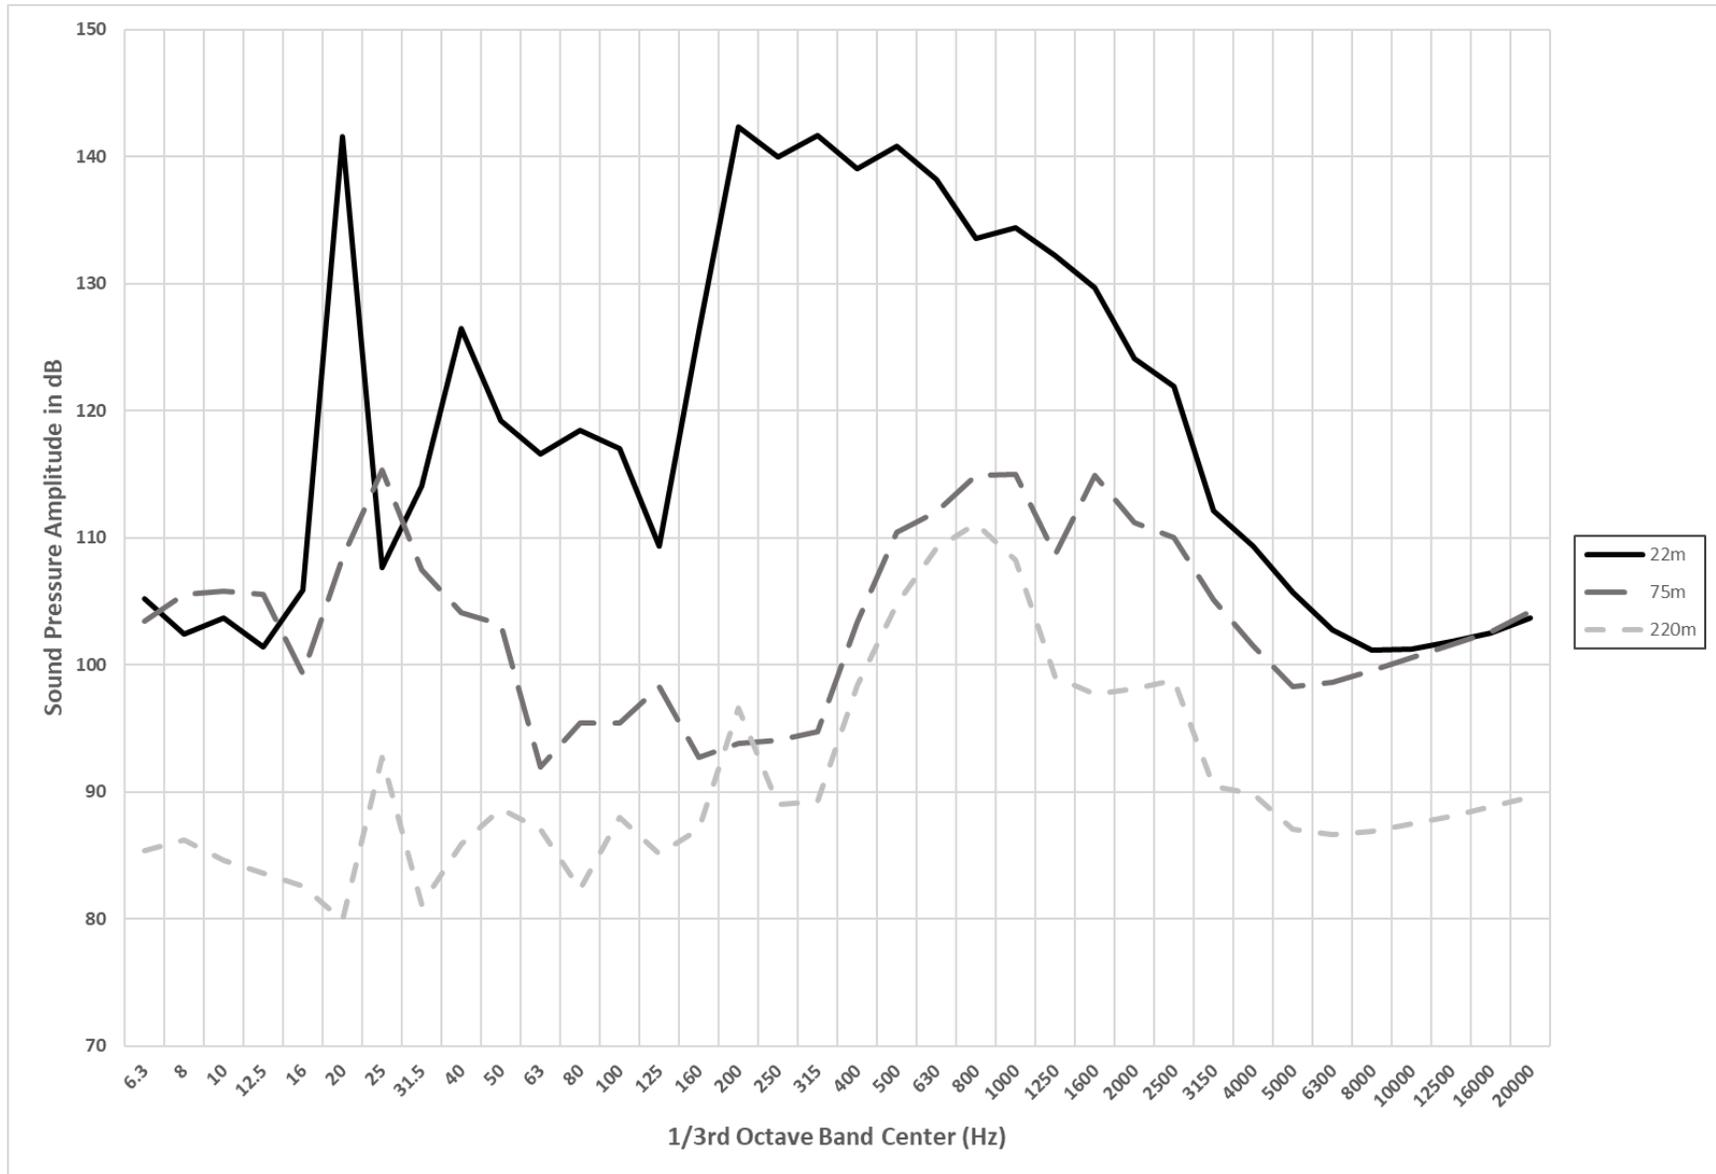
Figure B-3. 1/3 Octave Band Plot of Median LZeq over One Minute During the Installation of 20-inch Steel Pile #2 with a Vibratory Hammer on June 21<sup>st</sup>, 2019

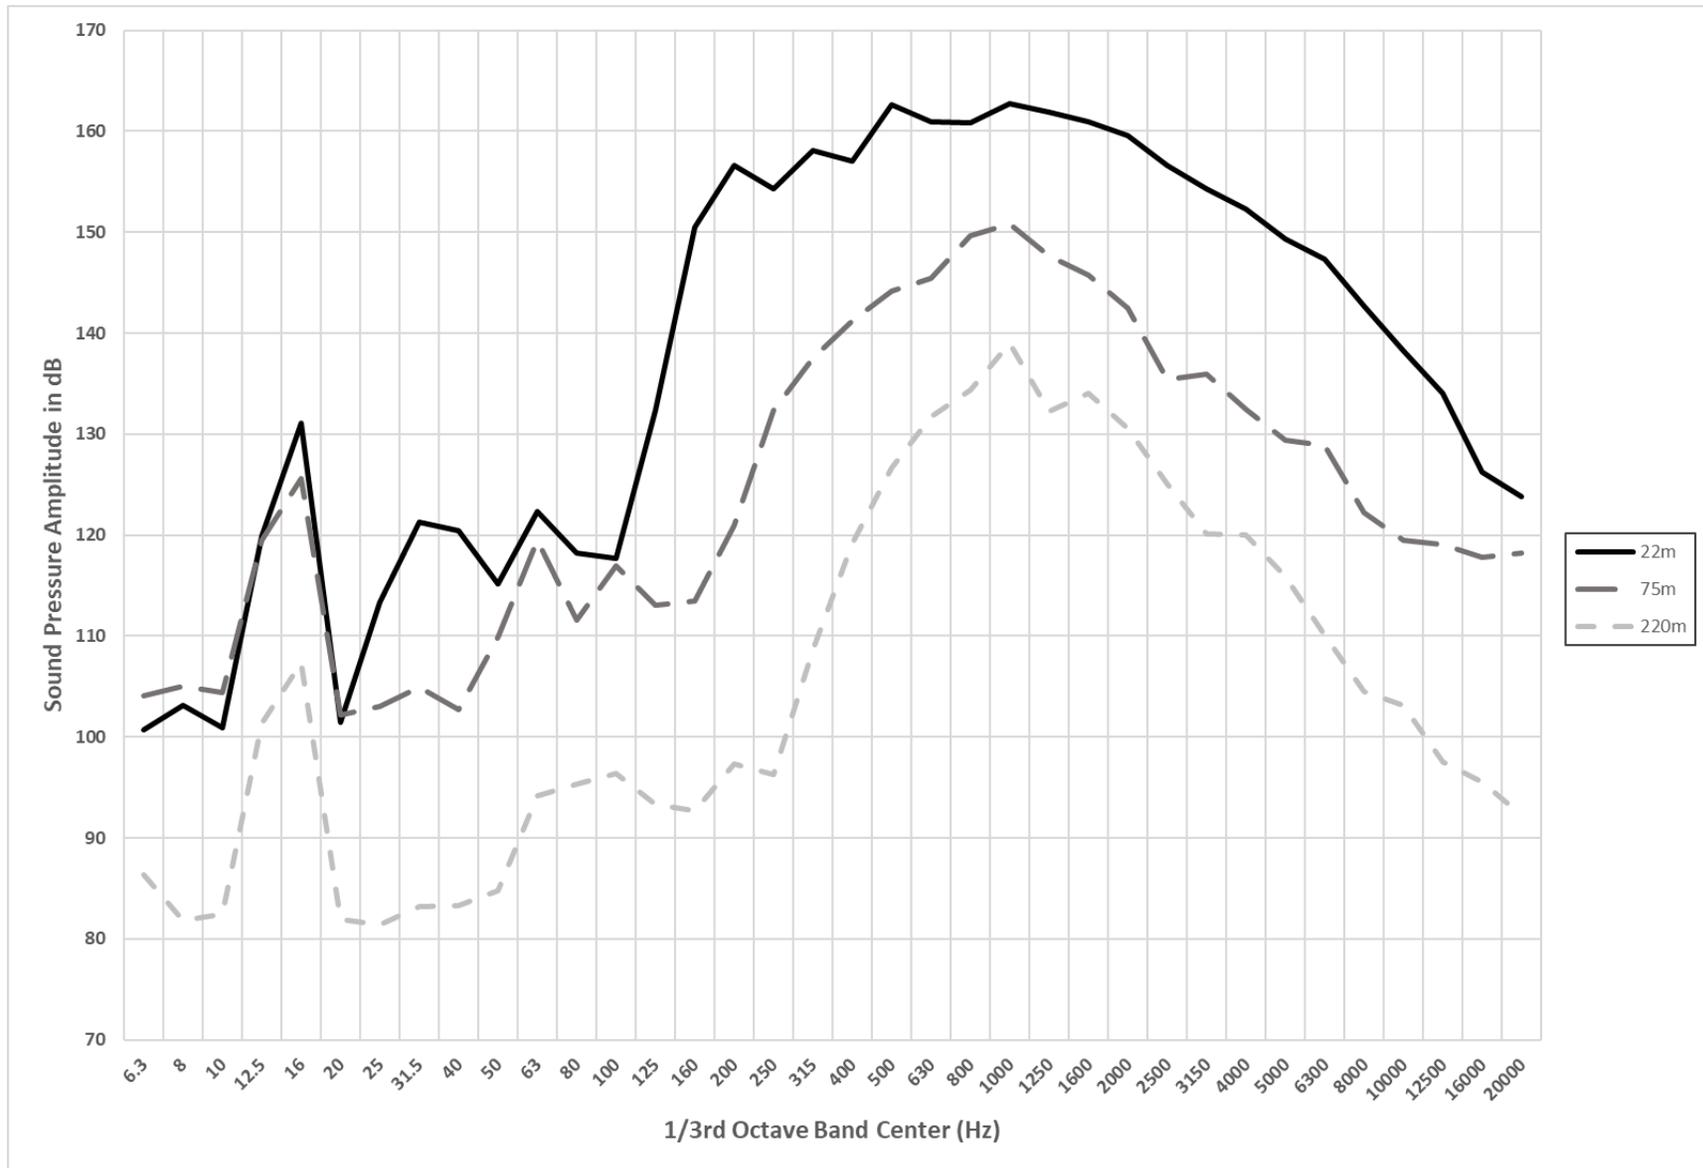
Figure B-5. 1/3 Octave Band Plot of Median LZeq over One Minute During the Installation of 36-inch Steel Pile #2 with a Vibratory Hammer on August 22<sup>nd</sup>, 2019

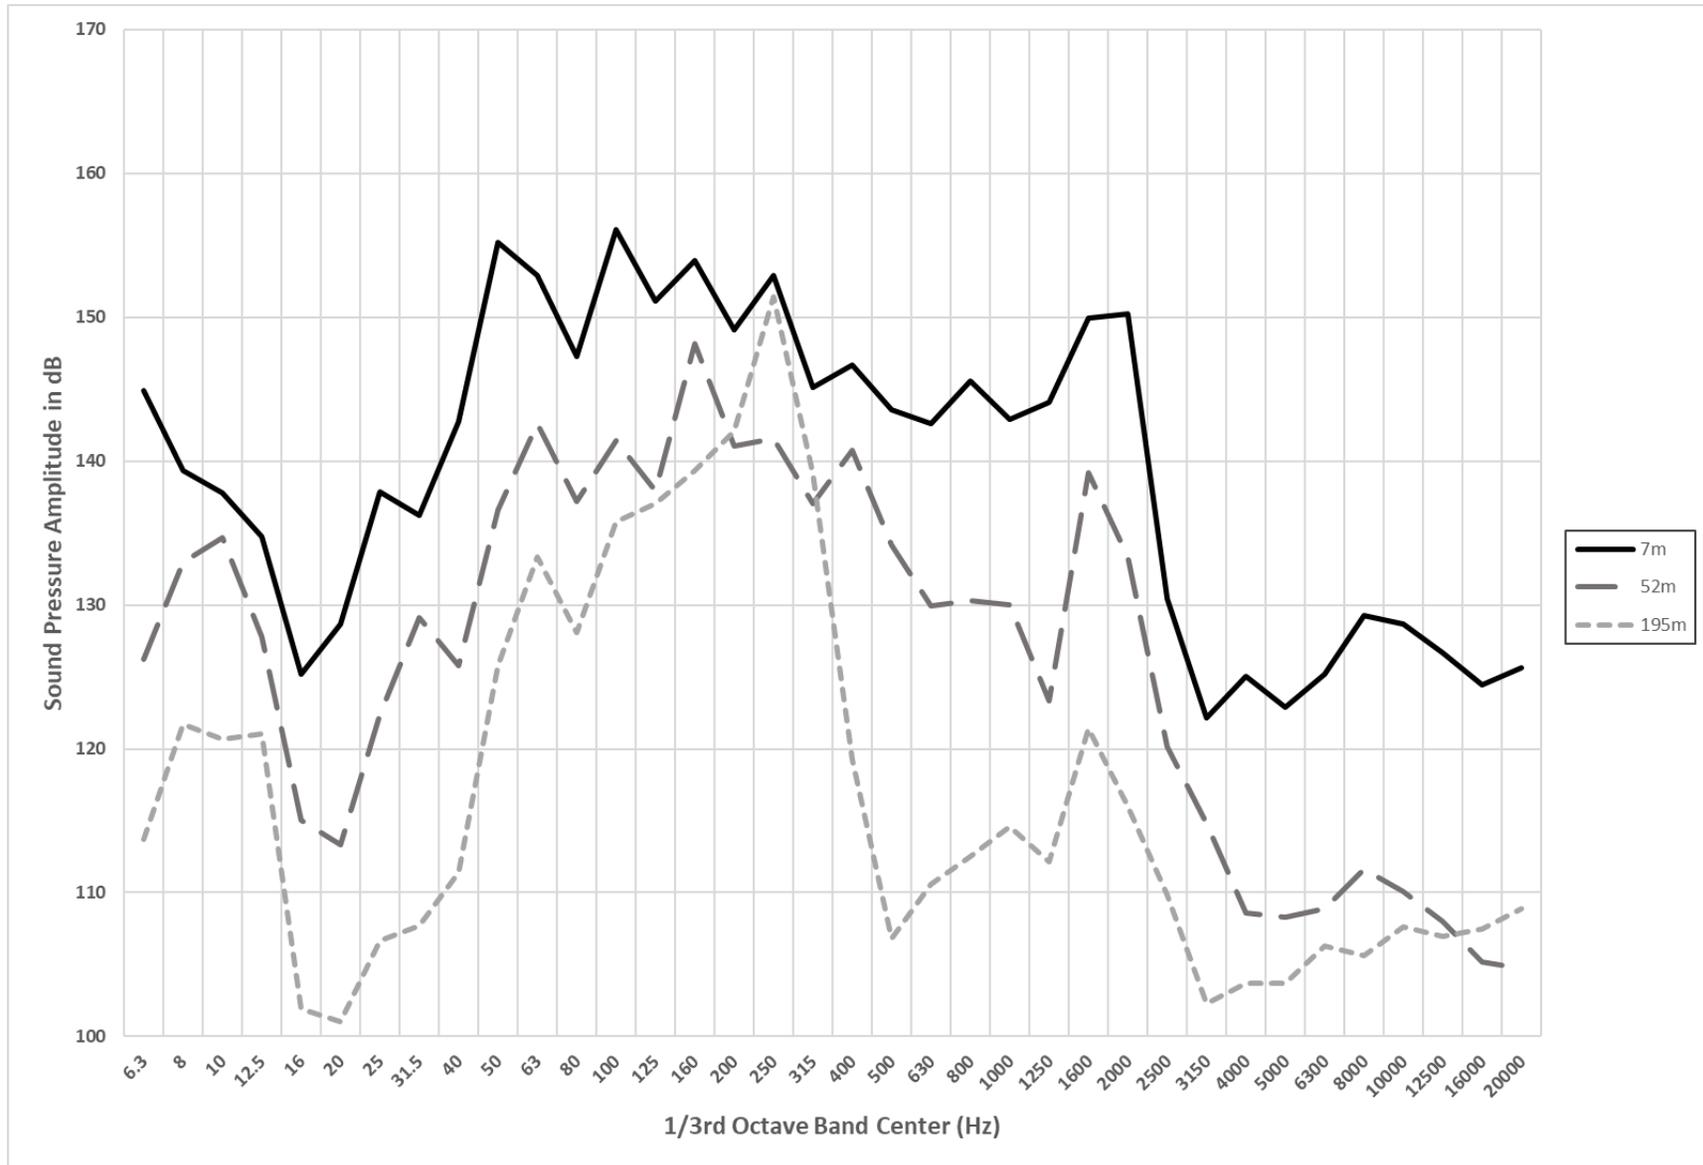
Figure B-6. 1/3 Octave Band Plot of Median LZI over Eight Pile Strikes During the Installation of 20-inch Concrete Pile #1 with a Diesel Impact Hammer on October 3<sup>rd</sup>, 2019

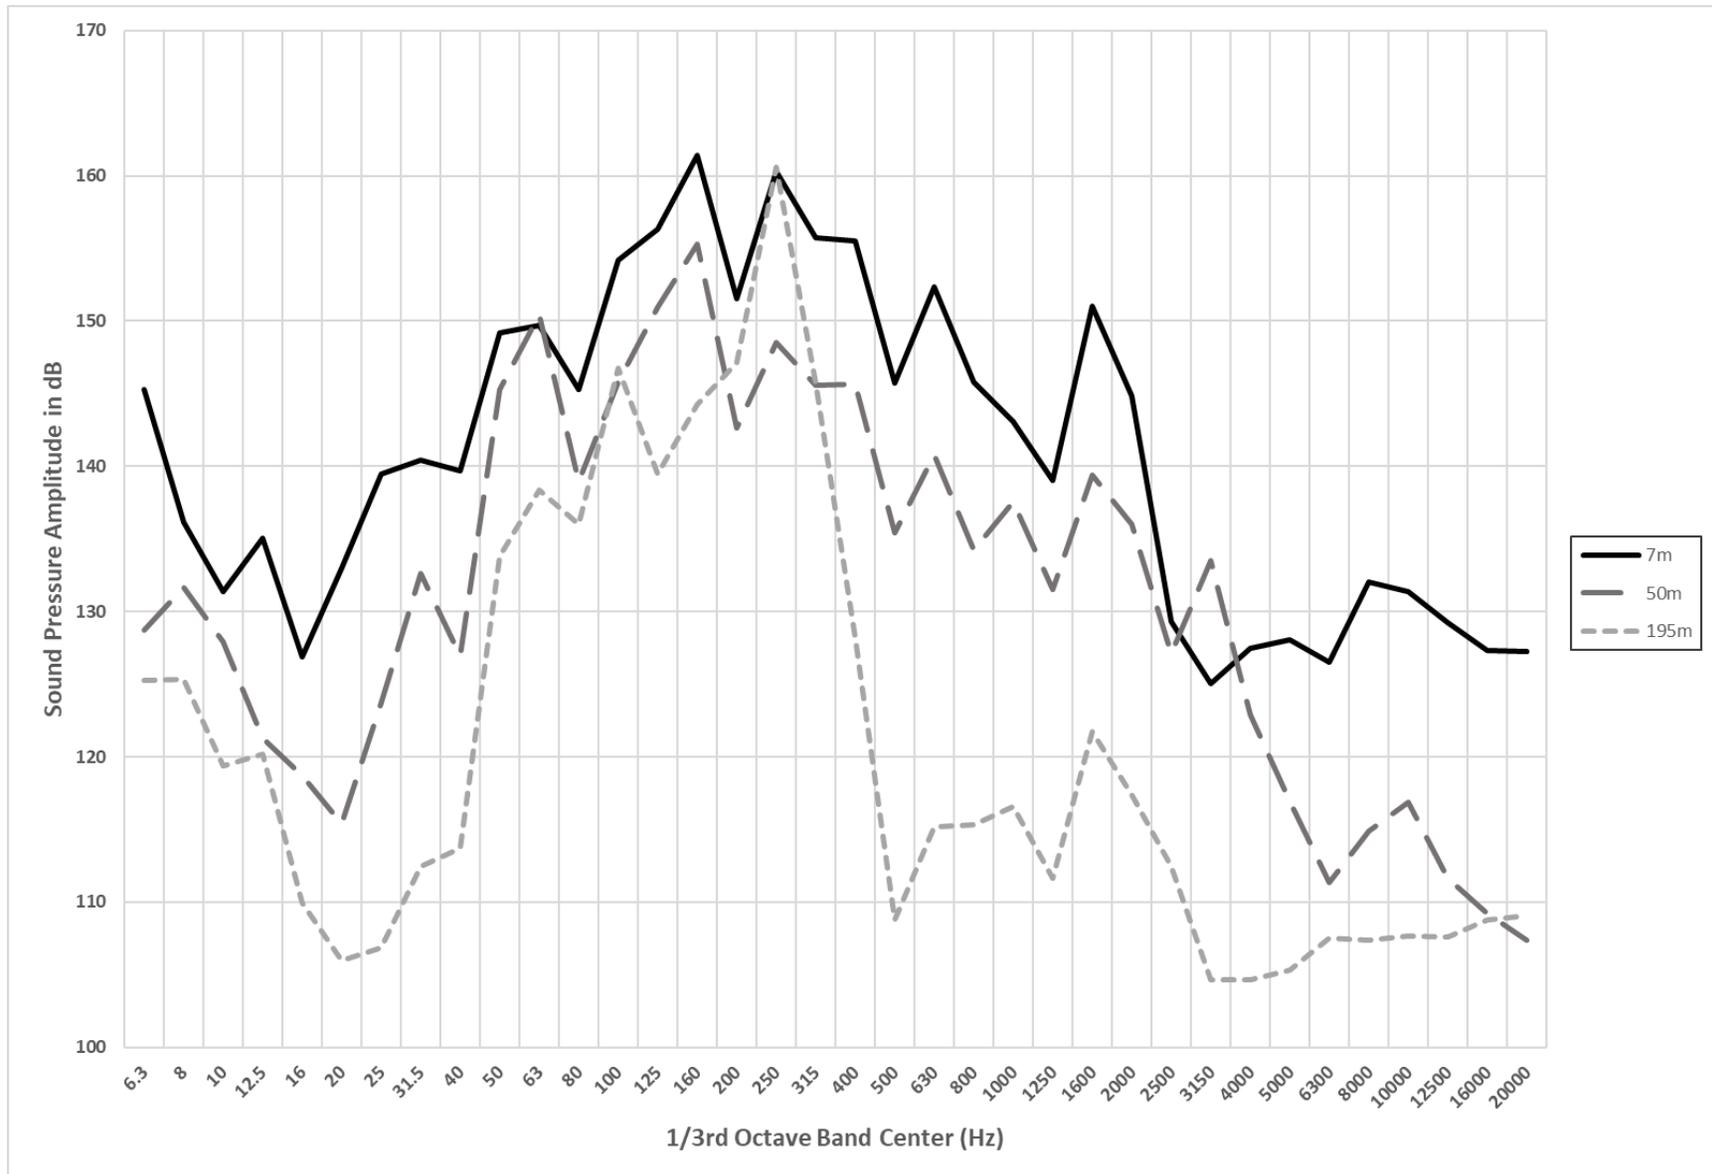
Figure B-7. 1/3 Octave Band Plot of Median LZI over Eight Pile Strikes During the Installation of 20-inch Concrete Pile #2 with a Diesel Impact Hammer on October 3<sup>rd</sup>, 2019
