# 2019 Annual Biological Monitoring and Mitigation Compliance Report

Chevron Long Wharf Maintenance and Efficiency Project

Chevron Products Company

January 15, 2020

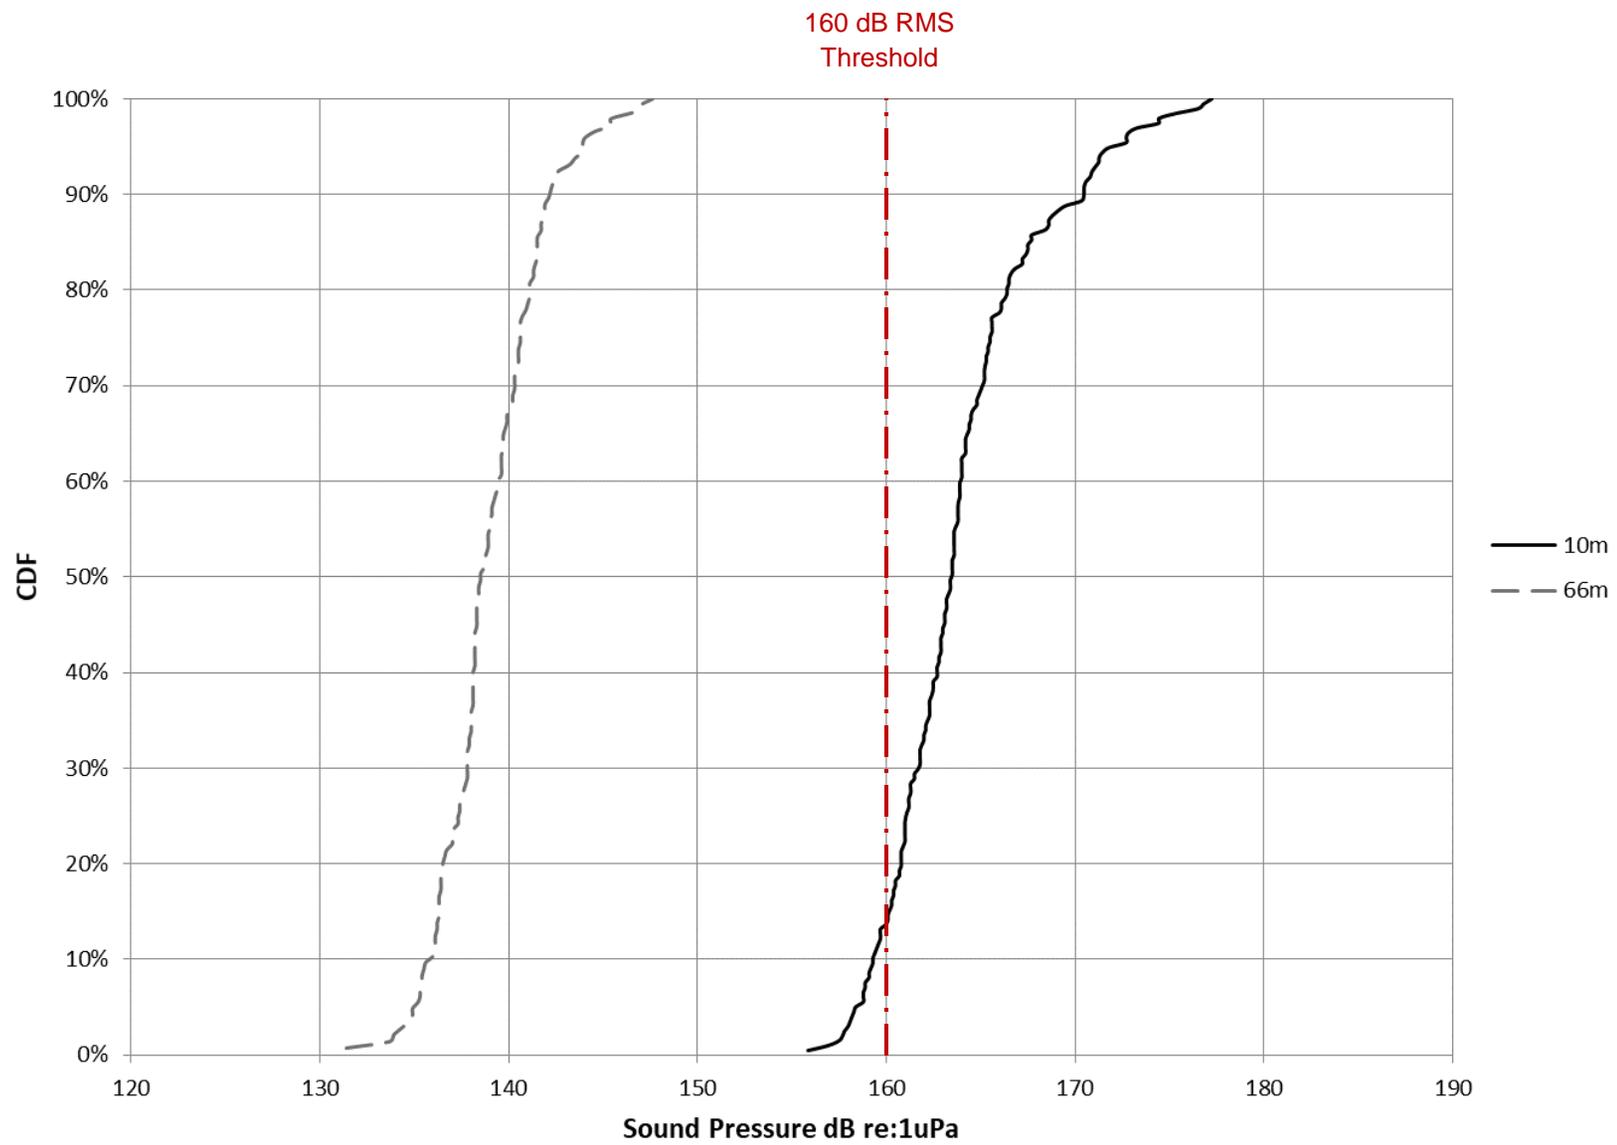
Figure C-1. CDF (RMS values) of the Installation of a 24-inch Concrete Pile with a Diesel Impact Hammer on June 5<sup>th</sup>, 2019

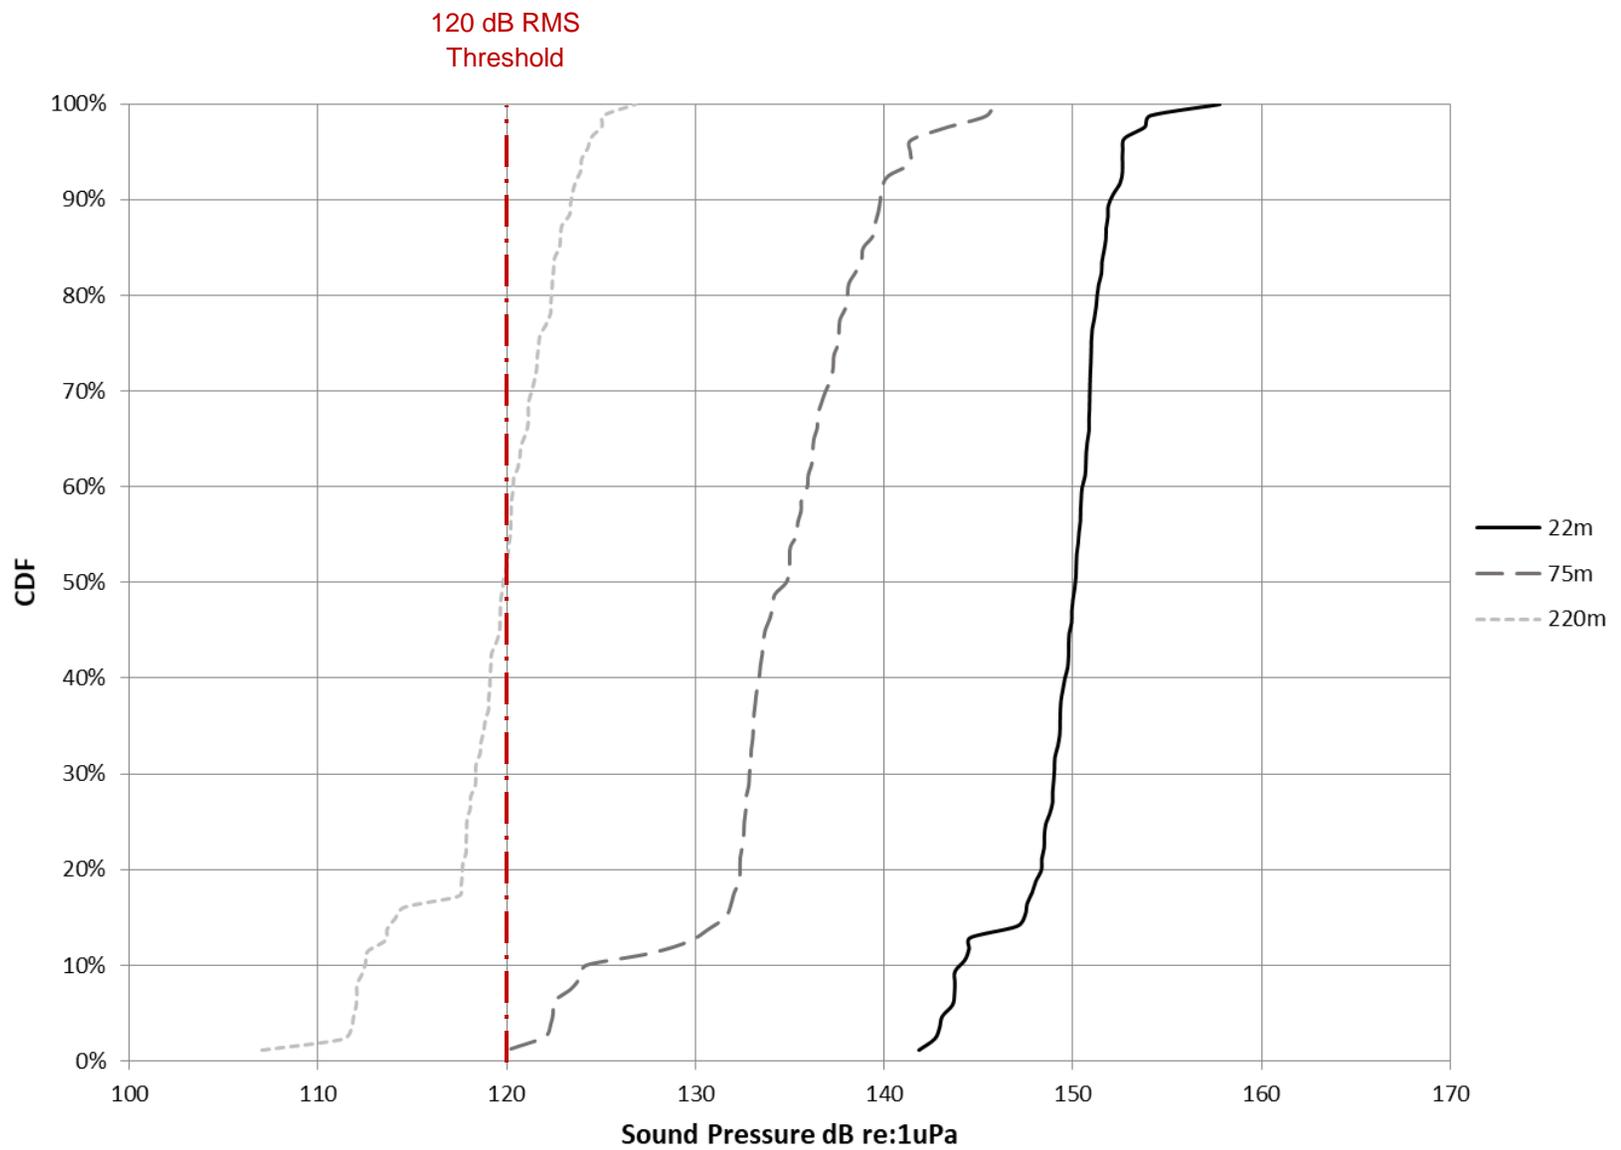
Figure C-2. CDF (RMS values) of the Installation of 20-inch Steel Pile #1 with a Vibratory Hammer on June 21<sup>st</sup>, 2019

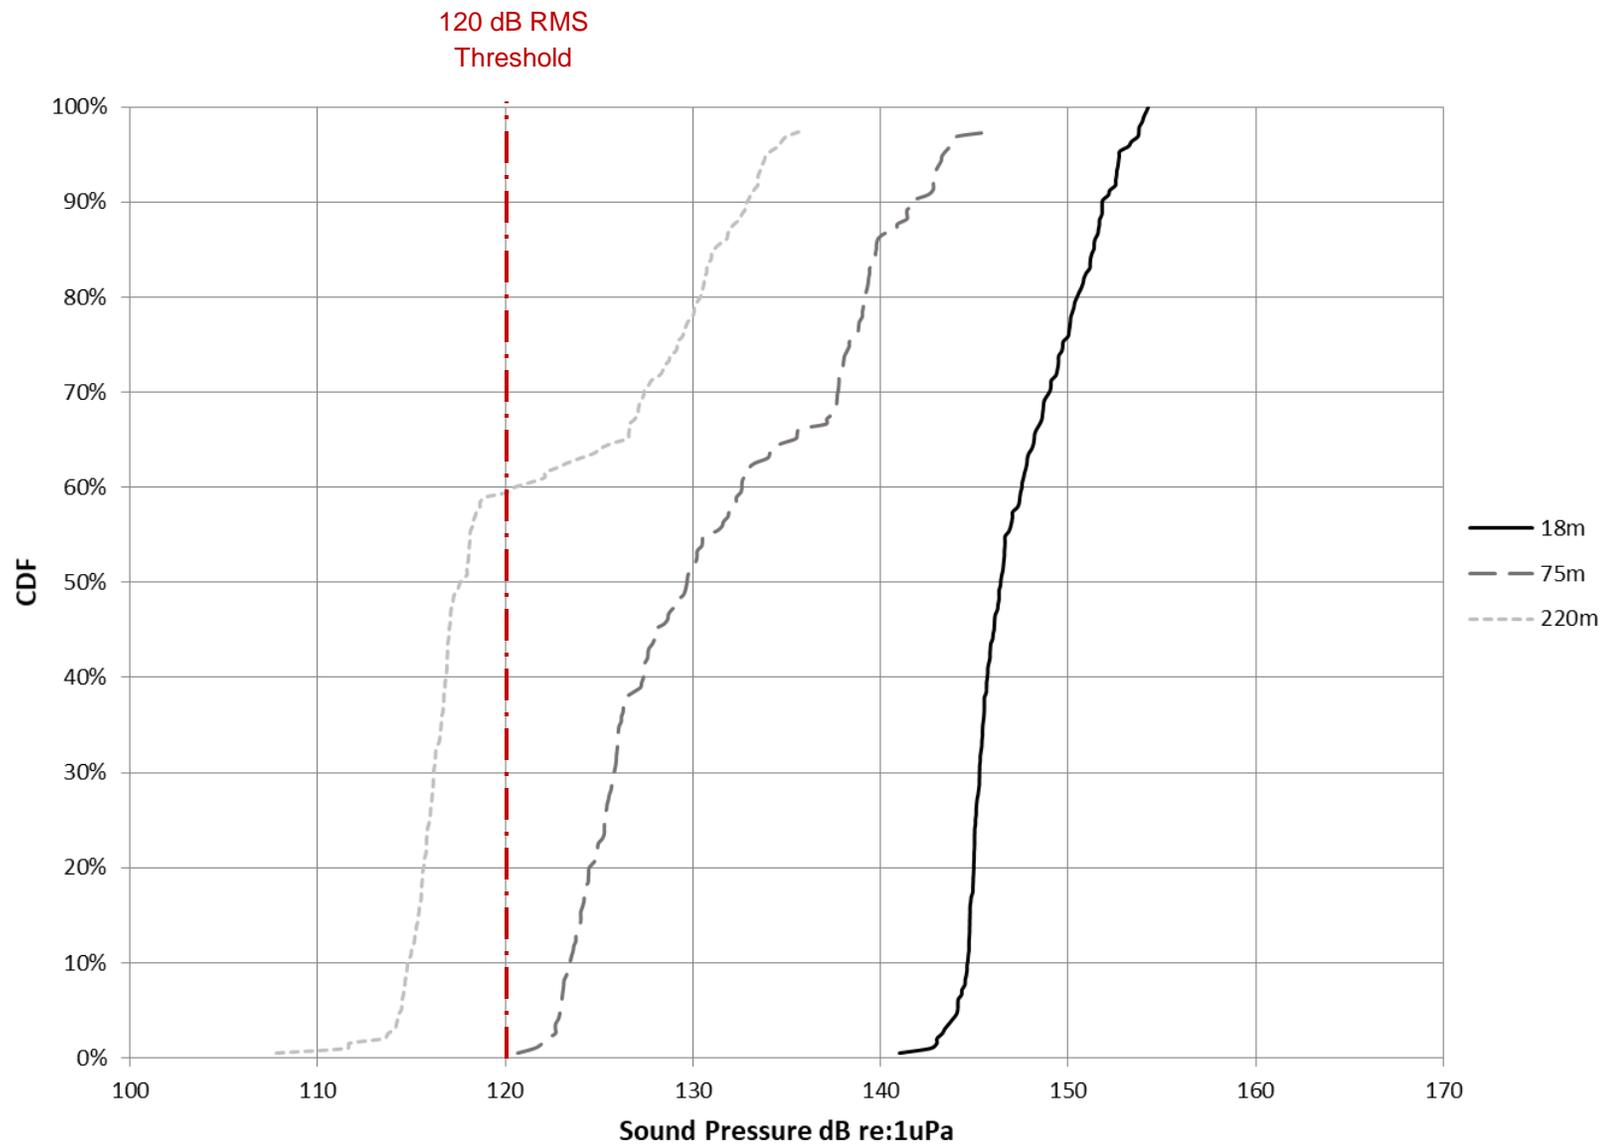
Figure C-3. CDF (RMS values) of the Installation of 20-inch Steel Pile #2 with a Vibratory Hammer on June 21st, 2019

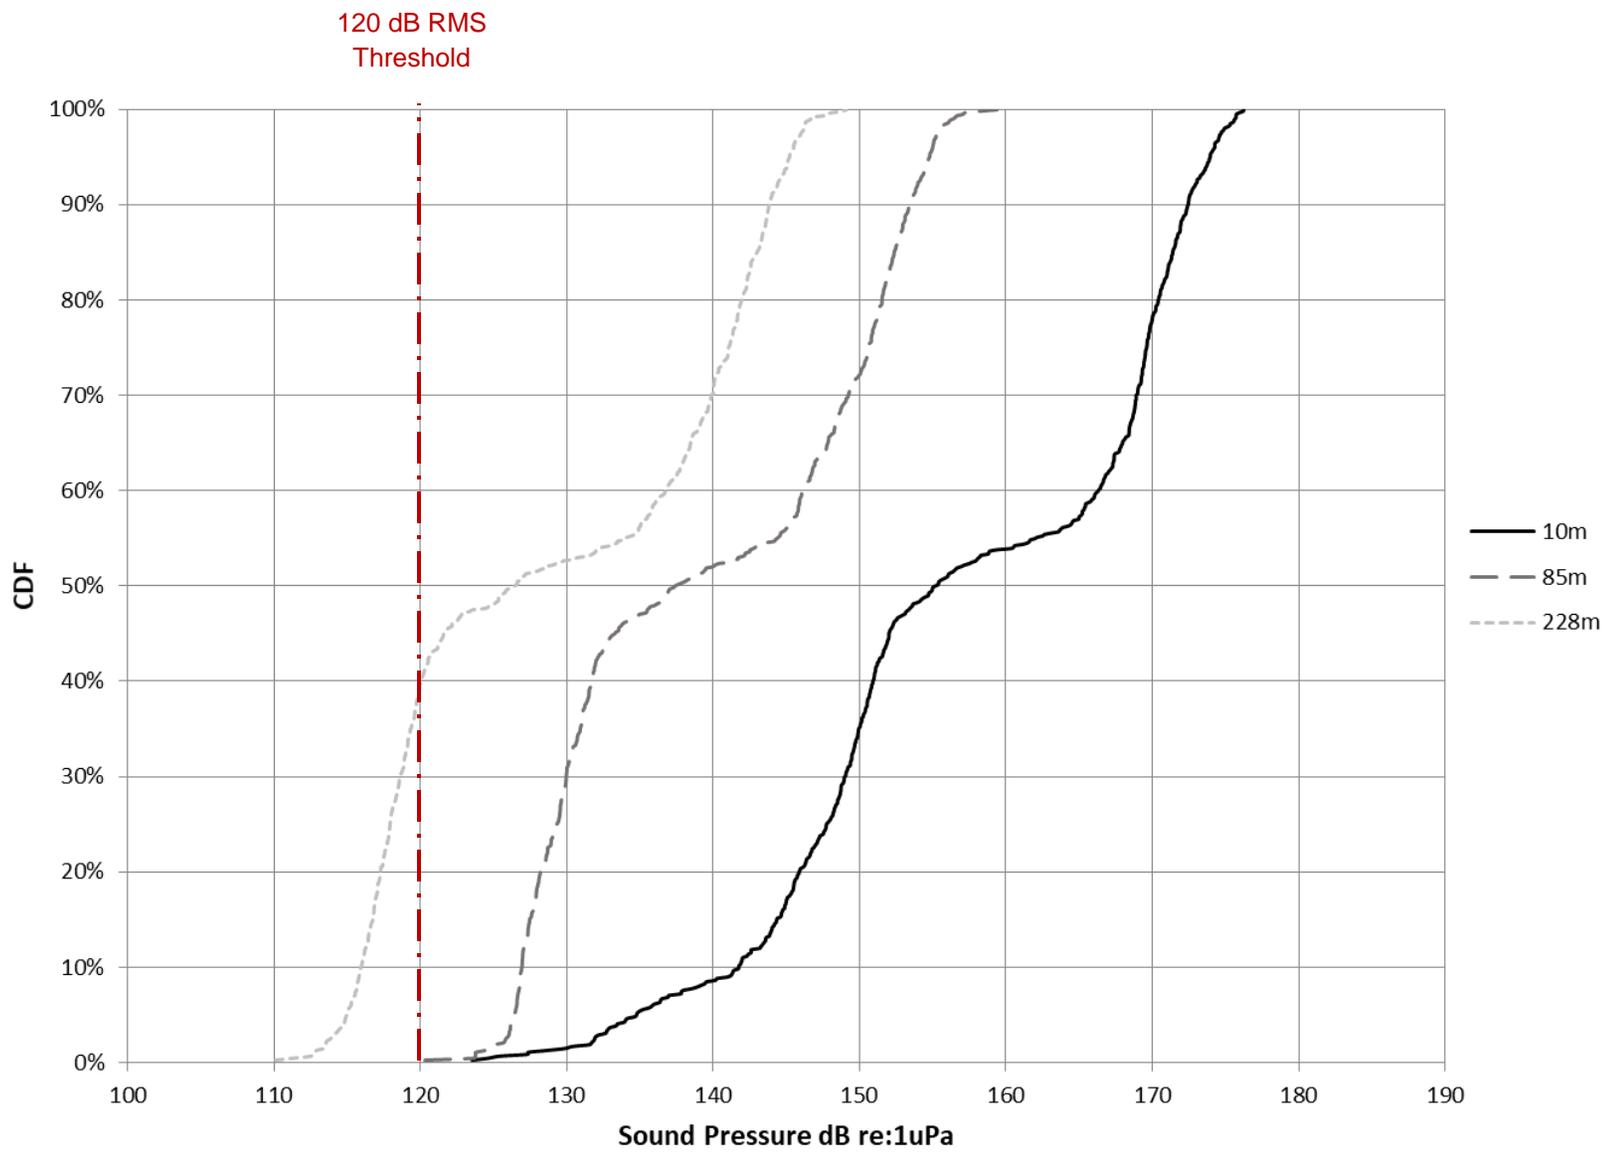
Figure C-4. CDF (RMS values) of the Installation of 36-inch Steel Pile #1 with a Vibratory Hammer on August 22<sup>nd</sup>, 2019

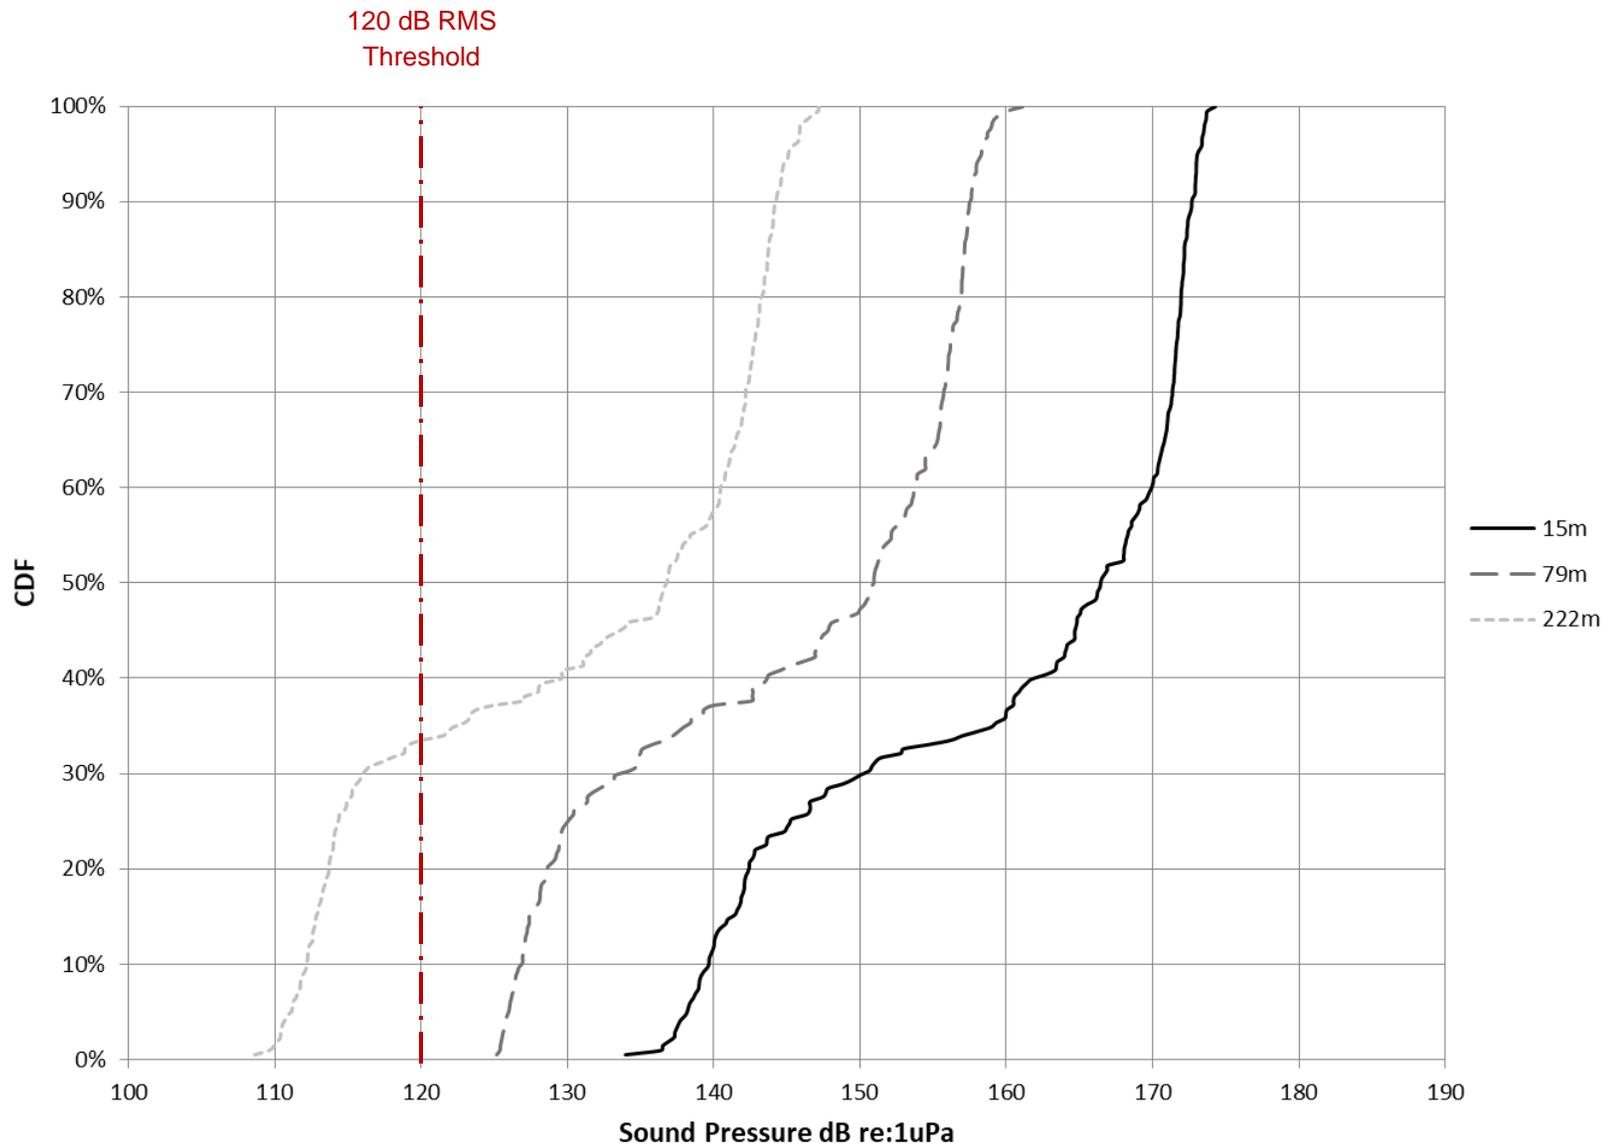
Figure C-5. CDF (RMS values) of the Installation of 36-inch Steel Pile #2 with a Vibratory Hammer on August 22<sup>nd</sup>, 2019

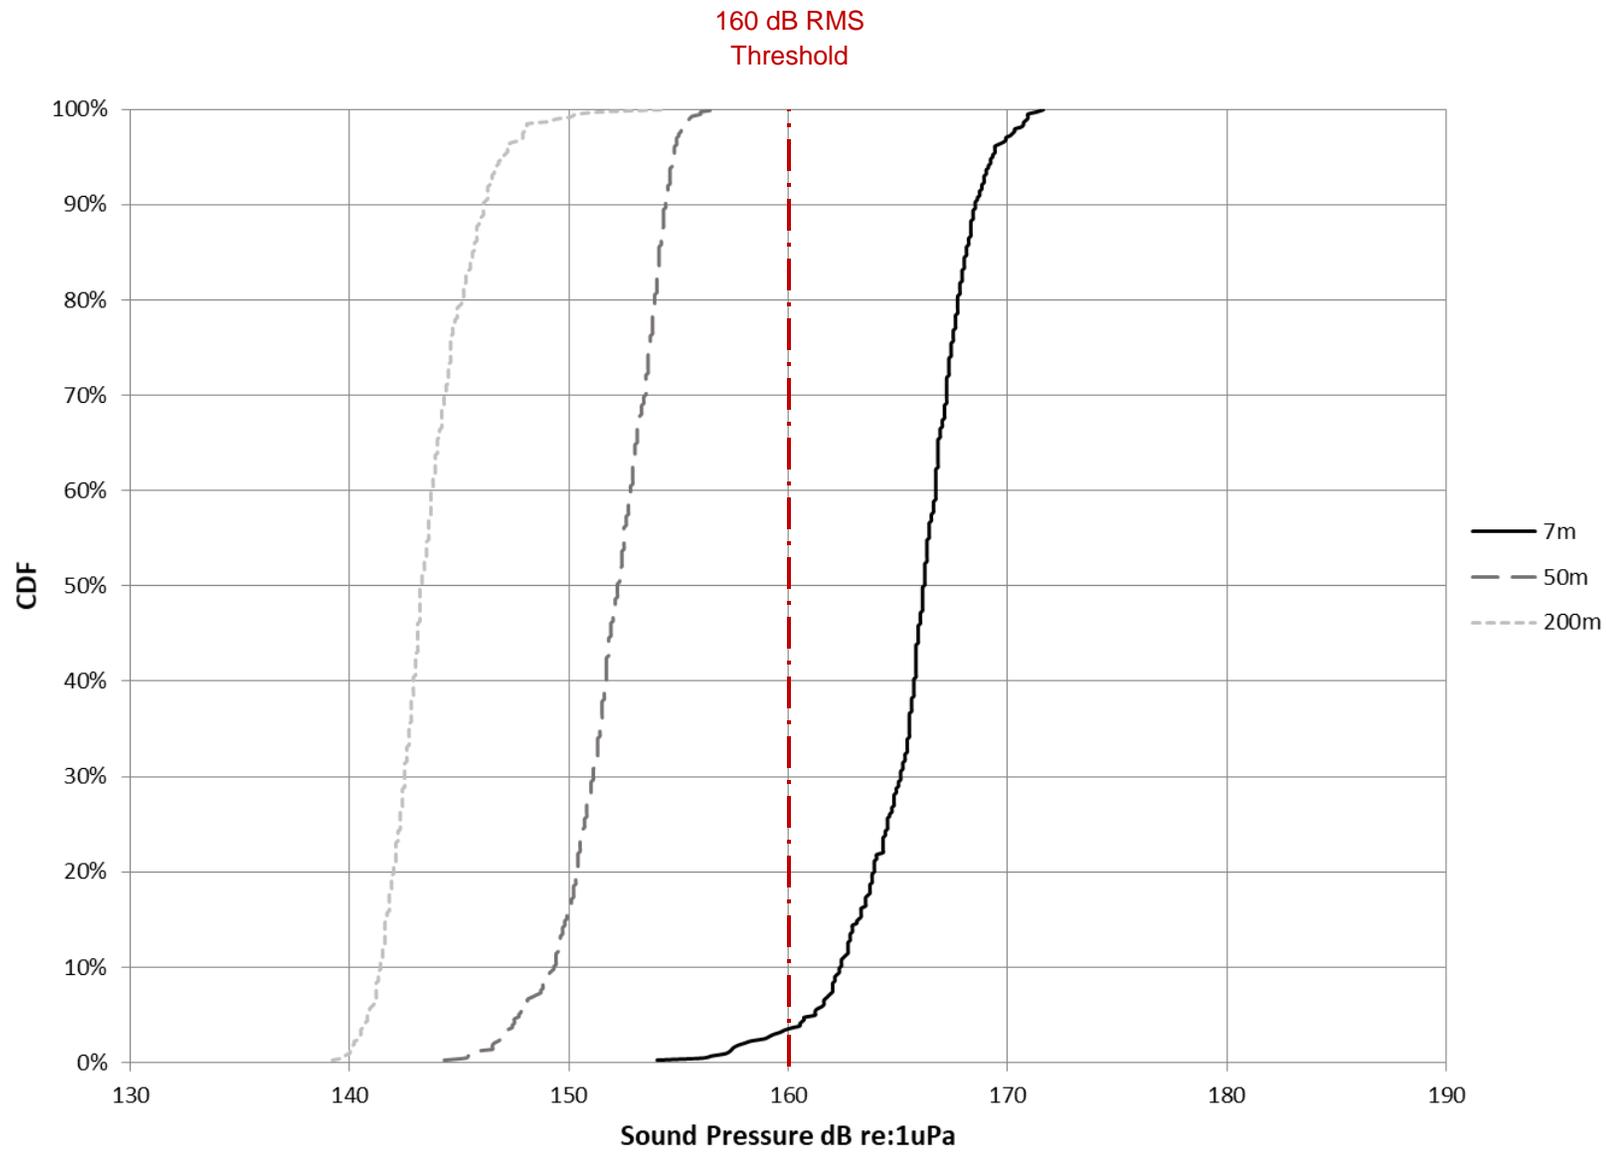
Figure C-6. CDF (RMS values) of the Installation of 20-inch Concrete Pile #1 with a Diesel Impact Hammer on October 3<sup>rd</sup>, 2019

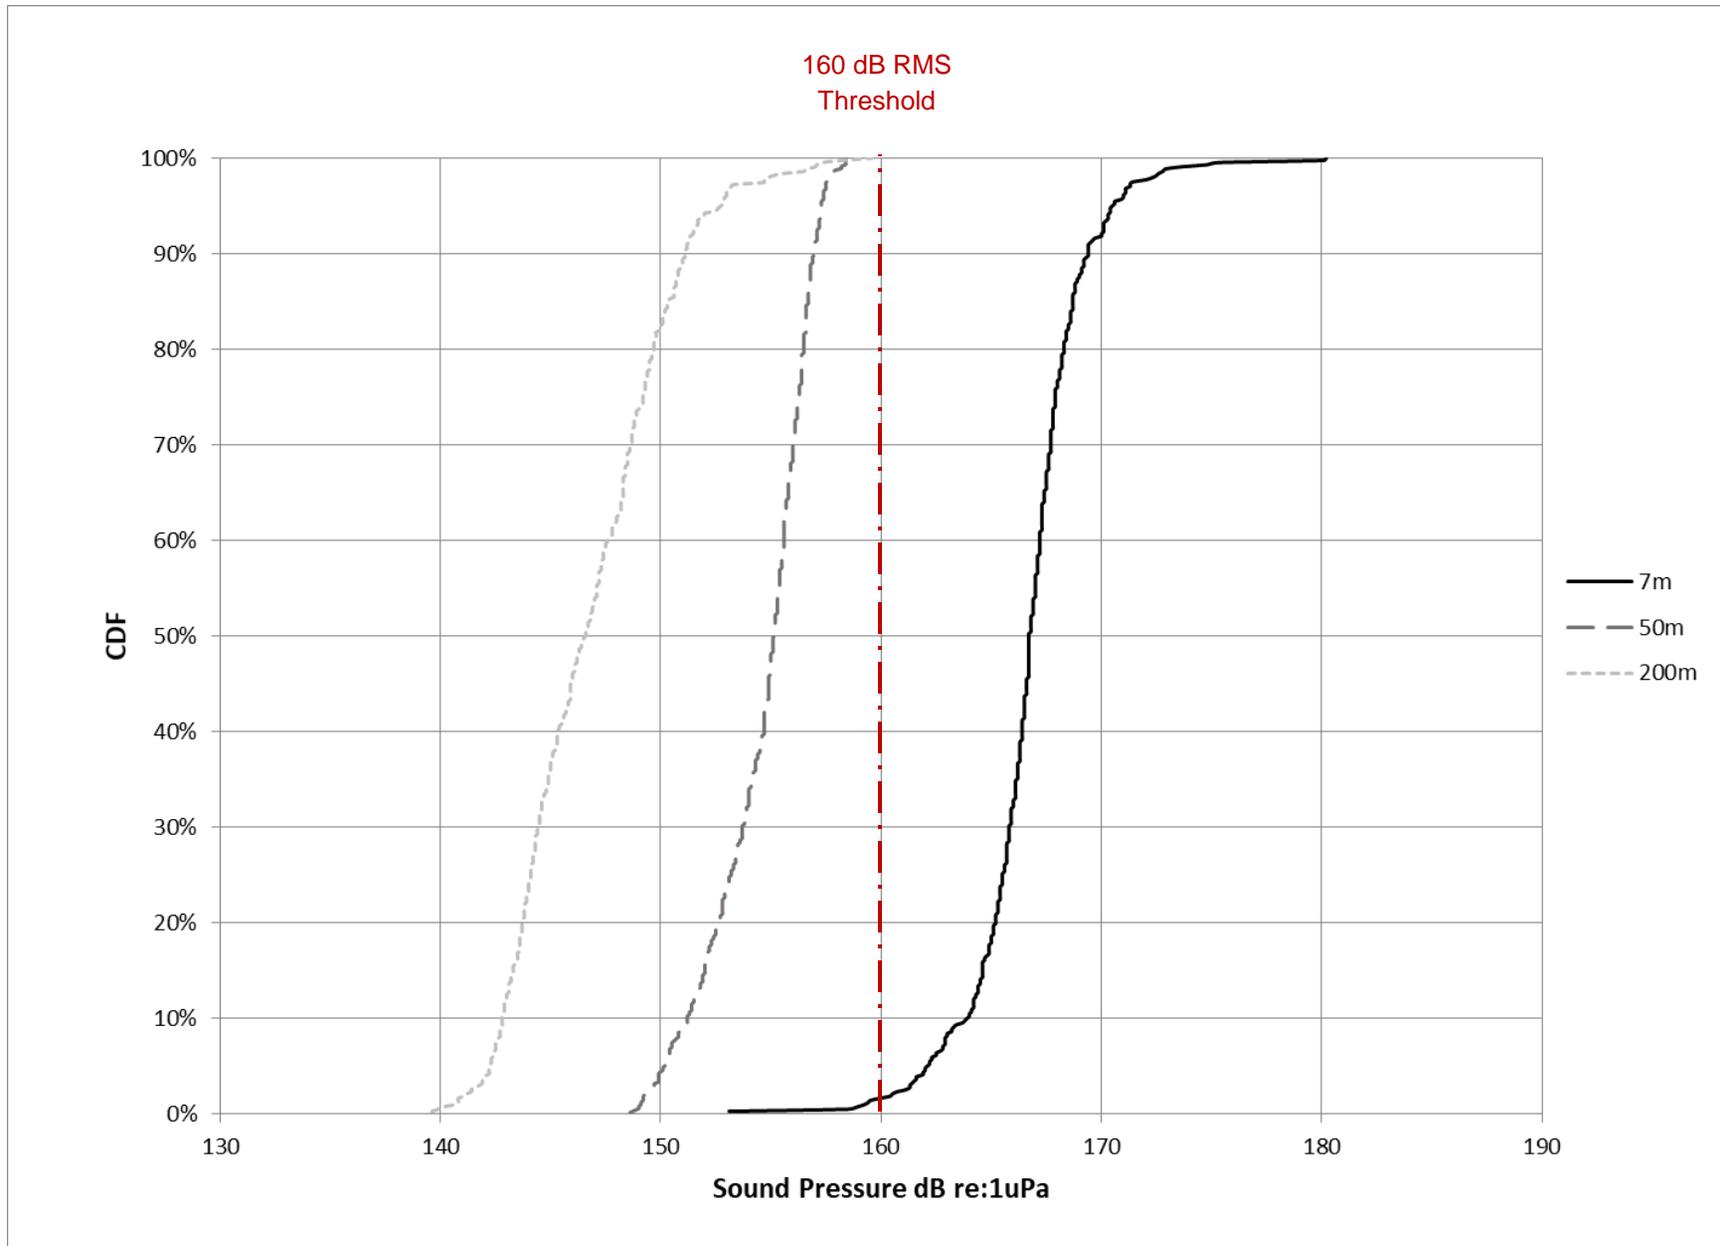
Figure C-7. CDF (RMS values) of the Installation of 20-inch Concrete Pile #2 with a Diesel Impact Hammer on October 3<sup>rd</sup>, 2019

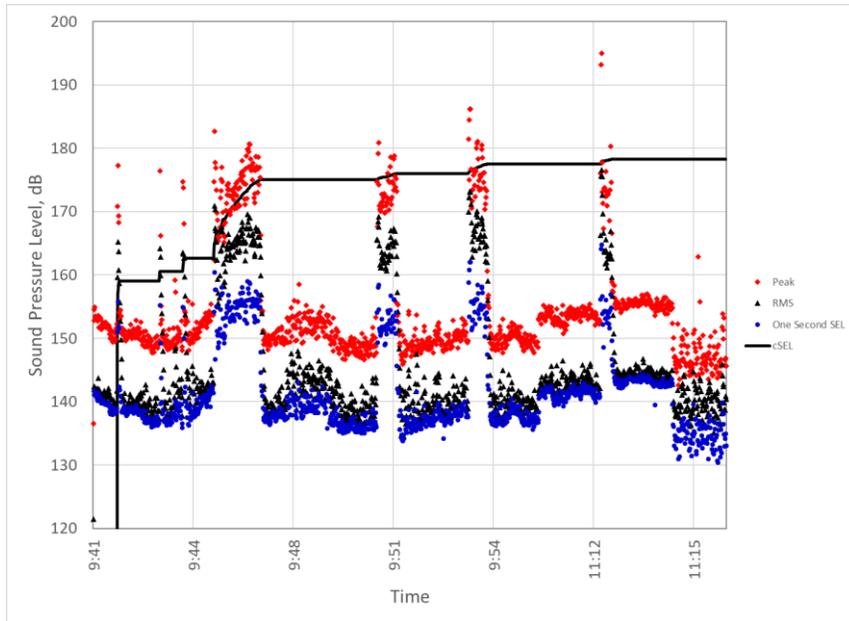
**Figure D-1. Time History Plot of the Installation of a 24-inch Concrete Pile with a Diesel Impact Hammer on June 5<sup>th</sup>, 2019 at 10 meters**

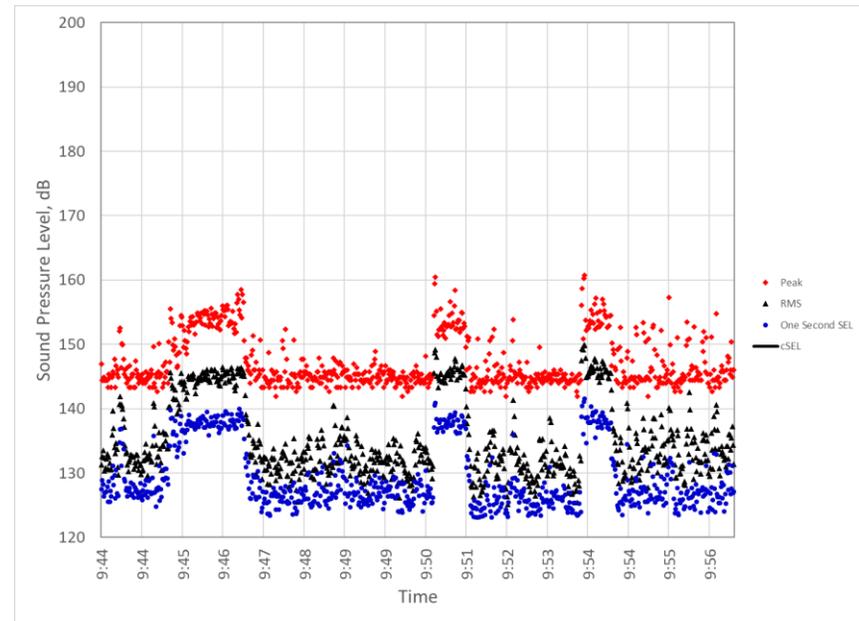
**Figure D-2. Time History Plot of the Installation of a 24-inch Concrete Pile with a Diesel Impact Hammer on June 5<sup>th</sup>, 2019 at 66 meters**

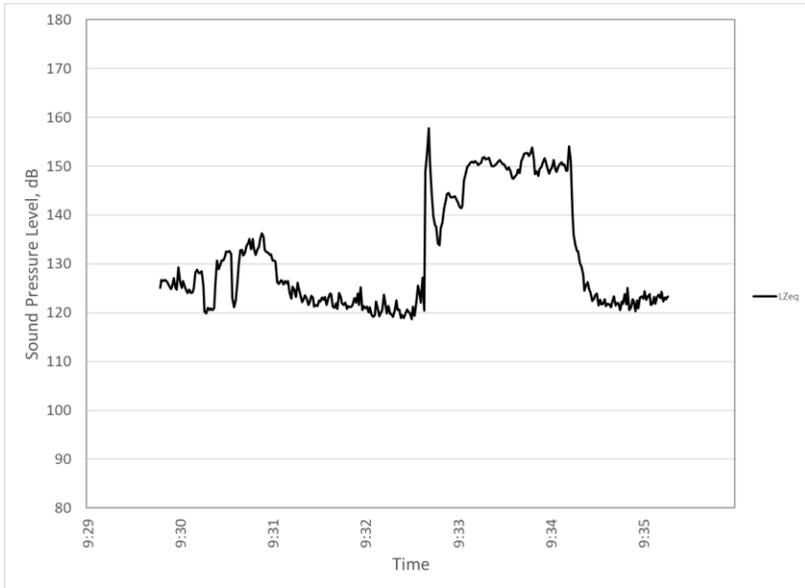
**Figure D-3. Time History Plot of the Installation of 20-inch Steel Pile #1 with a Vibratory Hammer on June 21<sup>st</sup>, 2019 at 22 meters**

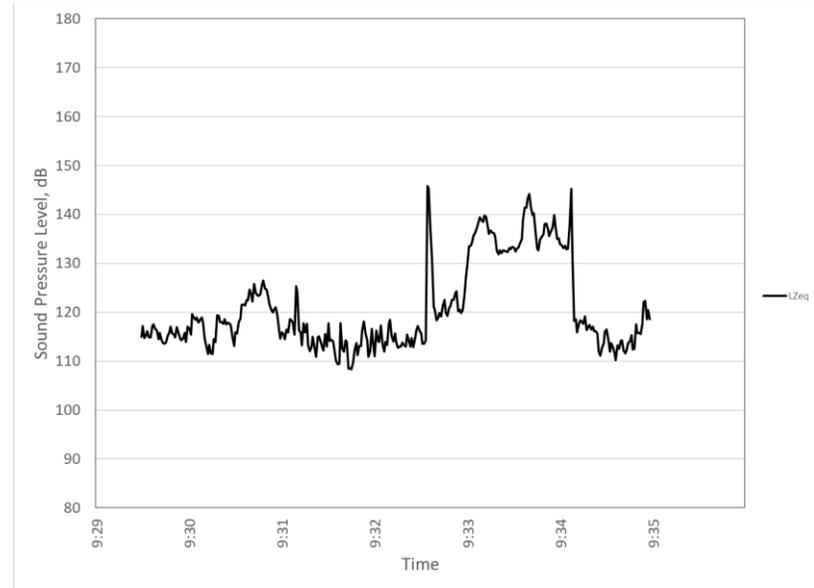
**Figure D-4. Time History Plot of the Installation of 20-inch Steel Pile #1 with a Vibratory Hammer on June 21<sup>st</sup>, 2019 at 75 meters**

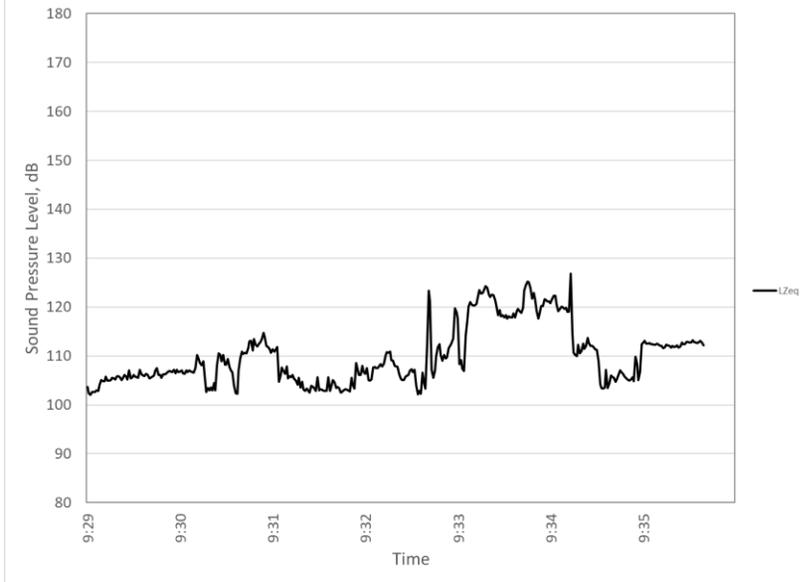
**Figure D-5. Time History Plot of the Installation of 20-inch Steel Pile #1 with a Vibratory Hammer on June 21<sup>st</sup>, 2019 at 220 meters**

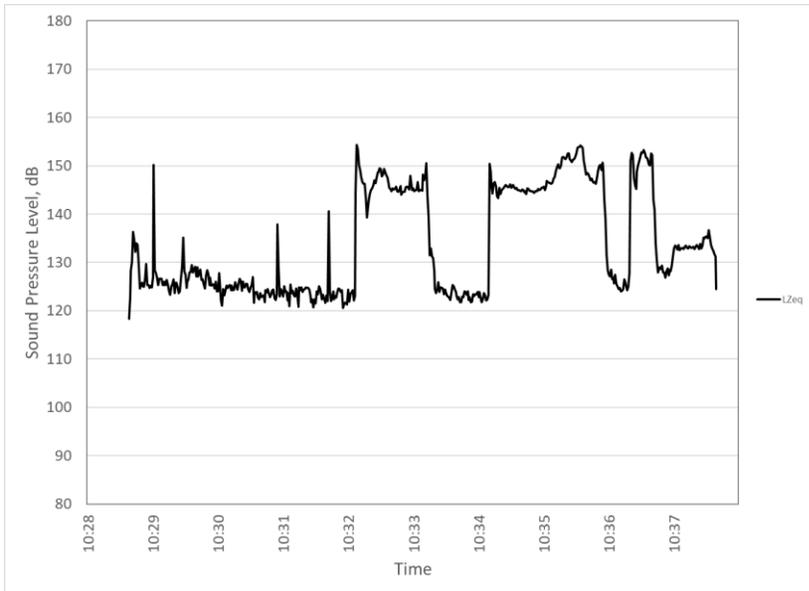
**Figure D-6. Time History Plot of the Installation of 20-inch Steel Pile #2 with a Vibratory Hammer on June 21<sup>st</sup>, 2019 at 18 meters**

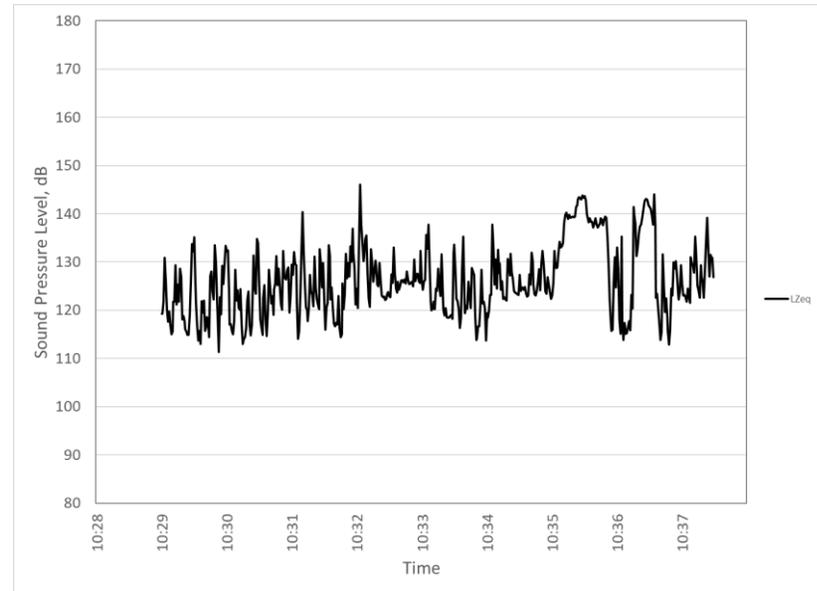
**Figure D-7. Time History Plot of the Installation of 20-inch Steel Pile #2 with a Vibratory Hammer on June 21<sup>st</sup>, 2019 at 75 meters**

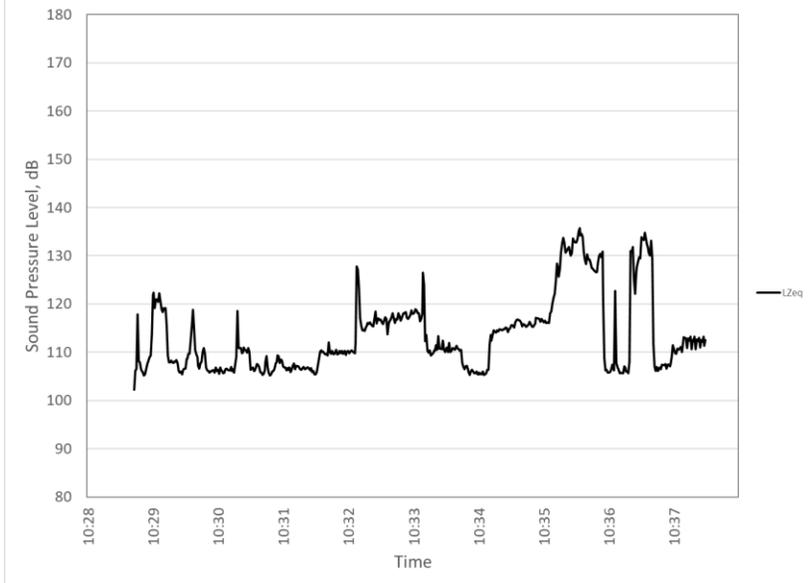
**Figure D-8. Time History Plot of the Installation of 20-inch Steel Pile #2 with a Vibratory Hammer on June 21<sup>st</sup>, 2019 at 220 meters**

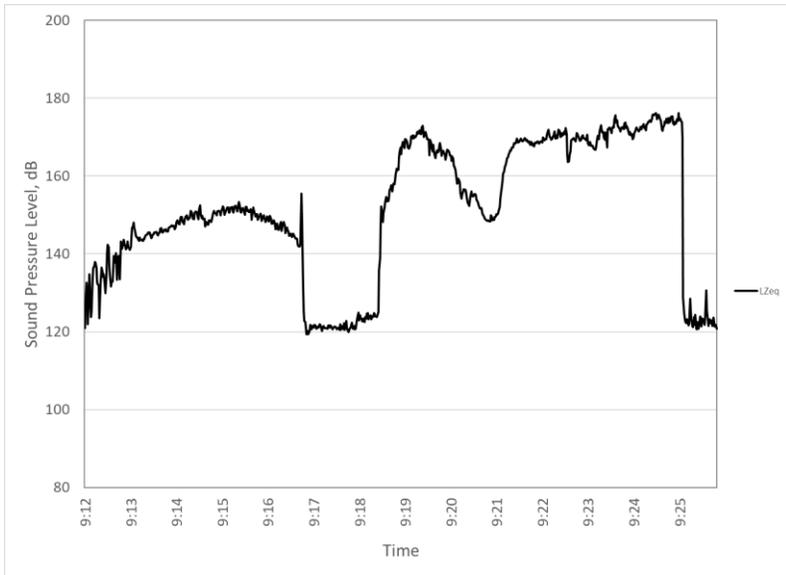
**Figure D-9. Time History Plot of the Installation of 36-inch Steel Pile #1 with a Vibratory Hammer on August 22<sup>nd</sup>, 2019 at 10 meters**

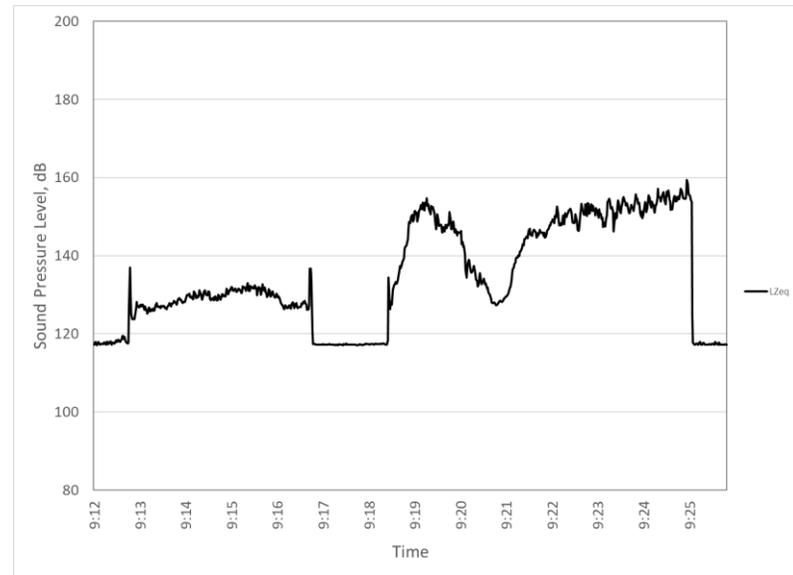
**Figure D-10. Time History Plot of the Installation of 36-inch Steel Pile #1 with a Vibratory Hammer on August 22<sup>nd</sup>, 2019 at 85 meters**

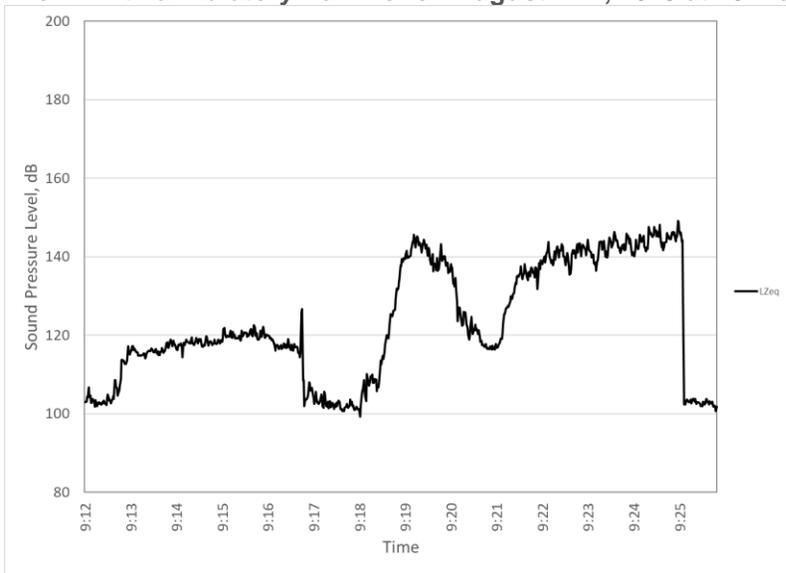
**Figure D-11. Time History Plot of the Installation of 36-inch Steel Pile #1 with a Vibratory Hammer on August 22<sup>nd</sup>, 2019 at 228 meters**

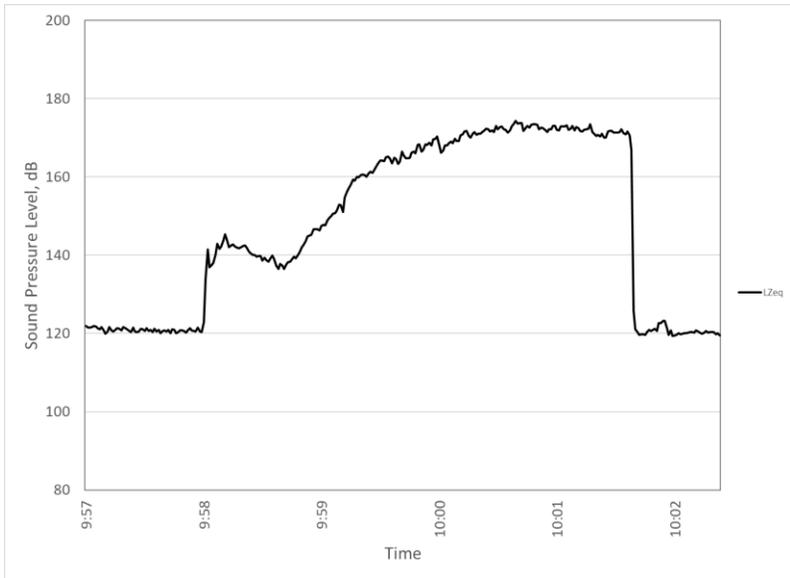
**Figure D-12. Time History Plot of the Installation of 36-inch Steel Pile #2 with a Vibratory Hammer on August 22<sup>nd</sup>, 2019 at 15 meters**

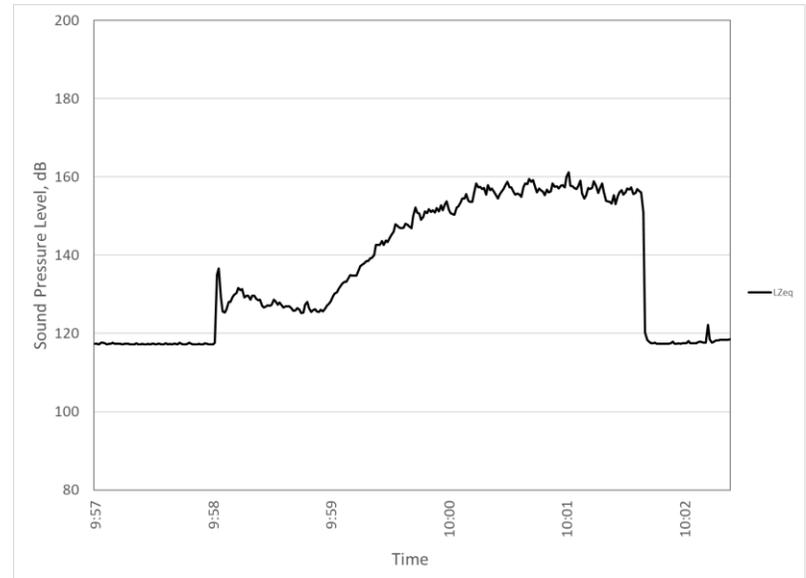
**Figure D-13. Time History Plot of the Installation of 36-inch Steel Pile #2 with a Vibratory Hammer on August 22<sup>nd</sup>, 2019 at 79 meters**

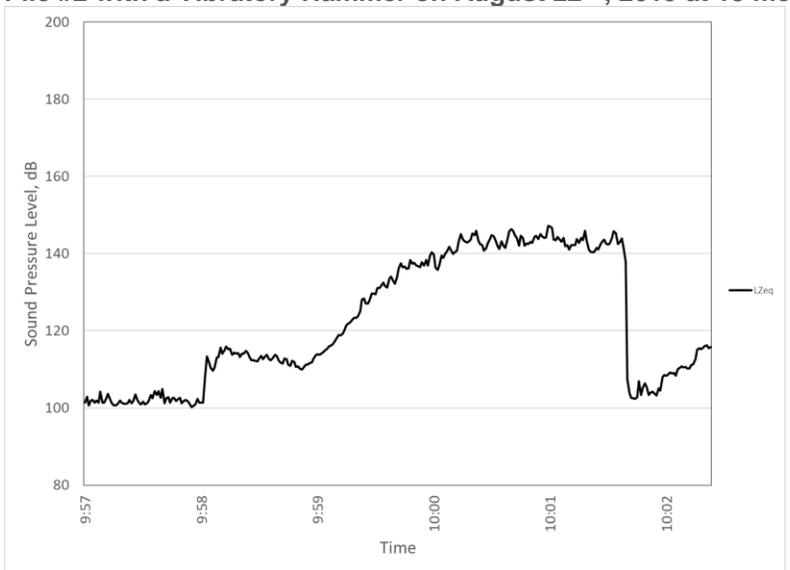
**Figure D-14. Time History Plot of the Installation of 36-inch Steel Pile #2 with a Vibratory Hammer on August 22<sup>nd</sup>, 2019 at 222 meters**

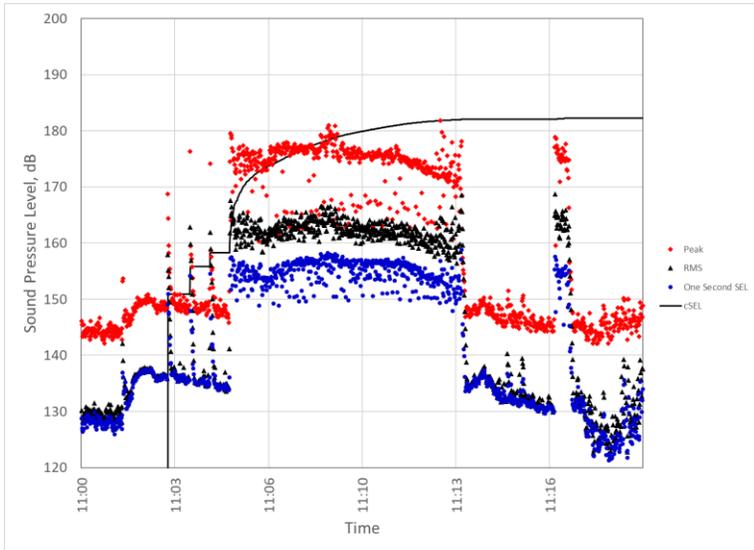
**Figure D-15. Time History Plot of the Installation of 24-inch Concrete Pile #1 with a Diesel Impact Hammer on October 3<sup>rd</sup>, 2019 at 7 meters**

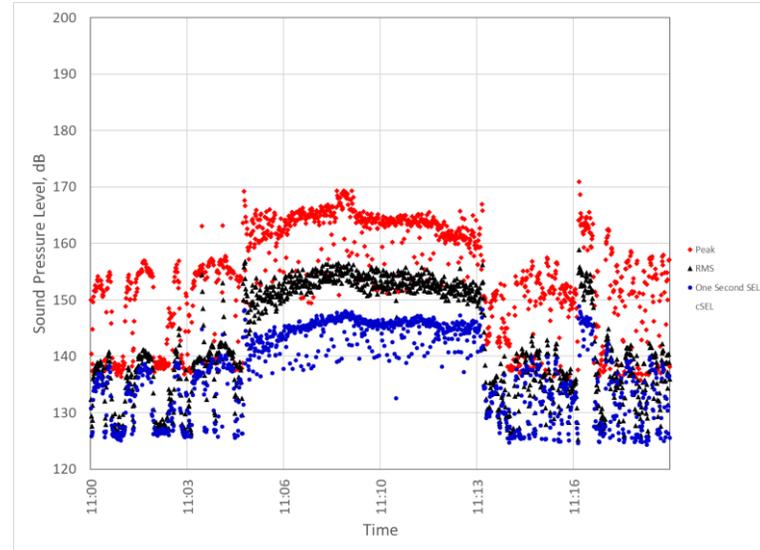
**Figure D-16. Time History Plot of the Installation of 24-inch Concrete Pile #1 with a Diesel Impact Hammer on October 3<sup>rd</sup>, 2019 at 52 meters**

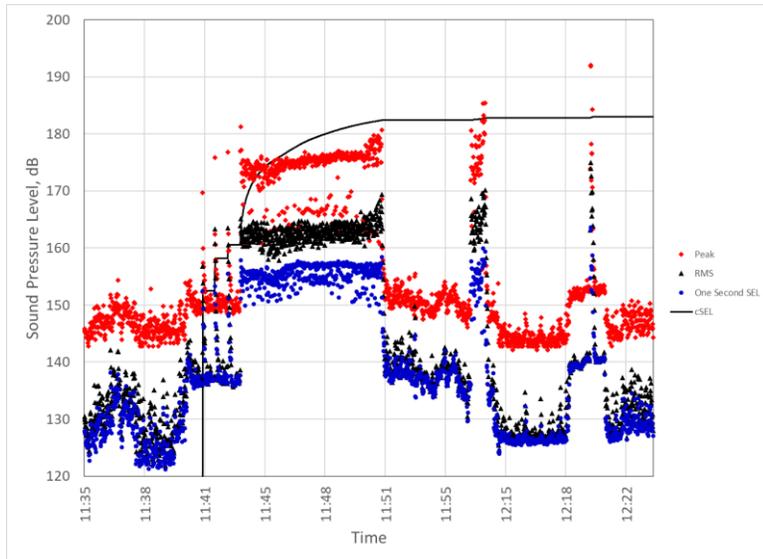
**Figure D-18. Time History Plot of the Installation of 24-inch Concrete Pile #2 with a Diesel Impact Hammer on October 3<sup>rd</sup>, 2019 at 7 meters**

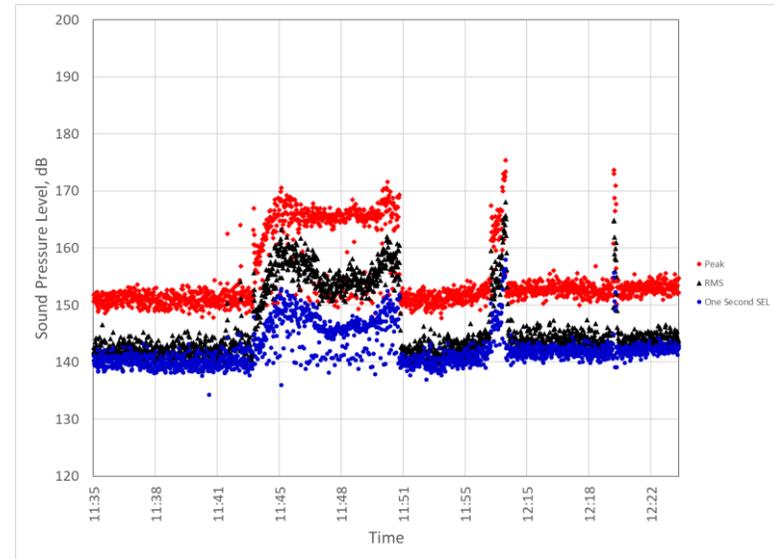
**Figure D-19. Time History Plot of the Installation of 24-inch Concrete Pile #2 with a Diesel Impact Hammer on October 3<sup>rd</sup>, 2019 at 50 meters**

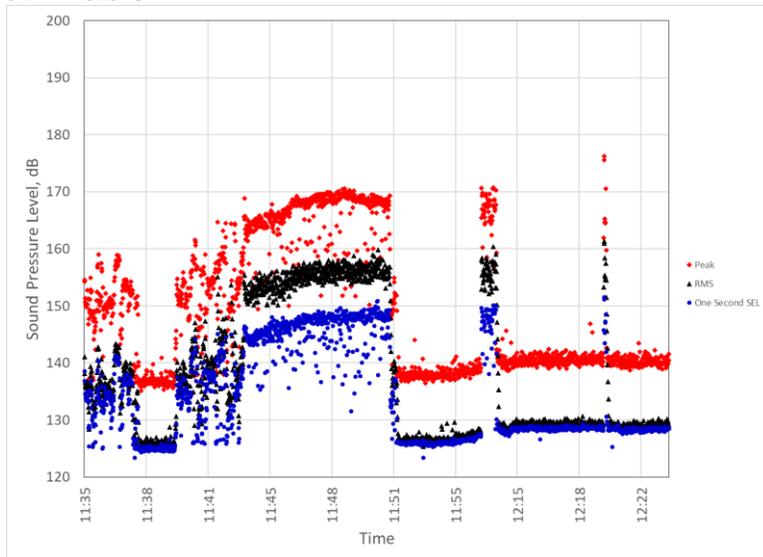
**Figure D-20. Time History Plot of the Installation of 24-inch Concrete Pile #2 with a Diesel Impact Hammer on October 3<sup>rd</sup>, 2019 at 195 meters**
