Subject: Elliott Bay Seawall Project (NWS-2011-778-WRD and NWR-2013-10650)
Marine Mammal and Acoustic Monitoring Season 1 Annual Report

Re: Elliott Bay Seawall Project (NWS-2011-778-WRD and NWR-2013-10650)
Marine Mammal Monitoring Season 1 Annual Report

**ELLIOTT BAY SEAWALL PROJECT SEASON 1 (2014)
ACOUSTIC MONITORING REPORT
(NWS-2011-778-WRD and NWR-2013-10650)**

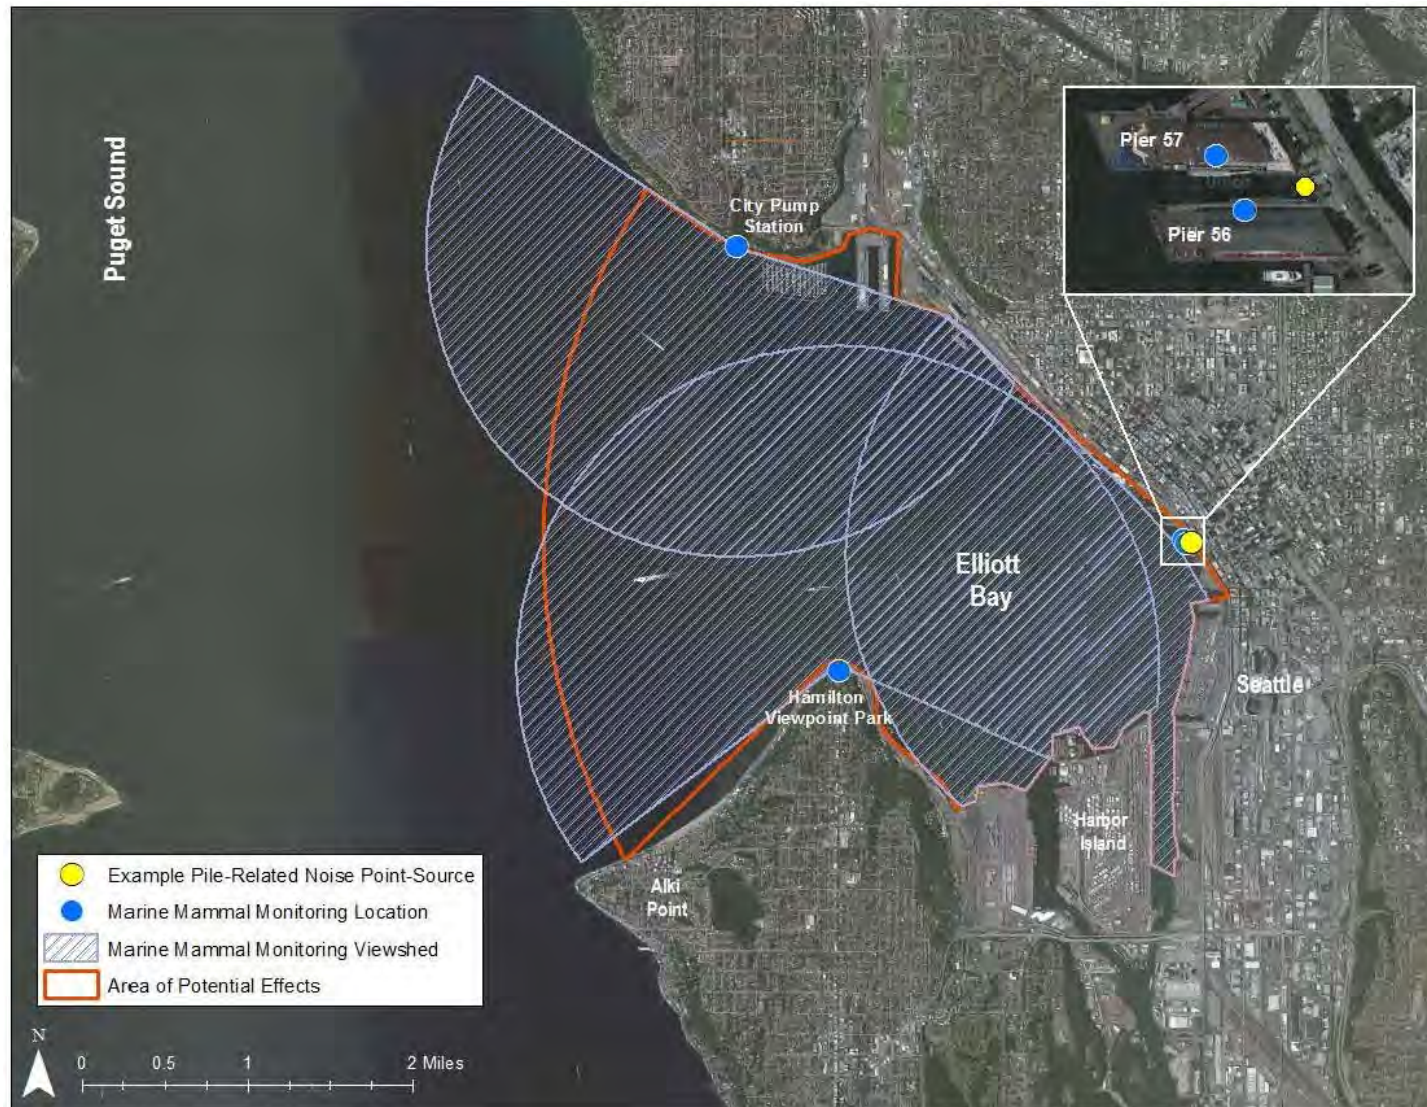
Figure 2. Marine Mammal Monitoring Area and Monitoring Locations

All monitoring was performed by land-based observers. The number of land-based observers was determined by the type of pile driving activity. One observer was located at the project site during impact and vibratory pile driving. During vibratory pile driving, two additional observers were located at designated viewpoints on the north and south entrance of Elliott Bay with unobstructed views of the

bay. The south monitoring point is located at the Hamilton Viewpoint Park pier, identified as the Alki monitoring site. The north monitoring point is located at the West 32nd Avenue City pump station, identified as the Magnolia monitoring site. The monitoring locations are shown on Figure 2 in Attachment A.

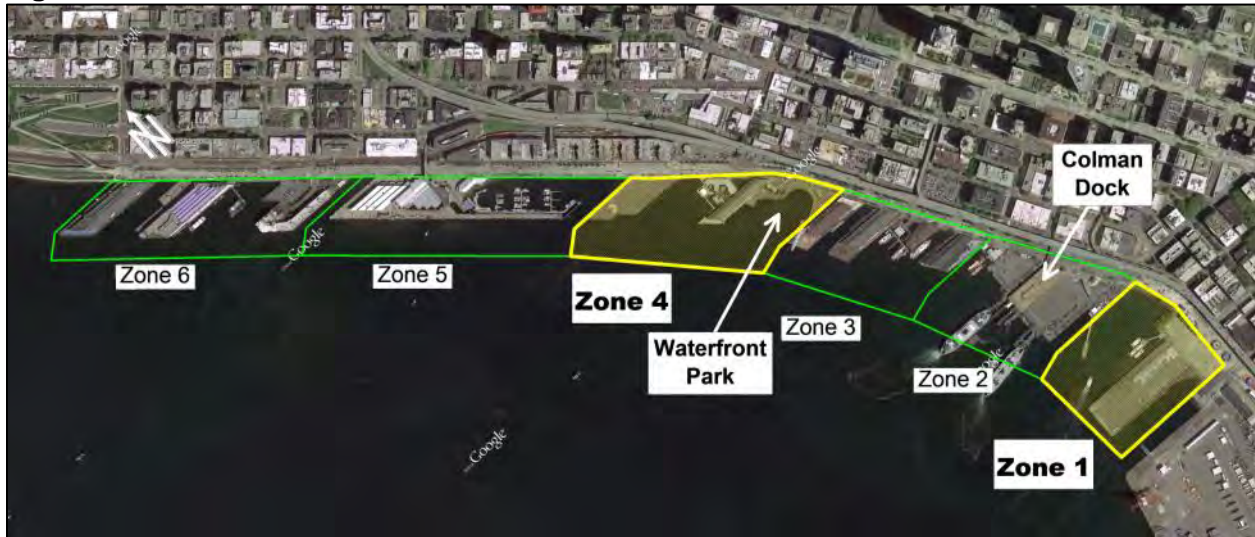
Figure 3.1 Season 1 Construction Zones

During Season 1, construction pile driving activities took place in two separate locations as shown in Figure 3.1. The southern location was in Zone 1, which is located south of Colman Dock and the northern location was in Zone 4, which is located near Waterfront Park. The Figure below illustrates the project location and the locations of Zones 1 and 4.

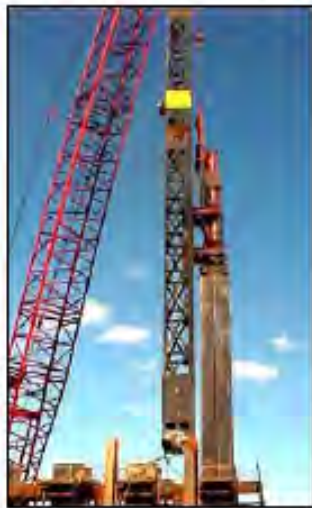
APE Model D62-42 Single Acting Diesel Impact Hammer

D62-42 in a stand-off driving Kingpile.

Concrete piles were driven with an APE Model D62-42 Single Acting Diesel Impact Hammer with a maximum striking energy of 153,799 foot-pounds. The weight of the ram was 13,671 pounds with a rated stroke of 11.25 feet and generated between 34 and 53 blows per minute. A six inch plywood pile cushion was used on top of the 24-inch concrete piles. A cut sheet of the hammer and pile cushion can be found in the Appendix of this Report.

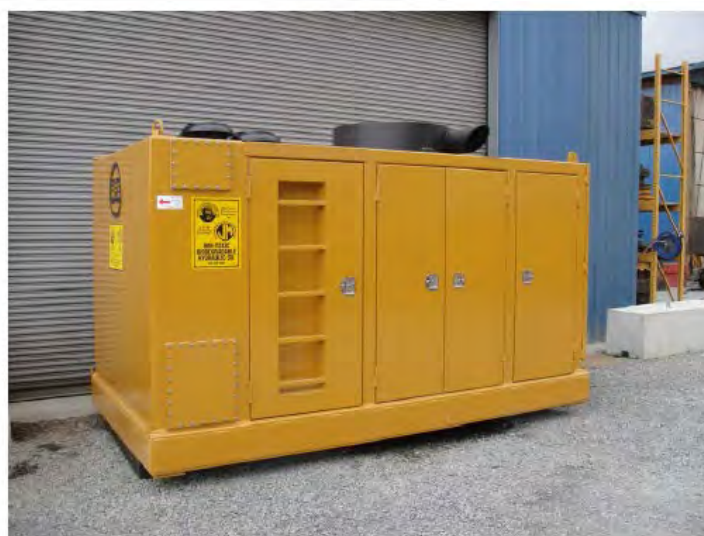
SPECIFICATIONS	DATA
Eccentric Moment	4,500 in-lbs (52 kgm)
Frequency	1,750 VPM
Driving Force @ 1,750 VPM	198 US tons (177.8 tons)
Driving Force @ 1,950 VPM	243 US tons (220.4 tons)
Amplitude without Attachment	0 to 1.25 in (32 mm)
Max Line Pull	150 US tons (136.1 tons)
Suspended Weight w/ Clamp and 75 ft Hose	17,500 lbs (7,936 kg)
Dynamic Weight w/ Clamp	9,625 lbs (4,365 kg)
Length	125 in (318 cm)
Width at Throat	14 in (35 cm)
Width	17 in (43 cm)
Height	100 in (254 cm)
Hydraulic Hose Length	150 ft (45 m)
Hydraulic Hose Weight 50 ft with Oil	2,000 lbs (907 kg)

SPECIFICATIONS	DATA
Power Unit Engine	C18 ACERT Tier III Certified
Hydraulic Tank (reserve)	60 gal (227 L)
Hydraulic Tank (main)	475 gal (1798 L)
Fuel Capacity	165 gal (625 L)
Clamp Flow	10 gpm (41 lpm)
Clamp Pressure (sheet clamp)	310 bar (4500 psi)
Maximum Hyd. Flow-Reverse	0-196 gpm (0-741.86 lpm)
Maximum Hyd. Flow-Forward	0-215 gpm (0-813.78 lpm)
Maximum Drive Pressure	4500 psi (310 bar)
Maximum Power	700 hp (514.86 kW)
Operating Speed	800 to 2100 rpm
Height	94 in (238.76 cm)
Width	82.25 in (208.92 cm)
Length	152 in (386.08 cm)
Weight	19,000 lbs (8618.26 kg)

Steel sheet piles were driven using an APE Model 250VM Vibratory Driver/Extractor operating at 1,750 VPM generating a driving force of 196 US tons. The suspended weight with clamp and 75 feet of hose is 17,500 pounds. A cut sheet of the vibratory driver can be found in the Appendix of this Report.
