Protected Species Mitigation and Monitoring Report

Marine Geophysical (Seismic) Survey
North Pacific Ocean

Gulf of Alaska
08 June 2019 – 24 June 2019

R/V Marcus G. Langseth

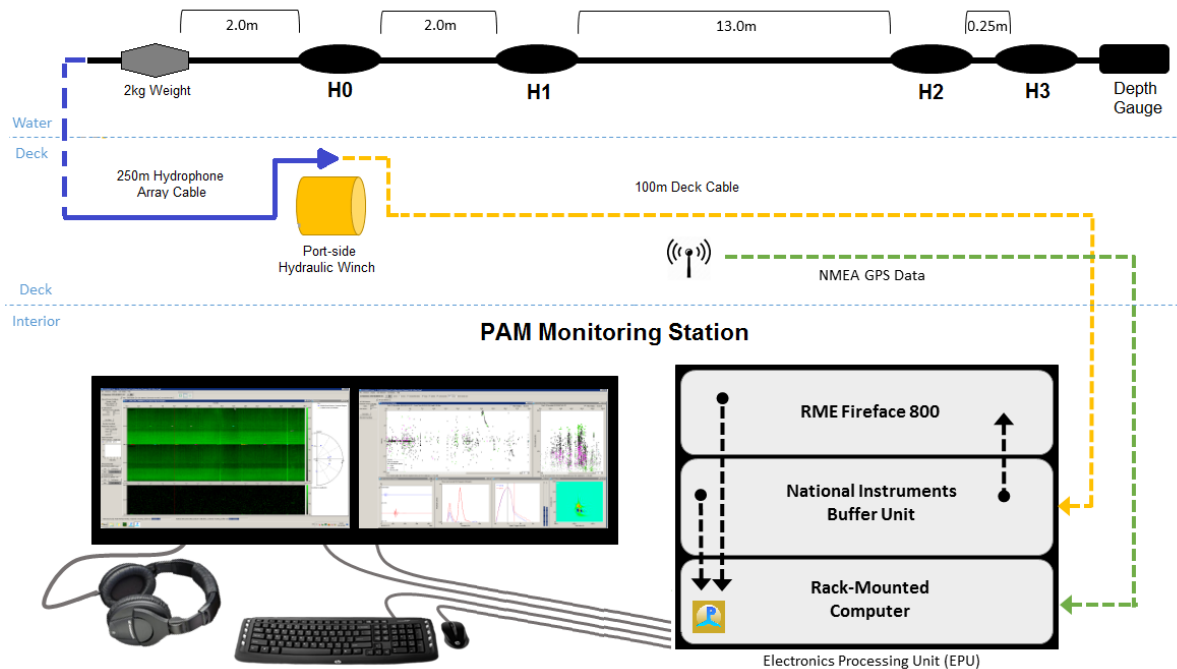
Figure 3: Simplified pathway of data through the PAM system on board the *Langseth*.

also present onboard in the event the main system components became damaged or inoperable. The diagram in Figure 3 is a simplified depiction of the PAM system installed on the *Langseth*, and further PAM system specifications can be found in Appendix C.

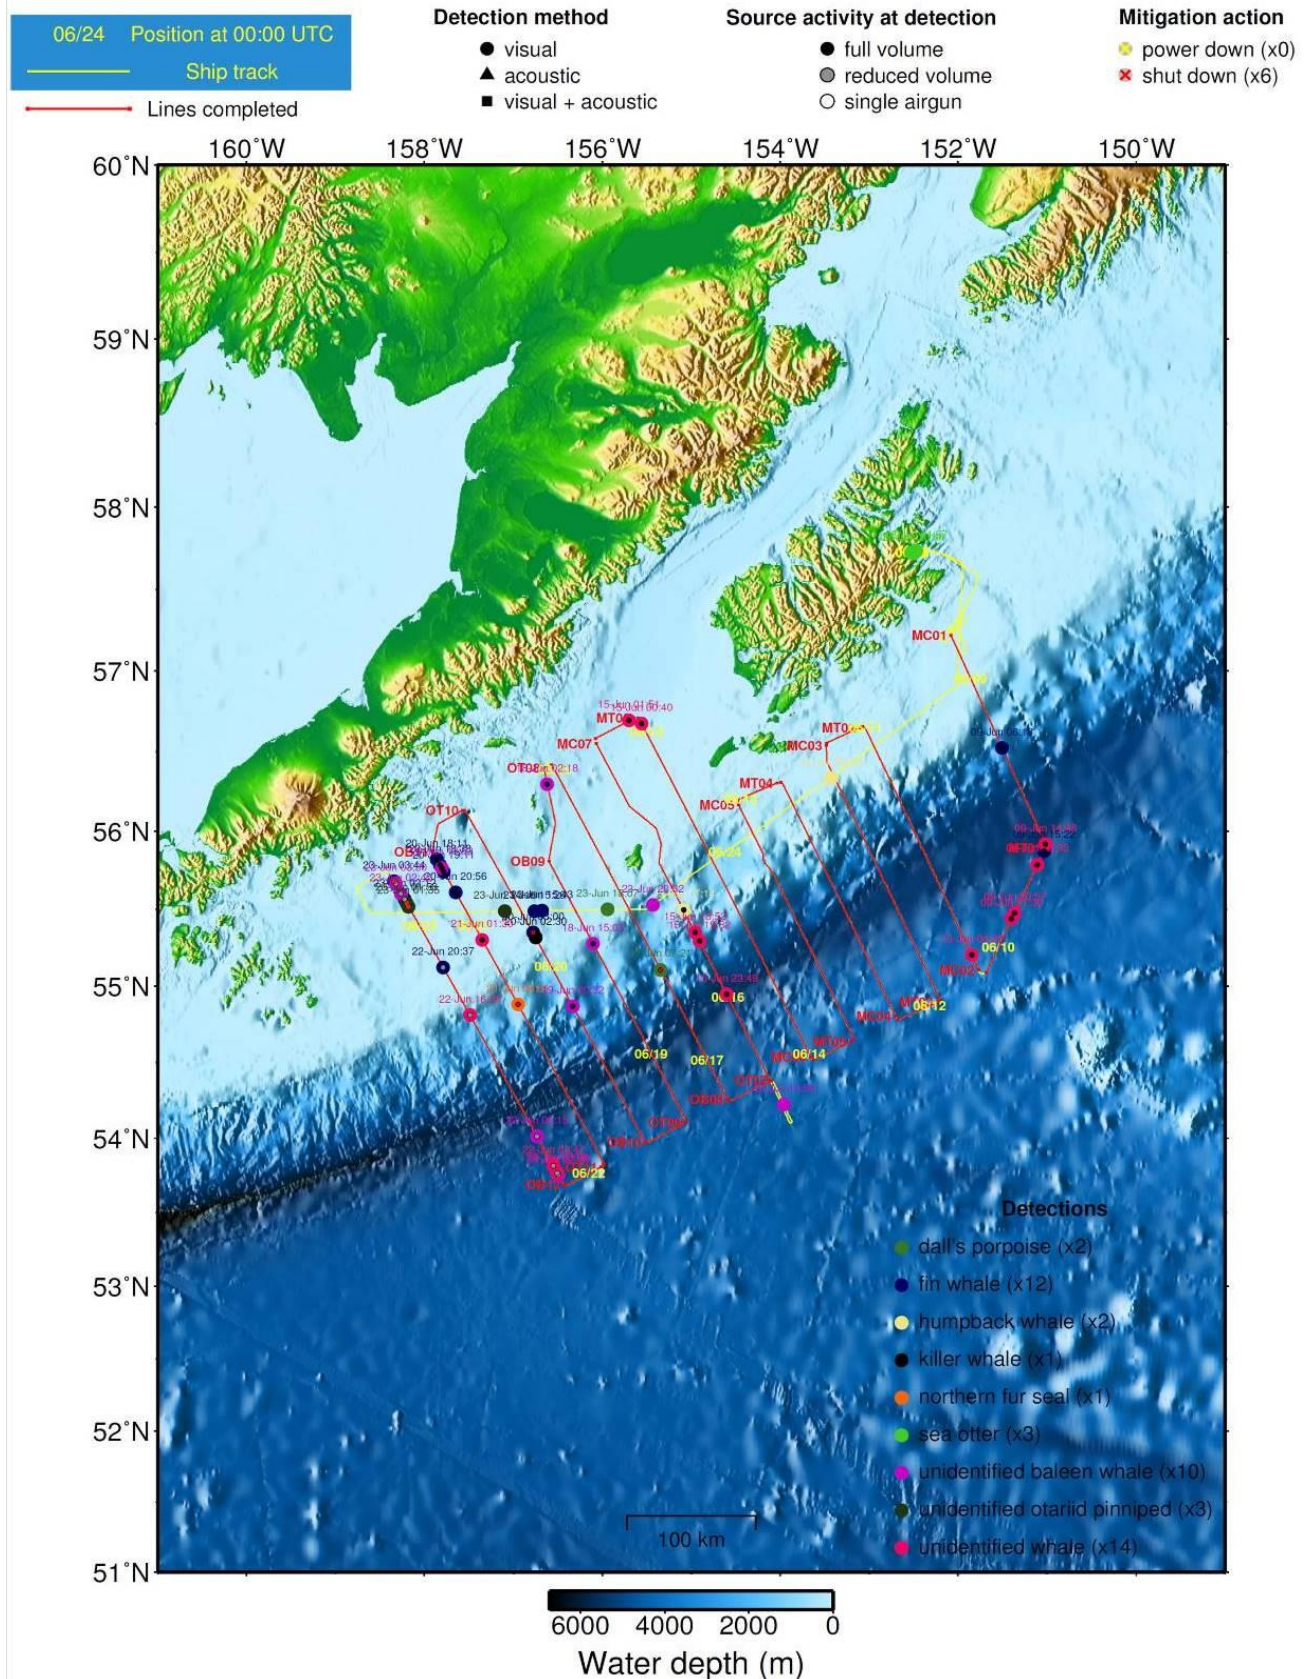
Figure 6: Protected species detections and vessel track lines during the survey.

The majority of the protected species detections occurred while the vessel was on a survey line (38 detections, 79% of all protected species detections) (Figure 6). The three detections of northern sea otters all occurred while the vessel was transiting in and out of port at the beginning and end of the survey program. The majority of the whale detections, and all of the pinniped, dolphin, and porpoise detections occurred south-west of Kodiak, during the last several survey lines of the project (Figure 7).
