Mangrove Forests

Coastal Green Infrastructure of the US Virgin Islands

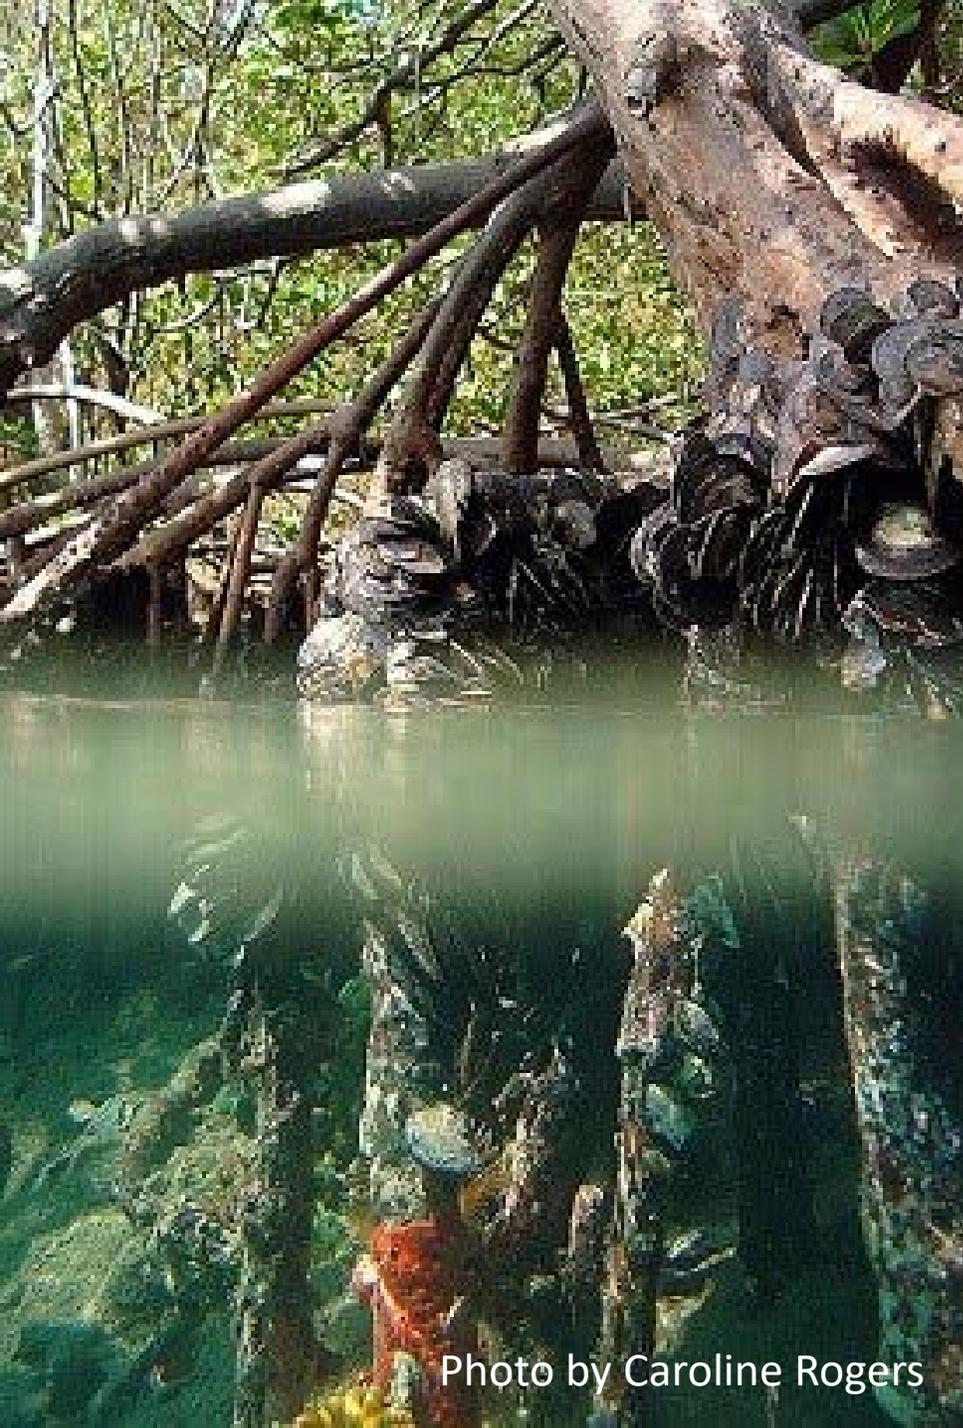
Mangroves in the USVI

- Mangrove forests in the Virgin Islands are the first the first level of defense in storm surge in hurricanes and mitigate inland flooding from heavy rains
- Shore stabilization
- Fisheries
- Wildlife

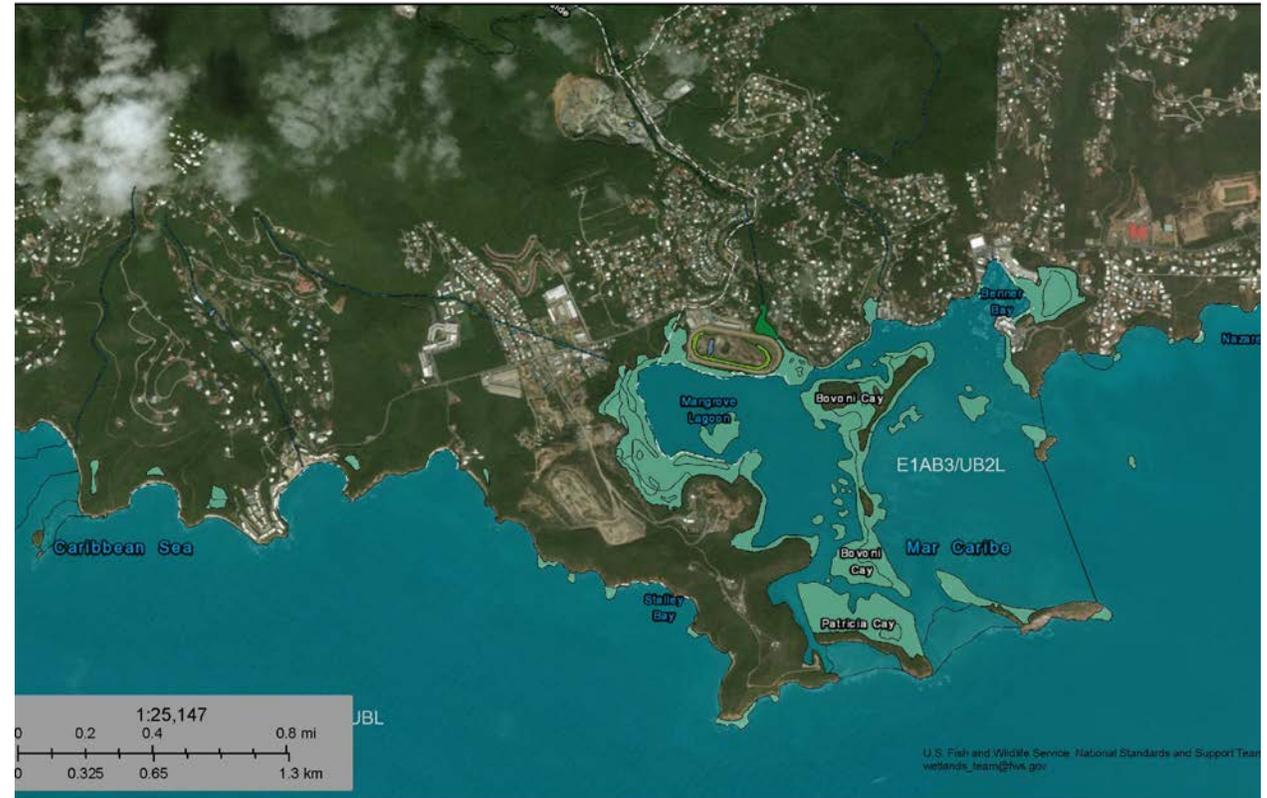
FWS Wetland in st thomas

- Resources such as the FWS wetland mapper are best when used at a larger scale
- US Forest Service – International Institute of Tropical Forestry landcover classification map is excellent and has a mangroves forest cover class

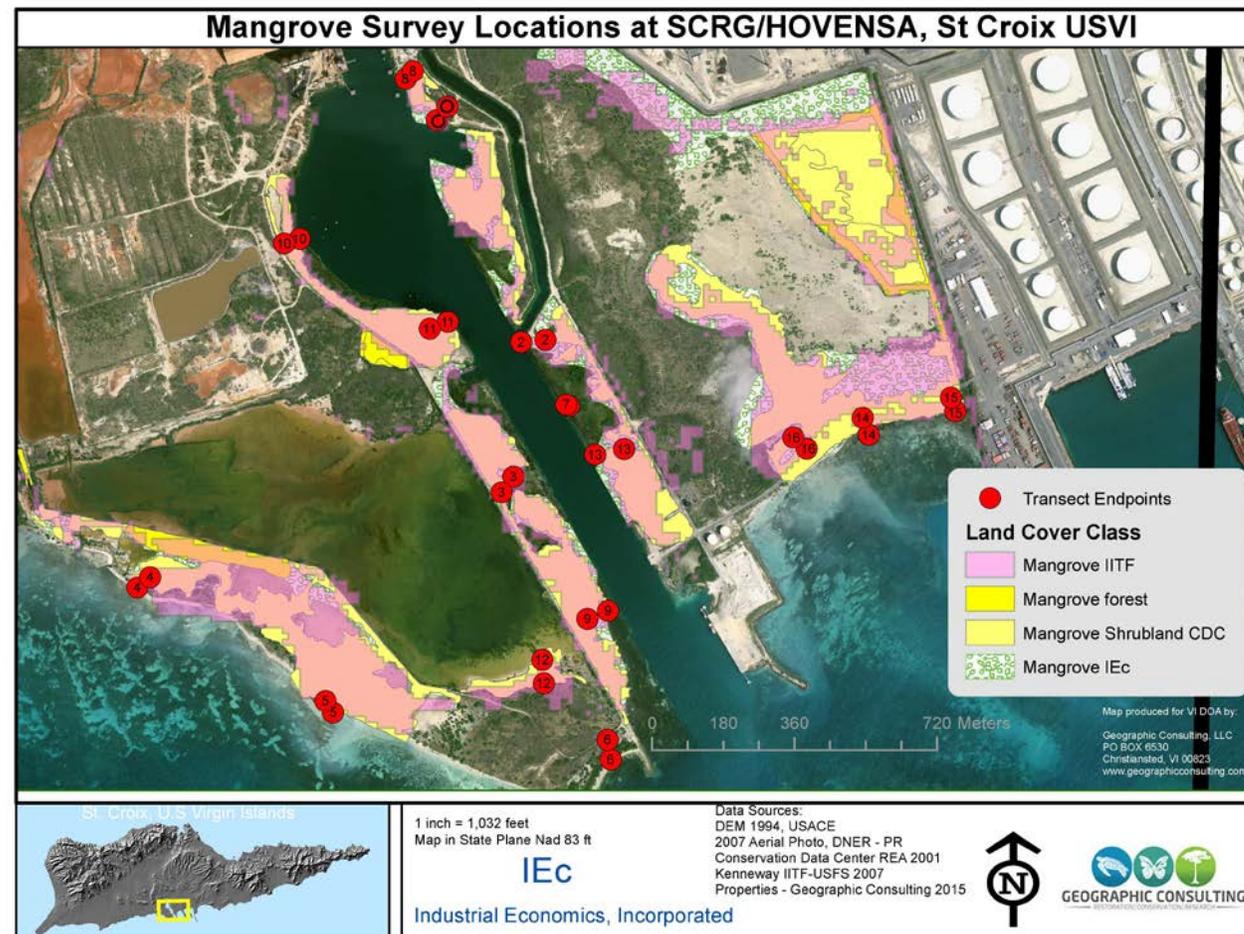
Great Pond & SCRG/Lime Tree Field study

- Multiple mangrove base layers combined to create study site in GIS
- Random point generation for transect locations
- Transects are perpendicular to the coastline
- Overstory; Height, canopy density, health...
- Understory; seedling density, species, size class

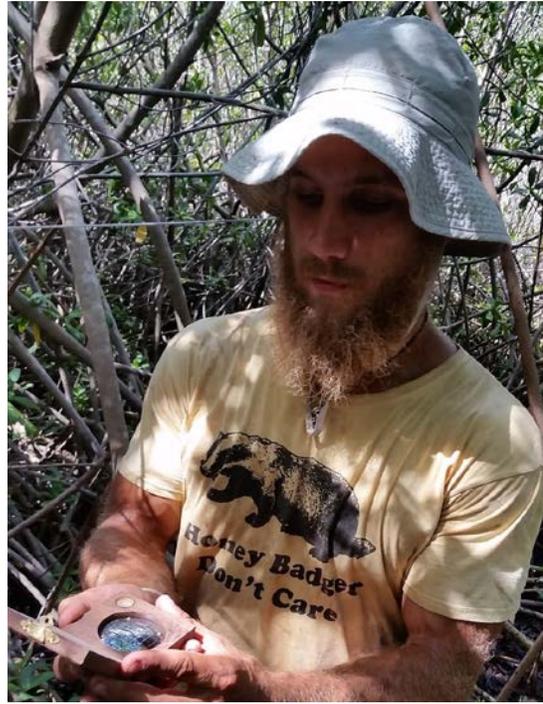
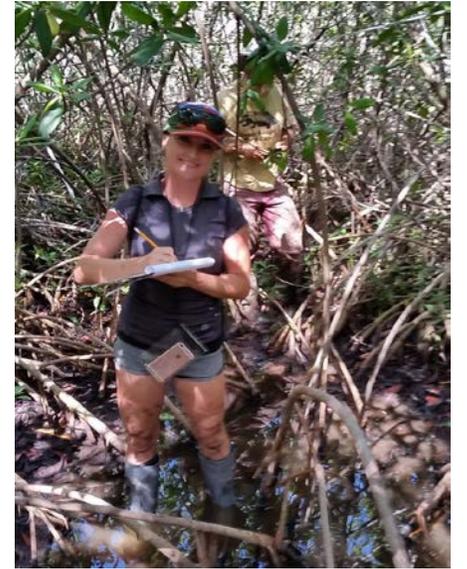
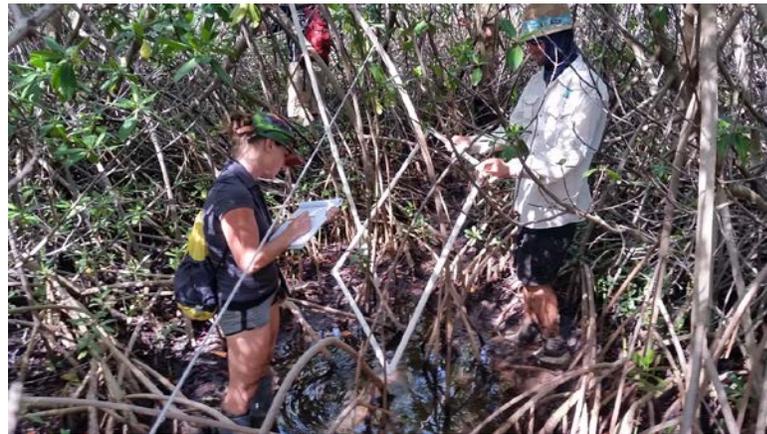
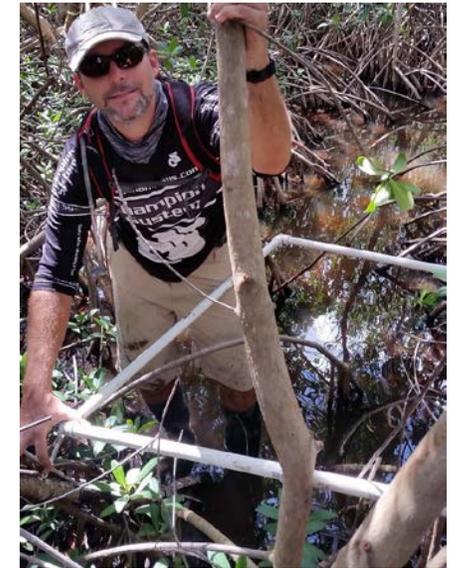
Great Pond used as a comparative reference

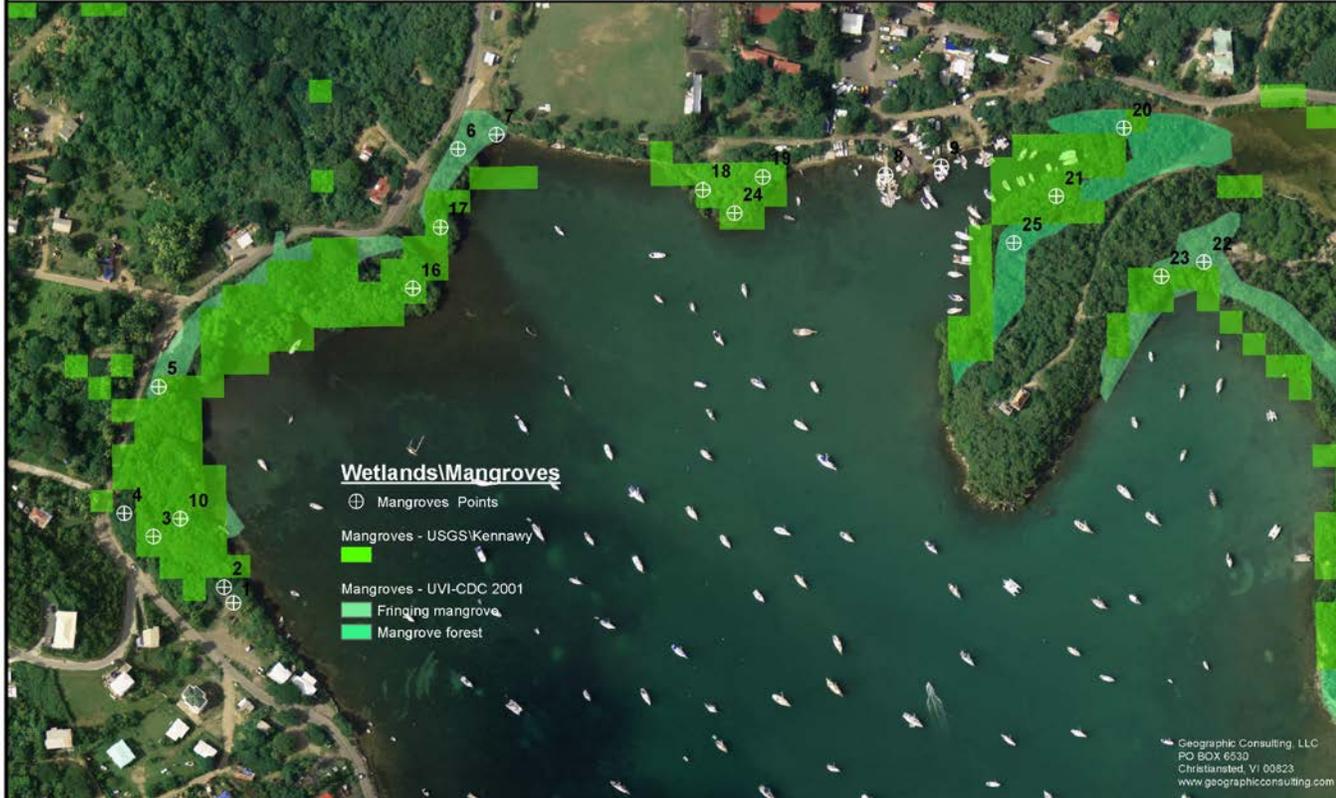
Post Hurricane Rapid Assessment of Coral Bay

- Rapid sampling methods assessed damage across the entire bay
- Canopy cover, ground cover, tree damage and regeneration were recorded

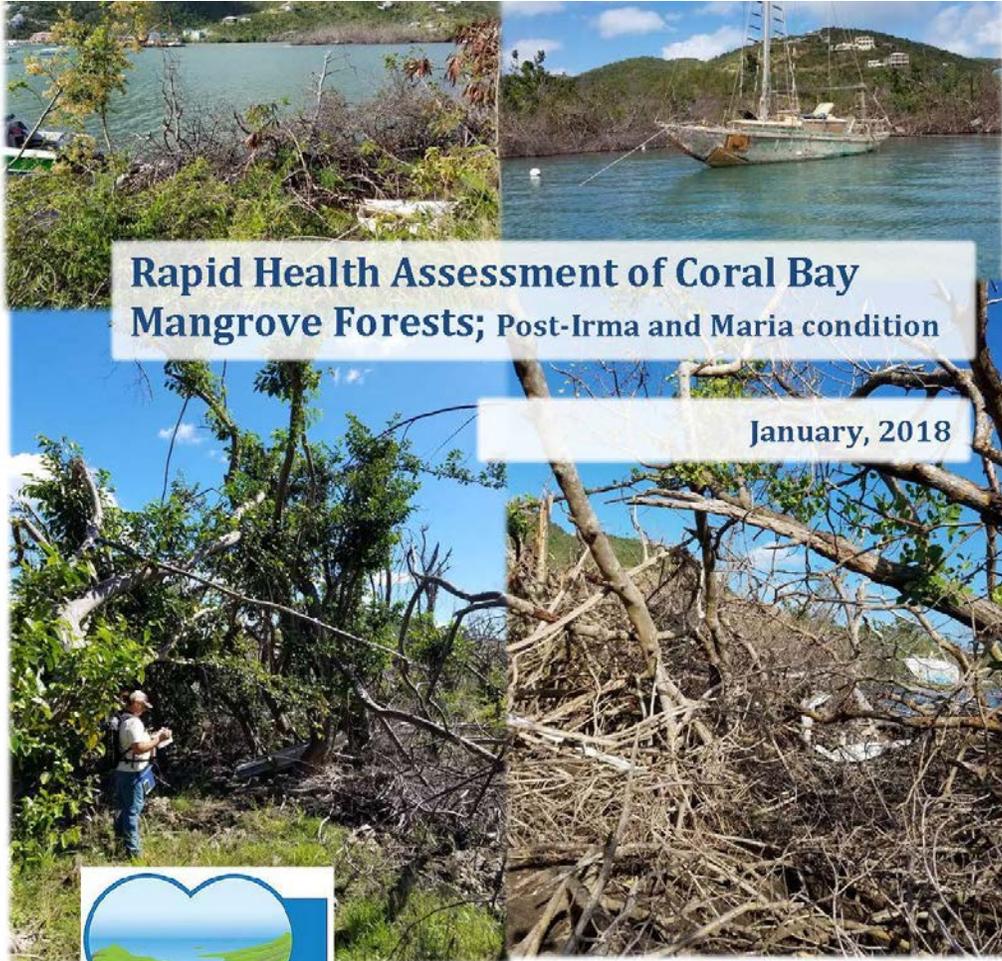
**Rapid Health Assessment of Coral Bay
Mangrove Forests; Post-Irma and Maria condition**

- All sample sites had tree damage over 50% recorded
- Damage of 100% recorded at several sample point
- Red mangroves, showed a higher degree of damage and few signs of regeneration
- Regeneration from propagules was widespread in some sample sites
- Recommendations and results were distributed to the Coral Bay community

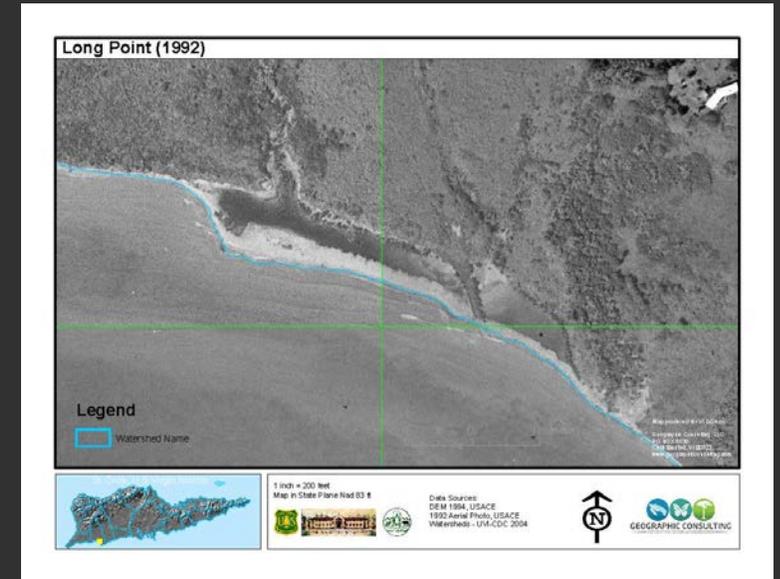
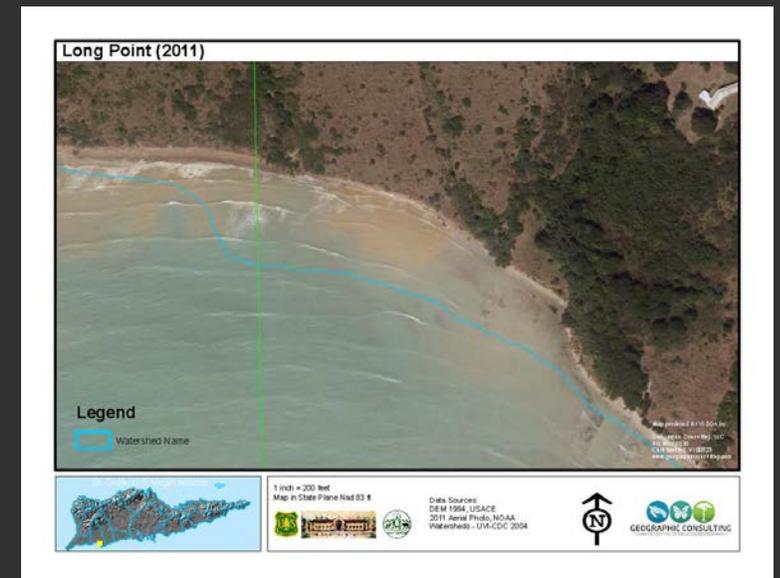
Proposed Long Point Mangrove Restoration

- Mangrove pond lost and coastline receded over 80 feet in some location
- Comparison does not include Maria Damage
- Geographic Consulting and Reef Ball proposed partial solution with green infrastructure
- *Phase 1 is ramping up a tree nursery!*
