**Final Incidental Harassment Authorization  
Monitoring Report**

**Washington State Department of Transportation  
Ferries Division**

**Coupeville Timber Towers Preservation Project**

**May 18, 2017**

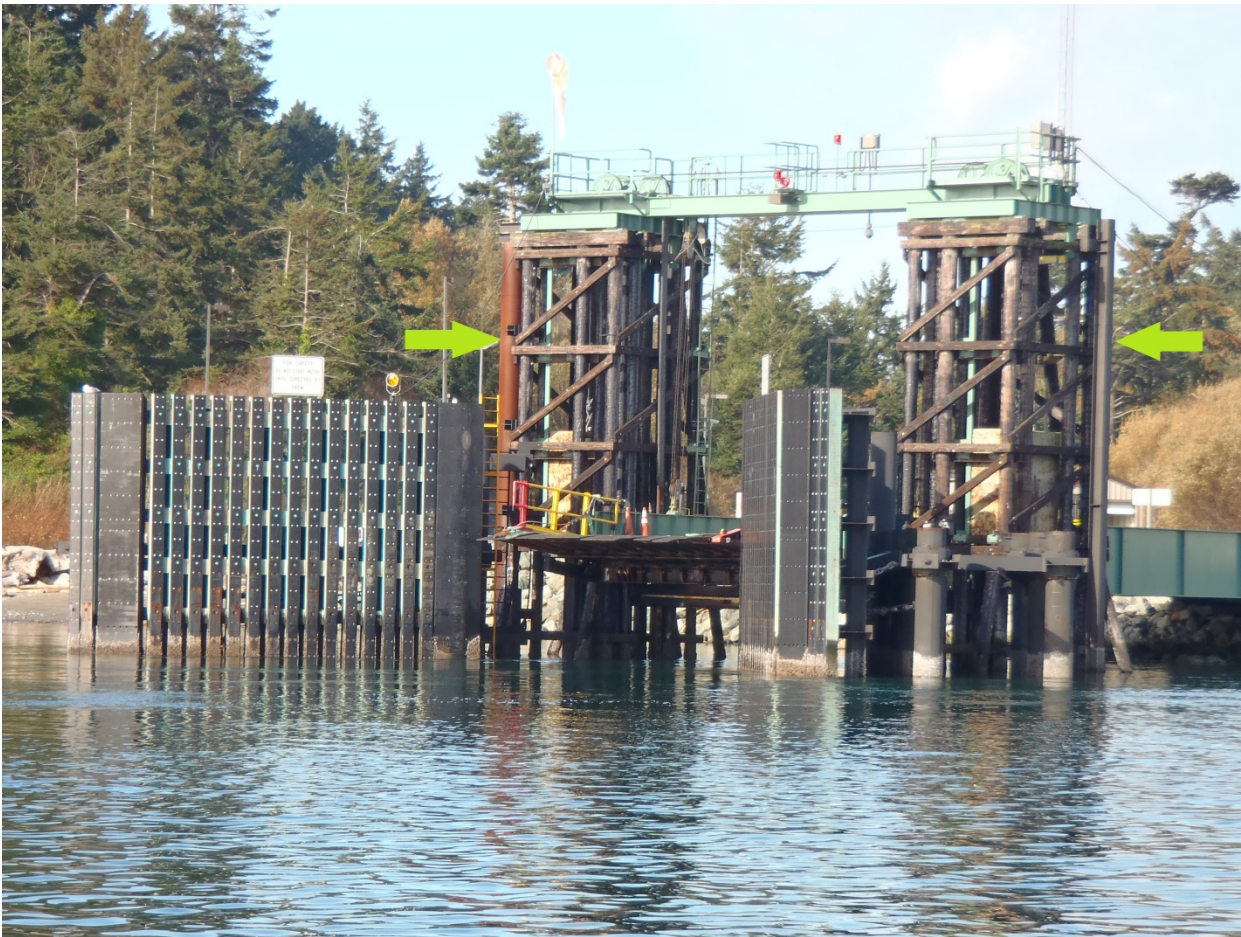
**Figure 2-1 Coupeville Timber Towers**

The transfer span towers and headframe house the cable and weight system that raises and lowers the transfer span to adjust to the tides, allowing for vehicle traffic to enter and exit the ferry vessel (Figure 2-1). The towers needed to be upgraded to due to scour from ferry vessel propellers that were reducing pile embedment. The project was completed in one in-water work window. Work took place from a barge containing a derrick, crane and other necessary equipment.

Eight 24-inch diameter hollow steel piles were installed to support the towers, and concrete caps were installed on top in order to support the headframe that houses the pulleys for the transfer span cables. Five 12-inch timber piles were removed to allow room for the new steel piles to be installed. The remaining tower timber piles remained in place to help support the structure.

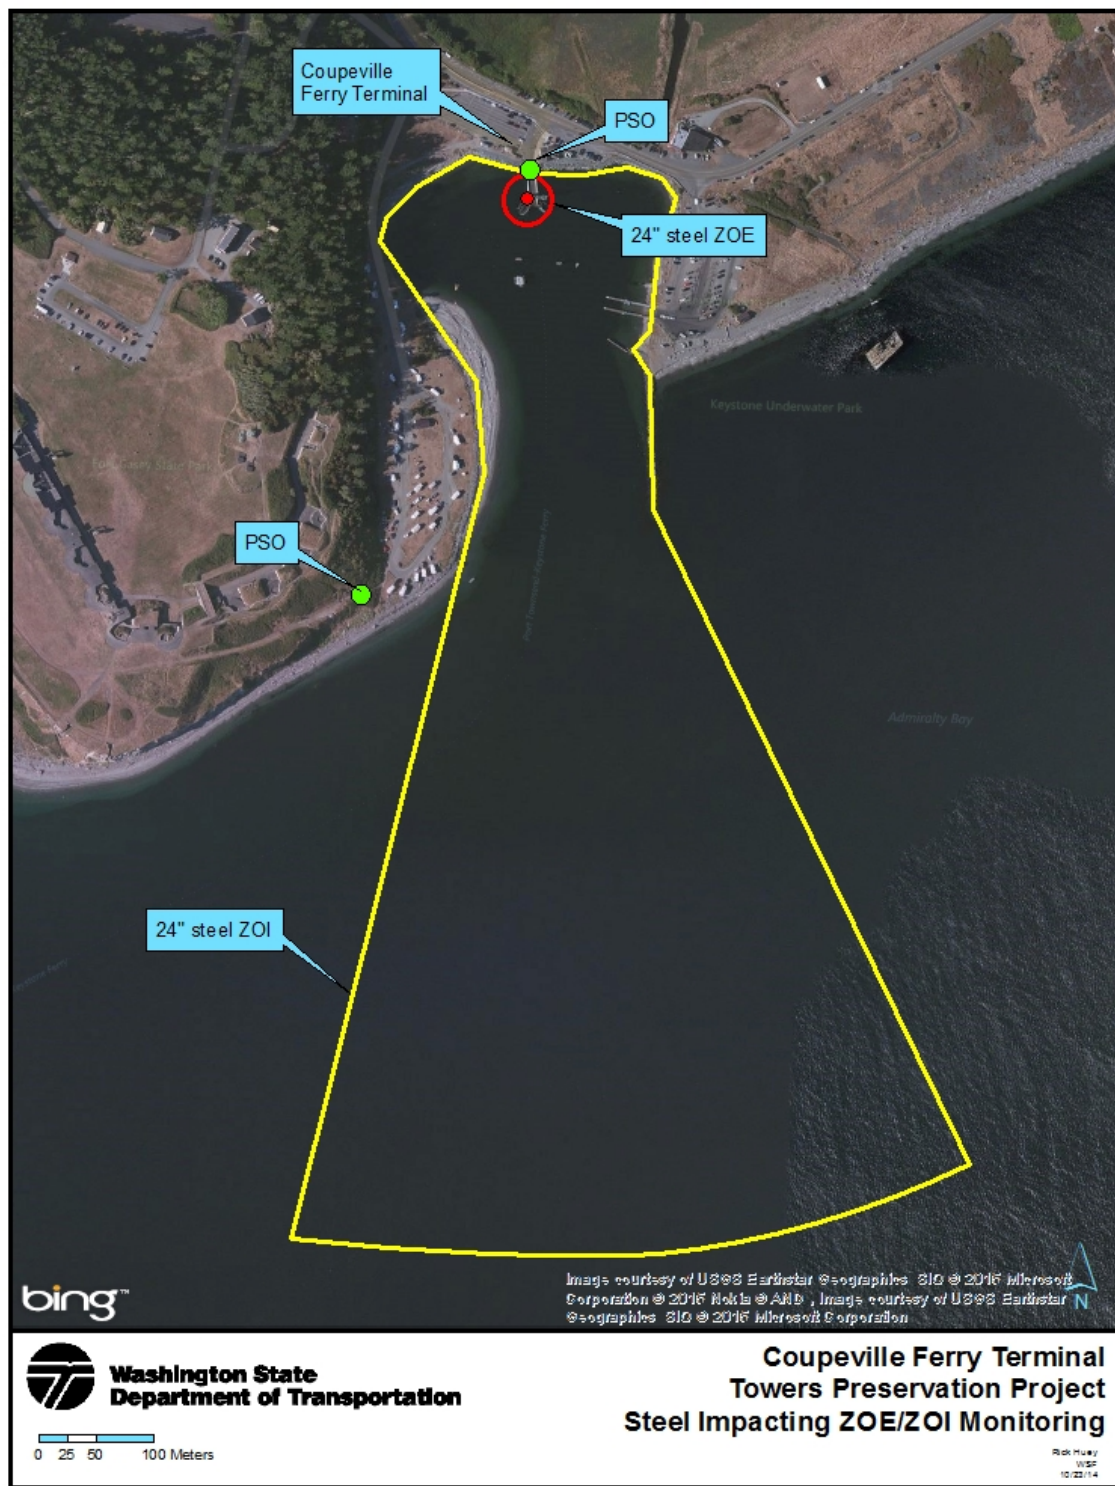
Figure 3-1 Predicted 24" Steel Impact Monitoring

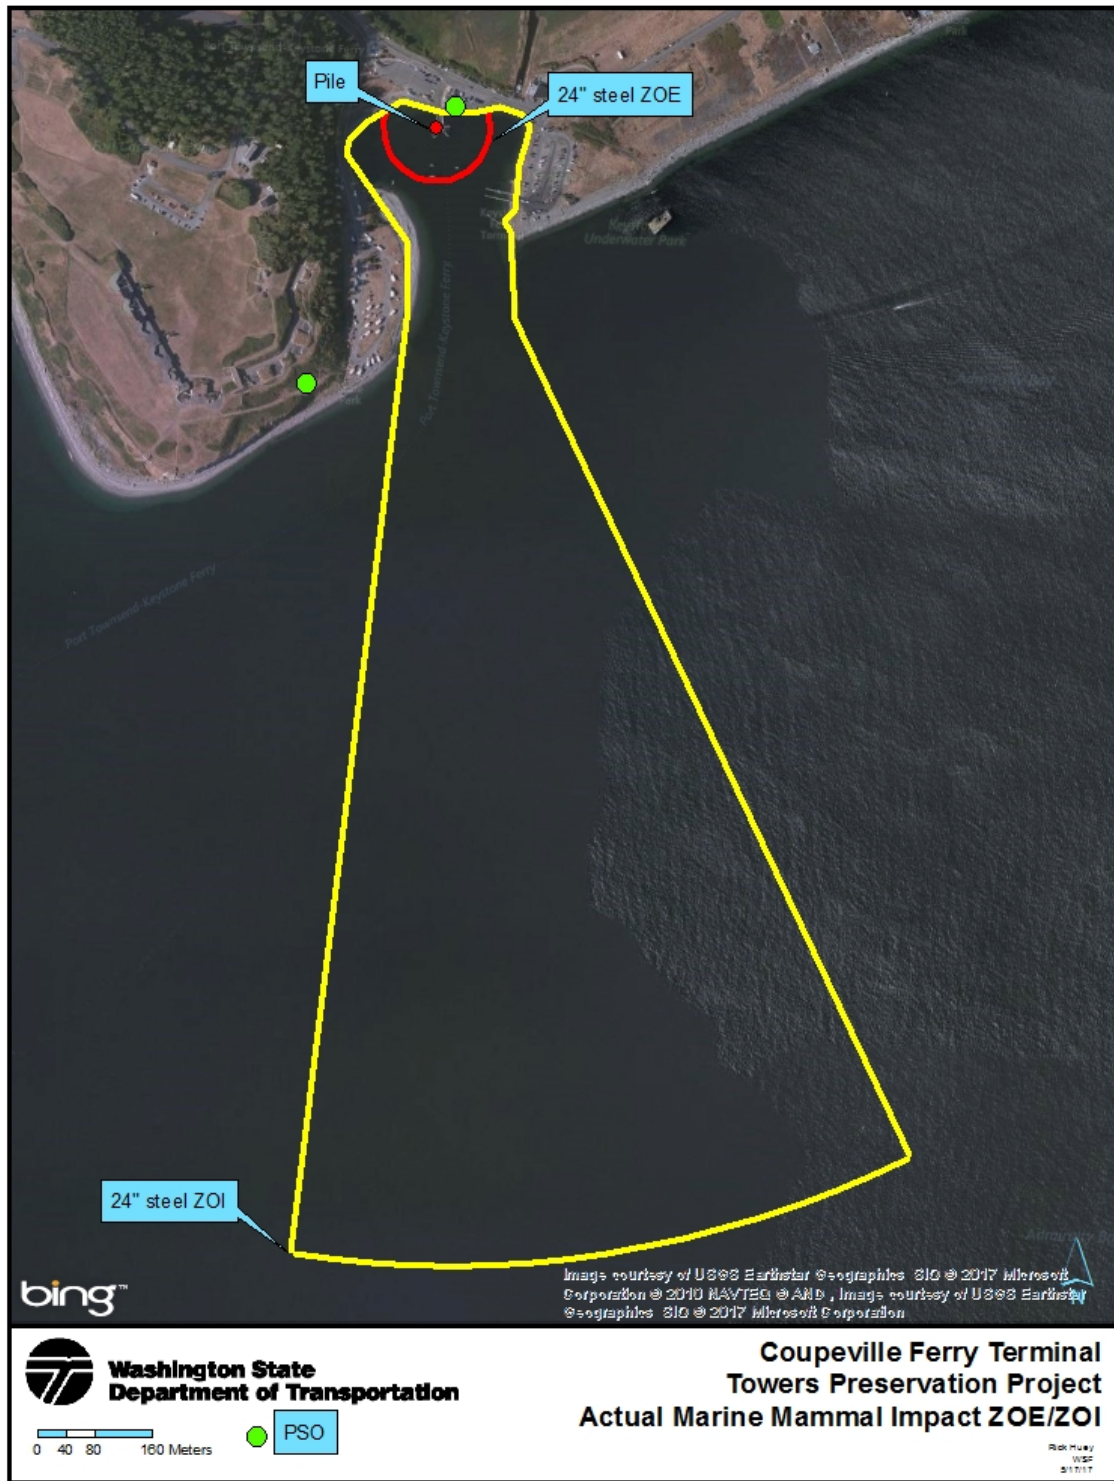
Figure 3-2 Actual 24" Steel Impact Monitoring

During the project, in-water measurements of impact pile driving noise levels were taken. Actual impact driving source level was a maximum of 193 <sub>RMS</sub> vs. the predicted 185 <sub>RMS</sub> source level used to establish the original monitoring areas. The ZOE/ZOI was adjusted accordingly to account for the actual source level (Figure 3-2).

- During 24-inch steel impact pile driving, two land-based PSOs monitored the ZOE and ZOI (Figure 3-2).
- During vibratory timber pile removal, two land-based PSOs monitored the ZOI (Figure 3-3).

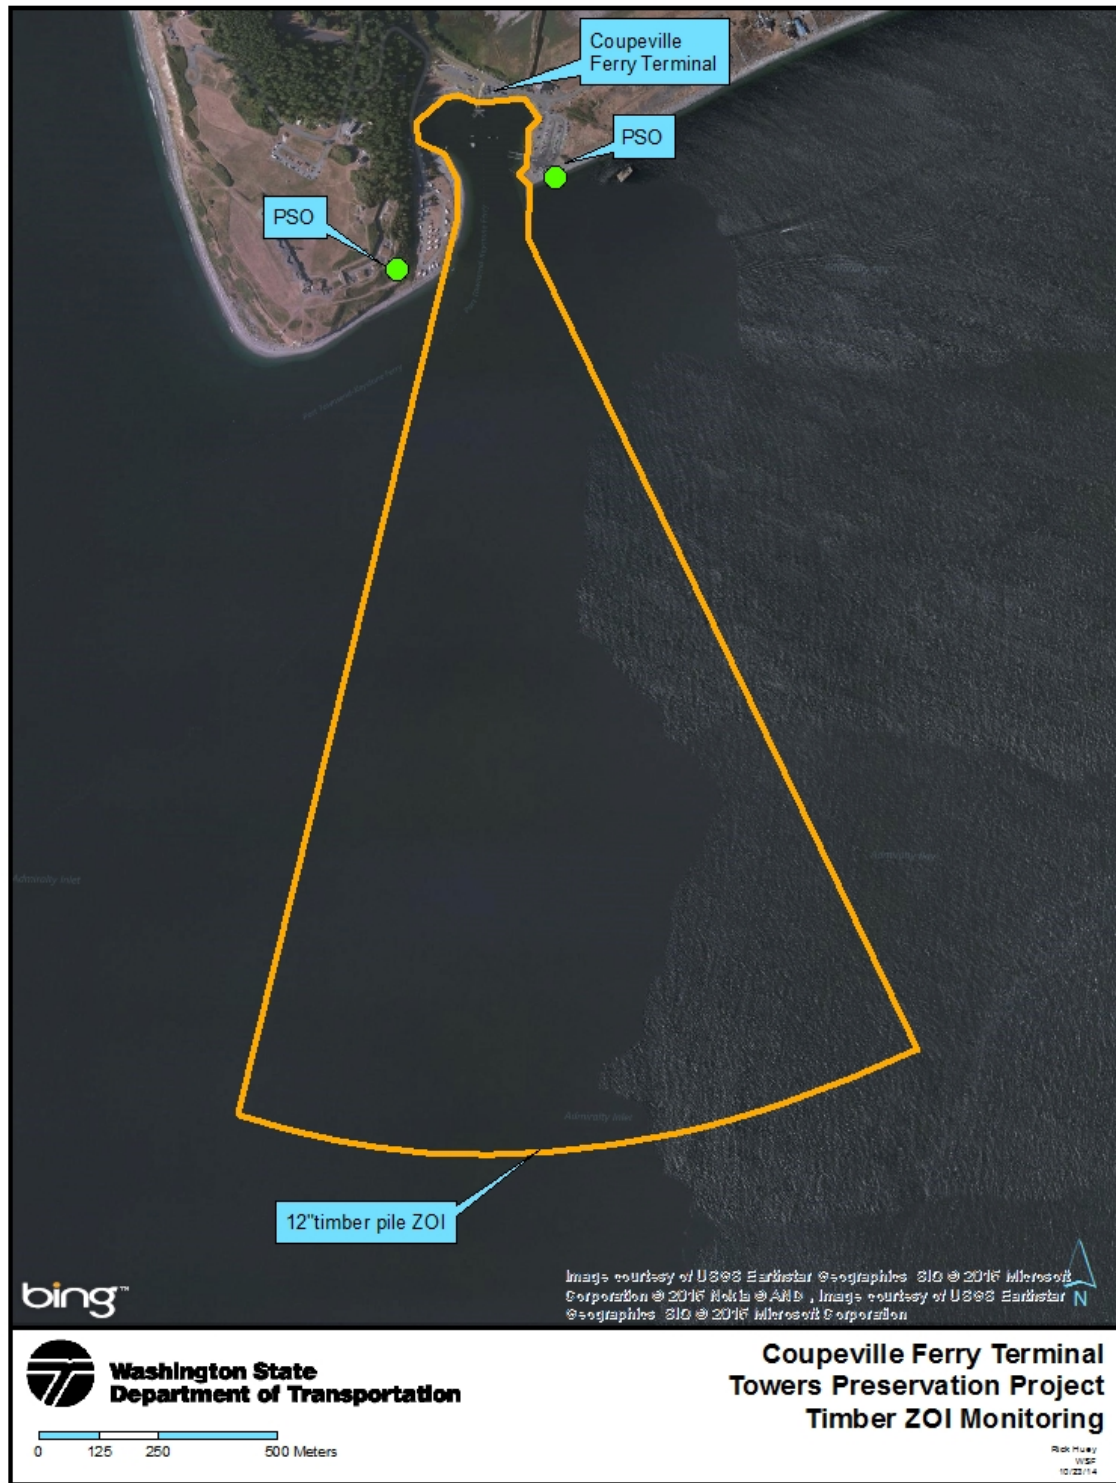
Figure 3-3 12" Timber Vibratory Removal Monitoring

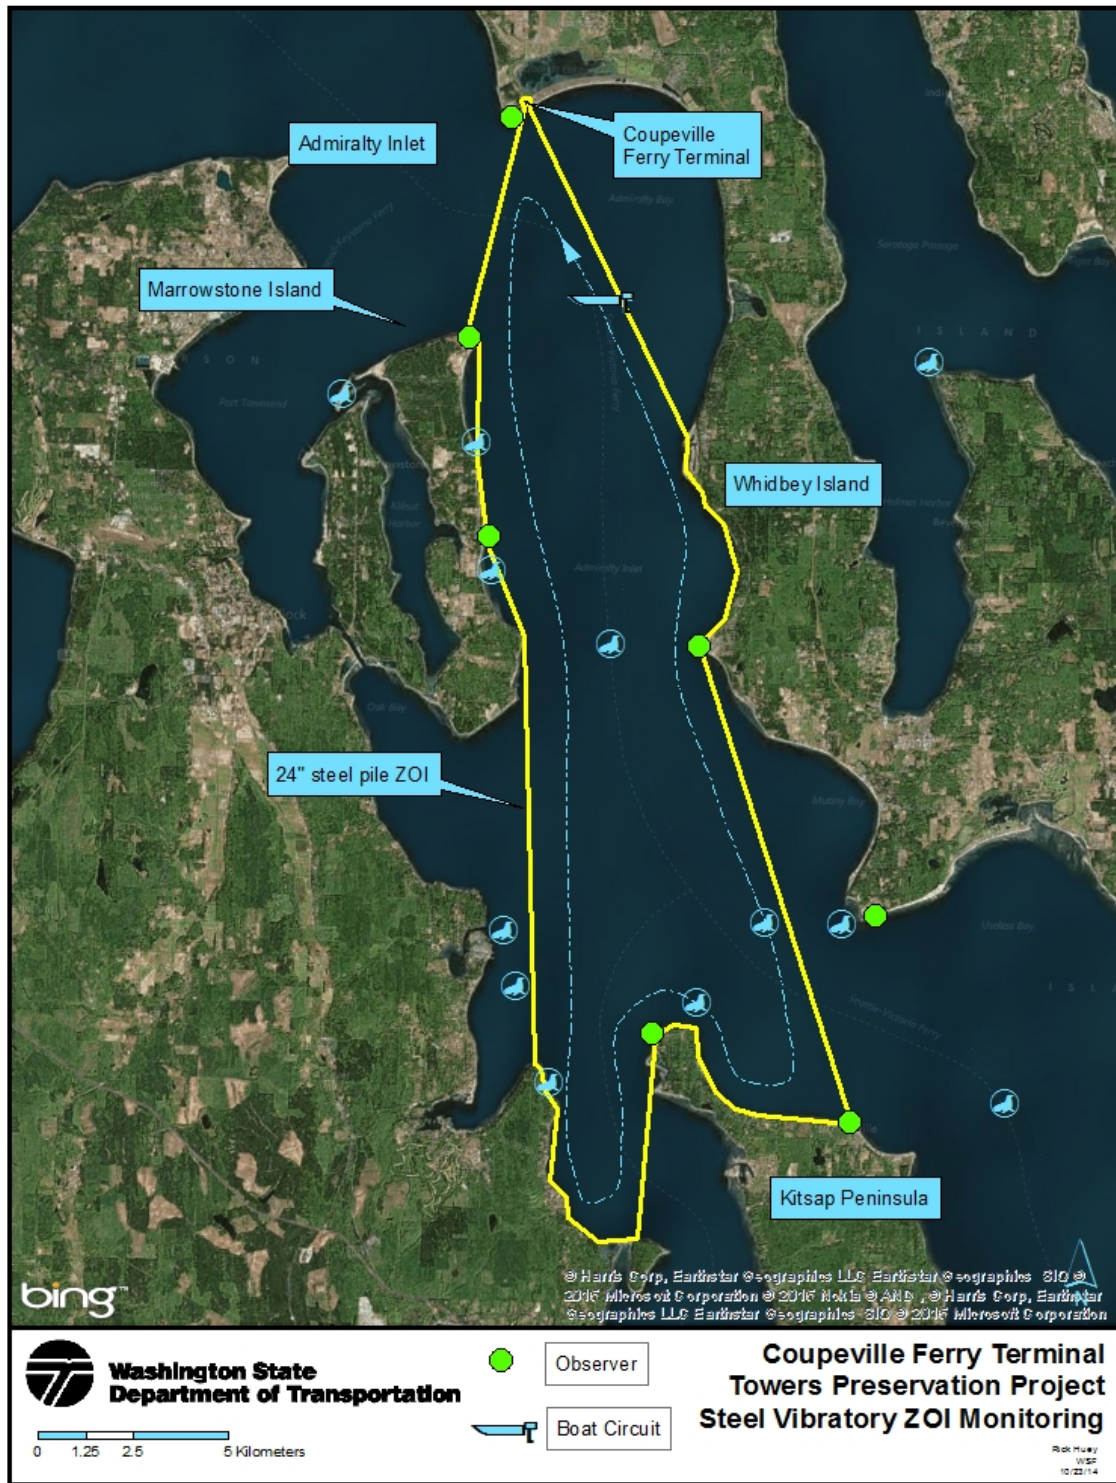
Figure 3-4 24" Steel Vibratory Removal Monitoring

Use of a vibratory hammer to drive steel piles would have created a 31 km/19-mile long/140 sq. km/54 square mile vibratory zone of influence (ZOI) (Figure 3-4). If there were delays due to the inability to monitor the ZOI (reduced visibility and rough water), then the two-day terminal closure would have been put at risk. Eliminating vibratory hammer installation reduced that risk.

- During 24-inch vibratory pile removal, 7 land-based PSOs and one monitoring boat with a PSO and boat operator monitored the ZOI (Figure 3-4).
- To verify the required monitoring distance, the ZOE and ZOIs were determined by using a range finder or hand-held global positioning system device.

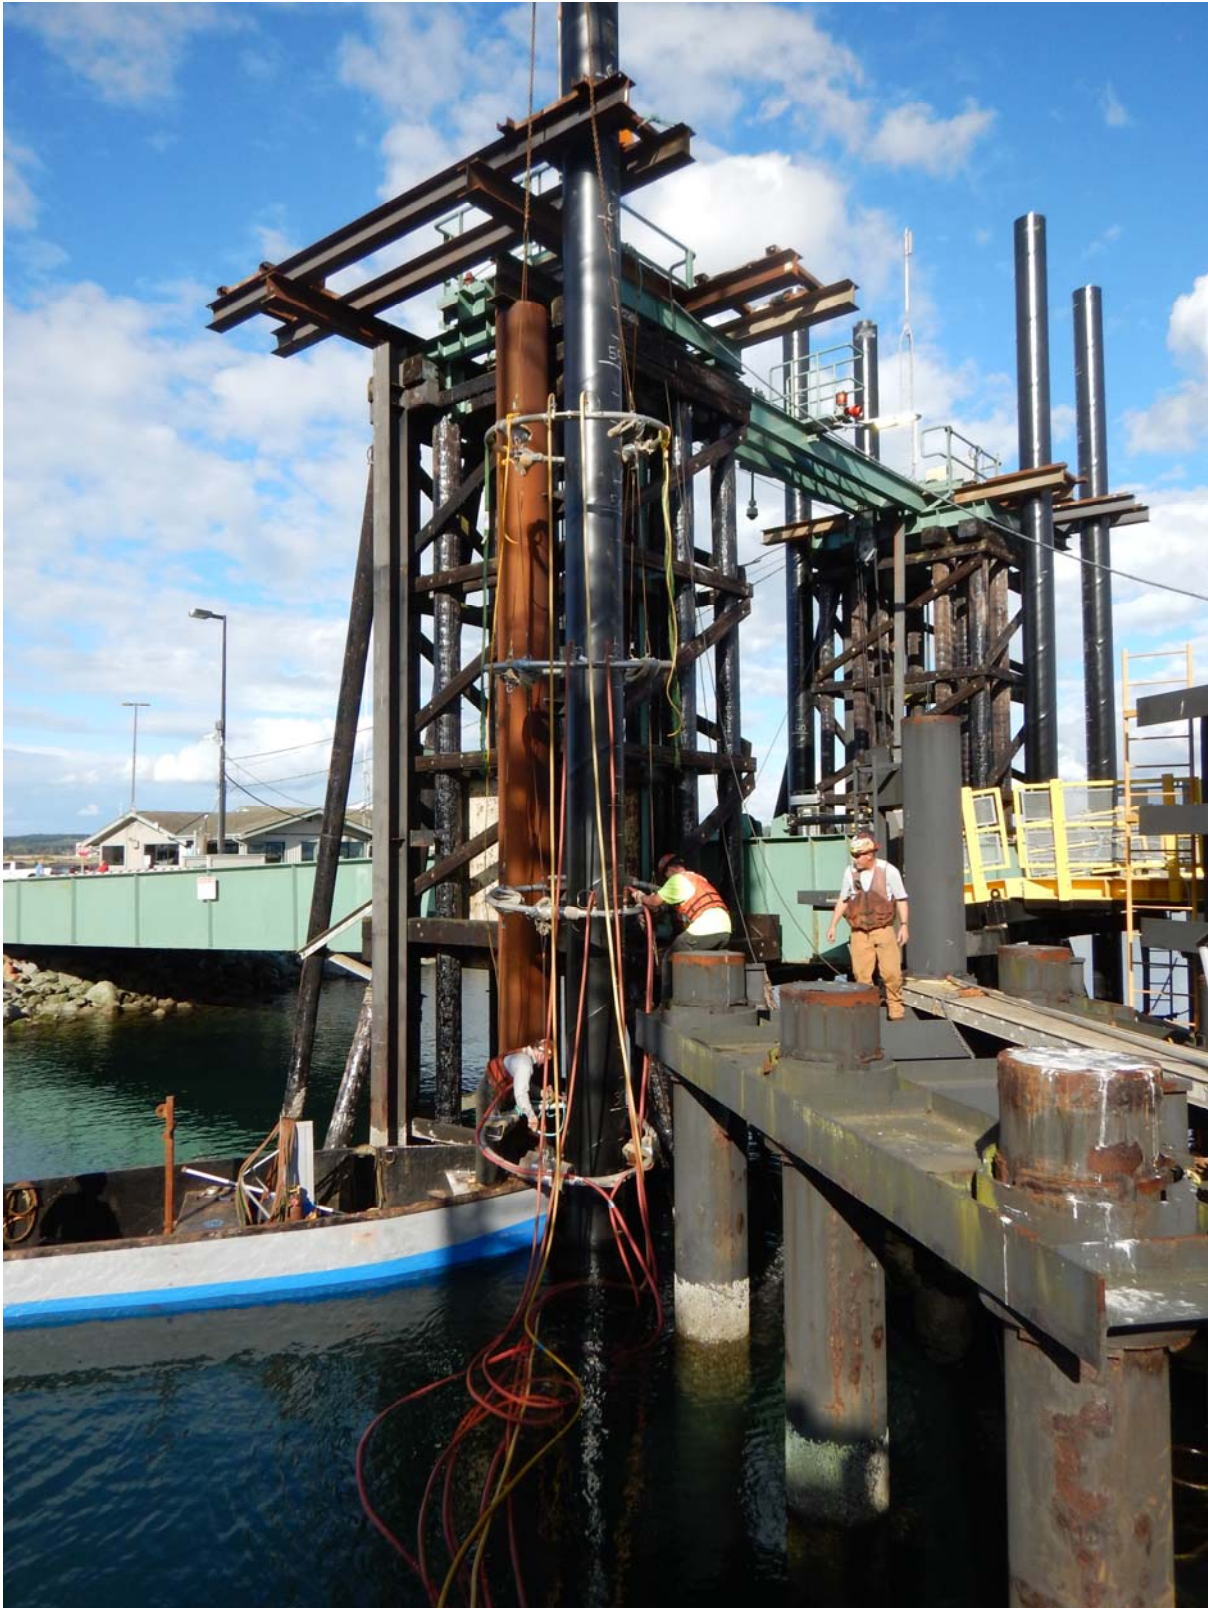
Figure 1 Preparing Bubble Curtain

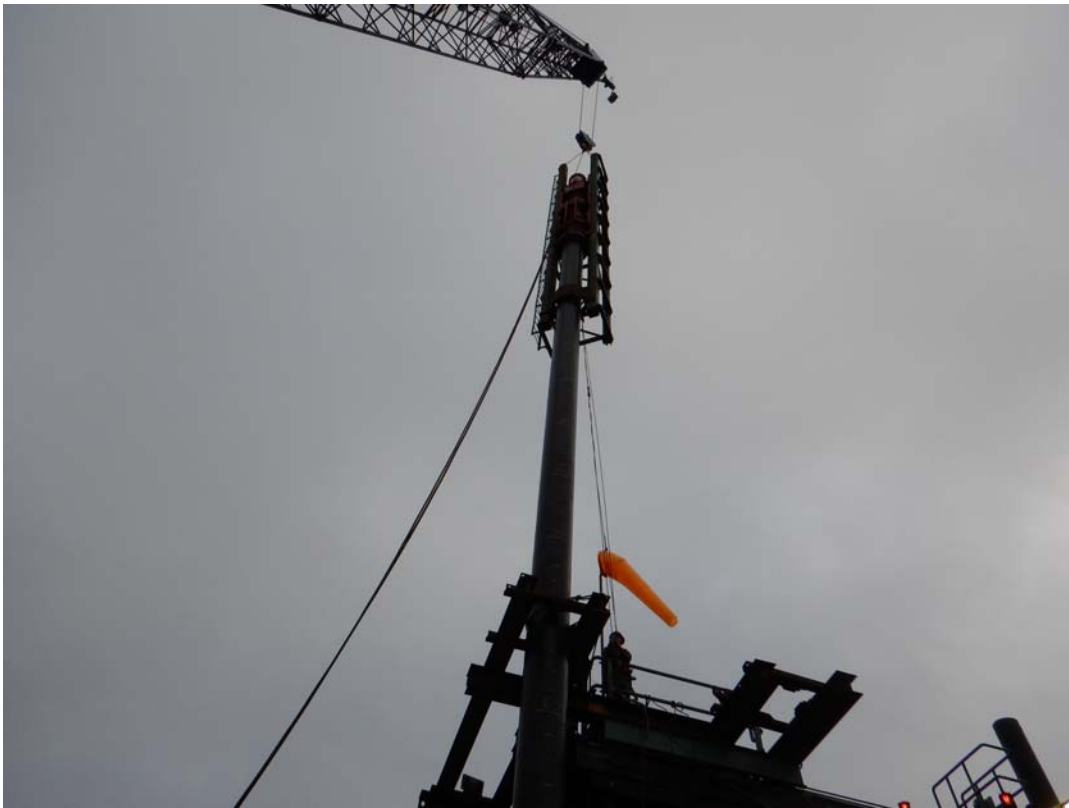
**Figure 2 Positioning Impact Hammer**

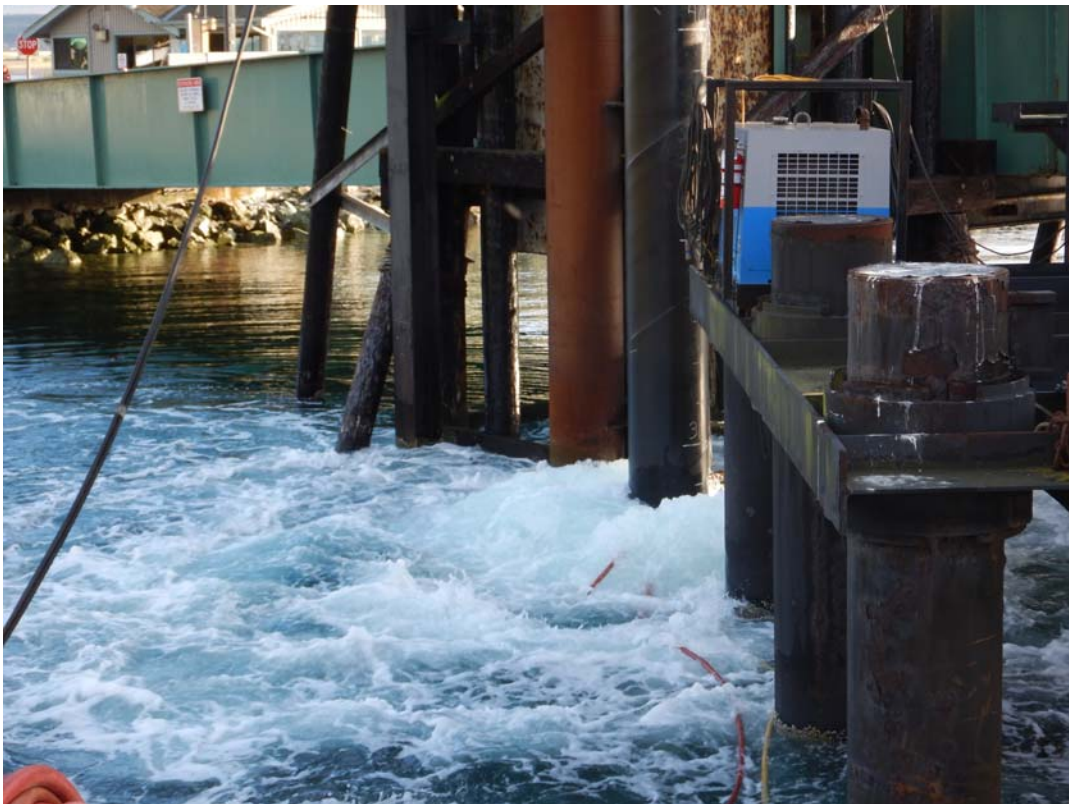
**Figure 3 Bubble Curtain Active**

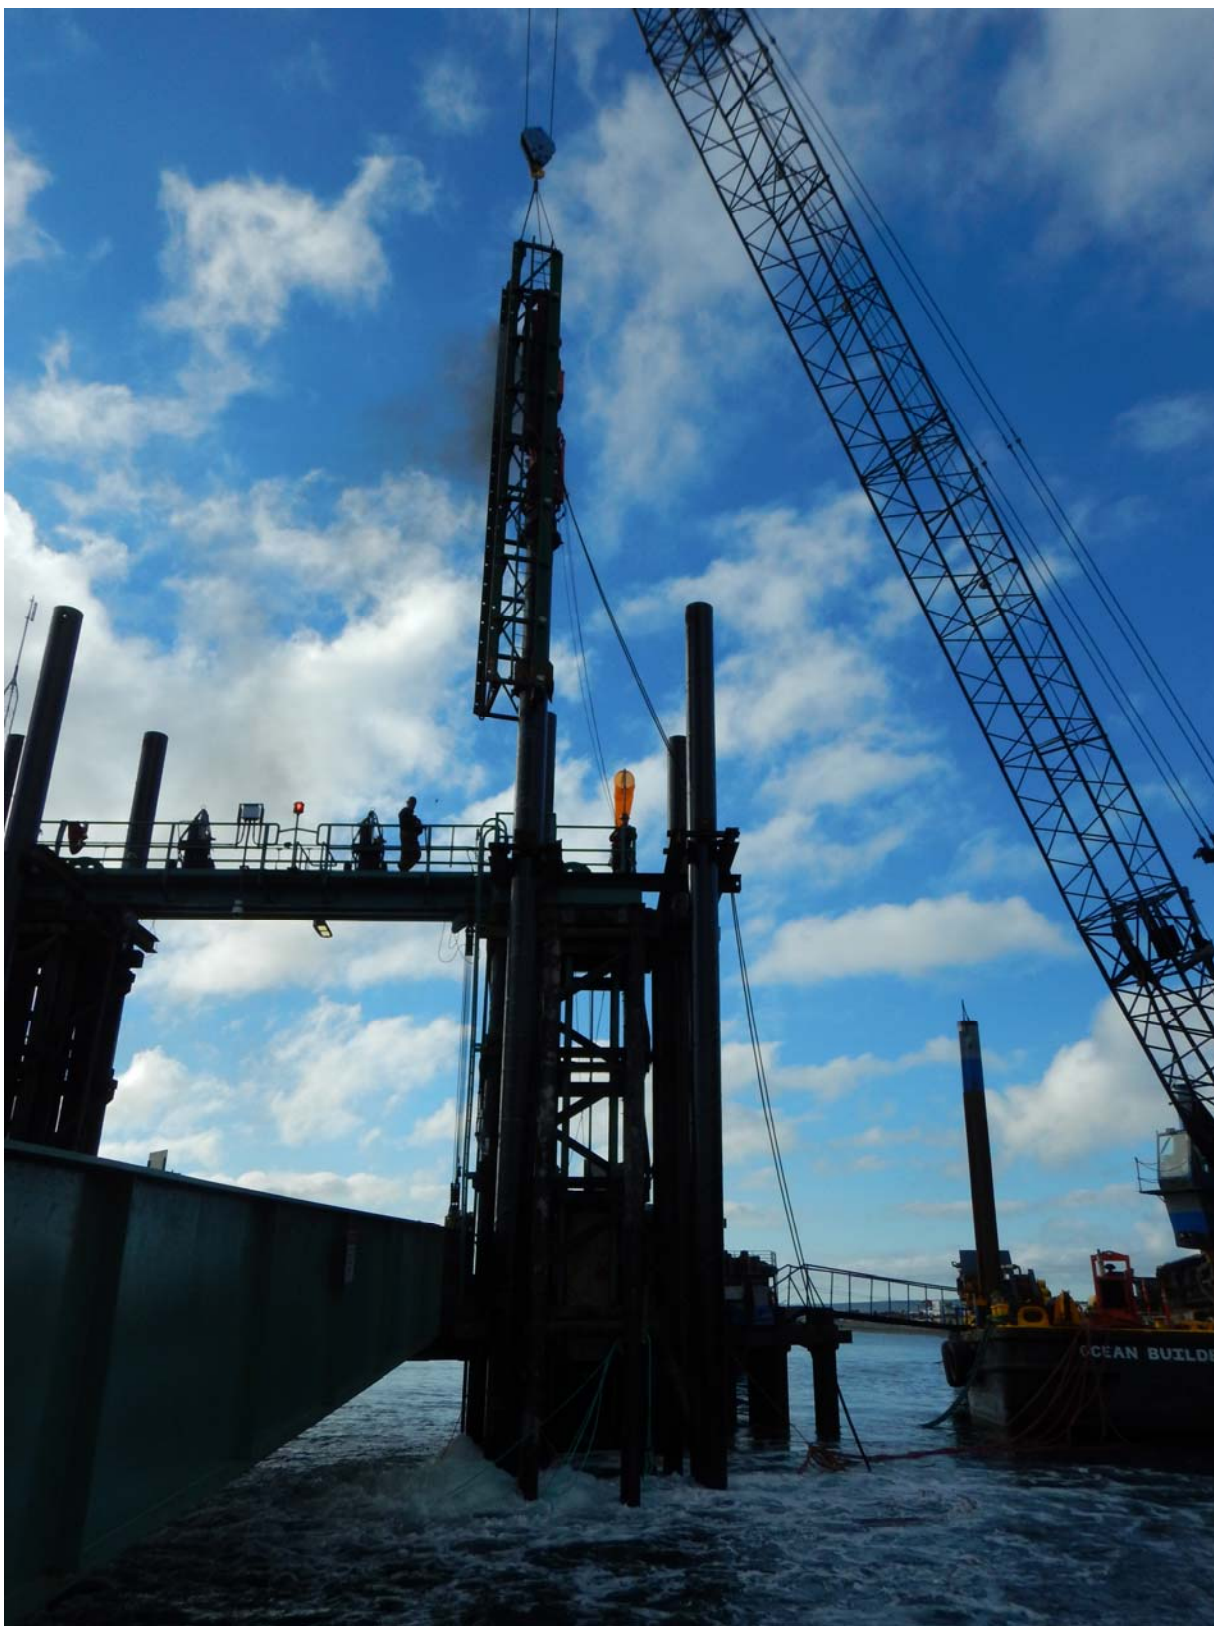
**Figure 4 Impact Driving**

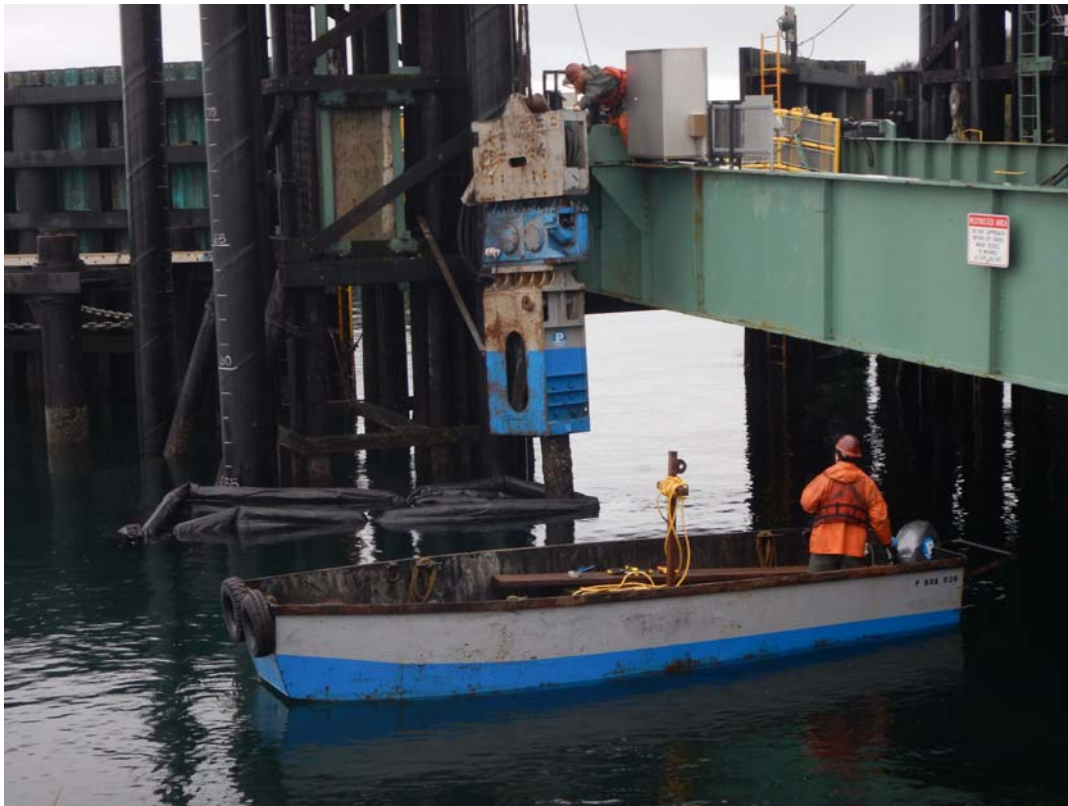
**Figure 5 Vibratory Removal of Timber Pile**

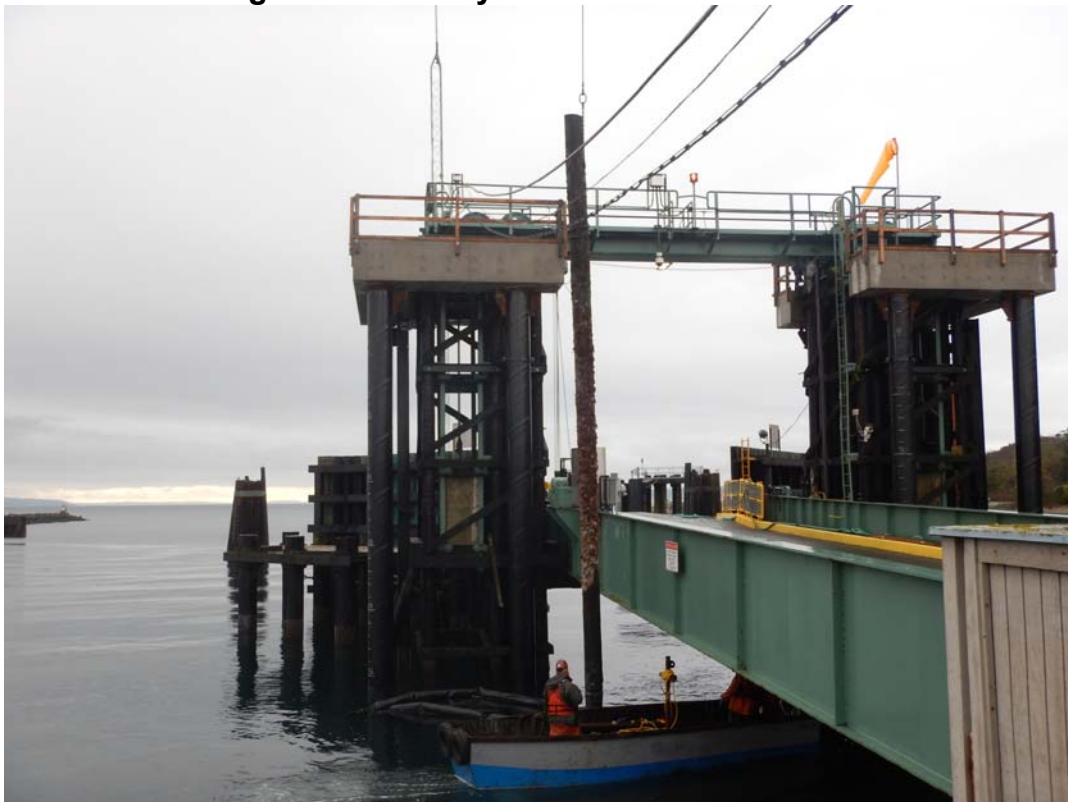
**Figure 6 Cable Lift Timber Pile to Barge**

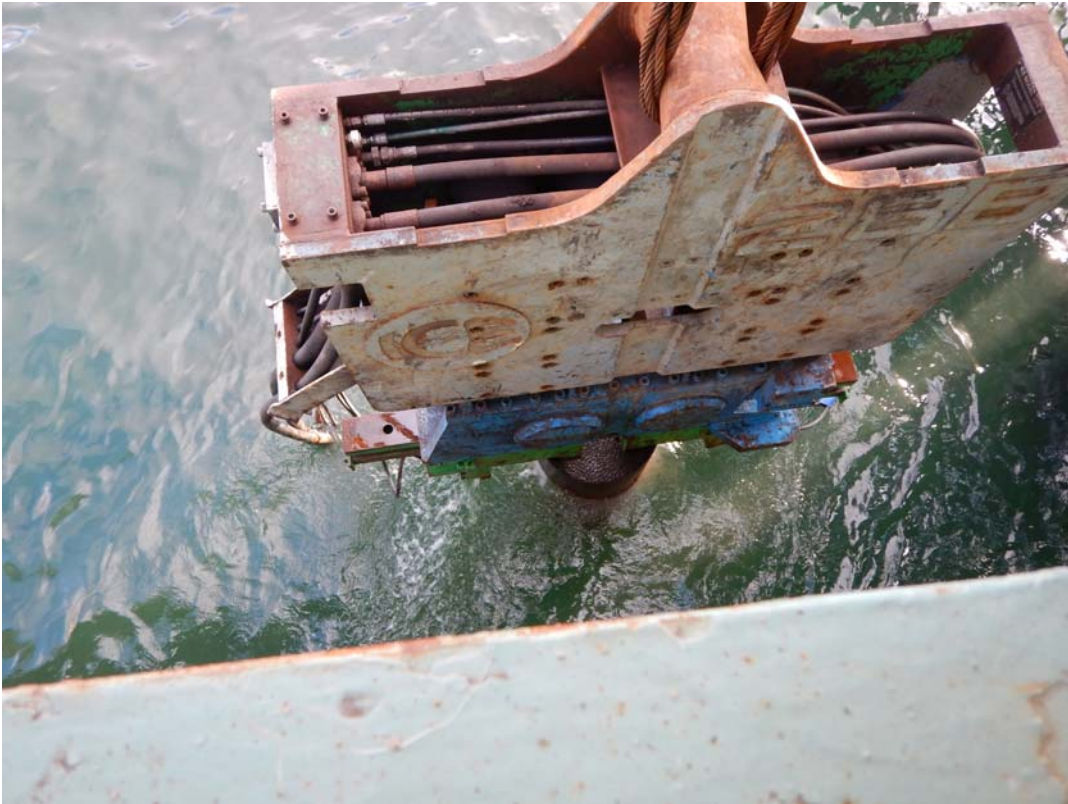
**Figure 7 Vibratory Removal of Steel Pile**

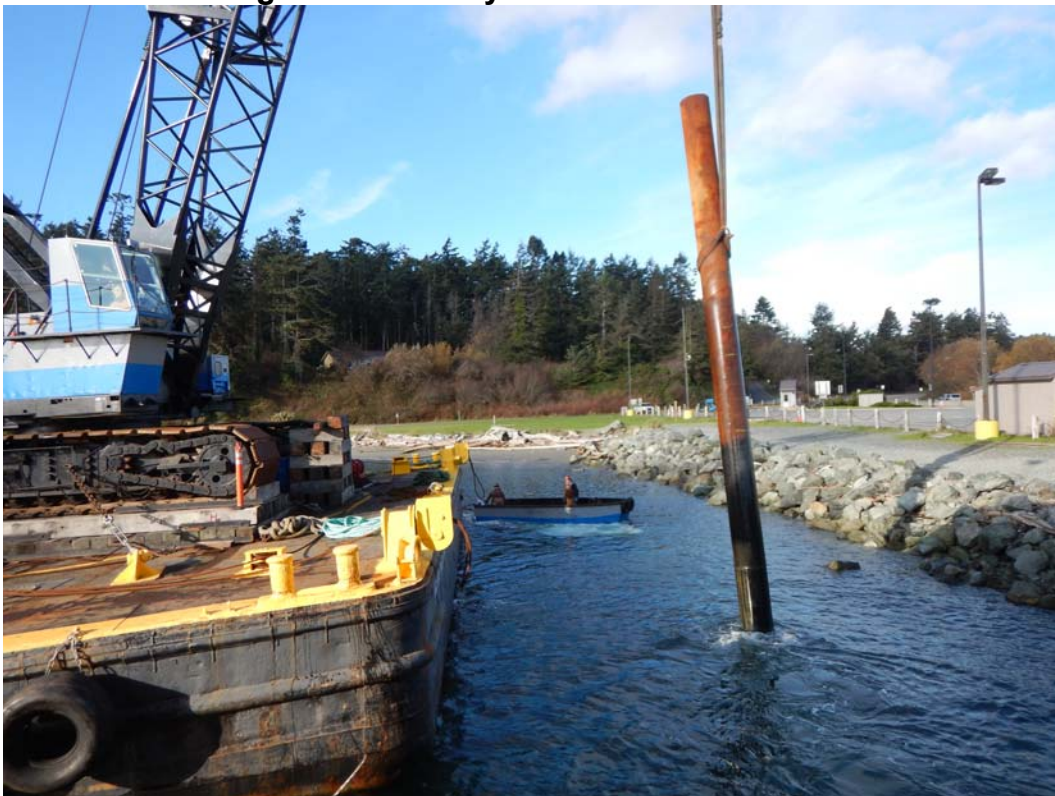
**Figure 8 Cable Lift of Steel Pile to Barge**
