**Seattle Multimodal Project at Colman Dock
Season Three Marine Mammal Monitoring Report**

**Washington State Department of Transportation
Ferries Division**

April 29, 2020

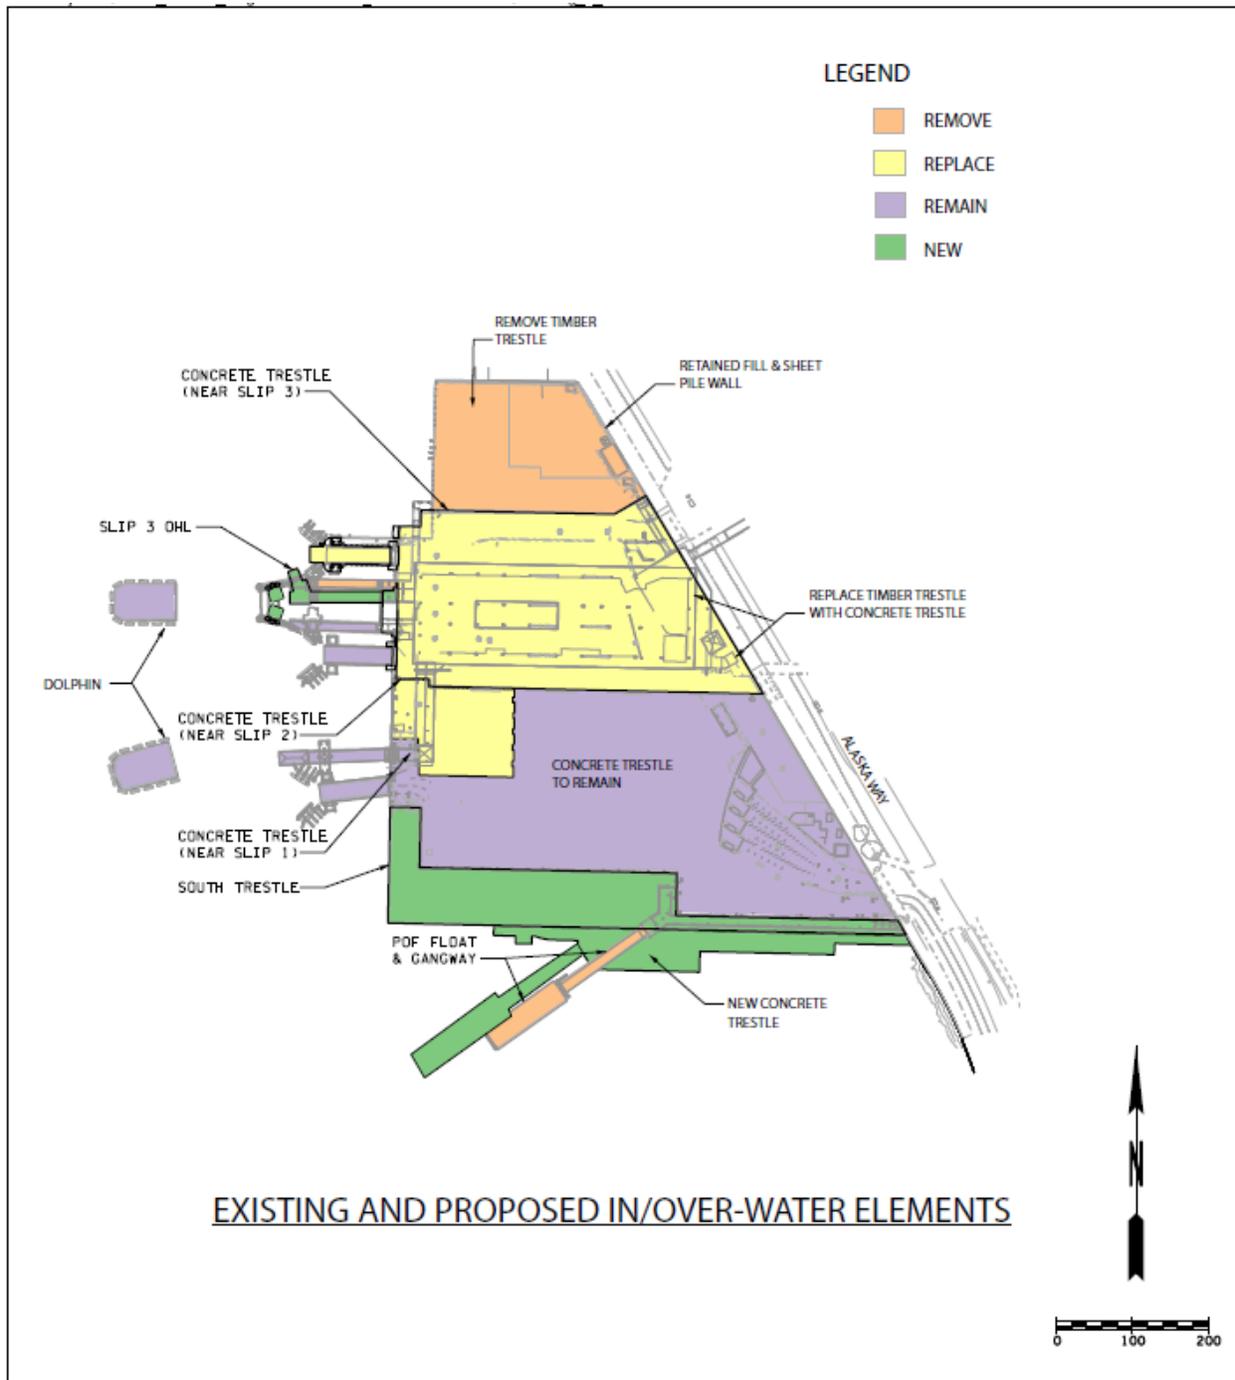
Figure 1-2 Existing/Proposed Construction Elements

The project will remove the northern timber trestle and replace a portion of it with a new concrete trestle (Figure 1-2). The area from Marion Street to the north edge of the property will not be rebuilt and will become, after demolition, a new area of open water. A section of fill contained behind a bulkhead underneath the northeast section of the dock will also be removed. WSF will construct a new steel and concrete trestle from Columbia Street northward to Marion Street.

Construction of the reconfigured dock will narrow (reduce) the OWC along the shoreline (at the landward edge) by 180 linear feet at the north end of the site, while 30 linear feet of new trestle would be constructed along the shoreline at the south end of the site. The net reduction of OWC in the nearshore zone is 150 linear feet.
