5. Chapter 5: Bull Creek Action Plan

5.1 Sub-Watershed Overview

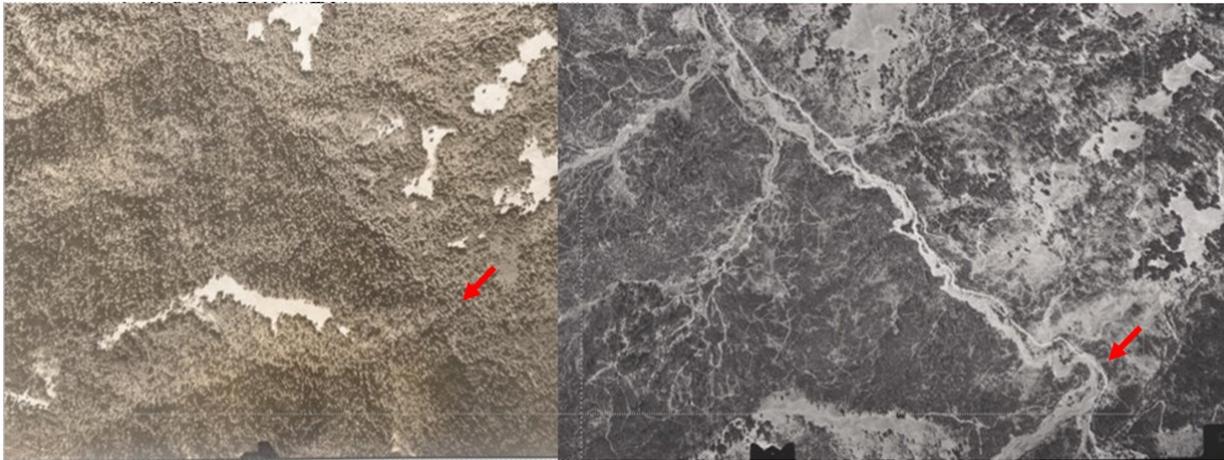
Figure 5-5. Upper Bull Creek from Slide Creek to Panther Creek from 1942 (left) to 1965 (right). The extensive upland road networks, deforestation, and flood damage are shown in stark contrast to the nearly unaltered 1942 landscape. The red arrows indicate the confluence of Panther Creek and Bull Creek.
