**ST. GEORGE REEF  
LIGHTHOUSE RESTORATION, MAINTENANCE, AND TOUR  
OPERATIONS**

**APPLICATION FOR A MARINE MAMMAL PROTECTION ACT INCIDENTAL  
HARASSMENT AUTHORIZATION**

**Applicant: St. George Reef Lighthouse Preservation Society**

November 2016

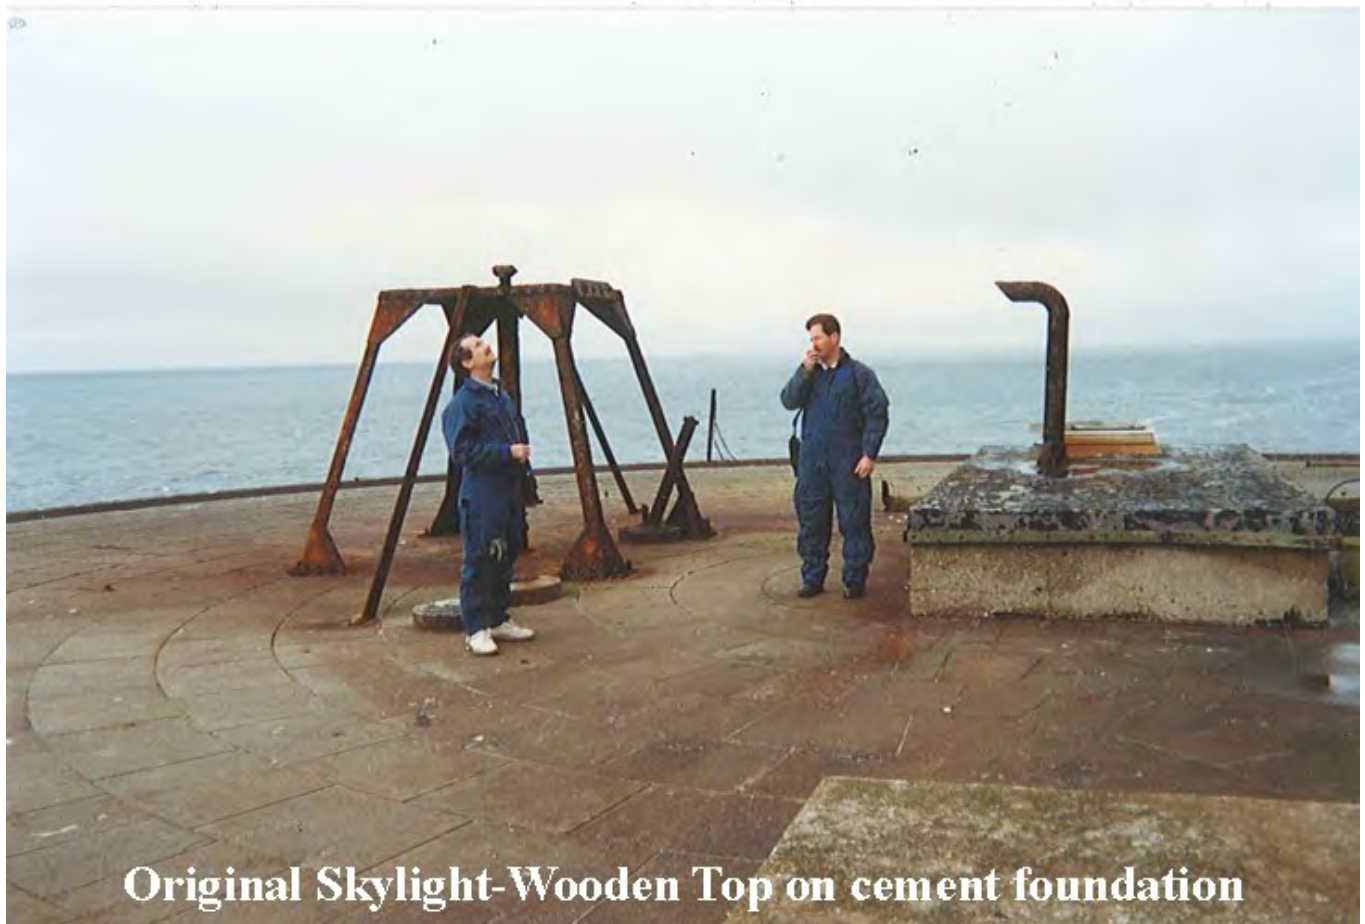
**Original Skylight-Wooden Top on cement foundation**

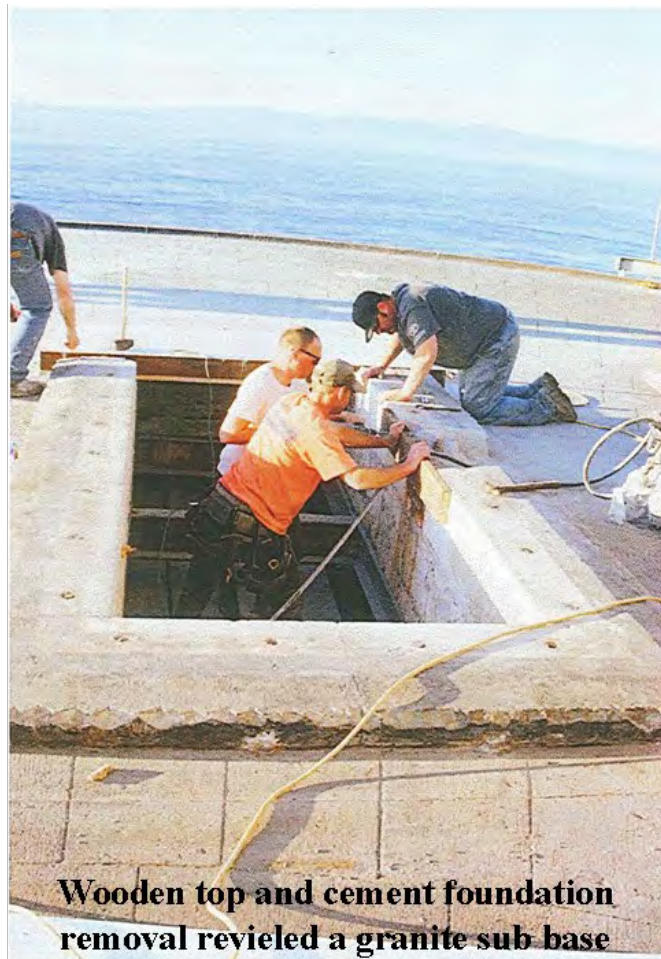
**Wooden top and cement foundation  
removal revealed a granite sub base**

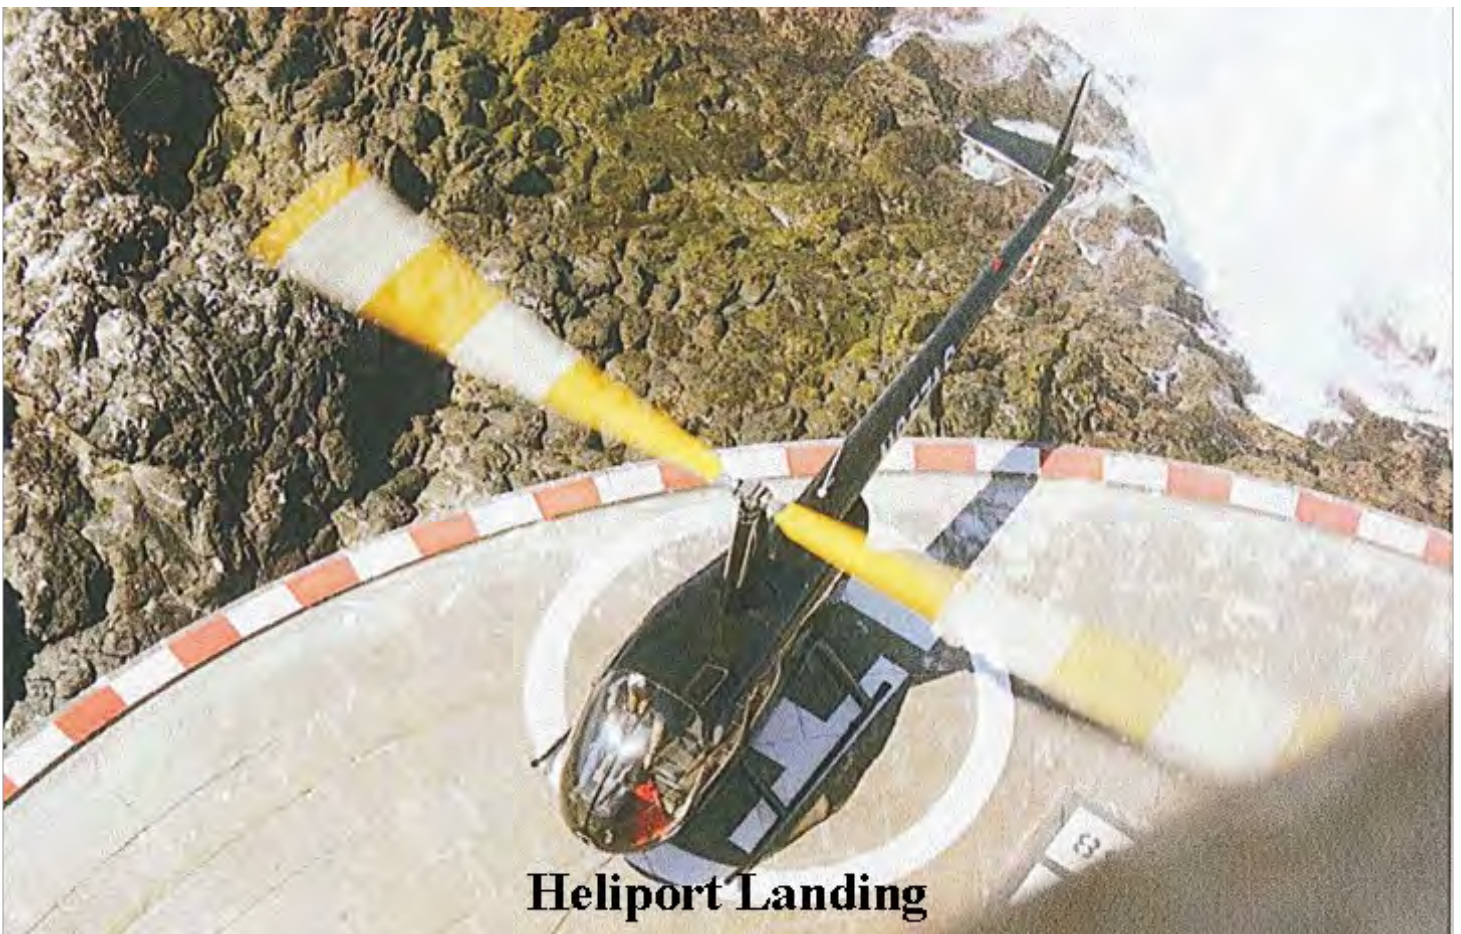
**Heliport Landing**
